19 January 2021

Project No.: G2102

RE: Preliminary Geotechnical Assessment Report for 19 Cromer Road, Cromer NSW 2099

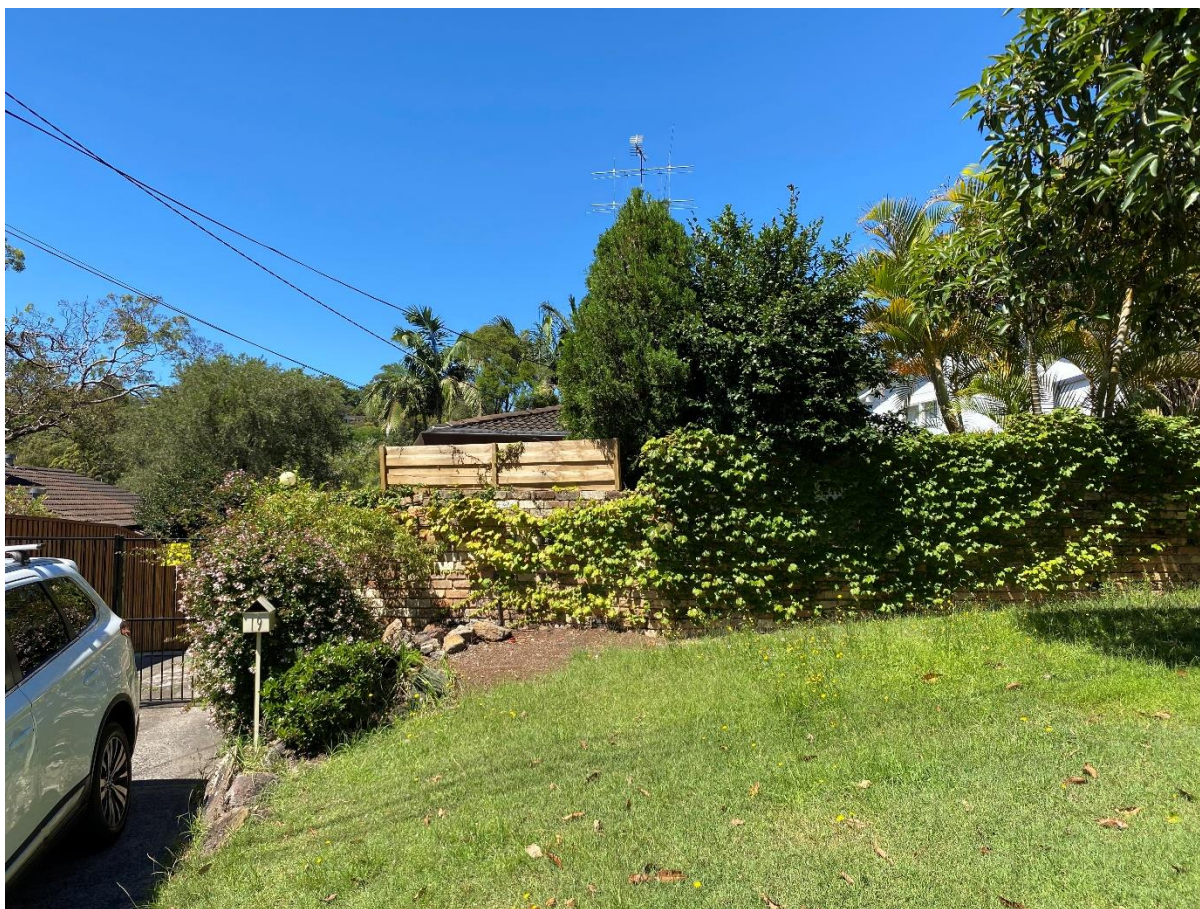
Front view of the property

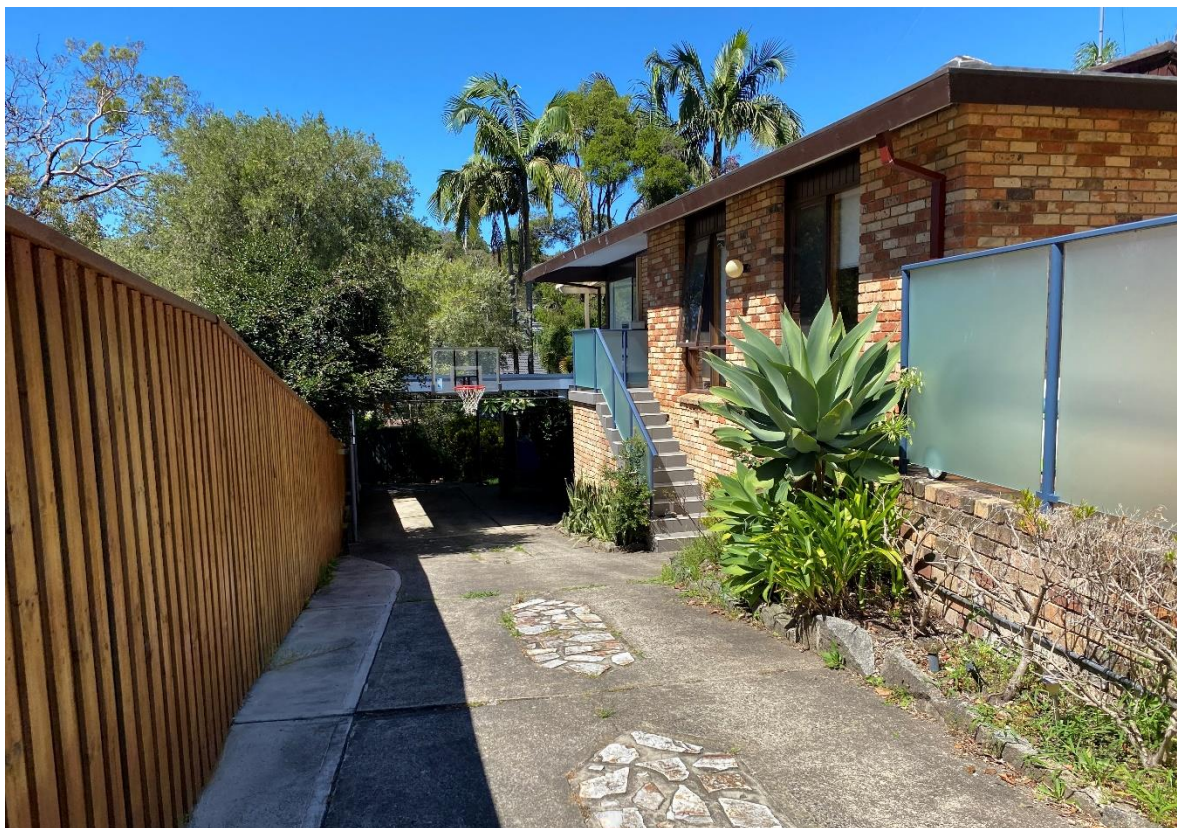
Driveway of the dwelling and the access to the backyard

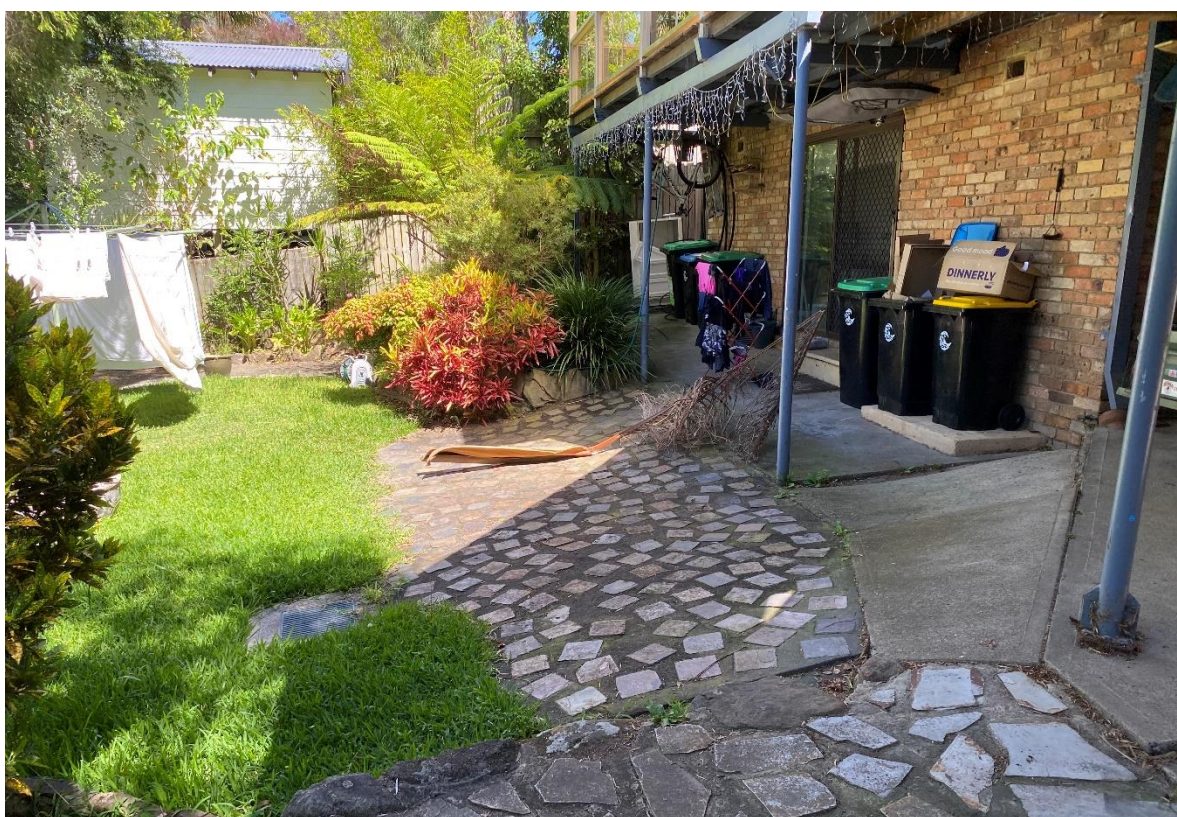
The existing Pergola & Deck to be removed and replaced with the new Pergola & Deck

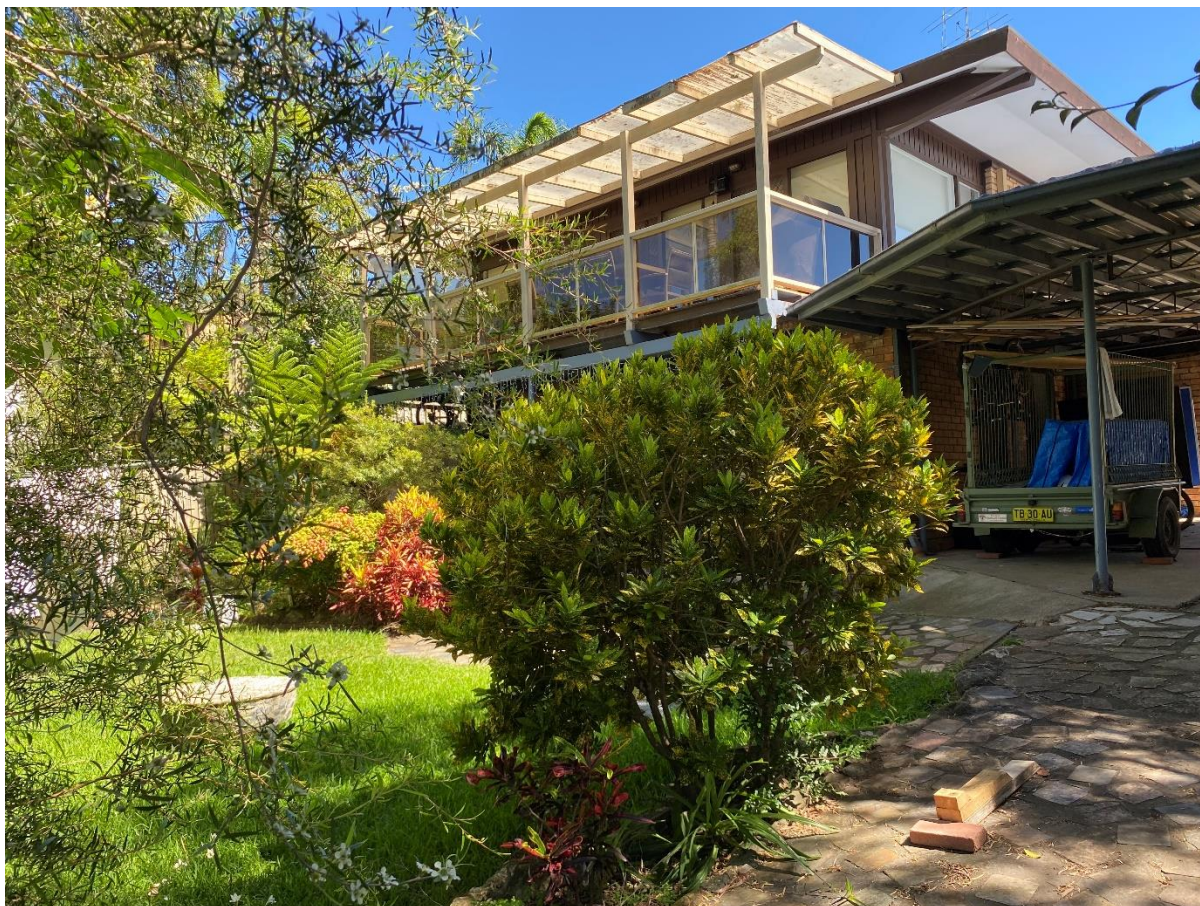
Backyard and the dwelling with the existing Pergola & Deck (Photo taken from rear to front)

There was no indication of instability in the vicinity of the proposed development site that could be attributed to the landslip hazards.

It is recommended that the foundation of footings should be placed on the competent ground and the quality of the founding stratum of footing excavations should be assessed by a suitably qualified geotechnical engineer or engineering geologist.
