GEOTECHNICAL INVESTIGATION REPORT

PROPOSED RESIDENTIAL DEVELOPMENT
122 - 124 QUEENSLIFF ROAD, QUEENSLIFF NSW

PREPARED FOR GEMINI QUEENSLIFF PTY LTD
AND KRISTOFFER HARVEY
REPORT ID: G22006QUE-R01F

Date: 22nd March 2022

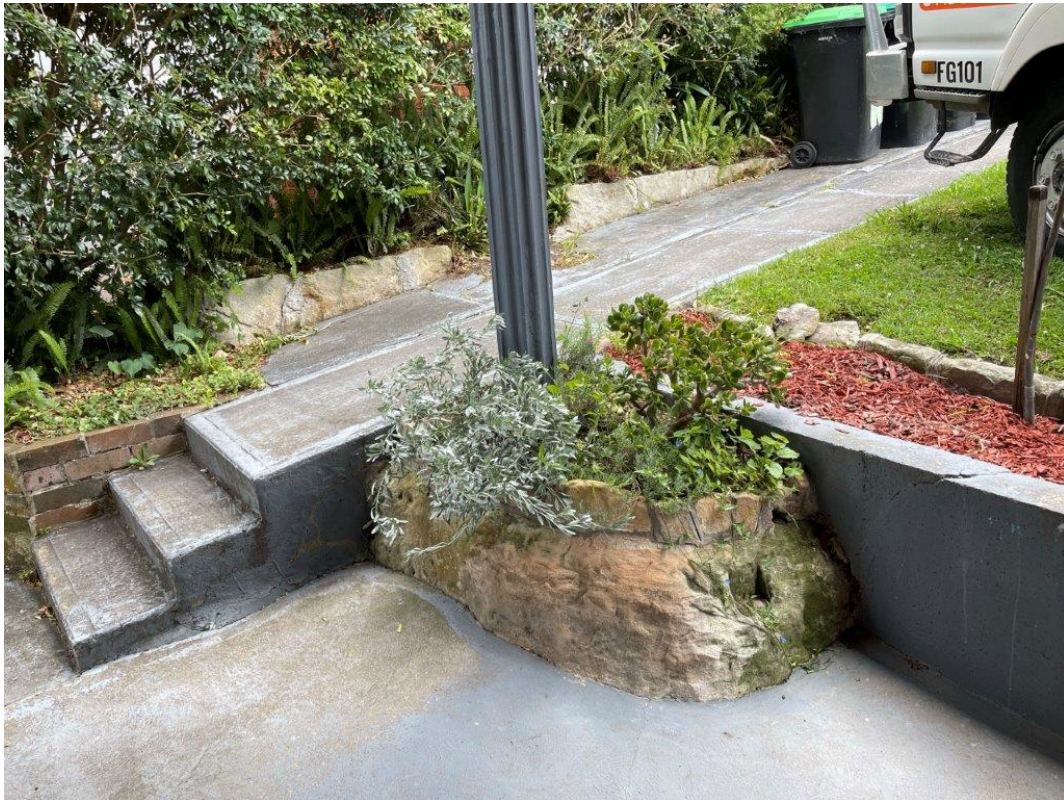
Plate 3: Exposed bedrock at the front of No. 124.

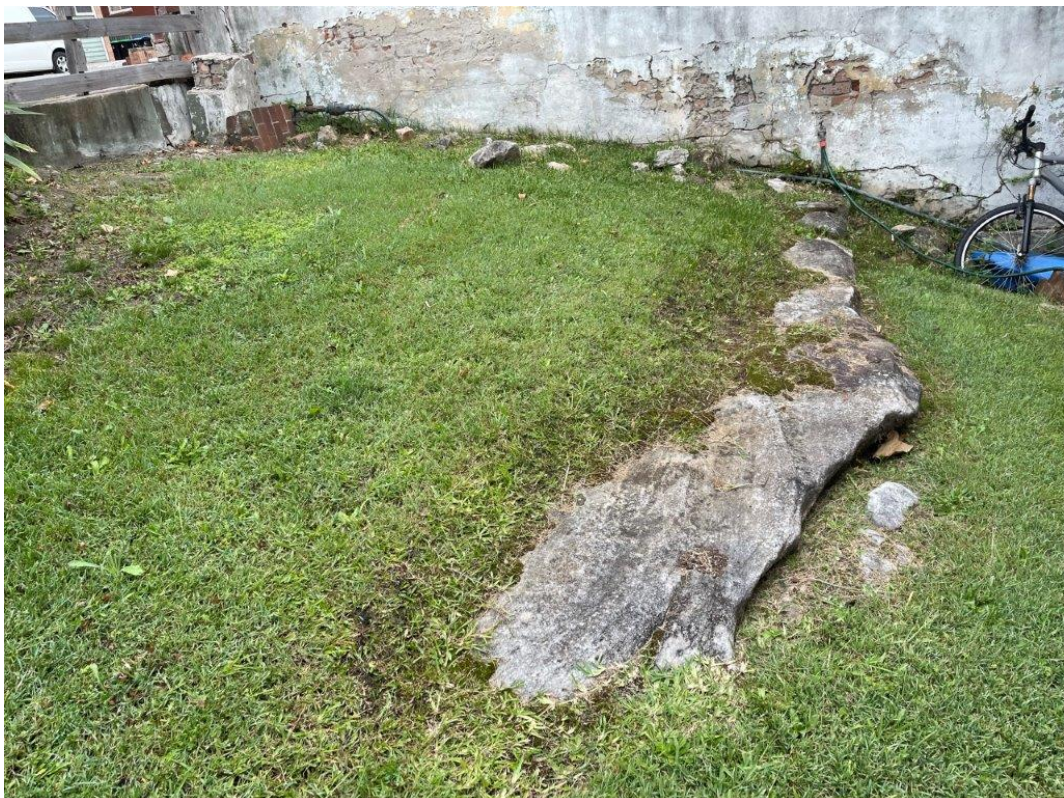
Plate 4: Exposed bedrock at the front of No. 122.

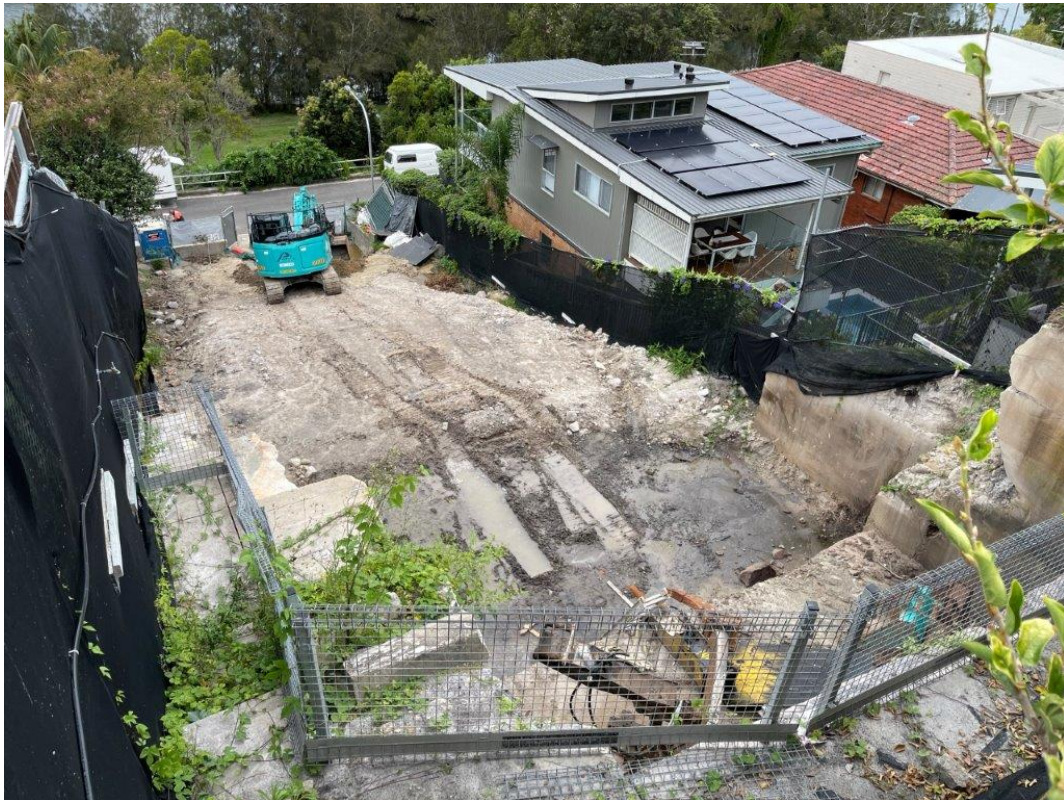
Plate 7: View to the south showing the excavation immediately to the south of No. 124.

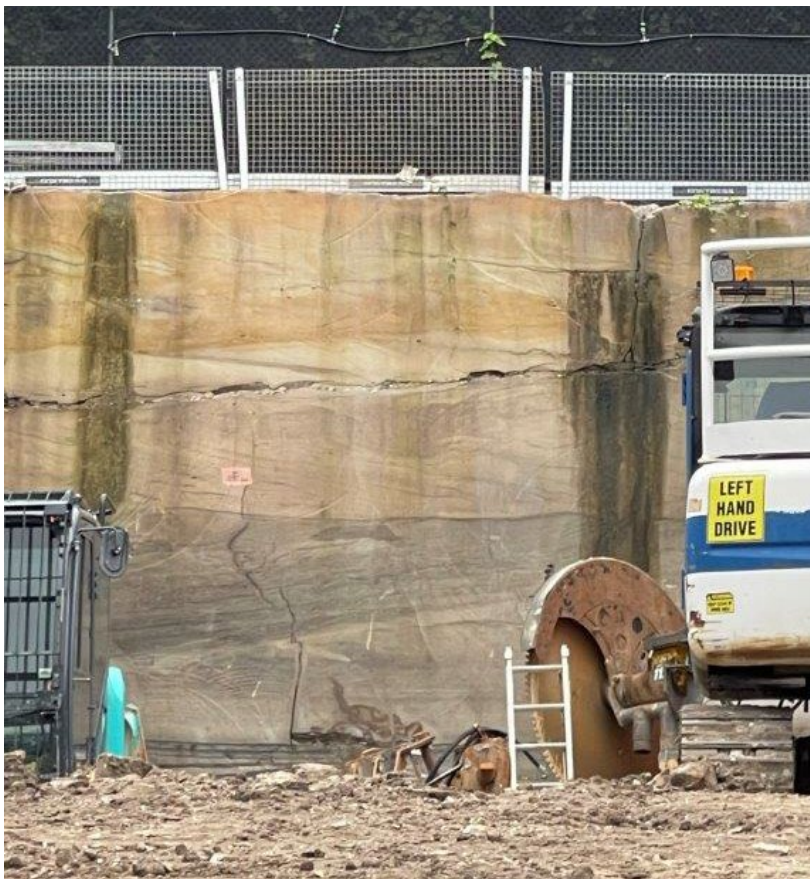
Plate 8: View of the vertical rock excavation face on the adjoining property to the south.

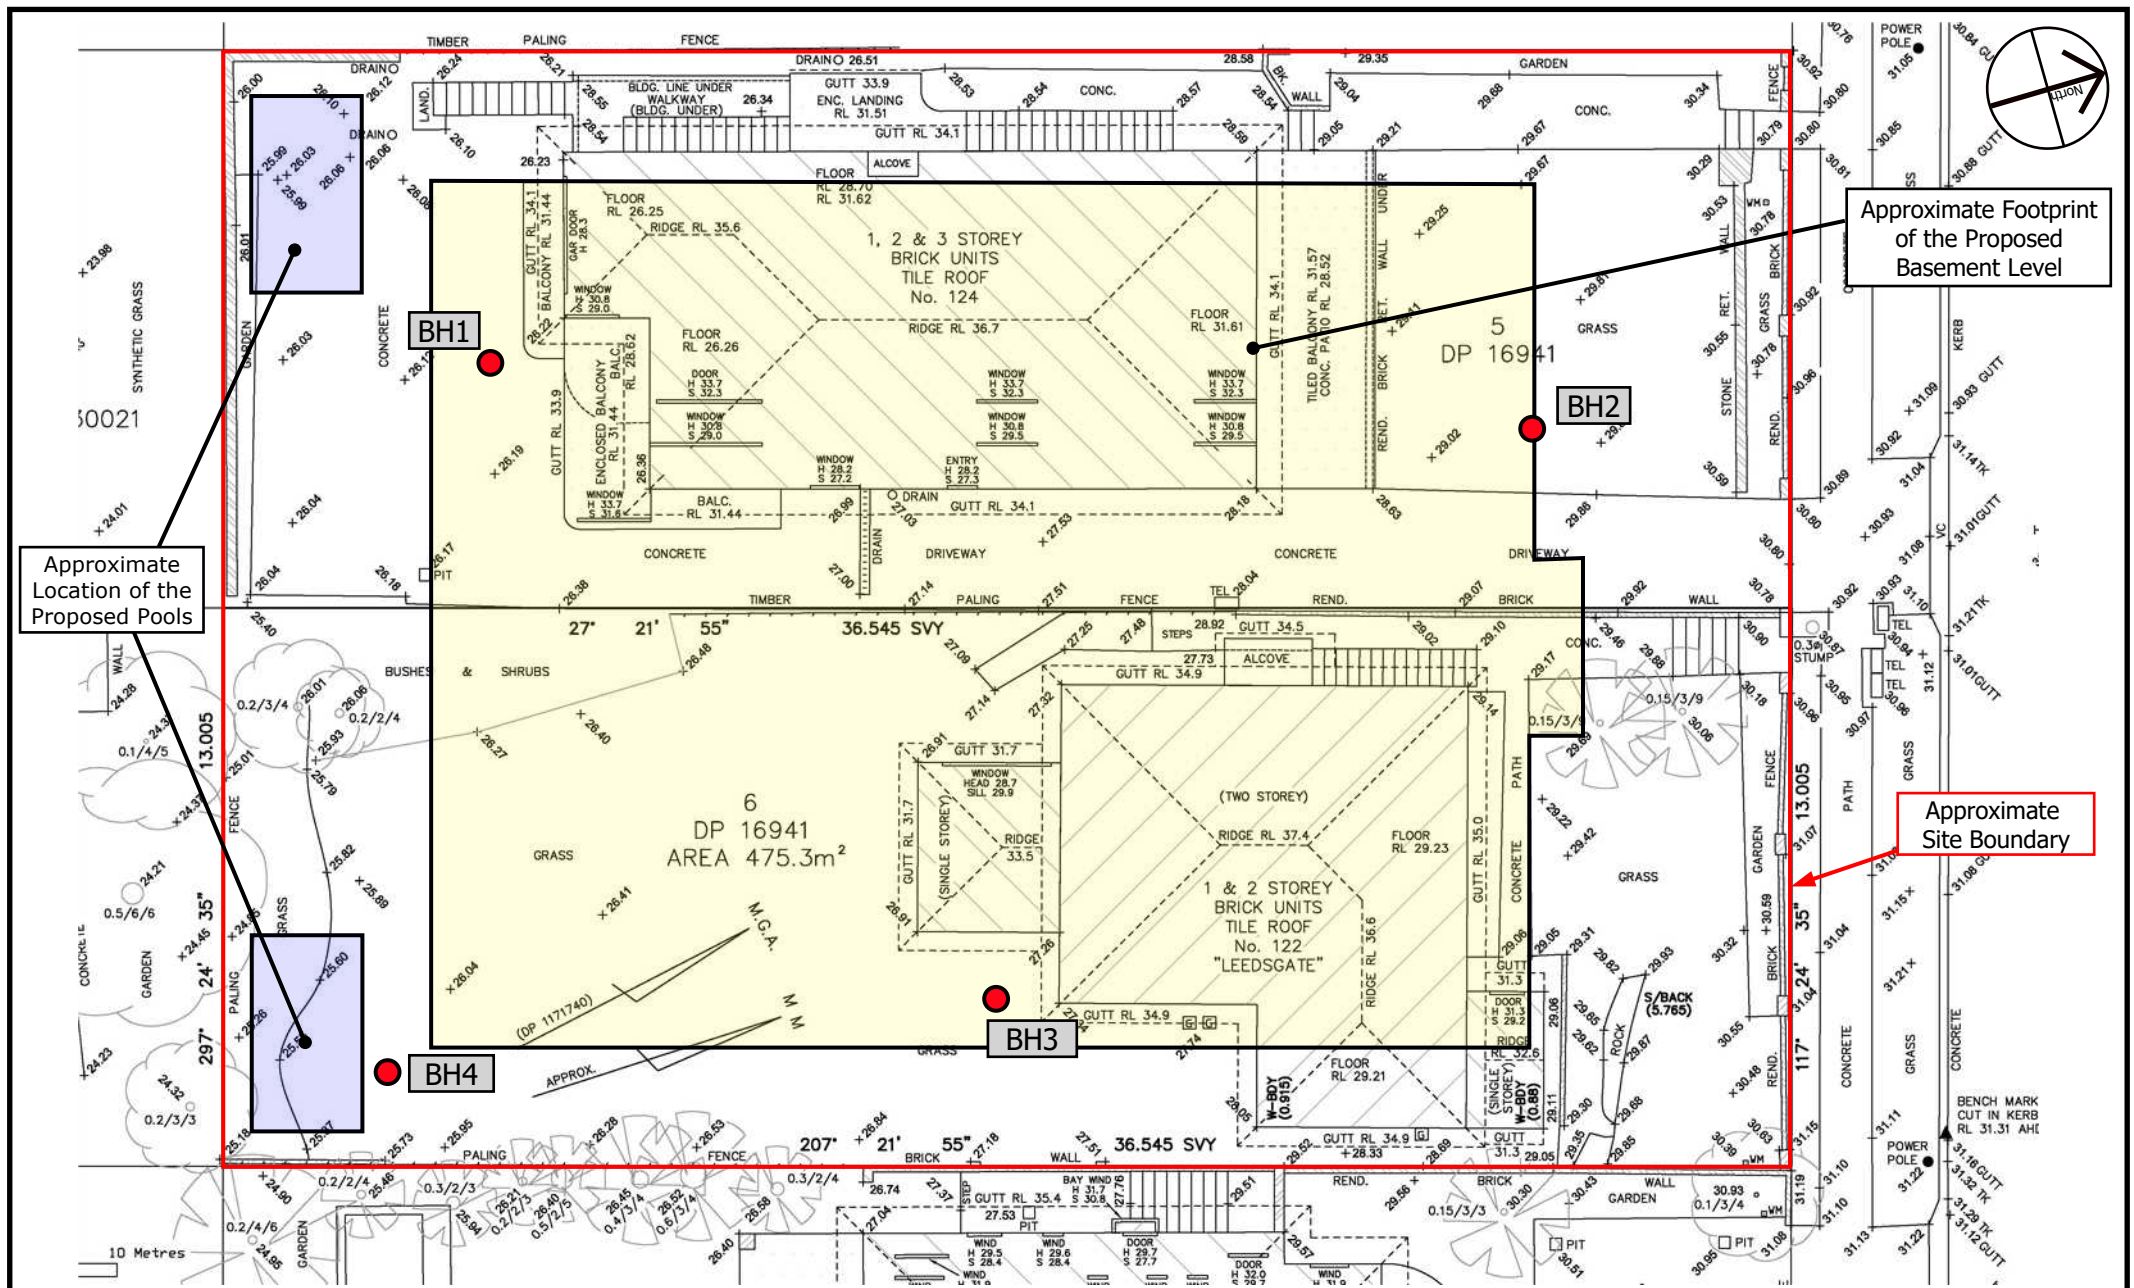
1 – Site Plan

A summary of the subsurface conditions encountered is provided in Section 4.1, while the locations of the boreholes are shown on **Figure 1** along with a copy of the survey plan.
