Report Title: Geotechnical Report 103 Narrabeen Park Parade, Mona Vale

Report Date: 29/7/20

GEOTECHNICAL INVESTIGATION:

New Garage, Storeroom and Lift at **103 Narrabeen Park Parade, Mona Vale**

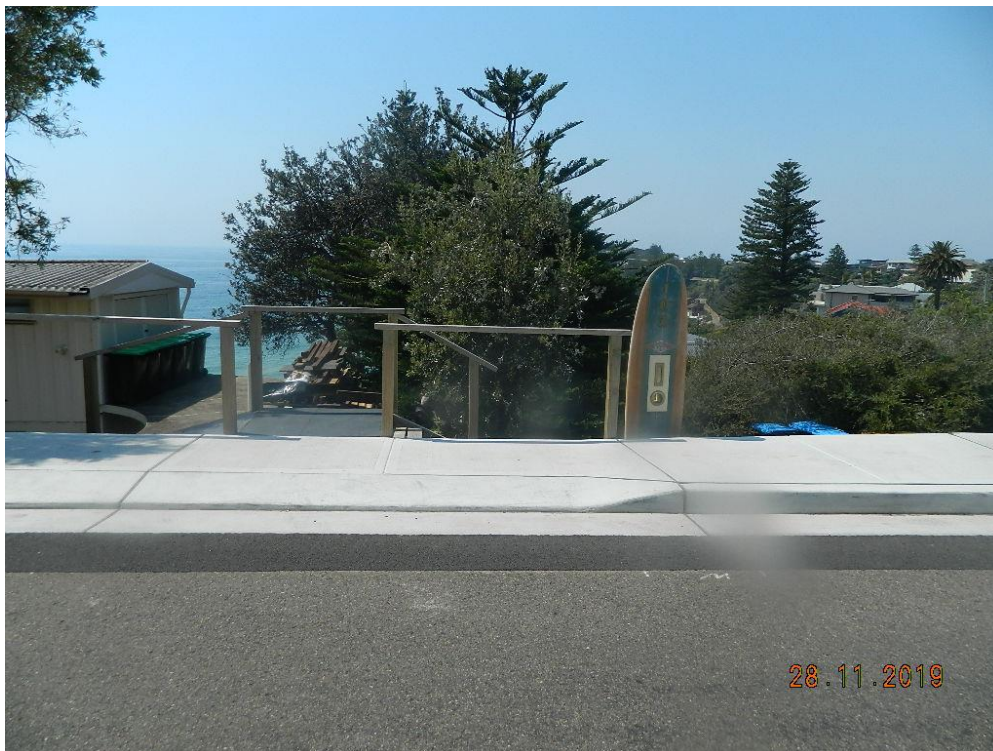
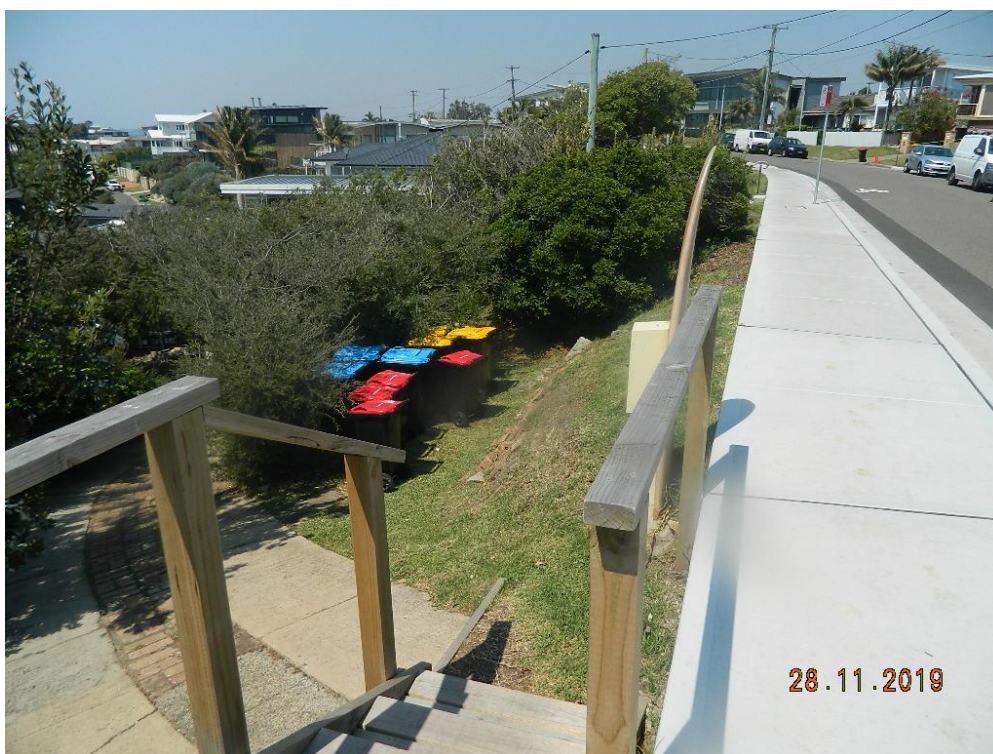
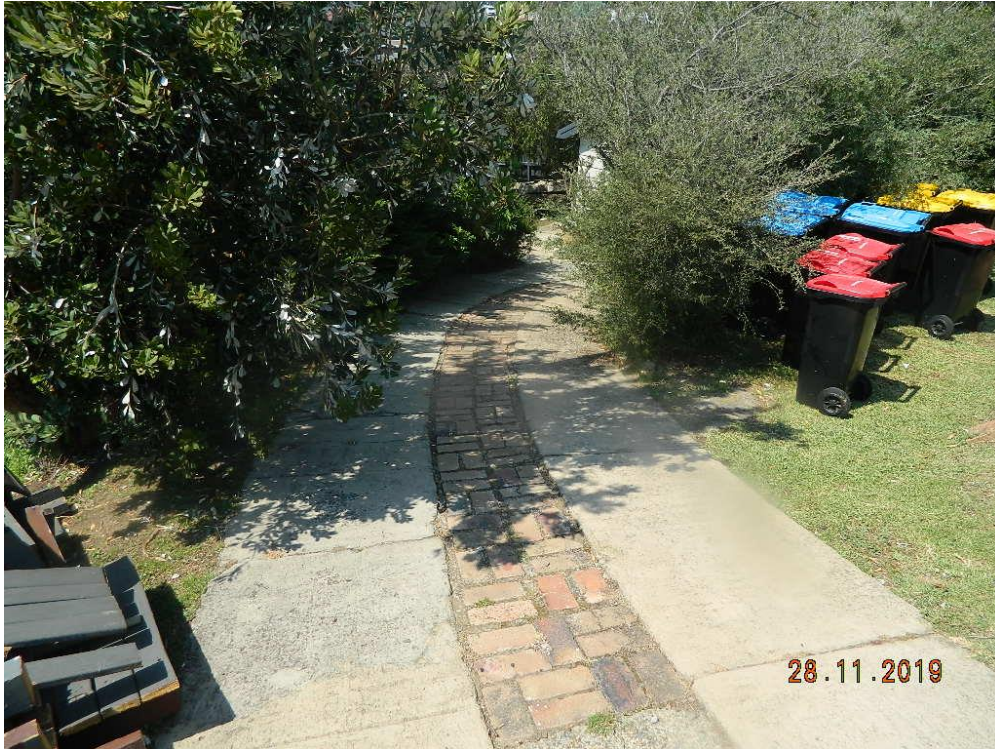
- 2.1** The site was inspected on the 28th of November, 2019.
- 2.2** This residential property is on the low side of the road and has a SE aspect. The block is located on the moderately graded middle reaches of a hillslope. The natural surface falls across the property at an average angle of ~15°. The slope above the property decreases in grade and the slope below the property increases in grade.
- 2.3** From the road frontage, steps and a pedestrian ramp lead to a concrete and brick paved driveway, which runs down the slope to a garage just below the uphill boundary of the property (Photos 1, 2 & 3). The fill batter for the road merges into the

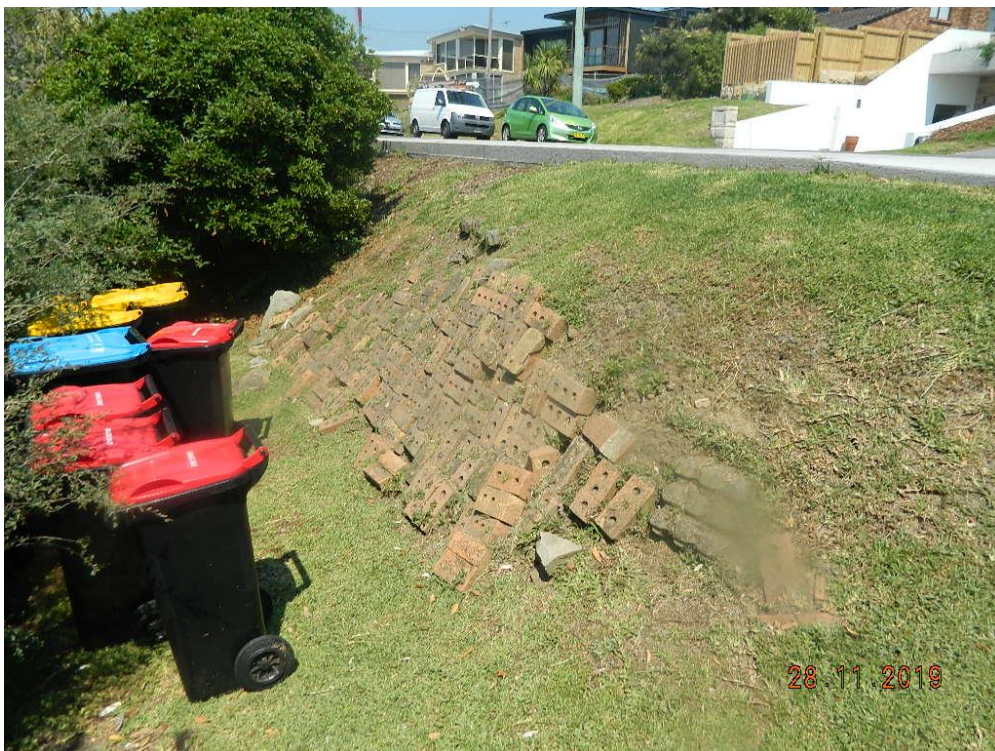
Photo 4

natural slope. In a small section adjacent to the stairs it is lined with bricks (Photo 4). The timber and weatherboard clad garage is supported on a concrete slab which shows some cracking but no movement related to slope instability (Photo 5). Between the driveway and house are garden beds and a lawn (Photos 6 & 7). An excavation has been made in the slope to provide a level platform for the house. The cut below the garden is supported by a stable stack rock retaining wall ~1.0m high (Photo 8). The cut below the lawn is supported by a stable sandstone retaining wall ~1.0m high (Photo 9).

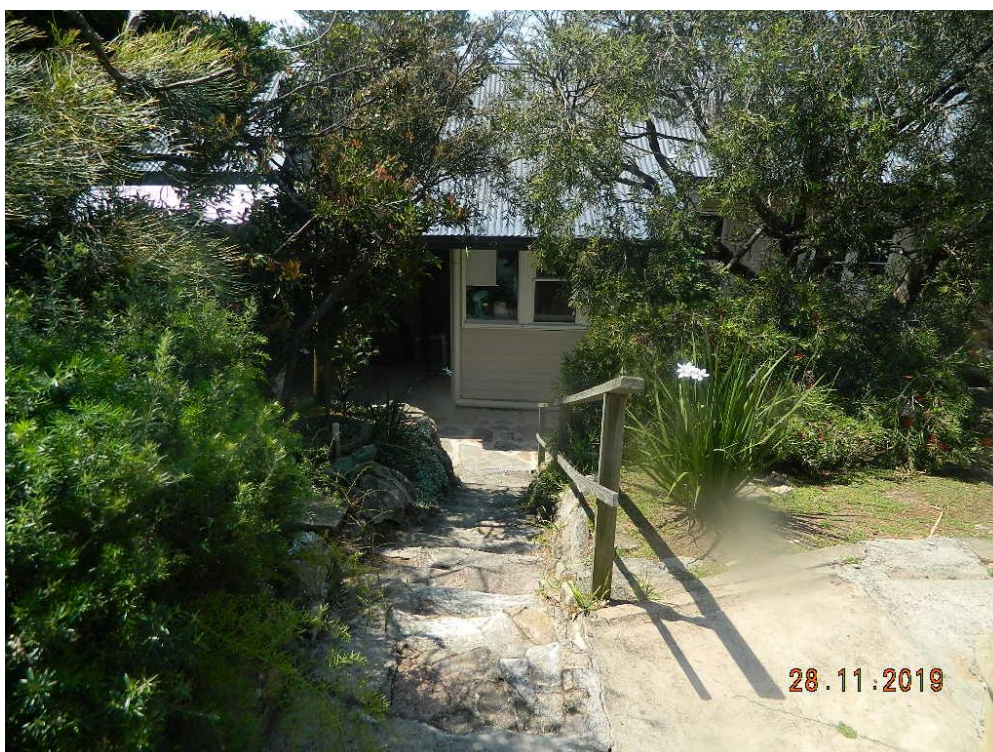
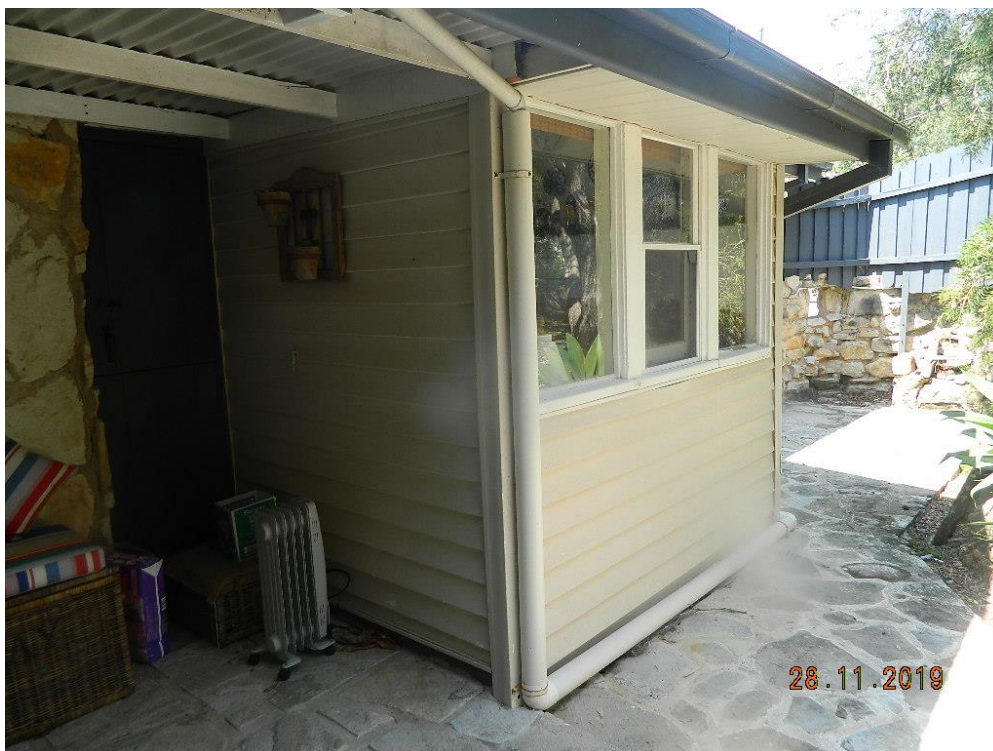
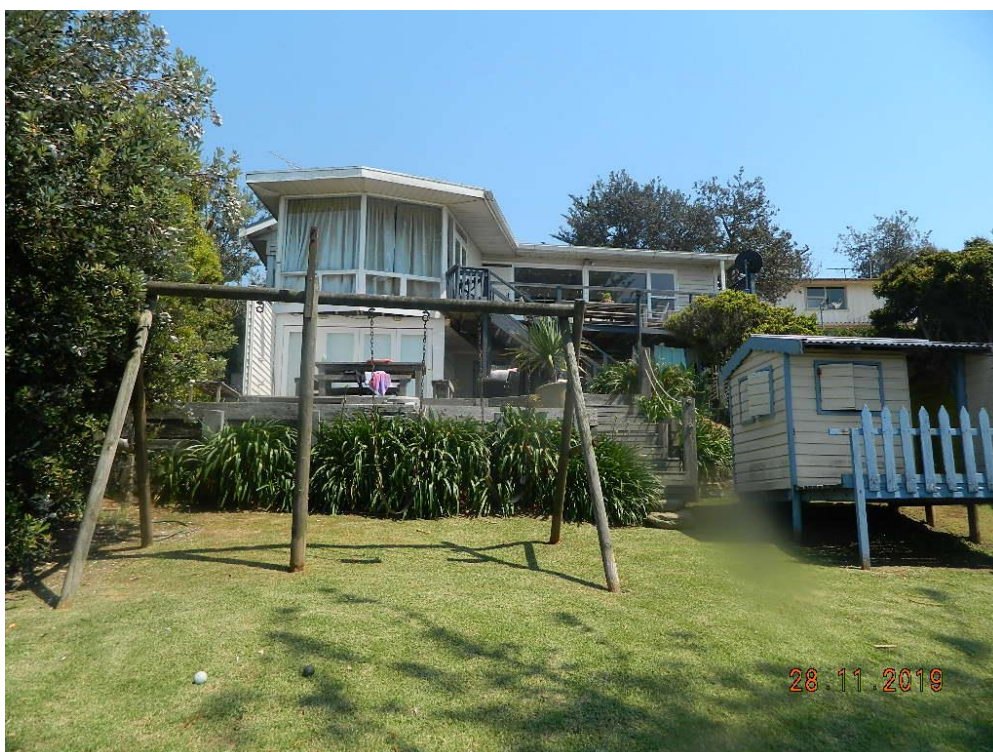
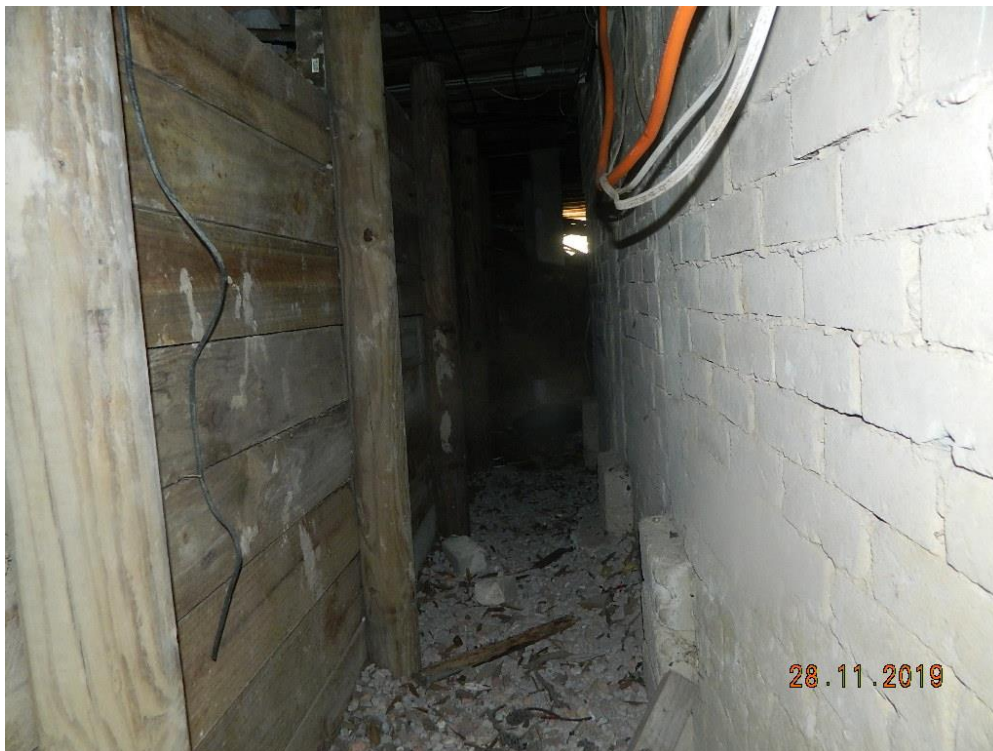
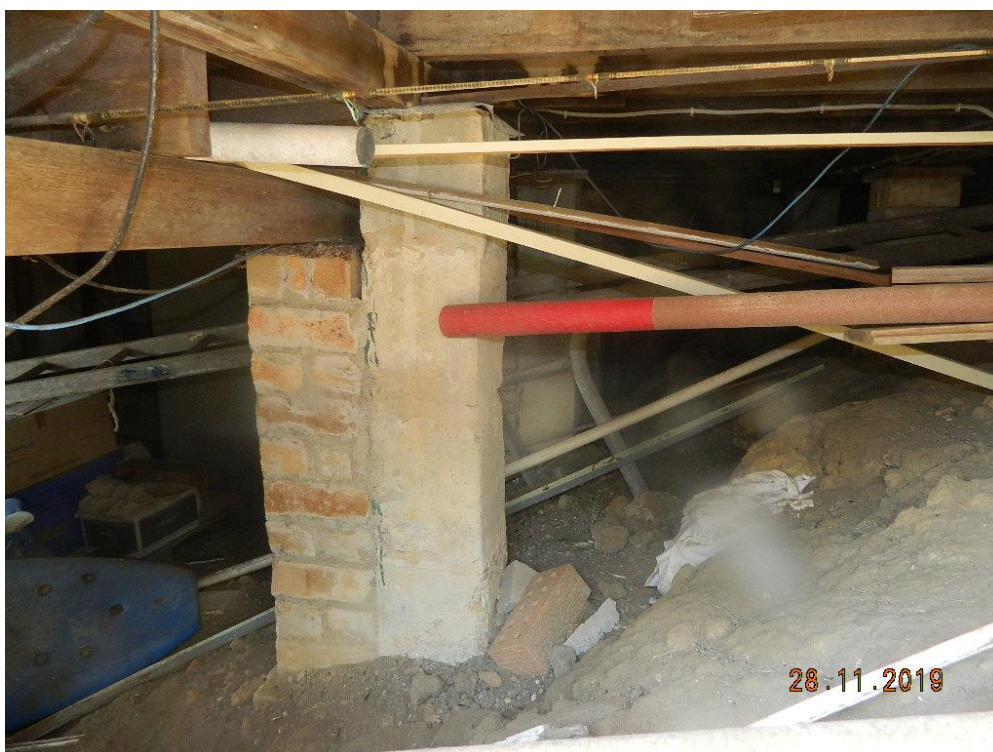
The two storey timber and weatherboard clad house is supported on brick walls, brick piers and concrete piers (Photos 10 to 14). The supporting walls and piers show no significant signs of movement. A stable timber retaining wall supports a cut batter located underneath the downhill side of the house (Photo 13). A suspended timber deck supported on timber posts extends off the downhill side of the house. (Photo 15). A fill that provides a level platform for a stone pavement is supported by a stable timber retaining wall (Photos 12, 16 & 17). A moderately sloping lawn descends downhill to the SE boundary of the property (Photo 18). Below the boundary the surface is covered in coastal shrub and continues to Warriewood Beach (Photos 19 & 20).

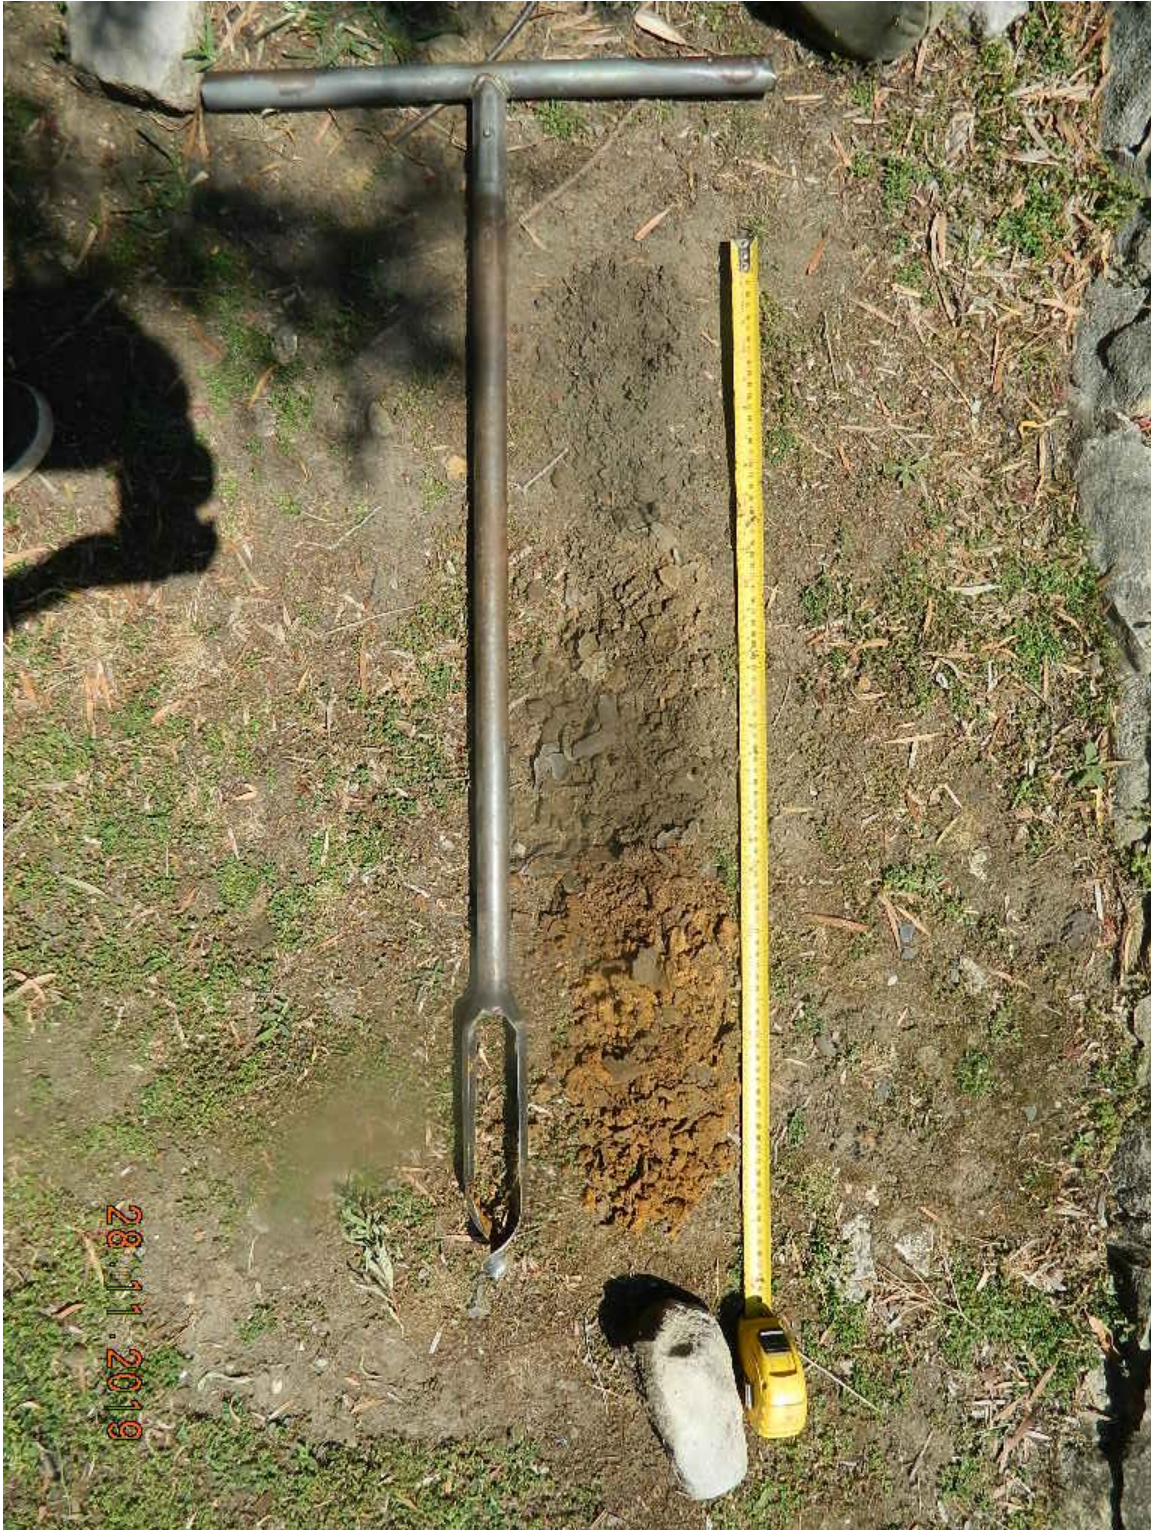
AUGER HOLE 1 (~RL34.5) – AH1 (photo 21)

Depth (m)	Material Encountered
0.0 to 0.2	SANDY SOIL , grey, fine to medium grained.
0.2 to 0.5	CLAYEY SOIL , grey brown, dry.
0.5 to 0.8	SANDY CLAY , orange brown, firm to stiff, moist.

End of hole @ 0.8m in firm to stiff sandy clay. No watertable encountered.

Photo 21: AH1 – Downhole is from top to bottom

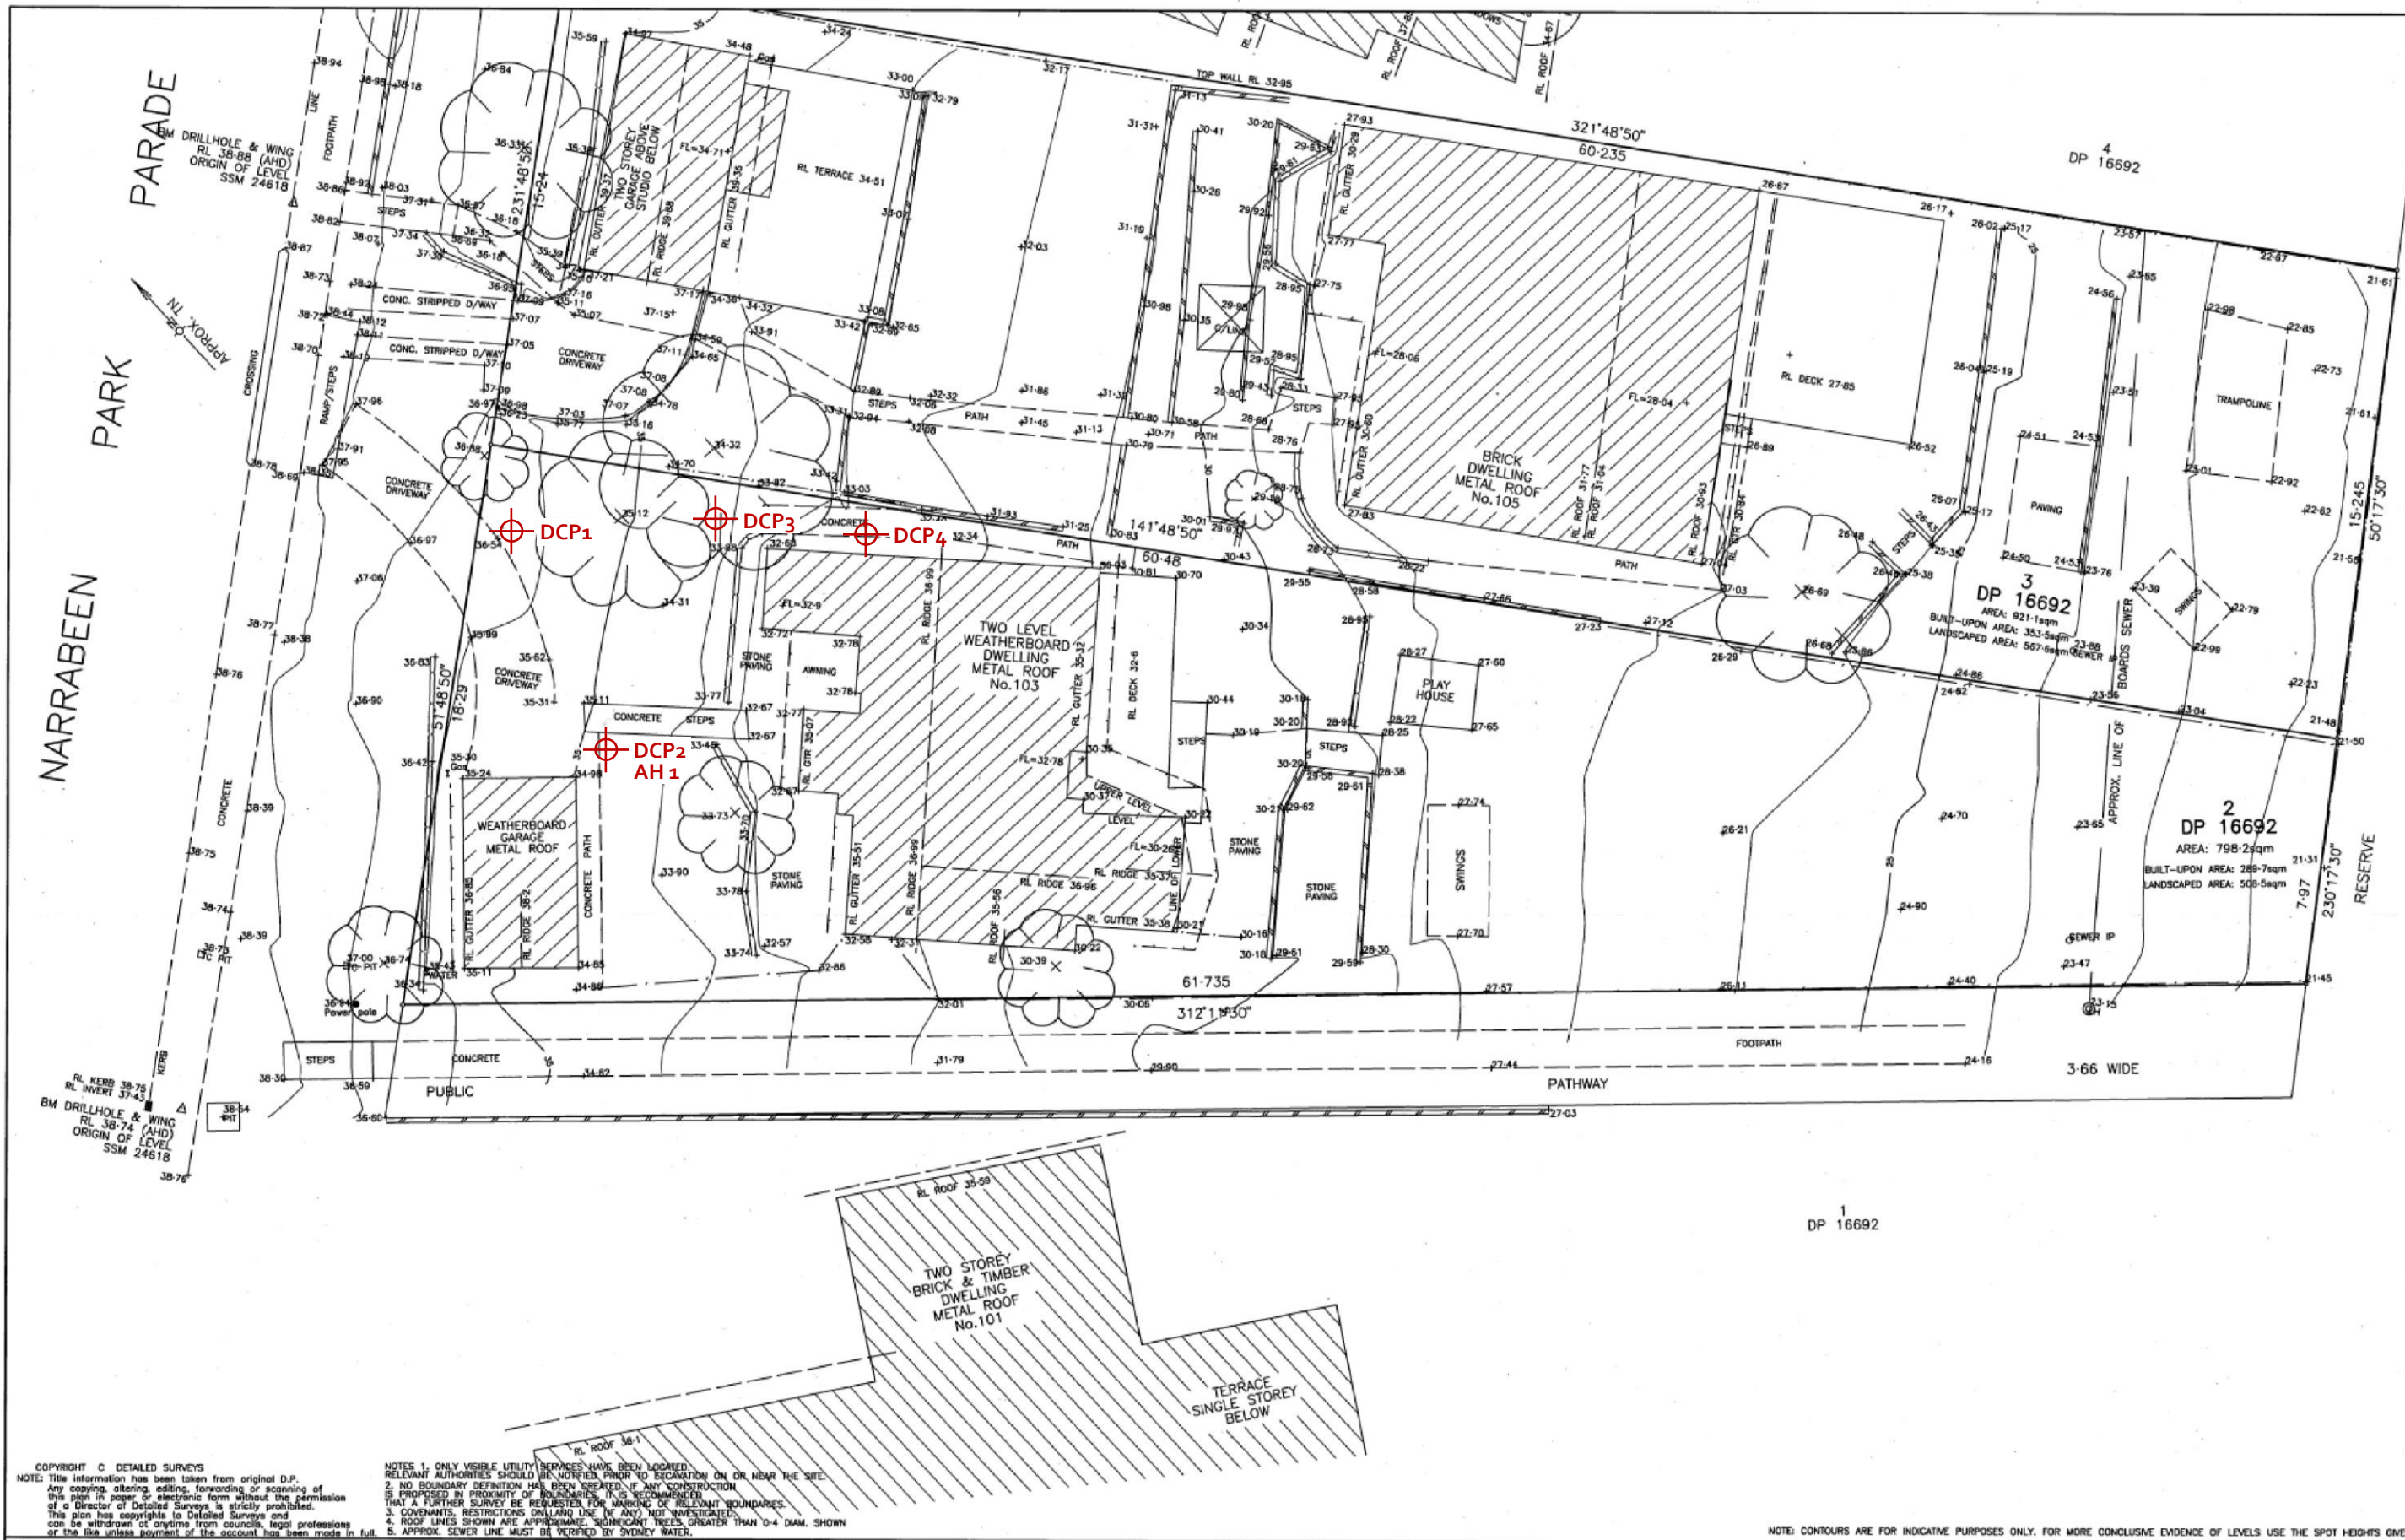
SITE PLAN - showing test locations

One auger hole was put down to identify the soil materials. Four Dynamic Cone Penetrometer (DCP) tests were put down to determine the relative density of the overlying soil and the depth to weathered rock. The locations of the tests are shown on the site plan. It should be

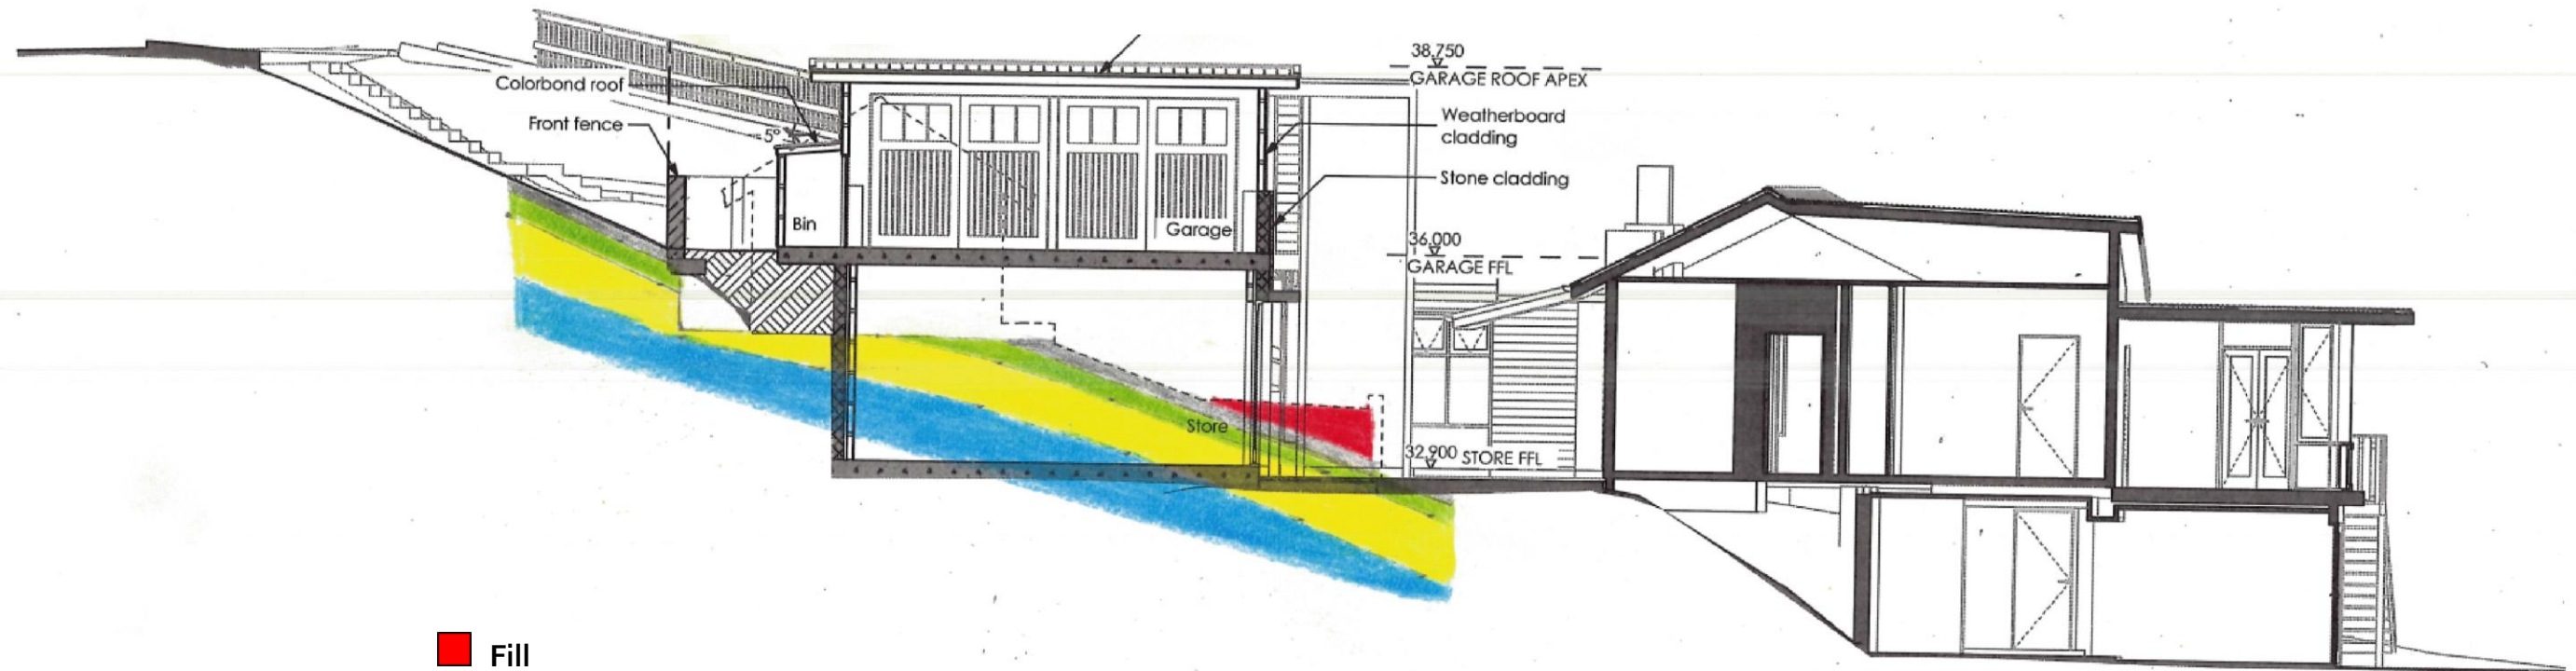
TYPE SECTION – Diagrammatical Interpretation of expected Ground Materials

The slope materials are colluvial at the near surface and residual at depth. They consist of a sandy topsoil over clayey soils and sandy clays. In the test locations, the clays merge into the weathered zone of the underlying rocks at a depth from between ~1.2m to ~2.3m below the current surface. The weathered zone of the underlying rock is interpreted as Extremely Low Strength Shale. It is to be noted that this material is a soft rock and can appear as a mottled stiff clay when it is cut up by excavation equipment. See Type Section attached for a diagrammatical representation of the expected ground materials.

- Fill
- Sandy Soil
- Clayey Soil
- Sandy Clay
- Narrabeen Group Rocks – Extremely Low Strength Shale - after being cut up by excavation equipment can resemble a stiff to hard clay.
