Address of site 28 Pacific Road, Palm Beach

Report Title: RISK ANALYSIS & MANAGEMENT FOR PROPOSED ALTERATIONS AND ADDITIONS AND SWIMMING POOL AT 28 PACIFIC ROAD, PALM BEACH- QY 00170

Report Date: 25th January, 2021

**RISK ANALYSIS & MANAGEMENT
FOR
PROPOSED ALTERATIONS AND ADDITIONS
AND SWIMMING POOL
AT
28 PACIFIC ROAD, PALM BEACH**

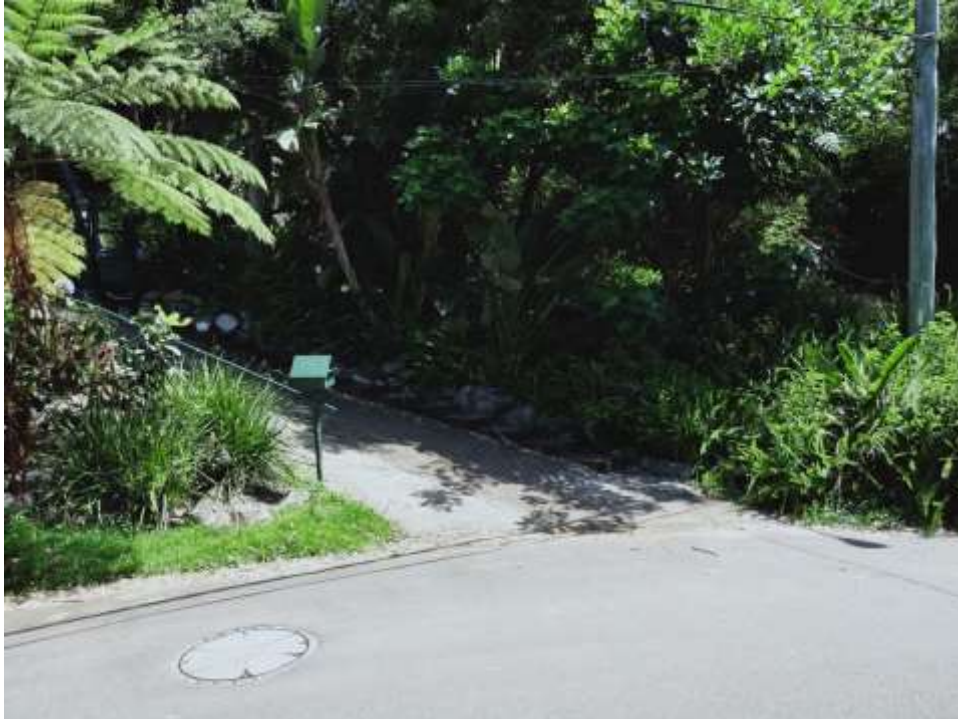
Photo 1

3.3 Vehicular access is from Pacific Road via the concrete crossing and paved driveway, Photo 1. A set of stairs on the western side of the driveway provides pedestrian access to the landscaped path and stairs which leads to the main entrance of the residence, Photo 2. The carport is at the top of the driveway where the exposed Hawkesbury Sandstone can be seen on the uphill side of the carport, Photo 3. An inclinometer runs adjacent the western boundary toward the main entrance of the existing residence, Photo 4. The front yard is a sloped lawn and garden area with some smaller landscaping retaining walls, Photo 5. Access to the rear of the existing residence is via landscaped stairs of the western side of the residence, Photo 6. The rear yard is a lawn and garden area sloping up to be level with the first of the existing residence, Photo 7. The natural slope is evident on the eastern side of the existing residence, Photo 8. Some cracking in the masonry was observed near the south eastern rear corner of the existing residence, Photo 9. Evidence of water flowing under the existing residence was observed which has also been previously controlled by a series of dish drains, Photos 10 to 11.

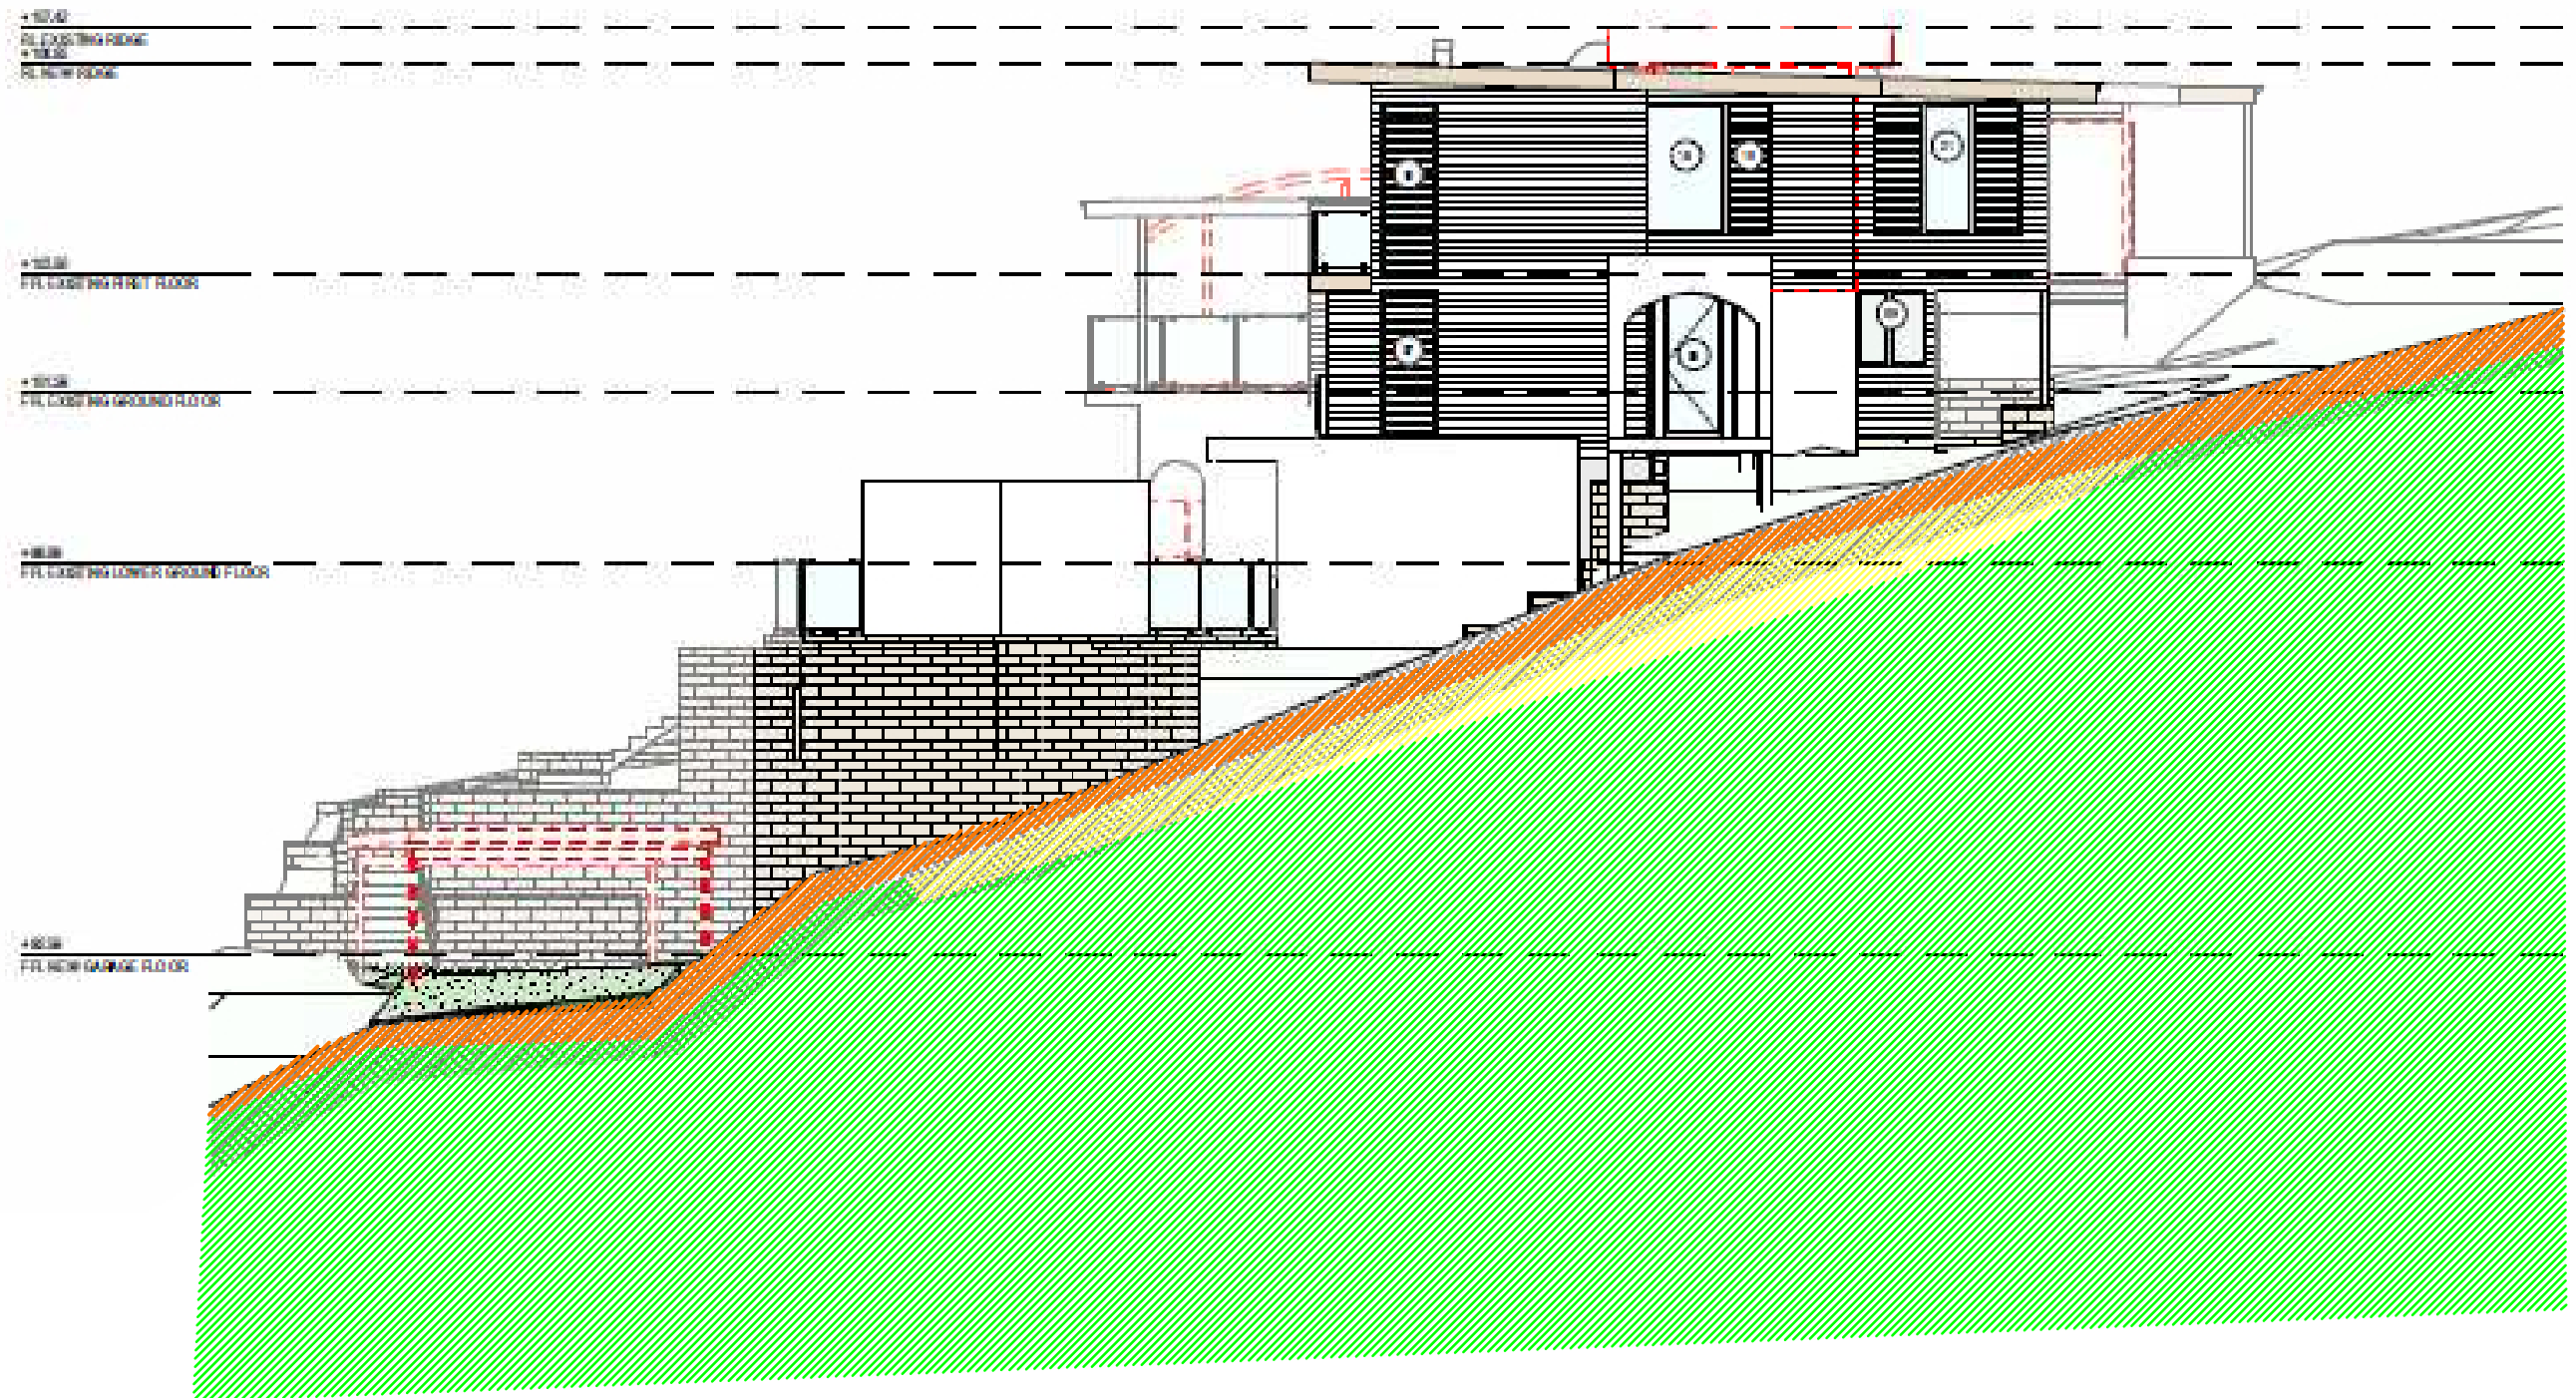
NOTE
 INTERPRETED SUB SURFACE SECTION ONLY.
 ACTUAL GROUND CONDITIONS MAY VARY.
