PICUS SONIC TOMOGRAPH REPORT

Subject tree. *Eucalyptus robusta*

11th November 2017

Re – Arborist Inspection - Picus Sonic Tomograph Testing

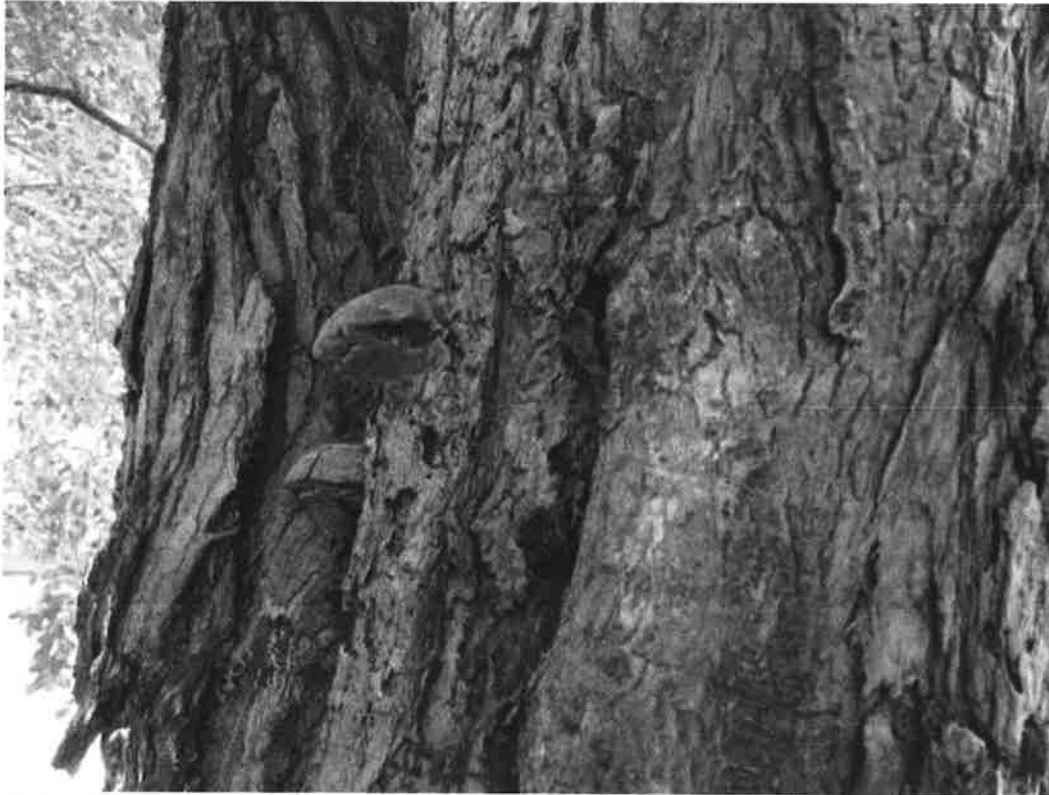
Australian Tree Consultants Pty Ltd undertook the site inspection and Picus test on 10th November 2017. A Visual Structural Tree Assessment (VSTA) was undertaken on the *Eucalyptus robusta* to determine the most probable area of concern. The Picus test on this tree was undertaken at 2 metres above ground level at the site of the two (2) *Phellinus* spp. bracket fungal fruiting bodies within the trunk wound site.

Photo 1. Trunk wound with two (2) *Phellinus* spp. bracket fungi fruits.

- Based on the results of the Picus test combined with Visual Tree Assessment as well as a WHS/OH&S assessment and usage of the site at the time of testing the tree was considered to be structurally compromised at the test location and should be removed.
- The management of the tree should be based on this Picus report as well as any other recent and, or, current Arboricultural reports or Visual Tree Assessments.

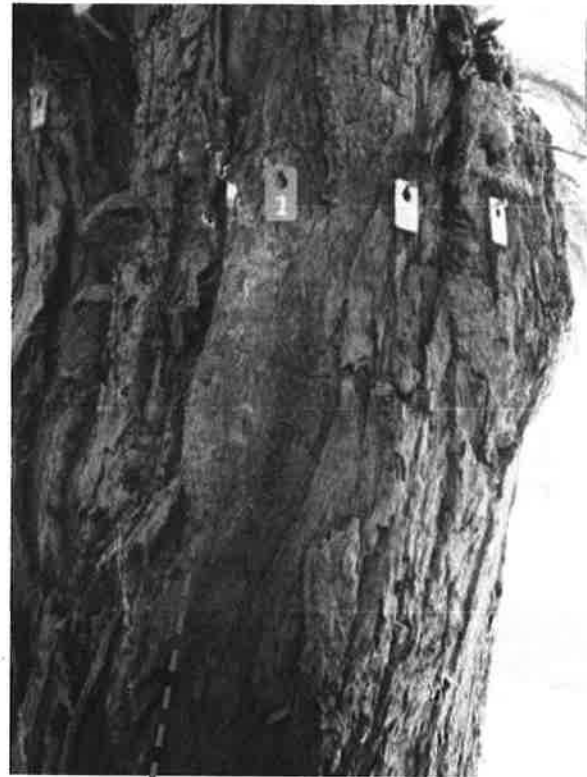
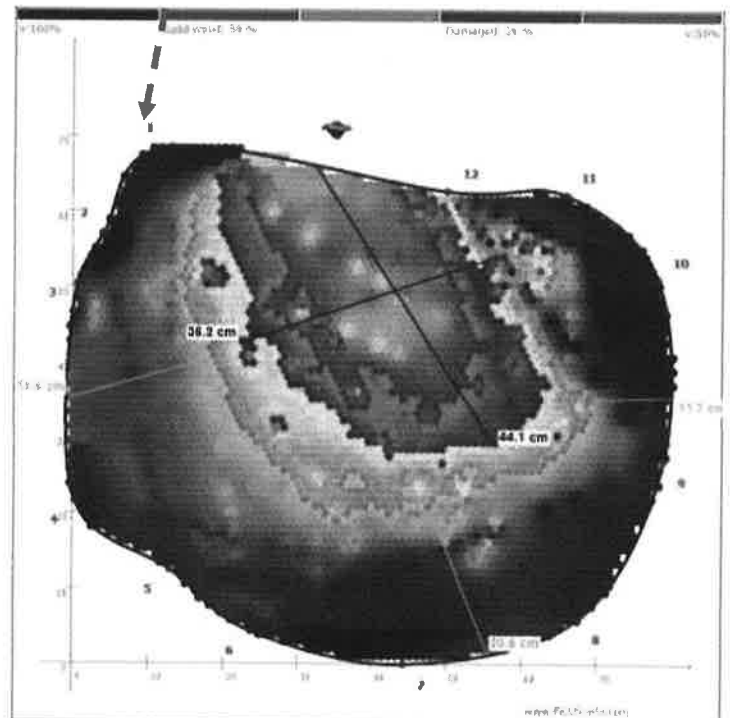
The Picus® Sonic Tomograph (Series 3) test shows (lower right insert) that this *Eucalyptus robusta* tree has extensive active fungus, decay and altering wood within the test location.

The test results indicate 59% of the test area is sound wood (brown areas), 15% consists of altering wood i.e. wood being altered by the fungus (green area) and 26% active fungus and decay (pink and blue areas).

The fungal activity and decay appears to have initially entered the trunk through past lower trunk damage. The active fungal pathogen (*Phellinus spp*), decay and altering wood have breached the outer trunk on the northern side of the tree between sensors 12 – 1. The active fungus is spreading towards the south-eastern side of the tree towards sensors 8 – 9.

The active fungal pathogen is progressing through the remaining sound wood at a moderate rate, as shown by the amount of altering wood, (green colouration).

The fungal activity measured 44.1 cm in a north-south direction and 36.2 cm in an east-west direction.

New incremental wood growth was recorded at sensors 1 – 2, 4 and in a thin band between sensors 6 – 11.

Sound wood that has not been compromised by the active fungus measured 19.6 cm the western side, 20.6cm on the southern side between sensors 7 – 8 and on the eastern side between sensors 9 – 10 sound wood remaining was 11.7cm.

The Picus test was undertaken at 2 metres above ground level at the location of lower trunk wounding which has two (2) *Phellinus* spp. bracket fungal fruiting bodies. The Picus Tomograph test showed that there is a moderate amount of altering wood 15% surrounding an extensive amount of fungal activity and decay 26% with 59% of sound wood remaining at the site of the test location.

The active fungal pathogen is progressing through the sound wood at a moderate rate, as shown by the amount of altering wood (green colouration), and has breached the outer trunk between sensors 12 – 1 and is spreading towards the south-eastern side of the tree towards sensors 8 – 9.

New incremental wood growth was recorded between sensors 1 – 2 and at sensor 4. A thin band was also recorded between sensors 6 – 11.

At the time of testing the Picus test results show that the structural integrity of the lower trunk has been compromised by the active fungal pathogen. *Eucalyptus robusta* trees are susceptible to *Phellinus* spp. bracket fungi and do not compartmentalise the active fungus as well as other Eucalyptus trees.
