Vertical Tree Management & Consultancy

Preliminary Arboricultural Impact Assessment --Proposed Subdivision--

Site: 69 Melwood Avenue Forestville NSW 2087

Date of Inspection: 17 June 2021

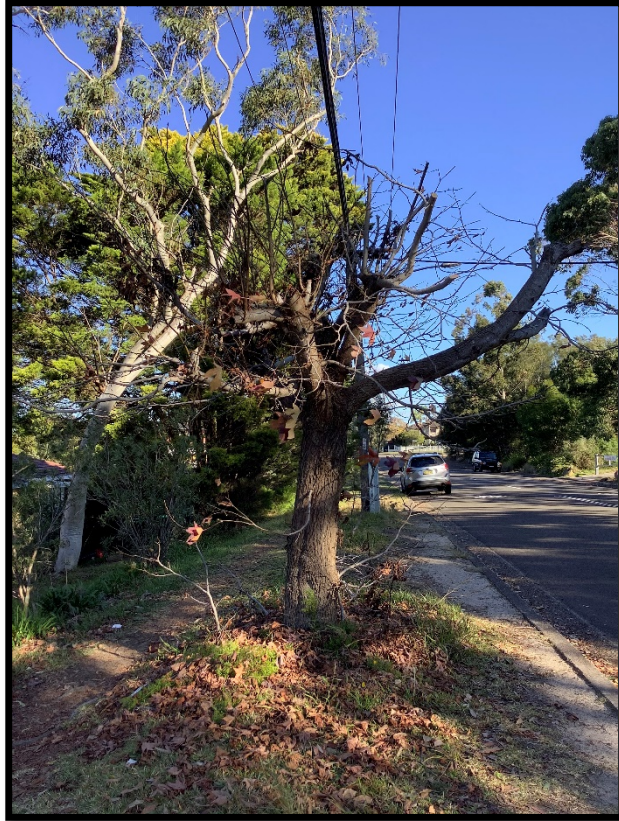
Figure 4 - Tree 1

Number	Species	Height	Spread	*DBH	**DGL	***TPZ	^SRZ	Age Class	Health	Condition	Significance	ULE	Retention Value
1	<i>Liquidambar styraciflua</i> (Liquid Amber)	4	3	400	400	2	2	Over Mature	Poor	Poor	Low	3 (Short)	Priority for Removal
Notes: Liquidambar on council nature strip is a poor specimen. It is 4 m in height and has been significantly lopped due to powerline clearance.													
Number	Species	Height	Spread	*DBH	**DGL	***TPZ	^SRZ	Age Class	Health	Condition	Significance	ULE	Retention Value
2	<i>Chamaecyparis obtusa</i> 'Crippsii' (Golden Hinoki Cypress)	13	9	1240	900	14.88	3.17	Over Mature	Fair	Poor	Moderate	3 (Short)	Consider for Removal
Notes: The Golden Hinoki Cyprus is located on the southern side of the driveway and is in fair health with poor structure throughout. Significant Included bark unions throughout the stem at ground level to 3m from ground level. Various locations of included bark and transverse cracks are contained within the canopy. Previous branch failures is evident. The tree has been constantly lopped for powerline clearance.

Liquidambar on council nature strip is a poor specimen. It is 4 m in height and has been significantly lopped due to powerline clearance. It has low landscape significance or ecological value. Priority for removal (figure 4).

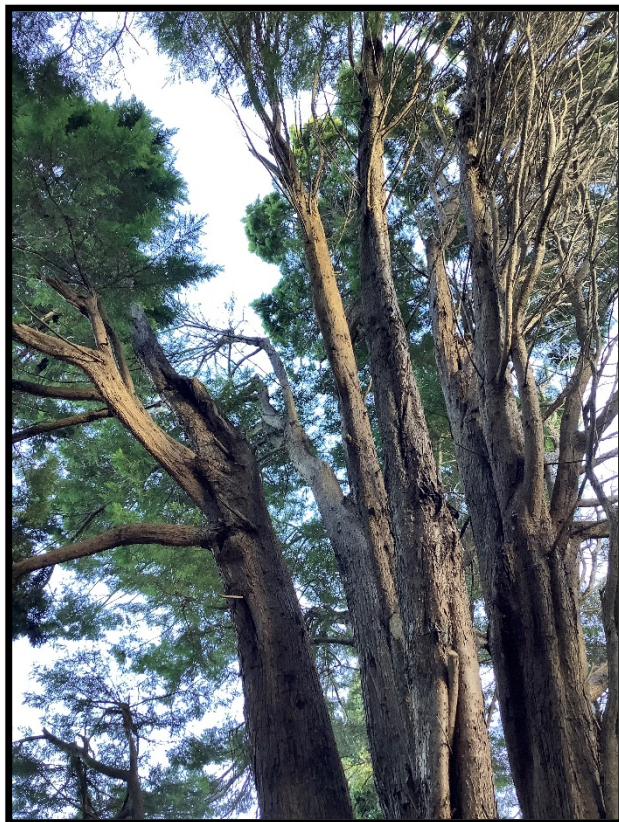
Figure 5 - Tree 2

The Golden Hinoki Cypress located on both sides of the driveway are in fair health with poor structure throughout. Significant included bark unions throughout the stem at ground level to 2m from ground level. Various locations of included bark and transverse cracks are contained within the canopy. Previous branch failures are evident. This tree is heavily suppressed and has poor form and shape. The tree has been constantly lopped for powerline clearance. To facilitate the installation of the easement these trees are required to be removed (figure 5).

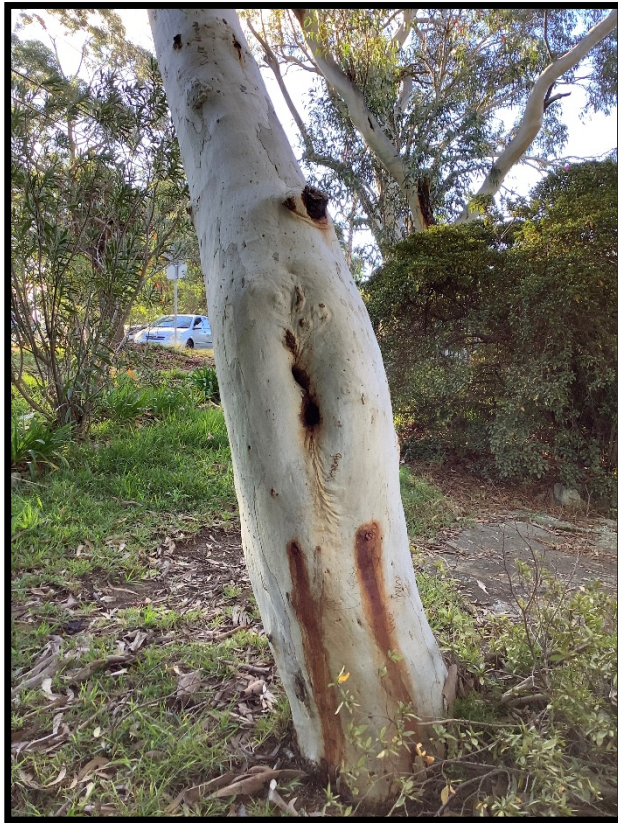
Notes: The scribbly gum located within the front yard of the property is growing on a rock shelf. The tree is in fair health with poor structure. The tree is heavily phototropic to the west with a 35° lean. At 1.5 m from ground level is a significant hollow within the tree. When sounded with a mallet, decay indicated throughout entire stem up to 5 m. Tip dieback was observed.													
Number	Species	Height	Spread	*DBH	**DGL	***TPZ	^SRZ	Age Class	Health	Condition	Significance	ULE	Retention Value
5	<i>Eucalyptus haemastoma</i> (Scribbly Gum)	12	10	460	540	5.52	2.55	Over Mature	Poor	Poor	Moderate	4 (Remove)	Priority for Removal
Notes: The scribbly gum located on the front boundary line is in poor health and poor structure. At 3 m from ground level at a bifurcated branch union there is significant decay with evidence of termite activity. The crown of the tree is sparse with significant chip dieback observed throughout. Tree is in advanced stages of decline.

The scribbly gum located within the front yard of the property is growing on a rock shelf. The tree is in fair health with poor structure. The tree is heavily phototropic to the west with a 35° lean. At 1.5 m from ground level is a significant hollow within the tree. The internal structure of the tree has been reduced and is a priority for removal (figure 6).

Figure 6 - Tree 4 - Internal Decay visible

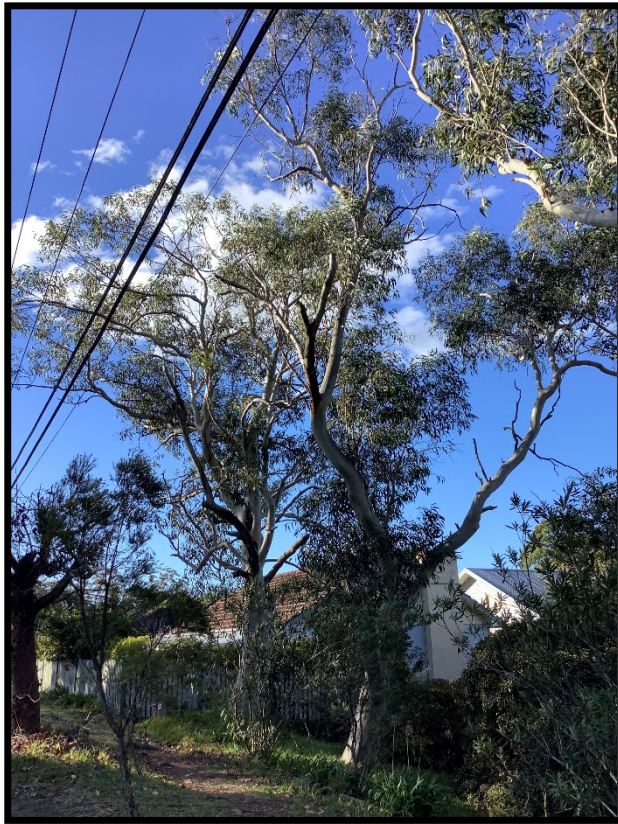
Figure 7 - Trees 5 and 6

The overmature scribbly gum is located on the front corner boundary and is in advanced stages of decline. Significant decay was observed through various locations on every branch union and every stem. The tree is a priority for removal (figure 7).

The overmature scribbly gum is located on the front corner boundary and is in advanced stages of decline. Significant decay was observed through various locations on every branch union and every stem. The tree contains 30% deadwood within the canopy and has a short ULE. Priority for removal (figure 7).

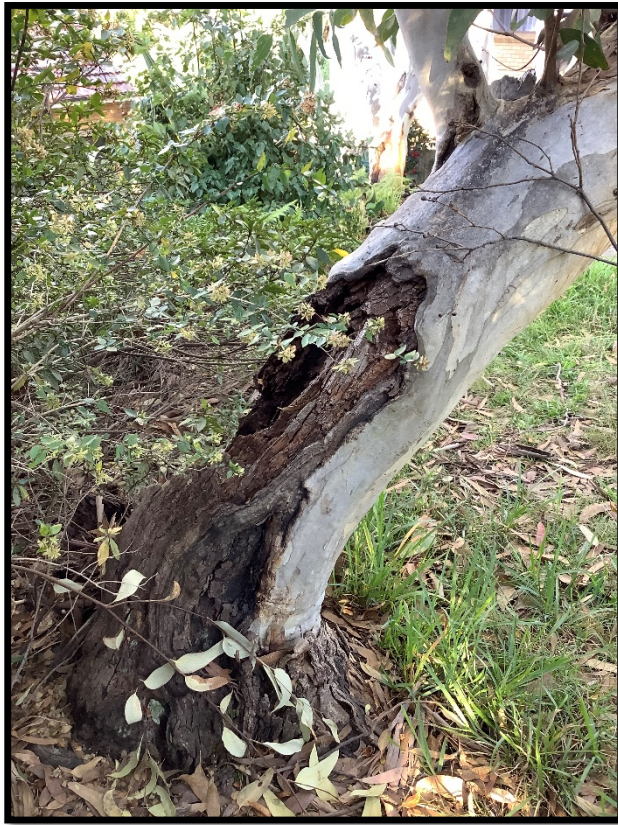
Figure 8 - Tree 7

The scribbly gum has significant decay extending from the root crown to 1 m from ground level. 20% sound wood remaining with significant decay throughout the internal structure of the tree. This tree is considered an immediate risk and is a priority for removal (figure 8).

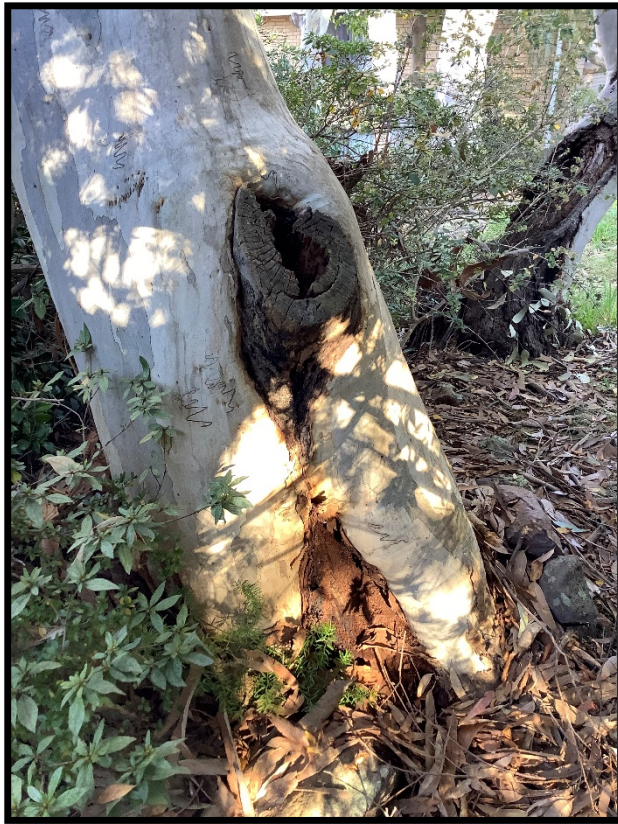
Figure 9 - Tree 8

8	<i>Eucalyptus haemastoma</i> (Scribbly Gum)	12	10	430	670	5.16	2.8	Mature	Fair	Poor	Low	4 (Remove)	Priority for Removal
Notes: The scribbly gum is located within the centre of the block and has significant decay extending from the root crown to 1 m from ground level. This decay is columnar and extends to 5 m from ground level.													
9	<i>Eucalyptus haemastoma</i> (Scribbly Gum)	13	12	710	1350	8.52	3.75	Mature	Good	Fair	Moderate	3 (Short)	Consider for Removal
Notes: The mature scribbly gum is growing on top of a rock shelf. The tree appears to have split the boulder and is growing within and on top. The tree appears to be in good health and fair structure however there are concerns about its overall stability in the ground. On the western stem at 3 m from ground level at a branch location there appears to be decay within the branch bark ridge. This decay is likely to be extending into the internal structure of the tree. At this location on the southern side is an occluded wound.

The scribbly gum is located within the centre of the block and has significant decay extending from the root crown to 1 m from ground level. This decay is columnar and extends to 5 m from ground level. The tree is considered a priority for removal (figure 9).

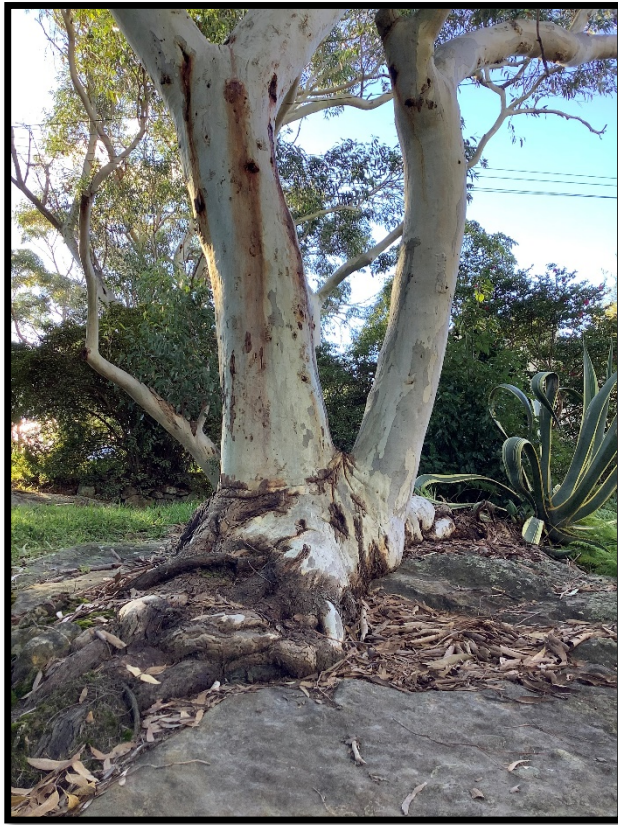
Figure 10 - Tree 9

The mature scribbly gum is growing on top of a rock shelf. The tree appears to have split the boulder and is growing within and on top. The tree appears to be in good health and fair structure however there are concerns about its overall stability in the ground. On the western stem at 3 m from ground level at a branch location there appears to be decay within the branch bark ridge. This decay is likely to be extending into the internal structure of the tree. At this location on the southern side is an occluded wound. This tree is considered for removal (figure 10).

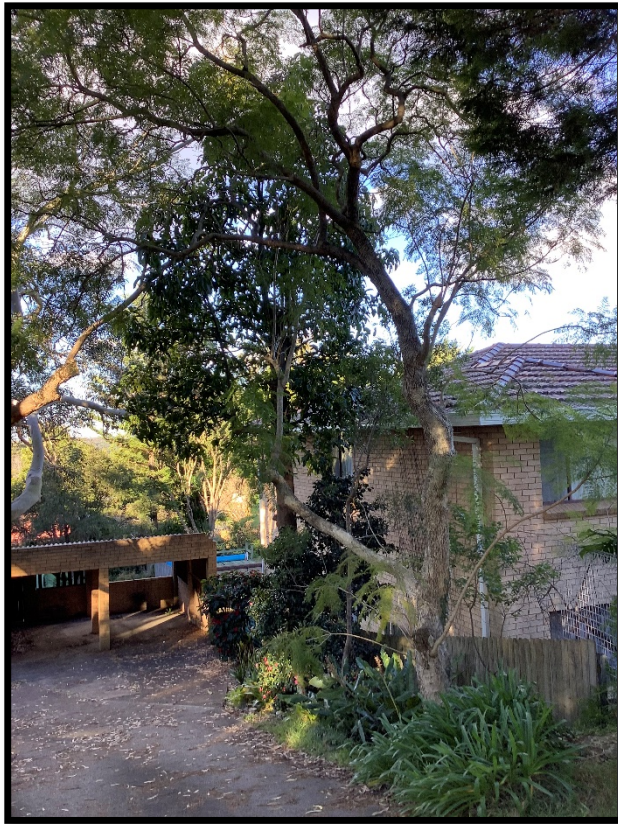
Figure 11 - Tree 10

10	<i>Jacaranda mimosifolia</i> (Jacaranda)	11	6	320	360	3.84	2.15	Mature	Fair	Poor	Low	3 (Short)	Priority for Removal
Notes: The mature Jacaranda tree is located on the side boundary of the property and is in poor health and poor structure. The tree is largely epicormic and has been significantly pruned over its lifetime. Low retention value.													
*DBH-Diameter at Breast Height; **DGL – Diameter at Ground Level ***TPZ – Tree Protection Zone; ^SRZ – Structural Root Zone – Explanatory notes in Appendix.

The mature Jacaranda tree is located on the side boundary of the property, it is in poor health and poor structure. The tree is largely epicormic and has been significantly pruned over its lifetime. The tree has a low retention value and low landscape significance and is considered for removal (figure 11).

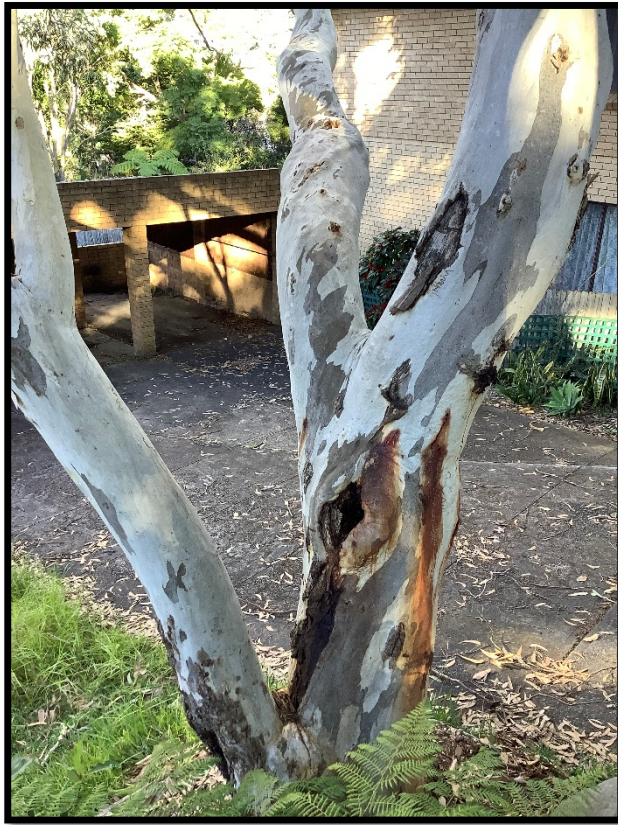
Figure 12 - Tree 11

Number	Species	Height	Spread	*DBH	**DGL	***TPZ	^SRZ	Age Class	Health	Condition	Significance	ULE	Retention Value
11	<i>Eucalyptus haemastoma</i> (Scribbly Gum)	12	12	570	740	6.84	2.92	Mature	Fair	Fair	Low	3 (Short)	Consider for Removal
Notes: The mature scribbly gum is located adjacent to the dwelling and is in poor health and poor structure. The tree is believed to be reaching over maturity and is in advanced stages of decline. There are several locations of sapwood decay leading into internal hardwood structural decay. Multiple locations throughout various stems with significant pockets of decay. The tree is unlikely to recover.													
Number	Species	Height	Spread	*DBH	**DGL	***TPZ	^SRZ	Age Class	Health	Condition	Significance	ULE	Retention Value
12	<i>Brachychiton acerifolius</i> (Illawarra Flame Tree)	10	6	410	440	4.92	2.34	Mature	Fair	Poor	Low	3 (Short)	Priority for Removal
Notes: The mature Illawarra Flame tree is located on the side boundary adjacent to the driveway and is in poor health and structure. The tree at some point has failed at 8 m from ground level. Four branches have been intentionally lopped at this location. The tree is 100% epicormic with low landscape significance and low retention value. Tree is located approximately 2.5 m from external wall of neighbouring dwelling.

The mature scribbly gum is located adjacent to the dwelling and is in poor health and poor structure. The tree is believed to be reaching over maturity and is in advanced stages of decline. There are several locations of sapwood decay leading into internal hardwood structural decay. There are various locations throughout various stems with significant pockets of decay. The tree is unlikely to recover and is considered for removal (figure 12).

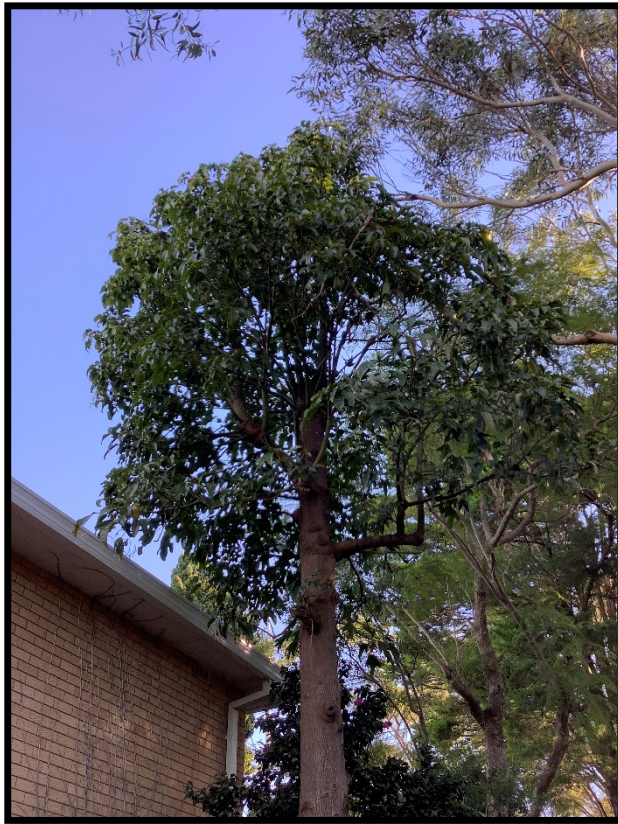
Figure 13 - Tree 12

The mature Illawarra Flame tree located on the side boundary adjacent to the driveway is in poor health and structure. The tree has failed at 8 m from ground level. The tree is 100% epicormic. The tree has a low retention value and low landscape significance and is a priority for removal.

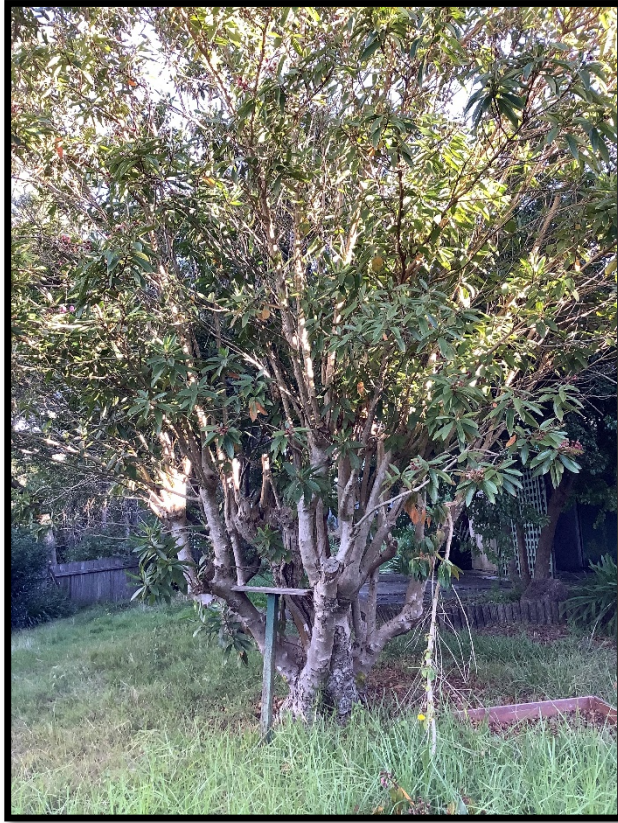
Figure 14 - Tree 13

Number	Species	Height	Spread	*DBH	**DGL	***TPZ	^SRZ	Age Class	Health	Condition	Significance	ULE	Retention Value
13	<i>Tibouchina granulosa</i> (Purple Glory)	5	5	Multi	420	2	2	Over Mature	Fair	Poor	Low	3 (Short)	Priority for Removal
Notes: The overmature Tibouchina is in fair health and poor structure. Tree has been continually lopped over its lifetime at 2 m from ground level. Significant internal decay at various locations throughout various stems. Low landscapes significance and retention value.													
Number	Species	Height	Spread	*DBH	**DGL	***TPZ	^SRZ	Age Class	Health	Condition	Significance	ULE	Retention Value
14	<i>Callistemon viminalis</i> (Weeping Bottle Brush)	6	8	480	430	5.76	2.32	Mature	Fair	Fair	Low	3 (Short)	Priority for Removal
Notes: The mature bottle brush tree is in fair health and poor structure. Tree is included at ground level. There are various locations of decay observed at ground level. Tree is largely epicormic with 30% deadwood contained within the canopy.

The overmature Tibouchina is in fair health and poor structure. Tree has been continually lopped over its lifetime at 2 m from ground level. Significant internal decay at various locations throughout various stems. Low landscape significance and retention value and is a priority for removal.

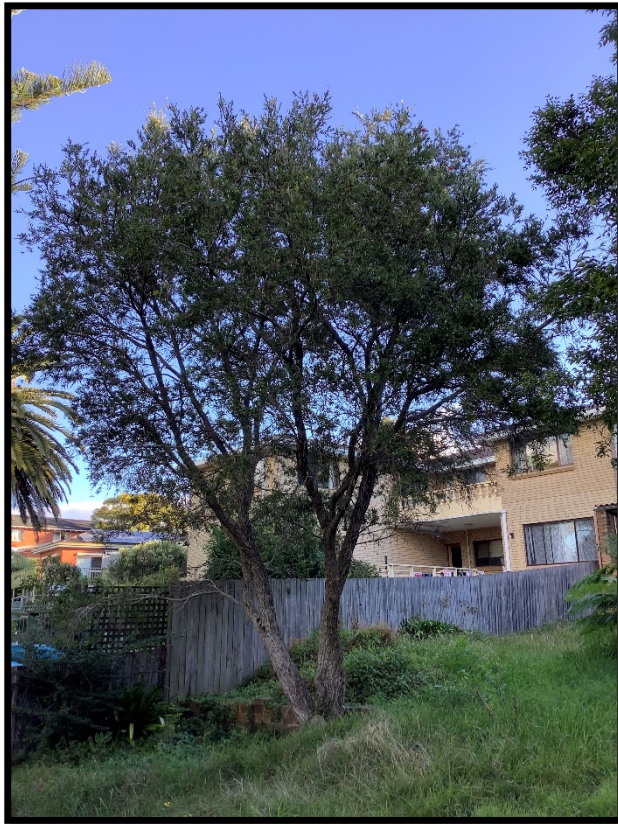
Figure 15 - Tree 14

The mature bottle brush tree is in fair health and poor structure. Tree is included at ground level. Tree is largely epicormic with 30% deadwood contained within the canopy. The tree has a low retention value and low landscape significance and is a priority for removal.

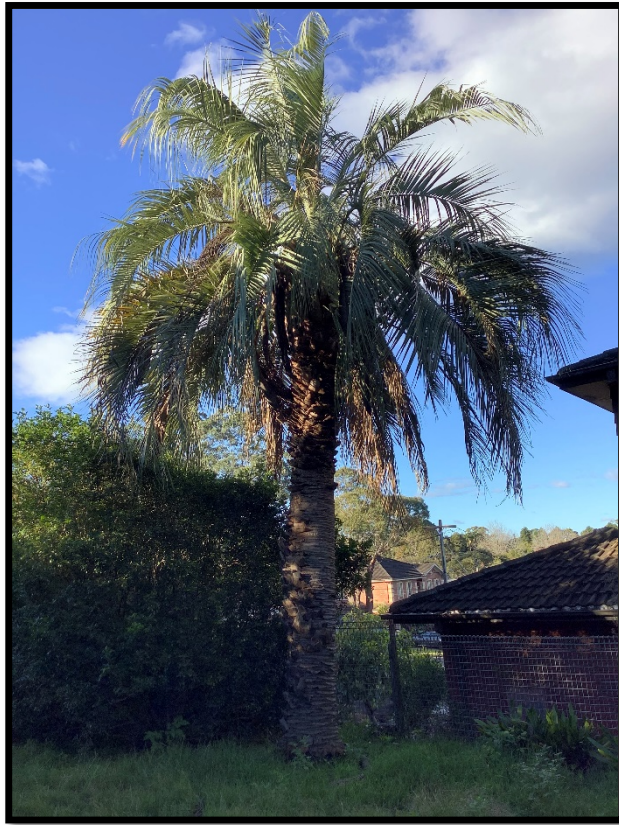
Figure 16 - Tree 15

Number	Species	Height	Spread	*DBH	**DGL	***TPZ	^SRZ	Age Class	Health	Condition	Significance	ULE	Retention Value
15	<i>Palm spp</i> (Unknown palm species)	8	3	410	410	2	2	Mature	Good	Good	Low	2 (Medium)	Consider for Removal
Notes: The palm located on the rear boundary of the property is in good health and good structure with no defects observed. The palm tree is on a minor lean towards the neighbouring dwelling. Tree has low landscape significance and contributes little to the surrounding canopy cover of the area.													
Number	Species	Height	Spread	*DBH	**DGL	***TPZ	^SRZ	Age Class	Health	Condition	Significance	ULE	Retention Value
16	<i>Araucaria heterophylla</i> (Norfolk Island Pine)	17	7	380	410	4.56	2.28	Mature	Good	Good	High	2 (Medium)	High
Notes: The mature Pine tree is in good health and good structure with no obvious defects observed. All care should be taken in an attempt to reduce impact within the tree protection zone of this tree.

The palm is located on the rear boundary of the property and is in good health and good structure with no defects observed. The palm tree is on a minor lean towards the neighbouring dwelling. The tree contributes little to the canopy cover of the surrounding area. The tree has a low retention value and low landscape significance and is considered for removal.

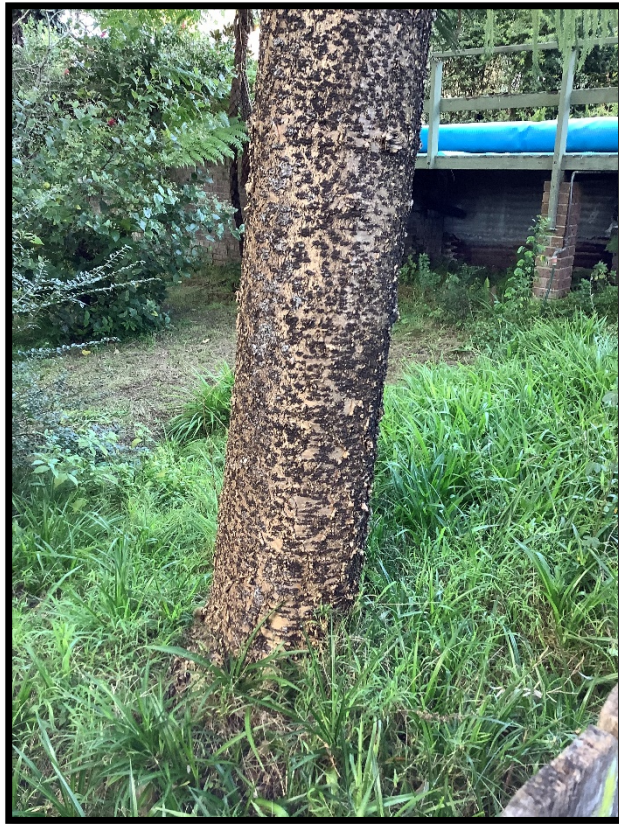
Figure 17 - Tree 16

The mature Pine trees is in good health and good structure with no obvious defects observed. All care should be taken in attempt to reduce impact within the tree protection zone of this tree. This tree has a high retention value.
