4 Laura Street, Seaforth

Geotechnical Comments for Section 4.55 (Formerly Section 96).

GEOTECHNICAL INVESTIGATION:

Landscaping at 4 Laura Street, Seaforth

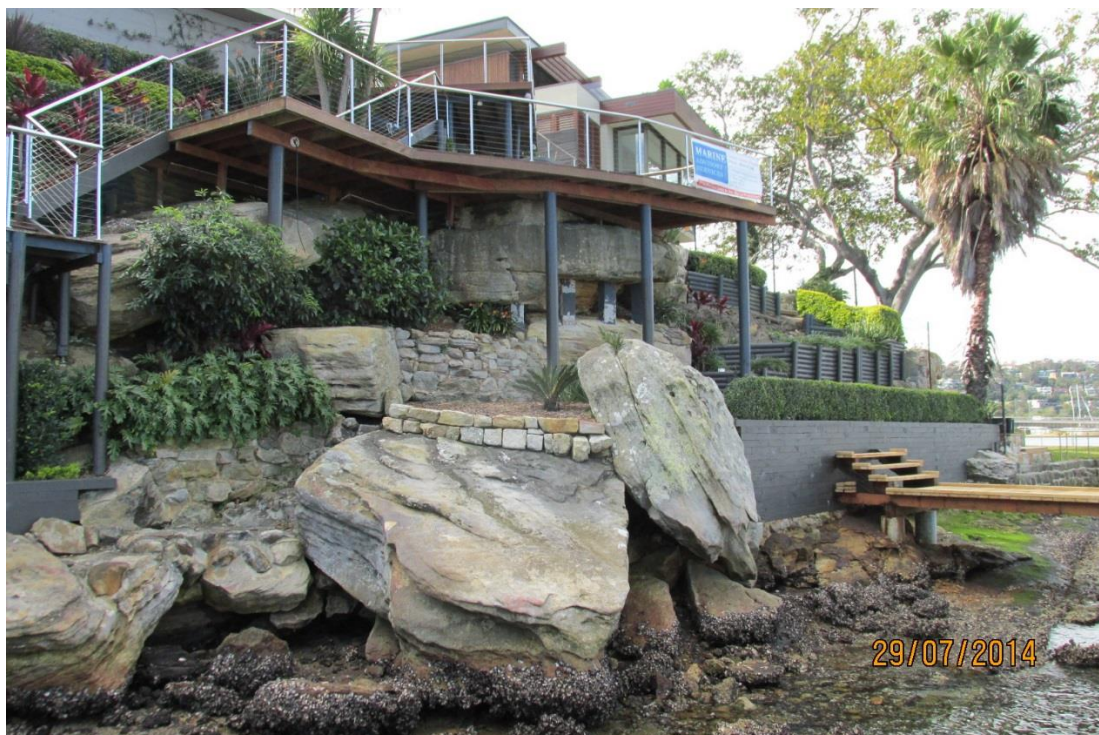
Photo 1

- 2.3** Sandstone bedrock is visible at the waterfront and also in the steep slope immediately above. Several loose boulders are scattered along the waterfront (Photo 1). These appear to be in stable positions. One in particular is lodged at a high angle and has come to rest on several other boulders (Photo 2). This boulder has been in place for a long time and is currently considered stable but care should be taken not to disturb its contact points during the construction. The boulder would not be stable should there be a significant seismic movement. The slope above has been landscaped with poorly constructed treated timber retaining walls and timber decks and walkways (Photo 1 & 3). The soldier piles supporting the walls are inadequately embedded and are tilting at angles up to 10 degrees from vertical (Photo 4). The decks and walkways are not all plum and some of the supporting timber posts can be seen to be tilting down slope. These works will be replaced as part of the proposed development.

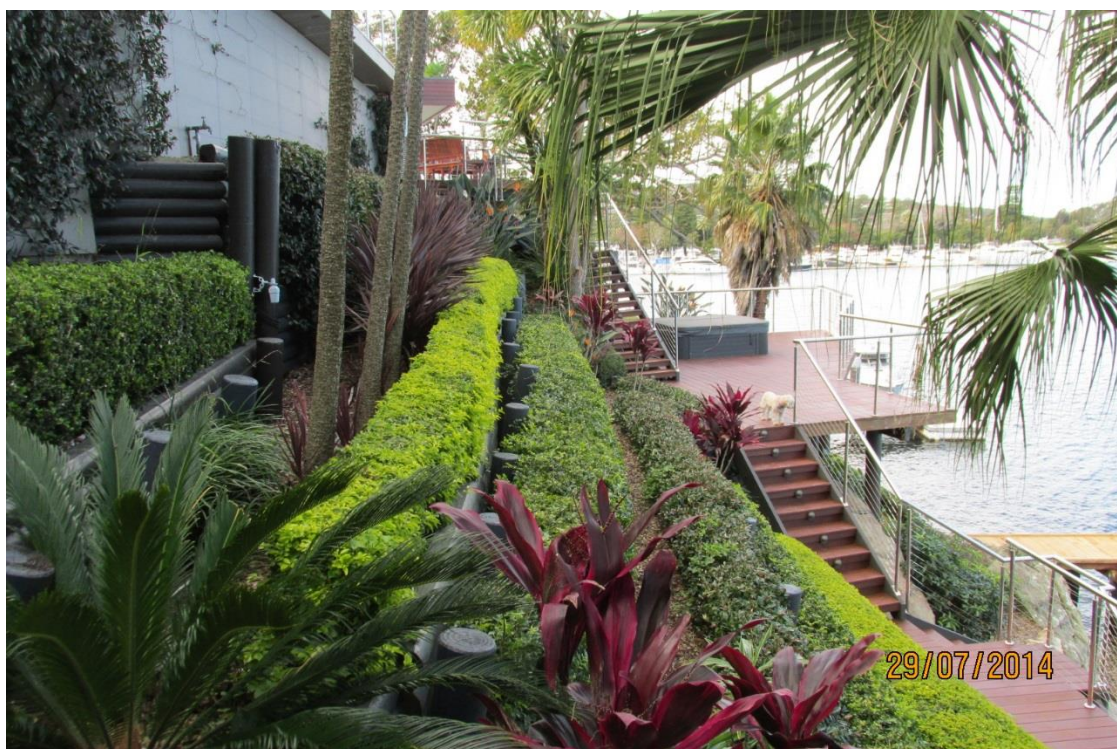
Photo 4

HAZARDS	Hazard One	Hazard One
TYPE	The slope that rises across the property failing and impacting on the house.	The tilting timber retaining walls below the pool failing.
LIKELIHOOD	'Unlikely' (10^{-4})	'Possible' (10^{-3})
CONSEQUENCES TO PROPERTY	'Minor' (8%)	'Medium' (15%)
RISK TO PROPERTY	'Low' (5×10^{-6})	'Medium' (2×10^{-4})
RISK TO LIFE	8.3×10^{-7} /annum	8.3×10^{-6} /annum
COMMENTS	'Acceptable' level of risk.	'Unacceptable' level of risk. To move risk to 'Acceptable' levels the retaining walls are to be replaced.

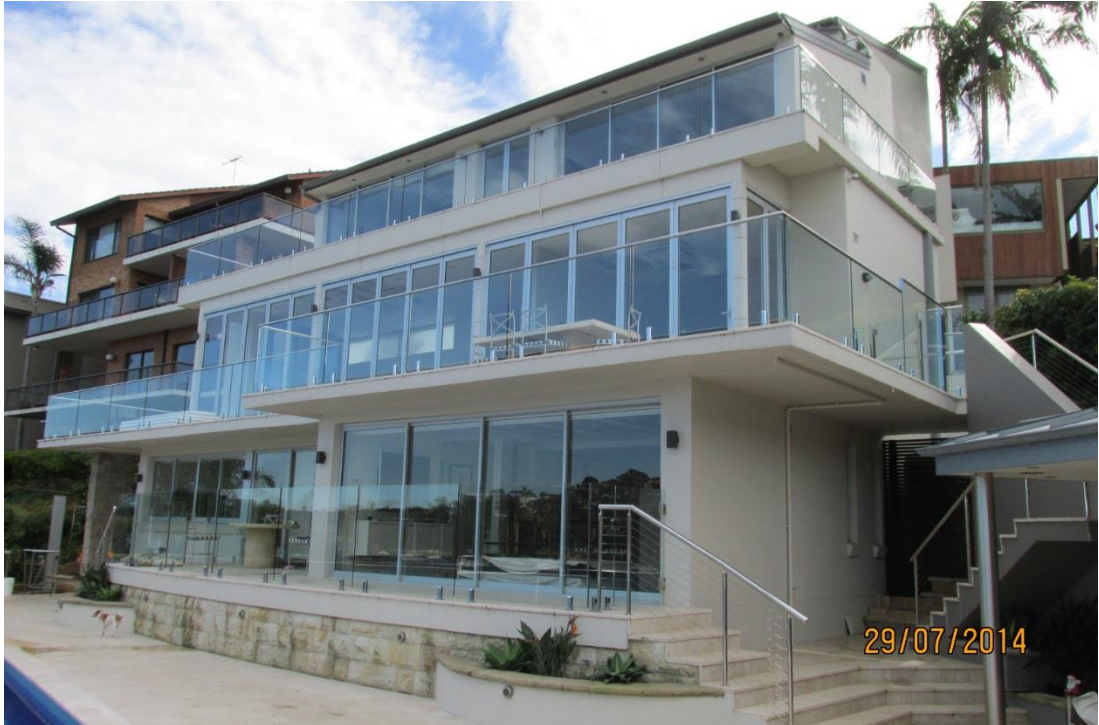
Photo 5

2.4 Above the landscaped waterfront slope the pool and part three level masonry house steps up the slope with the footprint of these structures covering the upper portion of the block (Photo 5). No signs of movement were observed in the supporting walls of the house or in the pool. A cut behind the lower level of the house is through stable sandstone bedrock (Photo 6).
