Report Title: Geotechnical Report 60 Palm Beach Road, Palm Beach

Report Date: 2/9/19

## **GEOTECHNICAL INVESTIGATION:**

New pool at **60 Palm Beach Road, Palm Beach**

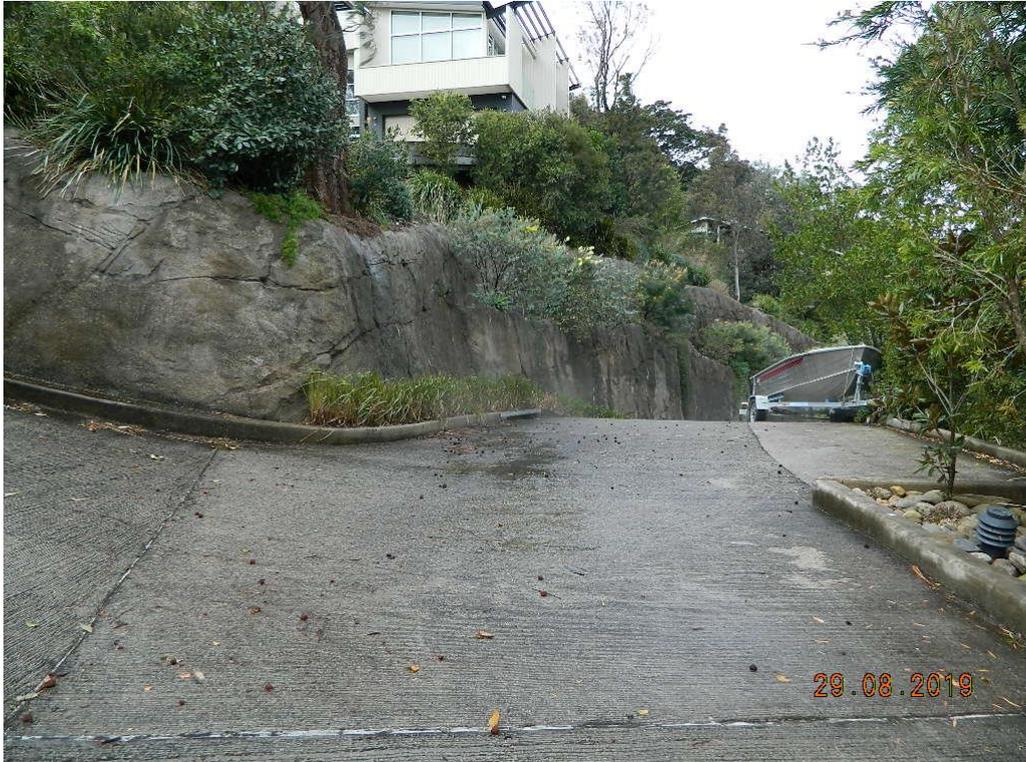
Photo 1

- 2.3** A shared concrete right of way carriageway (ROW) extends from Palm Beach Rd to the high side of the existing house. This ROW has been cut into the slope with the cut supported by stable concrete wall that show no signs of distress and appear stable (Photo 1). A partially suspended driveway and garage extend downhill of the ROW to the house (Photo 2). Outcropping sandstone is visible to the N of the driveway and above the house (Photo 3). The two storey part rendered brick part timber clad house is supported on concrete piers and brick walls that appear stable (Photo 4). A stair case to the N of the house grants access to a terraced lawn below. Stable 1.0m high timber retaining walls have been used to level the slope (Photo 5). A pool is proposed on the downhill side of the existing house. Immediately below the footprint of the proposed pool is a sandstone rock face (Photo 6). The rock making up the face

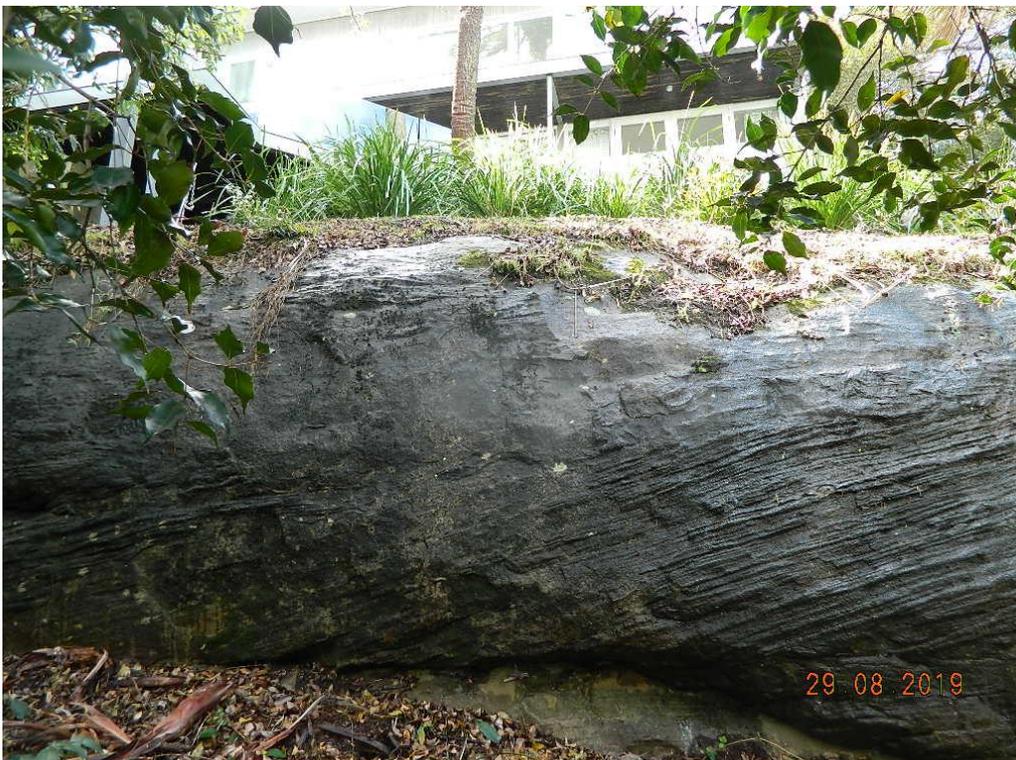
Photo 6

is at least Medium Strength and contains no geological defects that could impact on its stability.

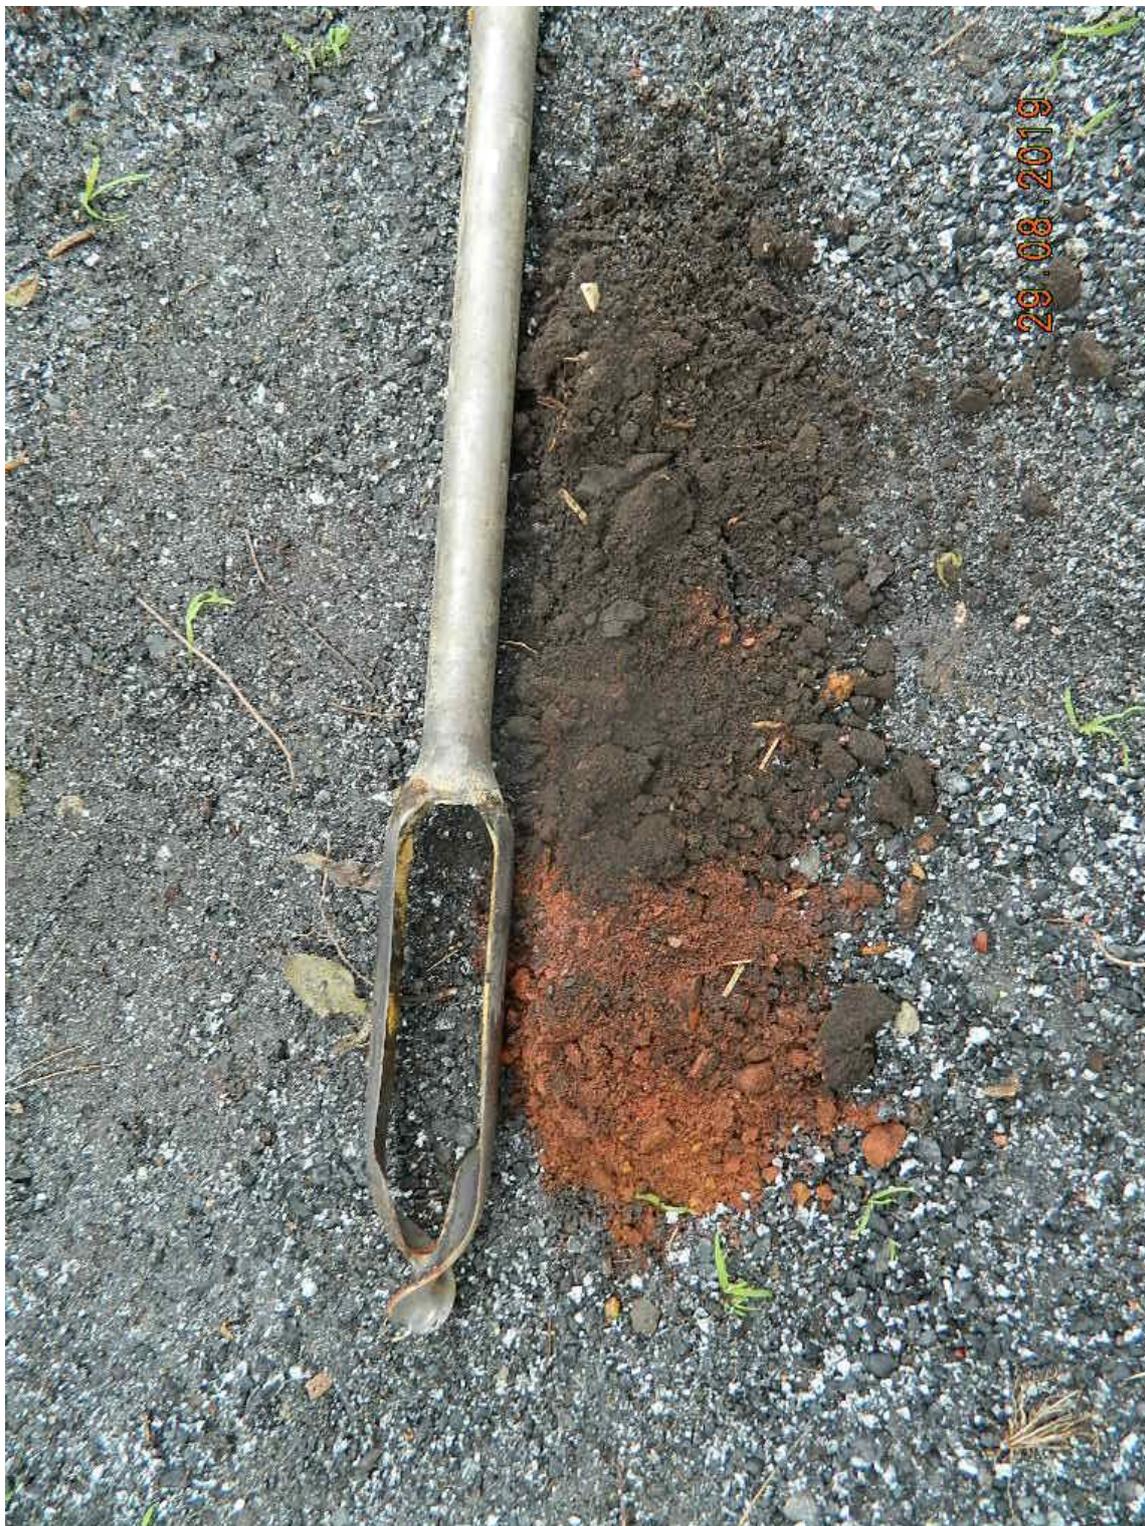
Photo 7 – AH1

#### AUGER HOLE 1 (~RL30.0) – AH1 (Photo 7)

Depth (m)	Material Encountered
0.0 to 0.2	<b>TOPSOIL</b> , Sandy soil, dark brown, medium grained with fine trace organic matter.
0.3 to 0.5	<b>SAND</b> , maroon, medium grained with weathered rock fragments.

End of hole @ 0.5m grinding on rock. No watertable encountered.
