Development Application for	<u>W & E WALKER</u> Name of Applicant
Address of site	<u>37 Sturdee Lane, Elvina Bay</u>

Report Title: RISK ANALYSIS & MANAGEMENT FOR PROPOSED INCLINATOR, ALTERATIONS AND ADDITIONS AT 37 STURDEE LANE, ELVINA BAY– QY 00089
Report Date: 11 th March, 2020
Author : GARTH HODGSON Reviewer: PETER THOMPSON
Author's Company/Organisation : HODGSON CONSULTING ENGINEERS PTY LTD

**RISK ANALYSIS & MANAGEMENT
FOR
PROPOSED INCLINATOR,
ALTERATIONS AND ADDITIONS
AT
37 STURDEE LANE, ELVINA BAY**

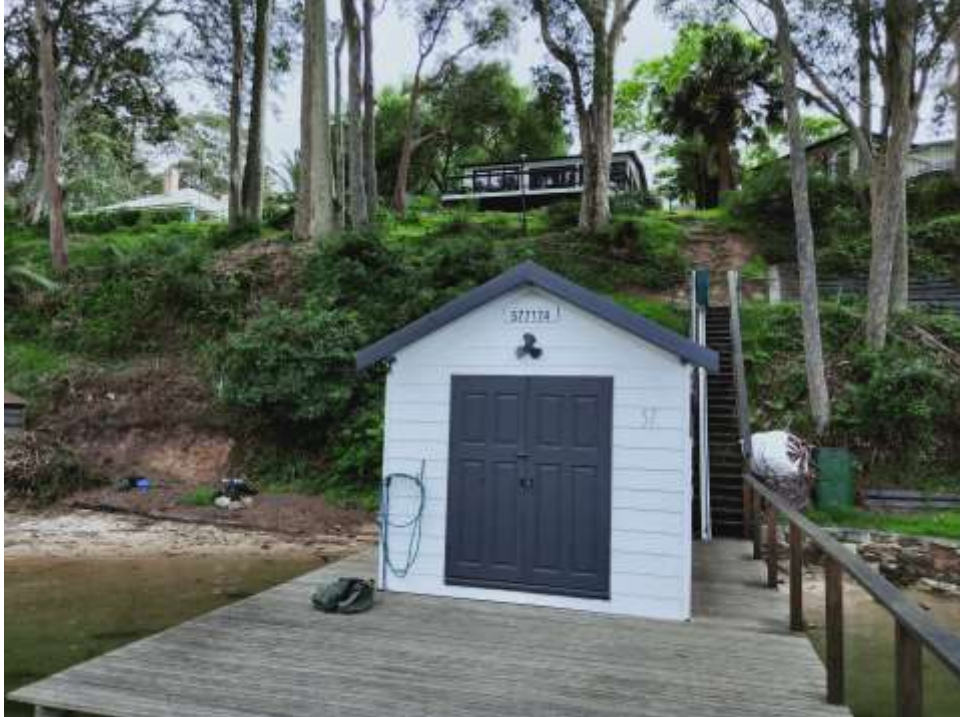
Photo 1

3.3 The site is accessed from the water front of Elvina Bay south of the existing residence. From the water front a stairway winds up to the residence, Photo 1. A very steep slope rises from the water front changing to a moderate to steep slope that leads up to the existing residence. The slope is well vegetated and various well established trees are growing towards the top of the slope, Photo 2. The crest of the slope where the existing residence located is covered by lawn, Photo 3. The existing studio and water tank are in the northern part of the subject property, Photo 4. The grassed slope steepens near the northern boundary down to Sturdee Lane where access is via some landscaped steps, Photo 5.

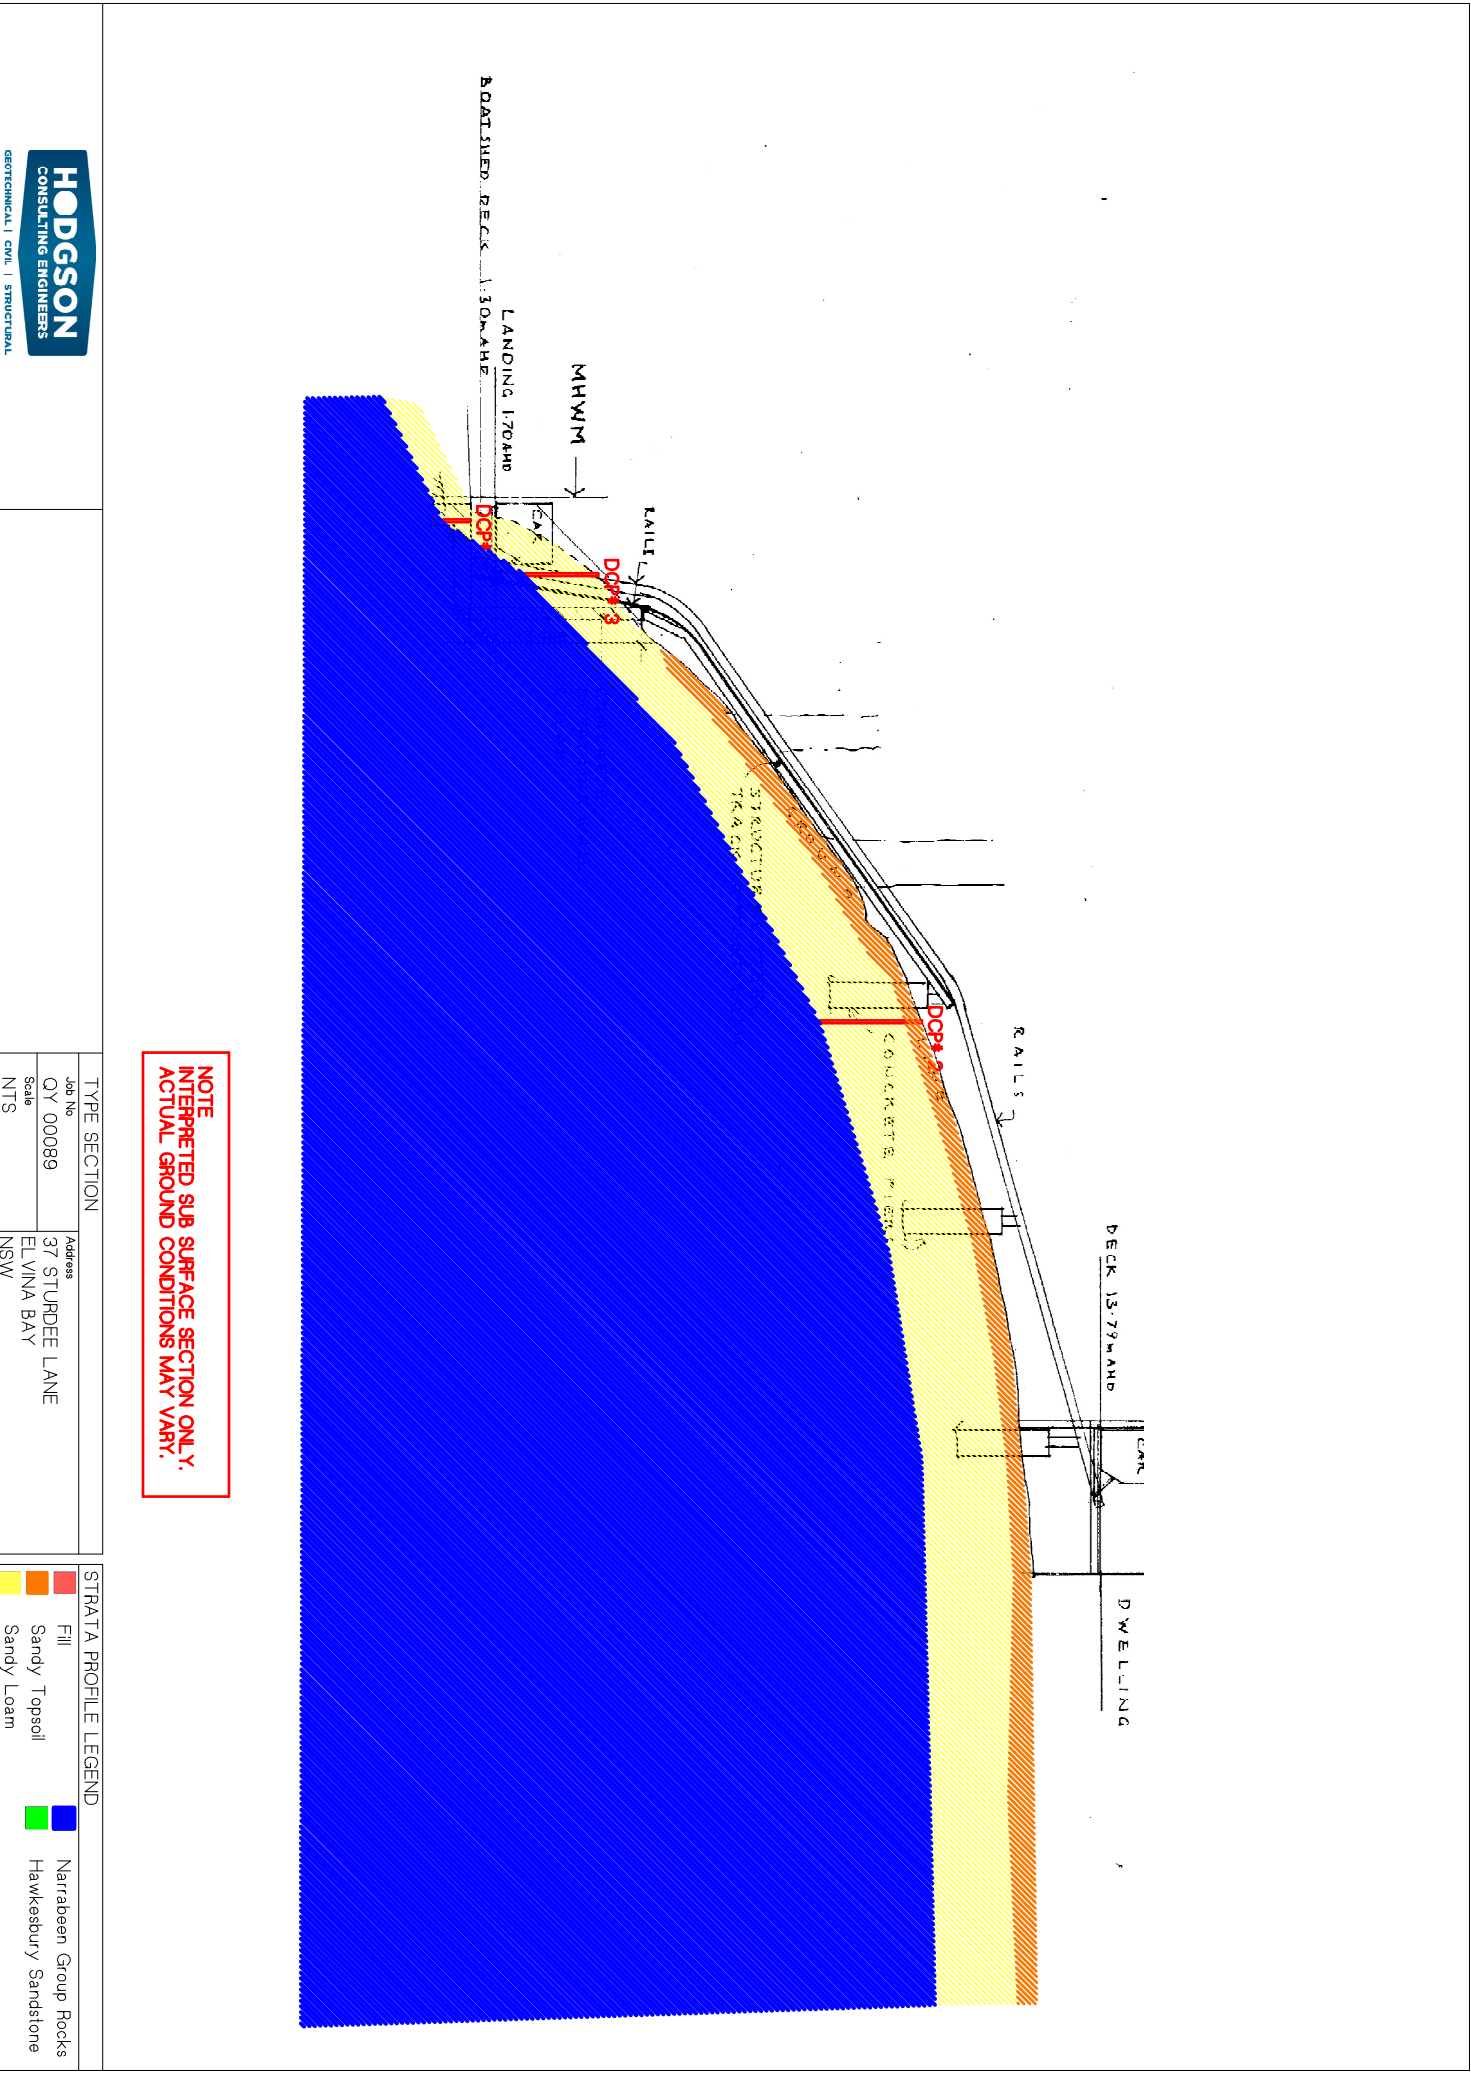
TYPE SECTION	
Job No	QY 00089
Address	37 STURDEE LANE EL VINA BAY NSW
Scale	NTS

4.2 The slope materials are colluvial in origin at the surface and become residual with depth. They consist of topsoil over sandy clays and clays that merge into the weathered rock at depths varying from 0.7 to 2.0 metres or deeper where filling has been carried out.
