# ARBORICULTURAL IMPACT REPORT

52 LAUDERDALE AVENUE  
FAIRLIGHT NSW

15 JUNE 2015

PREPARED FOR PLATFORM ARCHITECTS

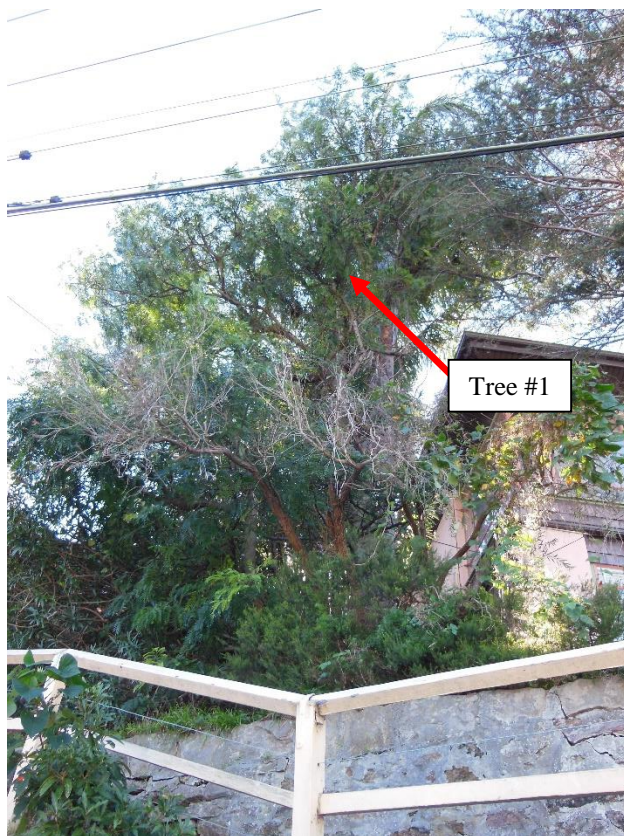
TREE NO.	SCIENTIFIC AND COMMON NAME	TPZ	SRZ	COMMENTS*
1	<i>Acacia elata</i> (Cedar Wattle)	5.2 metres	2.4 metres	The basement access ramp is approx. 9.2 metres from the tree at the closest point and is outside the tree's identified TPZ – no impact of substance.

Photograph 1: Tree # 1 – Illustrating the location and context.

- The proposed works are outside the identified TPZ of tree number 1 - it is not considered there will be any impact of substance on this trees and, with appropriate protection and management, it can be retained at its existing level of health.

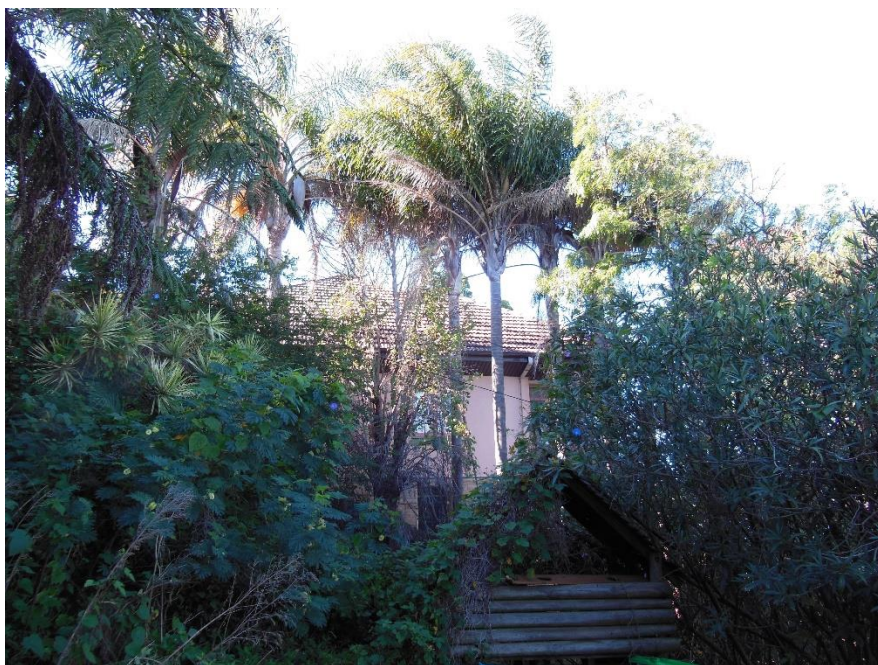
TREE NO.	SCIENTIFIC AND COMMON NAME	REASON
2	<i>Syagrus romanzoffiana</i> (Cocos Palm, Queen Palm)	Environmental pest species.
3	<i>Syagrus romanzoffiana</i> (Cocos Palm, Queen Palm)	Environmental pest species.
4	<i>Syagrus romanzoffiana</i> (Cocos Palm, Queen Palm)	Environmental pest species.
5	<i>Syagrus romanzoffiana</i> (Cocos Palm, Queen Palm)	Environmental pest species. Canopy conflict with T6.

6	<i>Syagrus romanzoffiana</i> (Cocos Palm, Queen Palm)	Environmental pest species. Canopy conflict with T5.
7	<i>Cupressus spp.</i> (Cypress)	The tree is dead.
8	<i>Syagrus romanzoffiana</i> (Cocos Palm, Queen Palm)	Environmental pest species.
9	<i>Syagrus romanzoffiana</i> (Cocos Palm, Queen Palm)	Environmental pest species.
10	<i>Nerium oleander</i> (Oleander)	Poisonous species. At the time of inspection the tree was of fair vigour and exhibited reduced foliage density and low levels of dieback.
12	<i>Cinnamomum camphora</i> (Camphor laurel)	Environmental pest species.
13	Dead tree (Possibly <i>Angophora costata</i> - Sydney Red Gum)	The tree is dead.
15	<i>Cinnamomum camphora</i> (Camphor laurel)	Environmental pest species.
17	<i>Cyathea australis</i> (Rough Tree Fern)	The tree is dead.
18	<i>Coprosma repens</i> (Mirror Bush)	The tree displays poor branch attachment with multiple poorly attached regrowth following severe past pruning. The tree has high levels of Creeping Fig growing on it and evidence of high levels of decay in the basal trunk.

Photograph 2: Illustrating the location and context of tree #s 1 to 8.

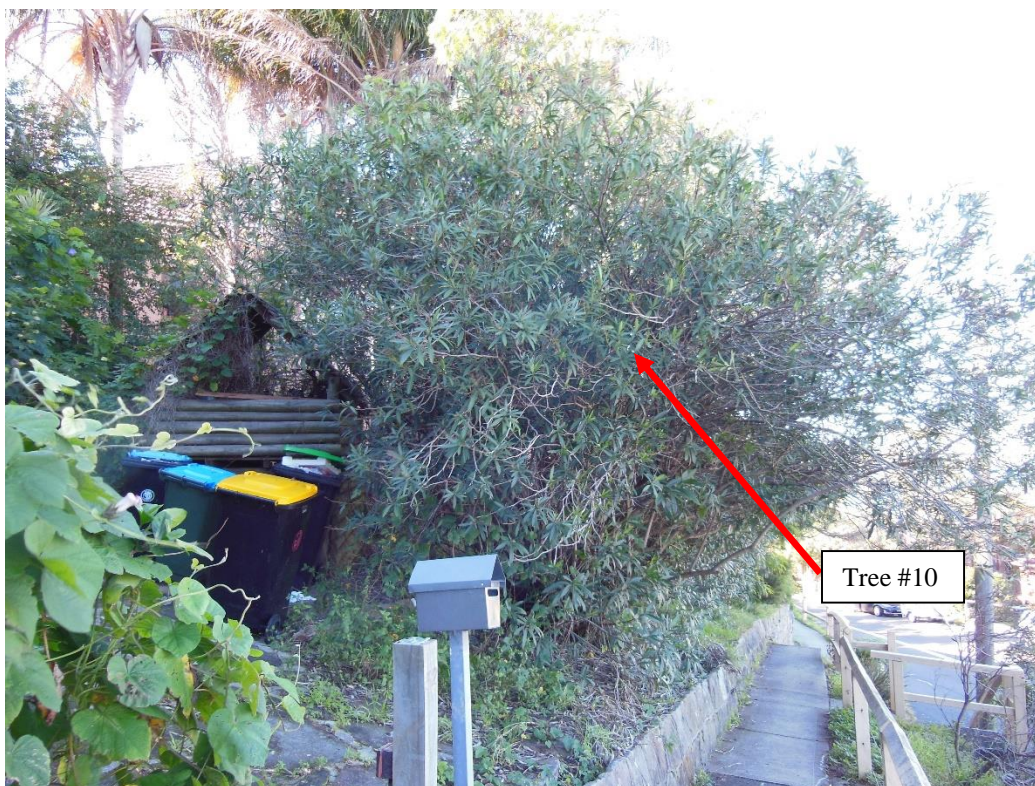
Photograph 3: Tree # 10 – Illustrating the location and context.

10	<i>Nerium oleander</i> (Oleander)	4.5	7	Up to 70 (650 above root flare)	650	650	Good foliage condition	Mature	Multi trunked	Upright trunk	Balanced canopy area	Lower limbs pruned in past to 2 metres for pedestrian access	Appears stable	Sound branch attachment	Good health	Fair vigour	5%	No visual evidence of significant pest or disease	2 Medium (15 to 40 years)	Low to moderate landscape significance	4	Poisonous species. At the time of inspection the tree was of fair vigour and exhibited reduced foliage density and low levels of dieback.
11	<i>Cyathea australis</i> (Rough Tree Fern)	3	3	200	N/A	N/A	Good foliage condition	Mature	Single trunk	Upright trunk	Balanced canopy area	No evidence of significant past pruning	Appears stable	N/A	Good health	Good vigour	<5%	No visual evidence of significant pest or disease	1 Long (> 40 years)	Low landscape significance	3	
12	<i>Cinnamomum camphora</i> (Camphor laurel)	3	2	Up to 120 (160 x 300 above root flare)	230	230	Good foliage condition	Semi Mature	Multi trunked	Upright trunk	Balanced canopy area	No evidence of significant past pruning	Appears stable	Sound branch attachment	Good health	Good vigour	<5%	No visual evidence of significant pest or disease	1 Long (> 40 years)	Environmental pest species	4	Environmental pest species.

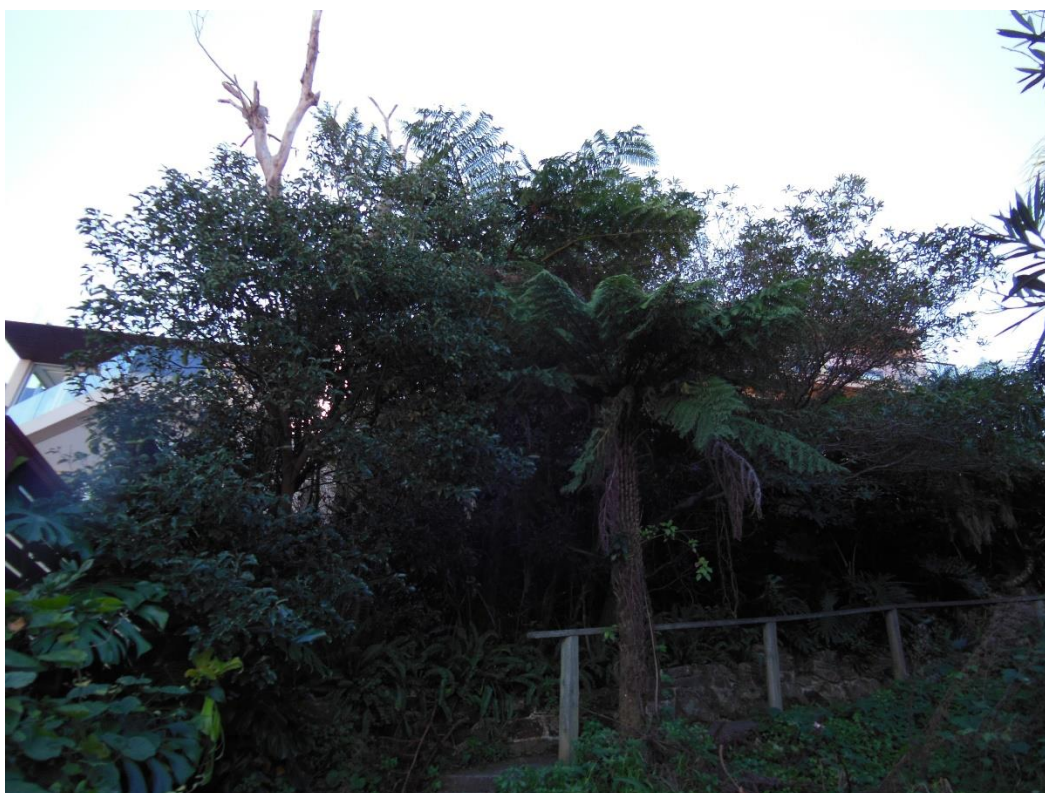
TREE NO.	SCIENTIFIC AND COMMON NAME	TPZ	SRZ	COMMENTS
14	<i>Pittosporum undulatum</i> (Native Daphne, Sweet Pittosporum)	3.1 metres	2 metres	A mature, single trunked specimen approximately 5 metres in height with a canopy spread of 7 metres and a diameter at breast height (DBH) of 260mm. In good health and of moderate landscape significance. The tree's past canopy development has been suppressed. At the time of inspection the tree was of fair vigour and exhibited reduced foliage size and density and low levels of dieback.

Photograph 4: Illustrating the location and context of tree #s 11 to 17.

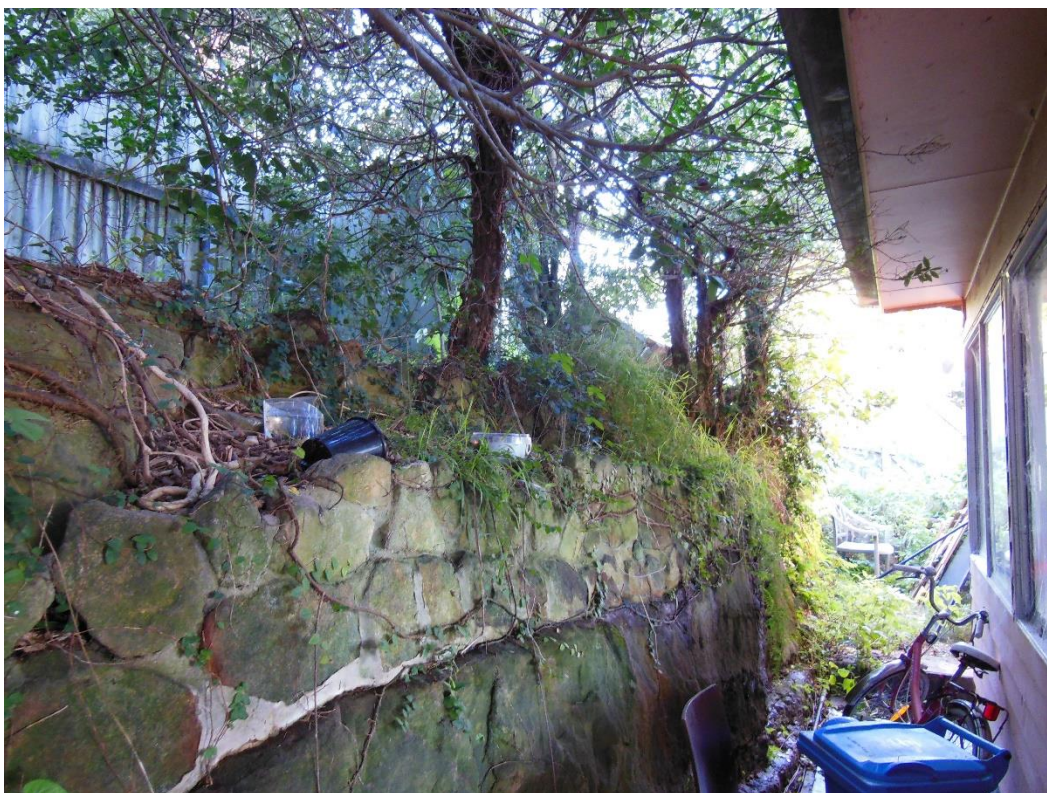
19	<i>Ligustrum sinense</i> (Small Leaved Privet)	Environmental pest species.
20	Dead tree	The tree is dead.
21	<i>Ligustrum sinense</i> (Small Leaved Privet)	The tree displays poor branch attachment with multiple poorly attached regrowth following severe past pruning. Low levels of dieback. Environmental pest species.

Photograph 5: Illustrating the location and context of tree #s 18 to 20.

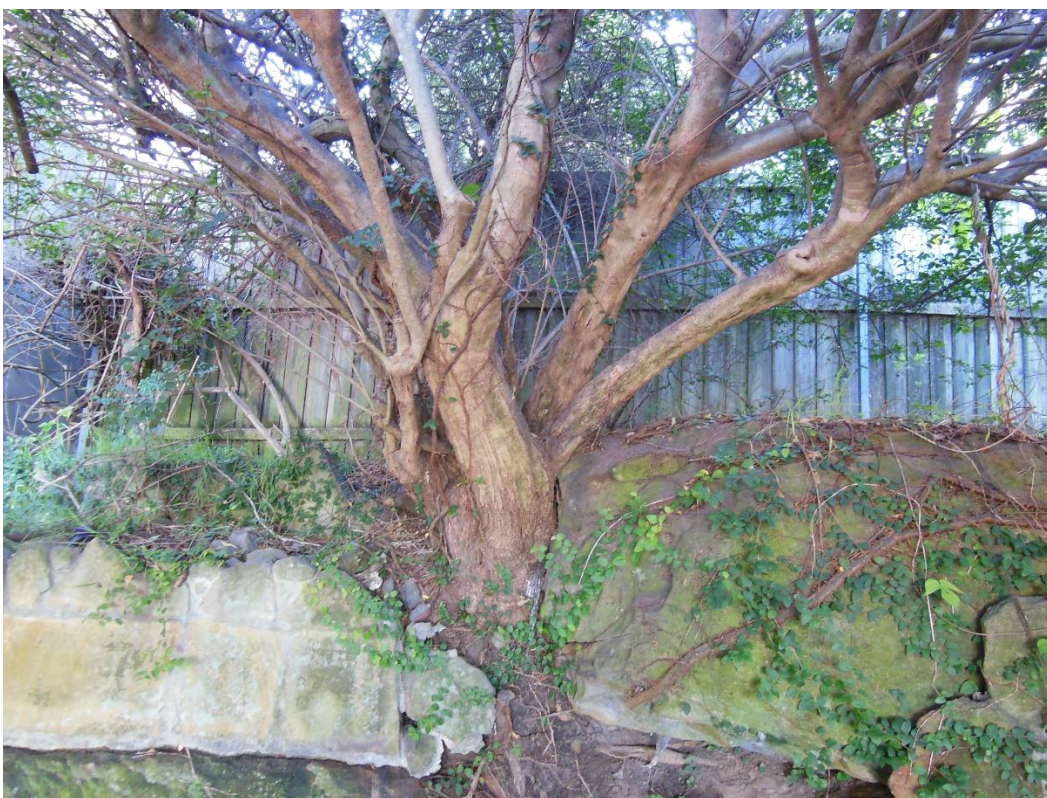
Photograph 6: Tree # 21 – Illustrating the location and context.
