REPORT ON GEOTECHNICAL SITE INVESTIGATION

PROPOSED NEW DWELLINGS WITH CARPARK

52 LAUDERDALE AVENUE, FAIRLIGHT

Project: 2016-013.1

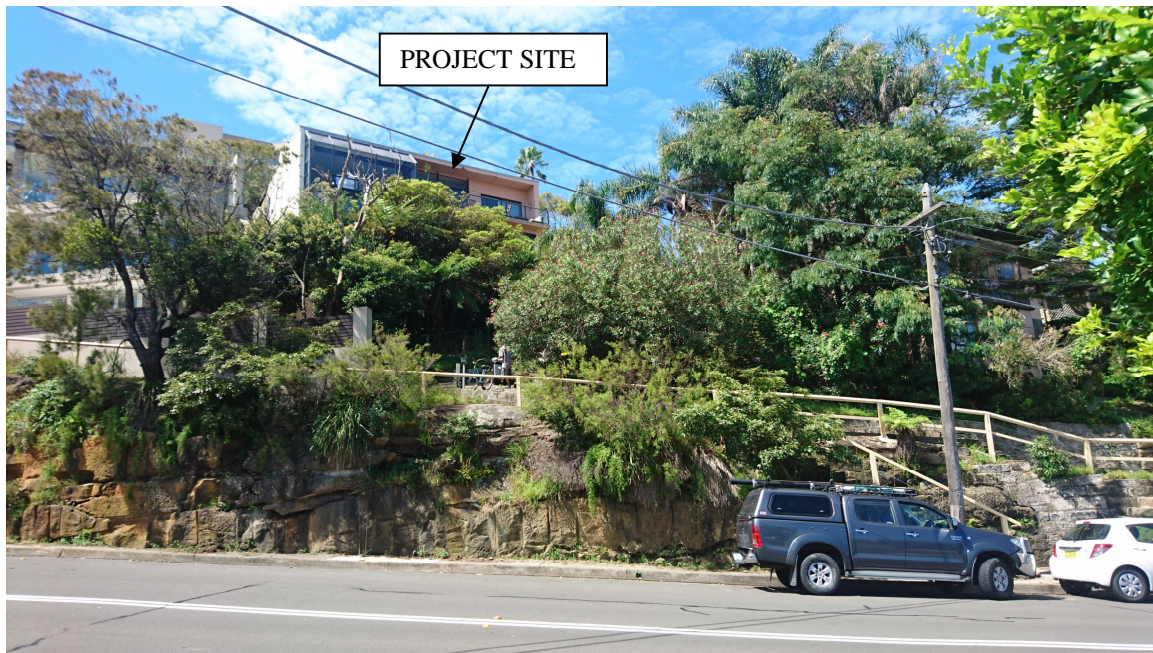
Photograph 1: Front view of the site, looking north

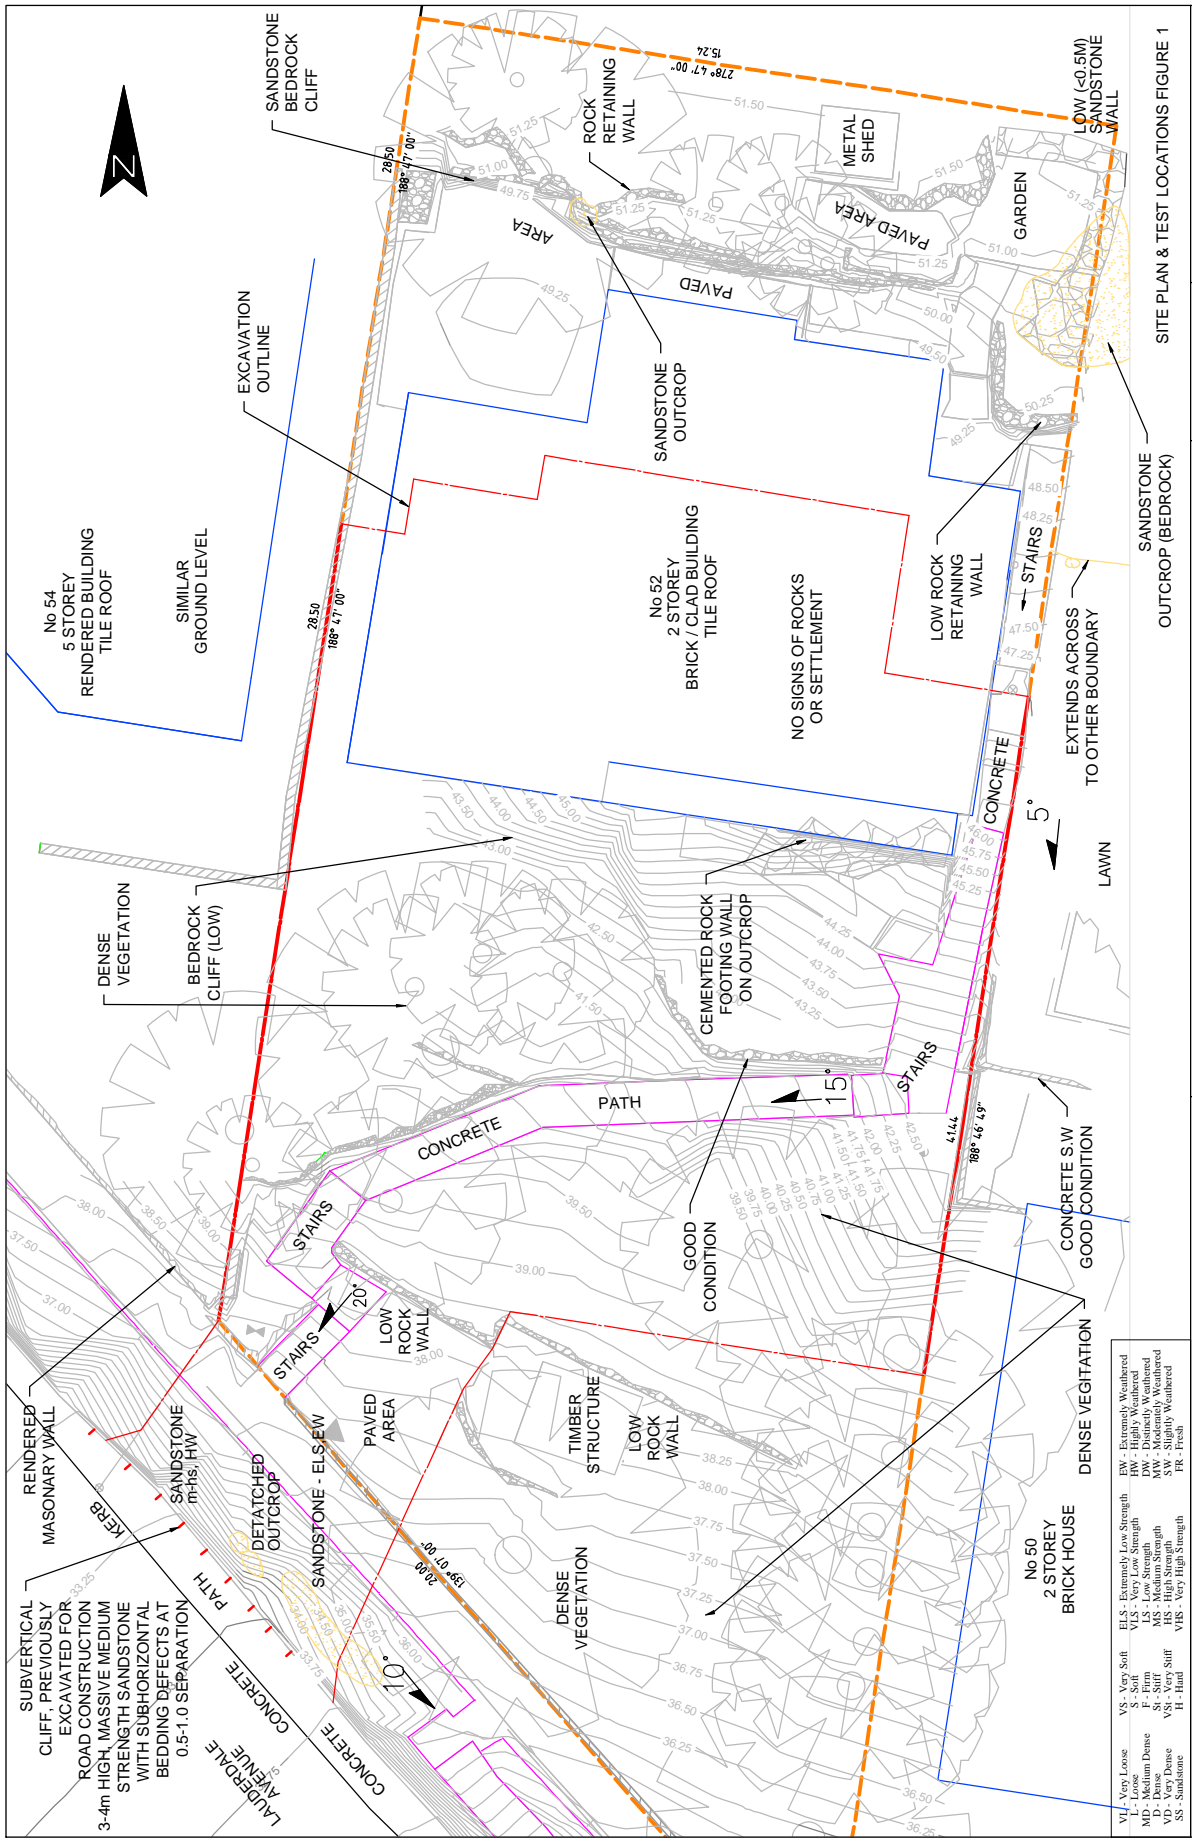
SITE PLAN & TEST LOCATIONS FIGURE 1

The site investigation identified outcropping sandstone bedrock across the site area, including outcrops at the surface at the front and rear of the existing house exposing medium to high strength, massive sandstone bedrock. A sandstone cliff extends across the site within the road reserve. This cliff appears previously excavated and contains several defects which could create unstable blocks of rock during excavation.

The sandstone bedrock exposed at the front and rear of the existing house and at the front boundary of the site is of medium to high strength and dominated by near horizontal bedding defects with few joint defects of a discontinuous nature. The project site contains no existing landslip hazards whilst there were no hazards identified within the neighbouring properties that could impact the site.
