## **Geotechnical Assessment**

**Project:** Alterations and Additions  
271 Whale Beach Road, Whale Beach, NSW.

**REF: AG 19061**  
14<sup>th</sup> May, 2019

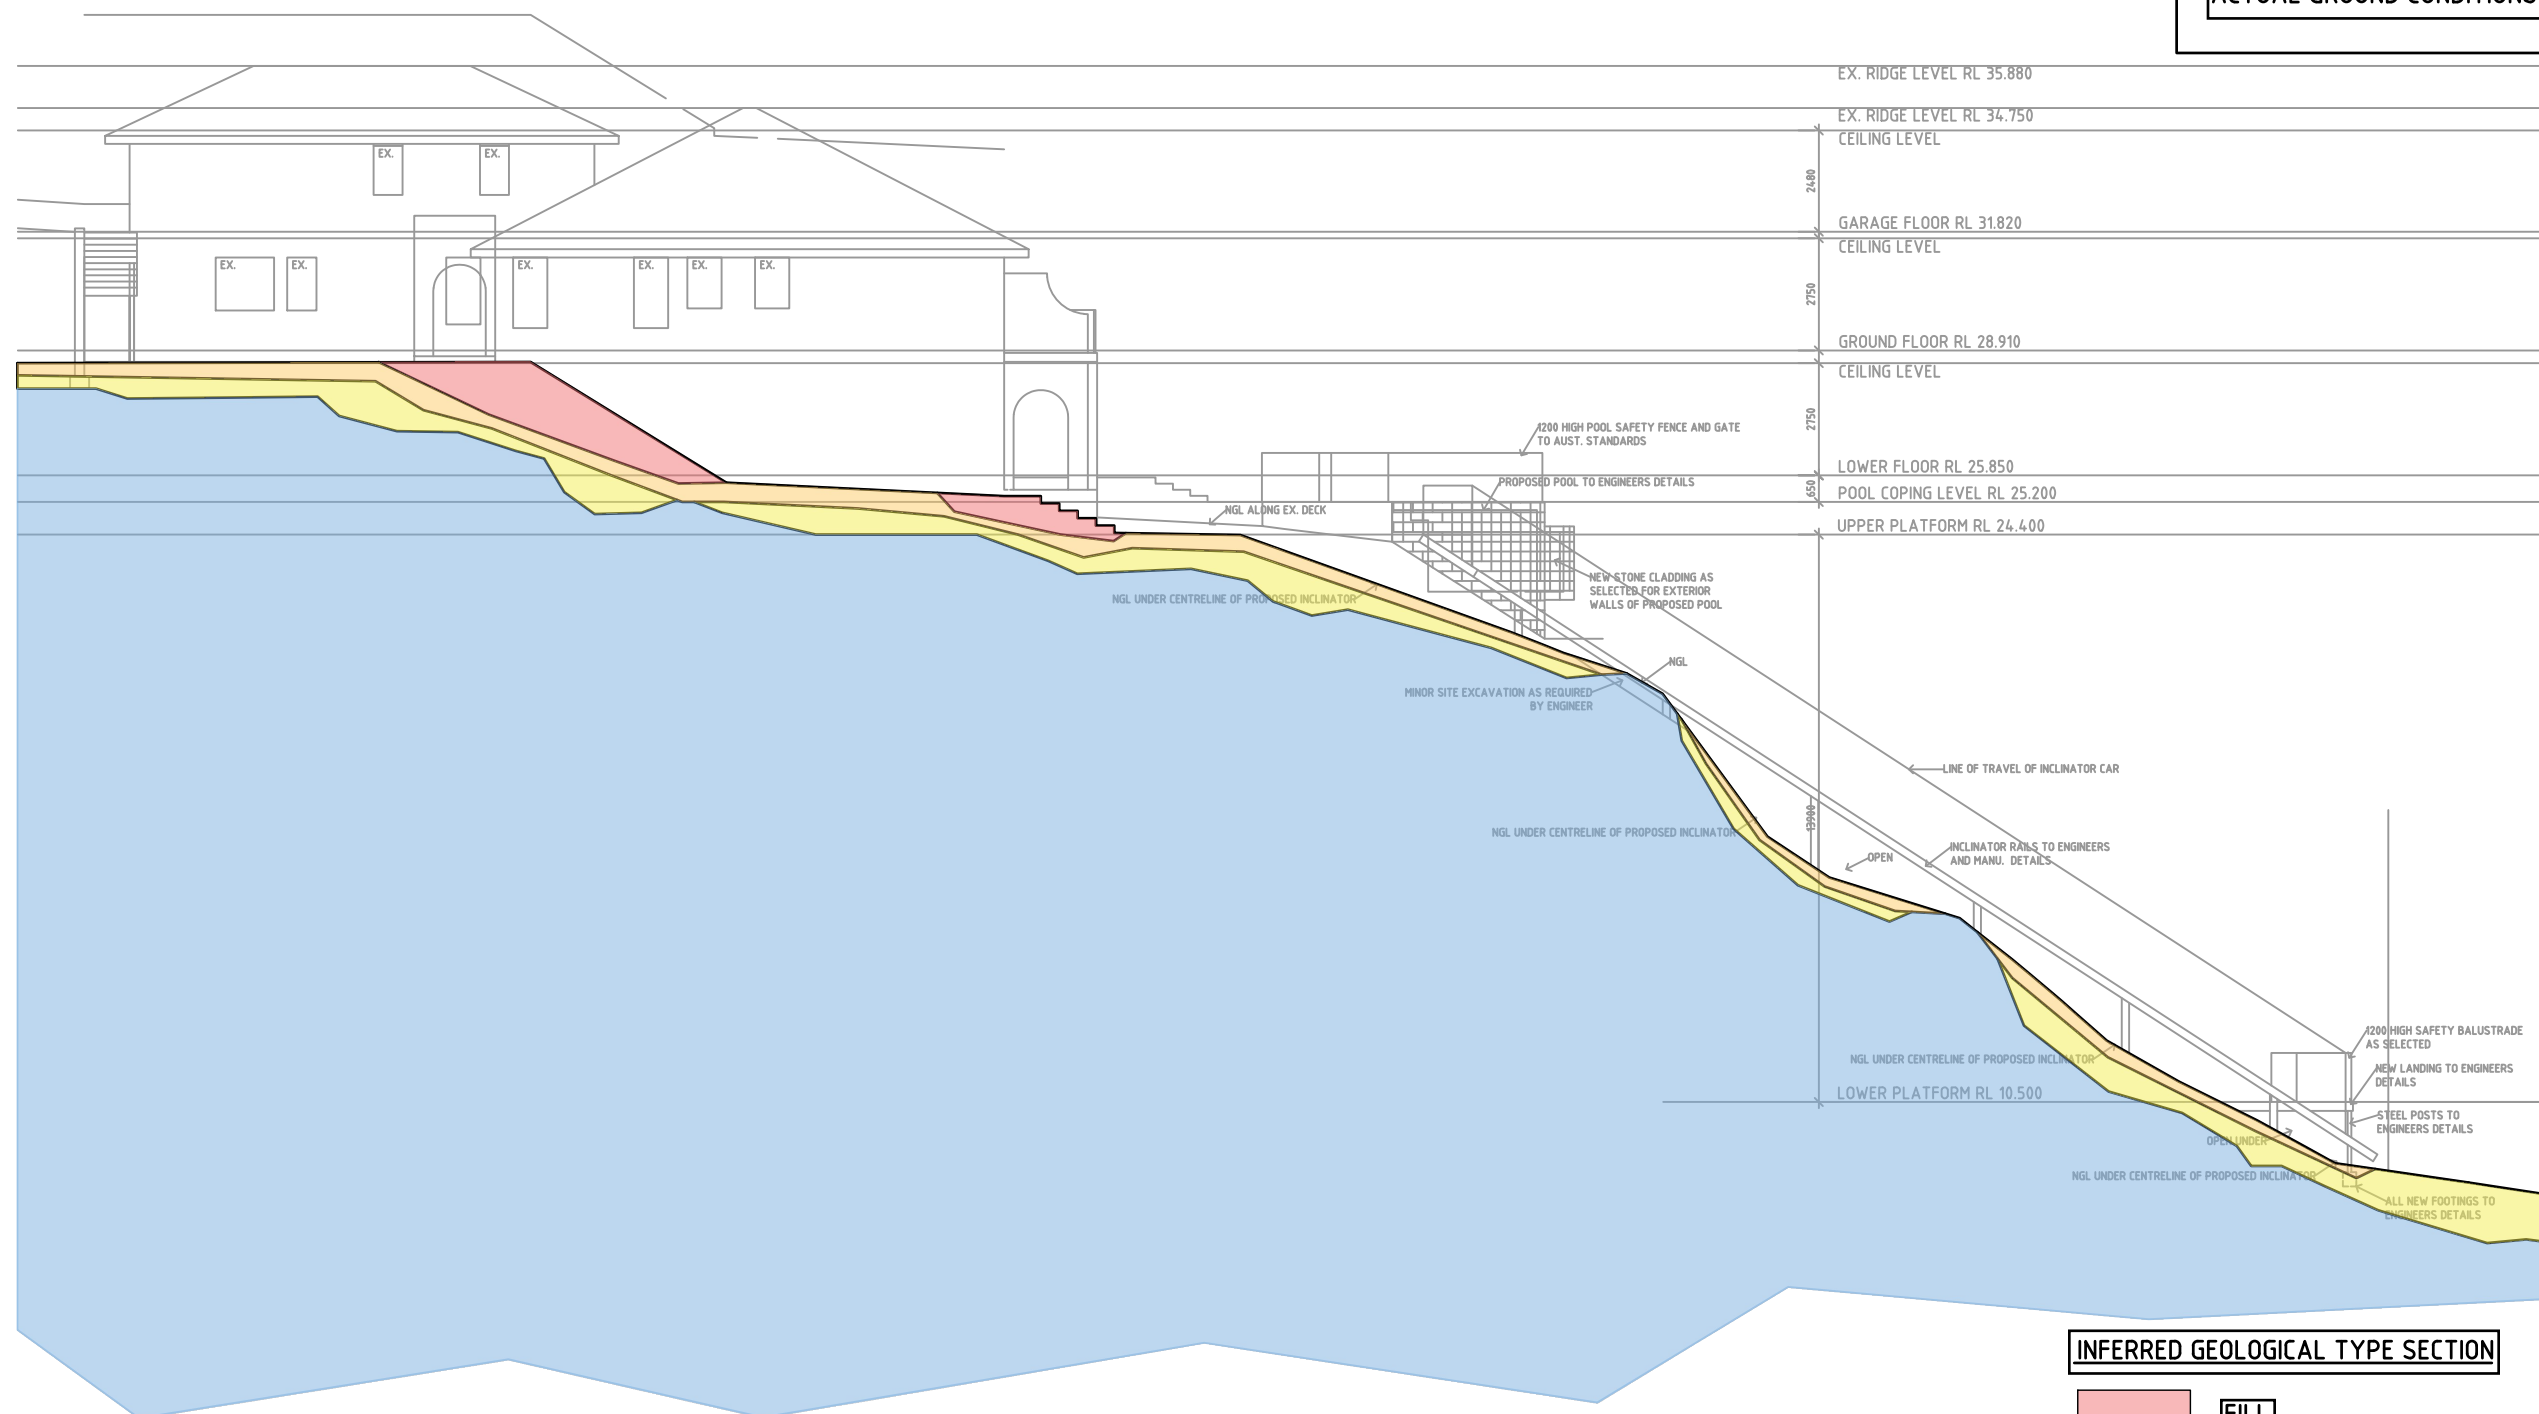
DRAWING NO: AG19061- S1

## INFERRED GEOLOGICAL SECTION
