**Geotechnical Assessment of Existing Public Stairway**

**Re:** 52 Lauderdale Avenue, Fairlight

**Project No:** 2016-013.2

**Comments:** Site inspection on 24<sup>th</sup> April, 2019

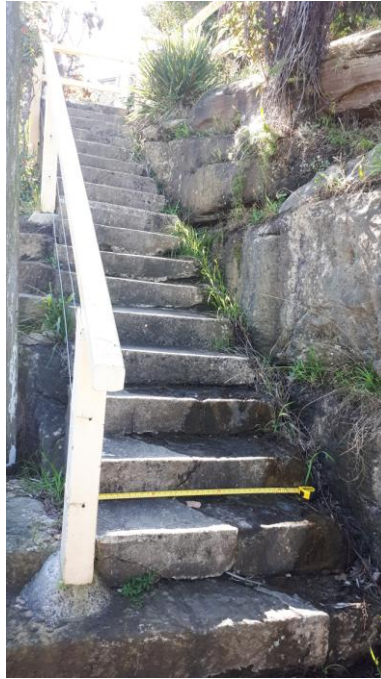
- The existing concrete stairway is located adjacent to a 3.00m – 4.00m high cliff within the road reserve and provides access from the street level to the upper foot path, as shown in Photo 1 below:

*Photo 1: Existing concrete stairway leading from street level to upper foot path*

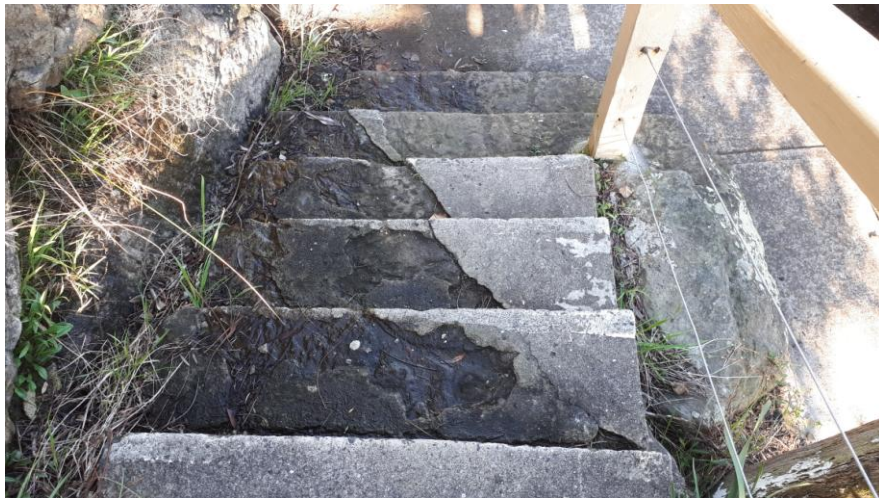
- Thin concrete cover over the bottom 5 steps of the stairway is almost completely damaged exposing the uneven rock surface. The perennial water seepage through the sub-horizontal bedding defects within the adjacent cliff face accumulates over the uneven rock surface and creates slippery conditions which is a major “Slip, Trip and Fall” hazard, shown in photo 2 below:

*Photo 2: Uneven and slippery rock surface over the bottom steps*

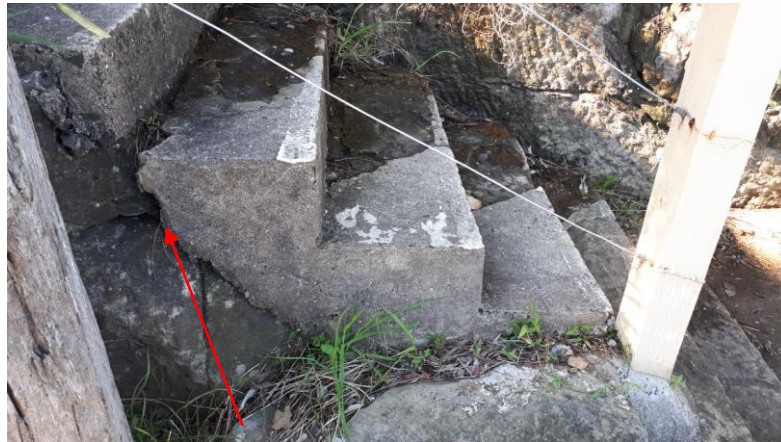
- Also the channel between the stairway and the cliff face is clogged up with washed out material and overgrowth which makes seepage water flow over concrete steps, creating slippery surface over the entire stairway.
- A significant crack was also observed between the concrete steps at the bottom which has caused rotation of the concrete steps along with losing contact with the founding bedrock, shown in Photo 3 below:

*Photo 3: Crack between concrete steps*

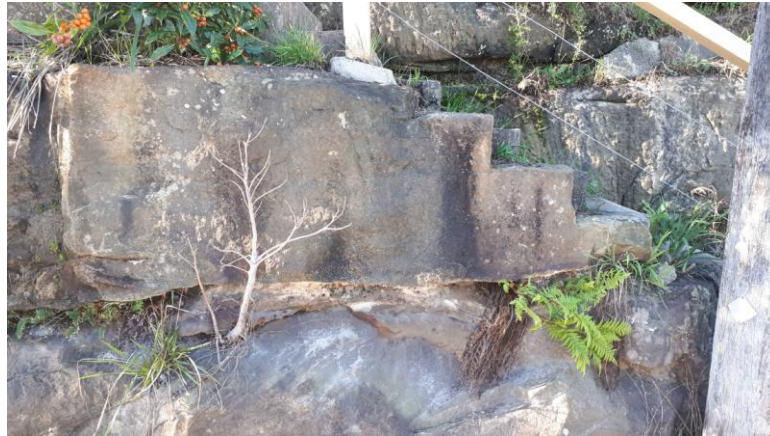
- The lower half of the stairway is resting over a bed of sandstone which is undercut as shown in Photo 4 below:

*Photo 4: Stairway founded on undercut bed of sandstone*

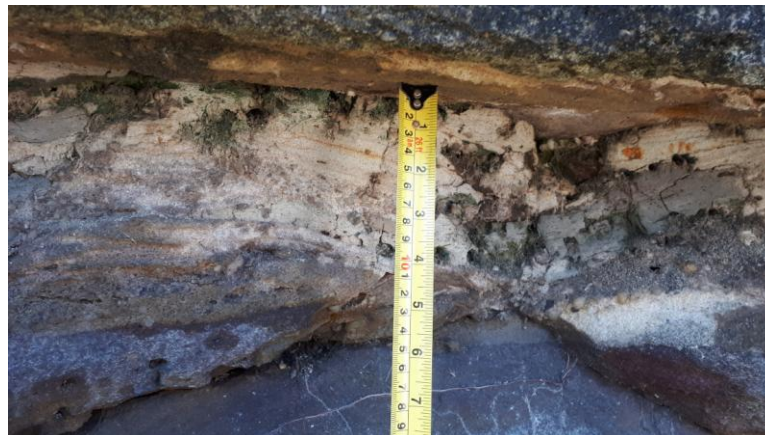
- The depth of the undercut is approximately 0.30m deep with an up 150mm thick clay seam located immediately below the undercut bed, as shown in Photo 5 below. This clay seam is highly susceptible to erosion due to water seepage that will lead to further destabilization of stairway founded above.

*Photo 5: Clay seam below the undercut rock*

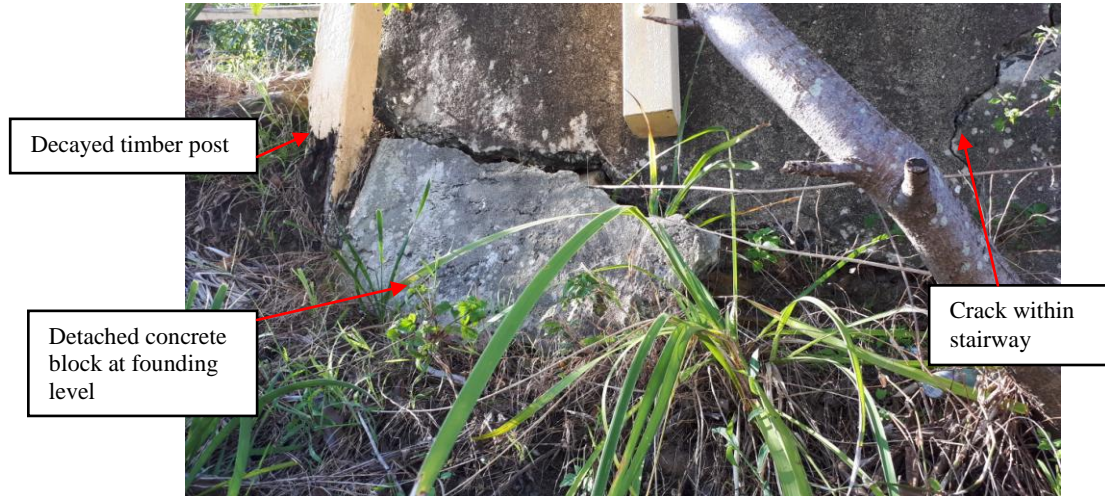
- The lower section at founding level of the top landing block of the stairway is completely detached from the main concrete structure where further cracks have developed and a severely decayed timber post has lost its footing completely, see Photo 6 below:

*Photo 6: Clay seam below the undercut rock*

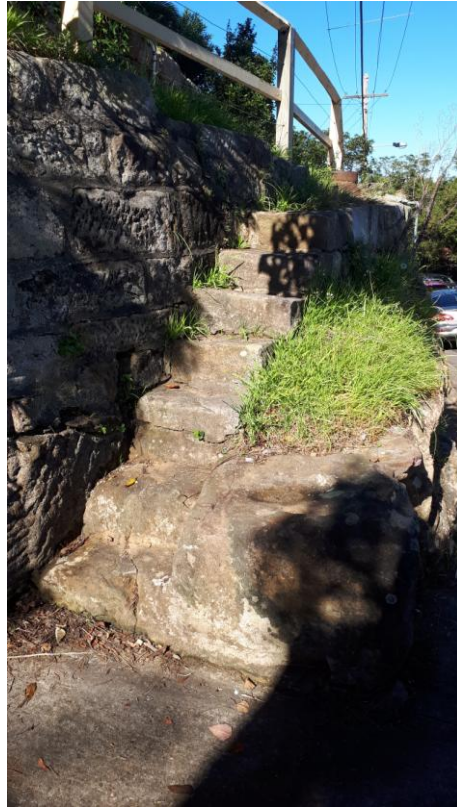
*Photo 7: Alternative location for relocation of stairway*

In view of the above mentioned risks regarding public safety and stability of the existing stairway, it is recommended that the stairway be relocated to a proposed location to the east of the existing stairway, as shown in Photo 7 below:

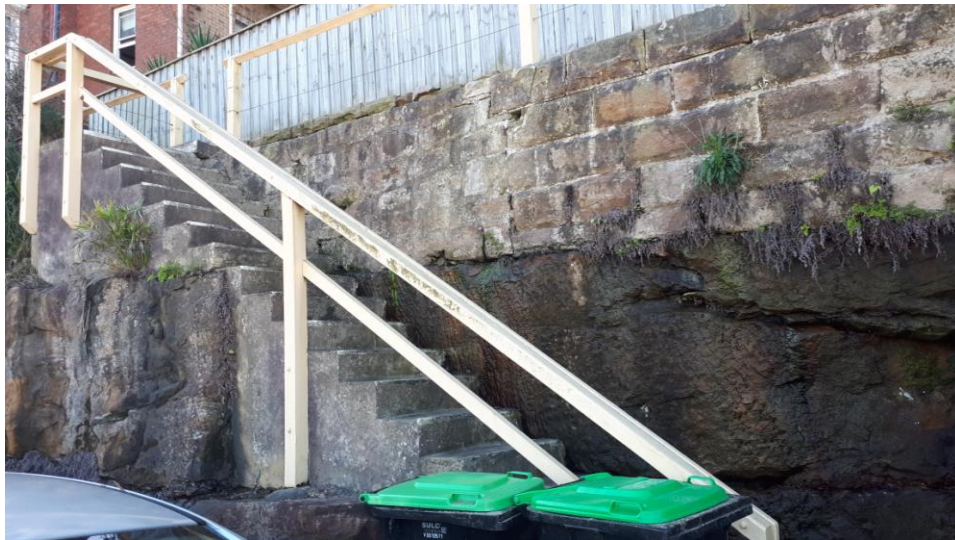
*Photo 8: Existing stairway in front of property No. 58 Lauderdale Avenue*

- The steps of this stairway are constructed over two monoliths of concrete founded over stepped rock cut faces which are in a very stable condition.
- The timber posts are very stable and well connected to the concrete blocks over a longer section of the concrete block.
- Water seepage through defects within the rock mass is collected in a channel and diverted away to avoid slippery conditions over the concrete steps.

There is sufficient space available at the proposed location of the stairway where it will be constructed as per Councils requirements. It is proposed that the new stairway will be constructed similar to an existing stairway located in front of the property No. 58 Lauderdale Avenue, as shown below in Photo 8 below:
