GEOTECHNICAL INVESTIGATION:

New House and Pool at 5A Hilltop Crescent, Fairlight

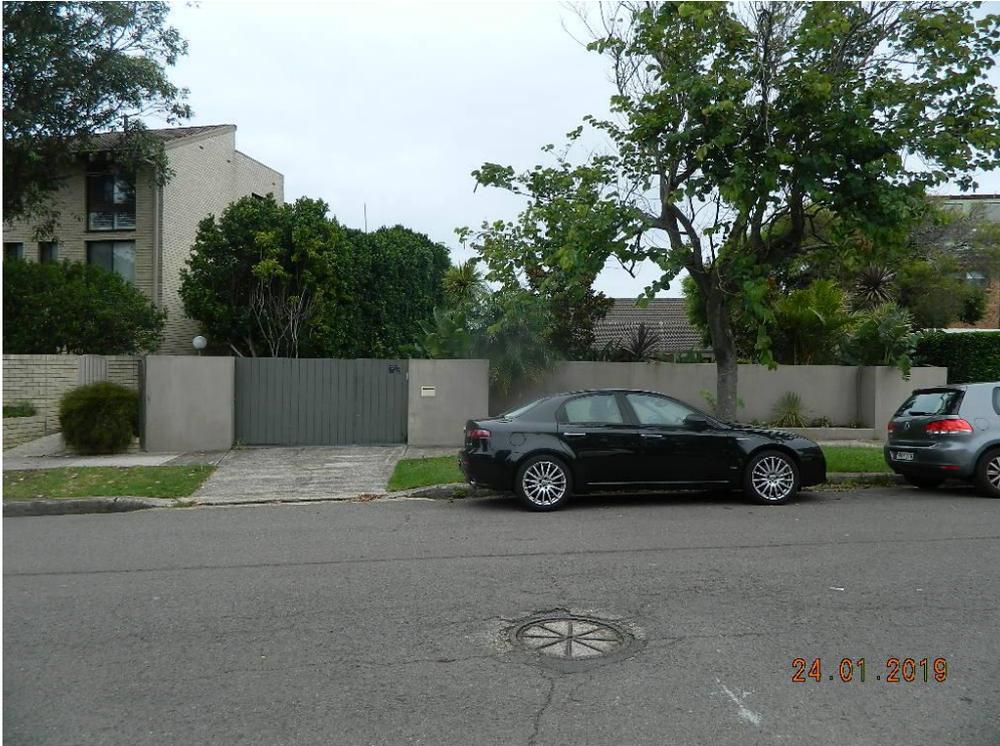
Photo 1

- 2.3** At the road frontage, a concrete driveway runs to a carport attached to the E side of the house (Photos 1 & 2). Between the road frontage and the house is a level lawn area surrounded by gardens (Photo 3). The part two storey brick house will be demolished as part of the proposed works (Photo 4). A gently sloping artificial turfed lawn extends from the downhill side of the house to the downhill boundary (Photo 5). A timber clad shed on the downhill side of the house will be demolished as part of the proposed works (Photo 6). No significant signs of movement were observed on the

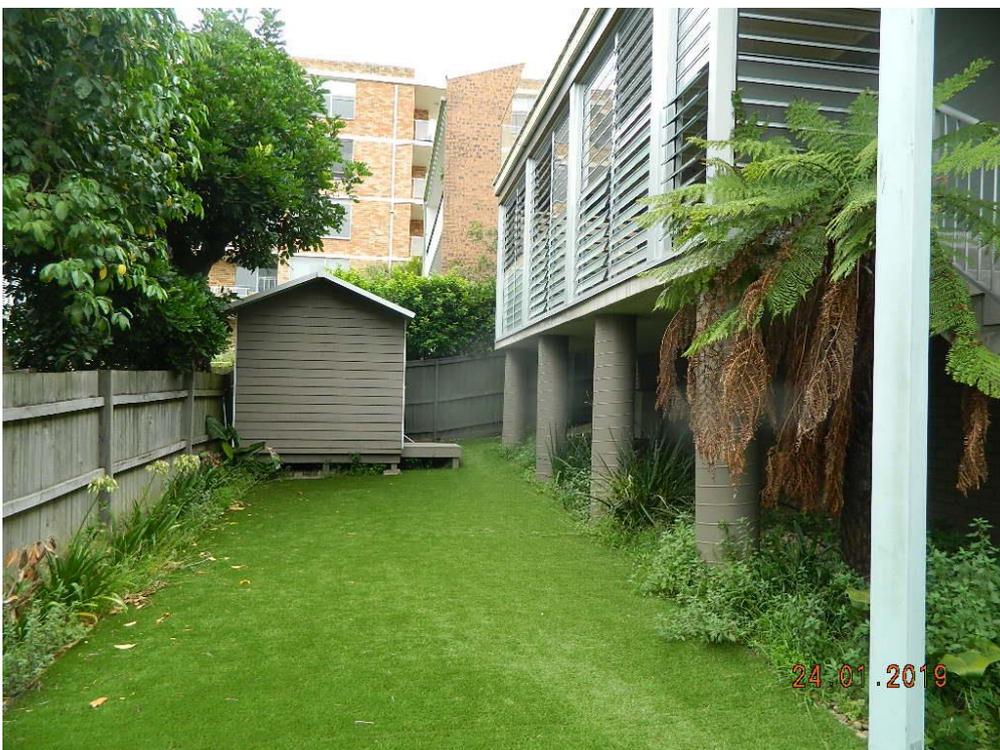
Photo 6

No geotechnical hazards were observed above, below or beside the property. The moderate slope that falls across the lower portion of the property is a potential hazard (**Hazard One**). The vibrations from the proposed house excavation are a potential hazard (**Hazard Two**). The proposed excavations are a potential hazard until retaining walls are in place (**Hazard Three**).

HAZARDS	Hazard One	Hazard Two	Hazard Three
TYPE	The moderate slope that falls across the lower portion of the property impacting on the proposed works (Photo 6)	The vibrations produced during the proposed excavations impacting on the supporting brick walls of the neighbouring houses to the E and W.	The proposed excavation for the lower ground floor and pool collapsing onto the worksite before retaining walls are in place.
LIKELIHOOD	'Unlikely' (10^{-4})	'Possible' (10^{-3})	'Possible' (10^{-3})
CONSEQUENCES TO PROPERTY	'Minor' (8%)	'Medium' (20%)	'Medium' (15%)
RISK TO PROPERTY	'Low' ($\times 10^{-6}$)	'Moderate' (2×10^{-4})	'Moderate' (2×10^{-4})
RISK TO LIFE	7.3×10^{-7} /annum	5.8×10^{-6} /annum	2.9×10^{-4} /annum
COMMENTS	This level of risk is 'ACCEPTABLE'.	This level of risk to life and property is ' UNACCEPTABLE '. To move the risk levels to acceptable levels the recommendations in Section 12 are to be followed.	This level of risk to life and property is ' UNACCEPTABLE '. To move risk to 'ACCEPTABLE' levels the recommendations in Section 13 are to be followed.

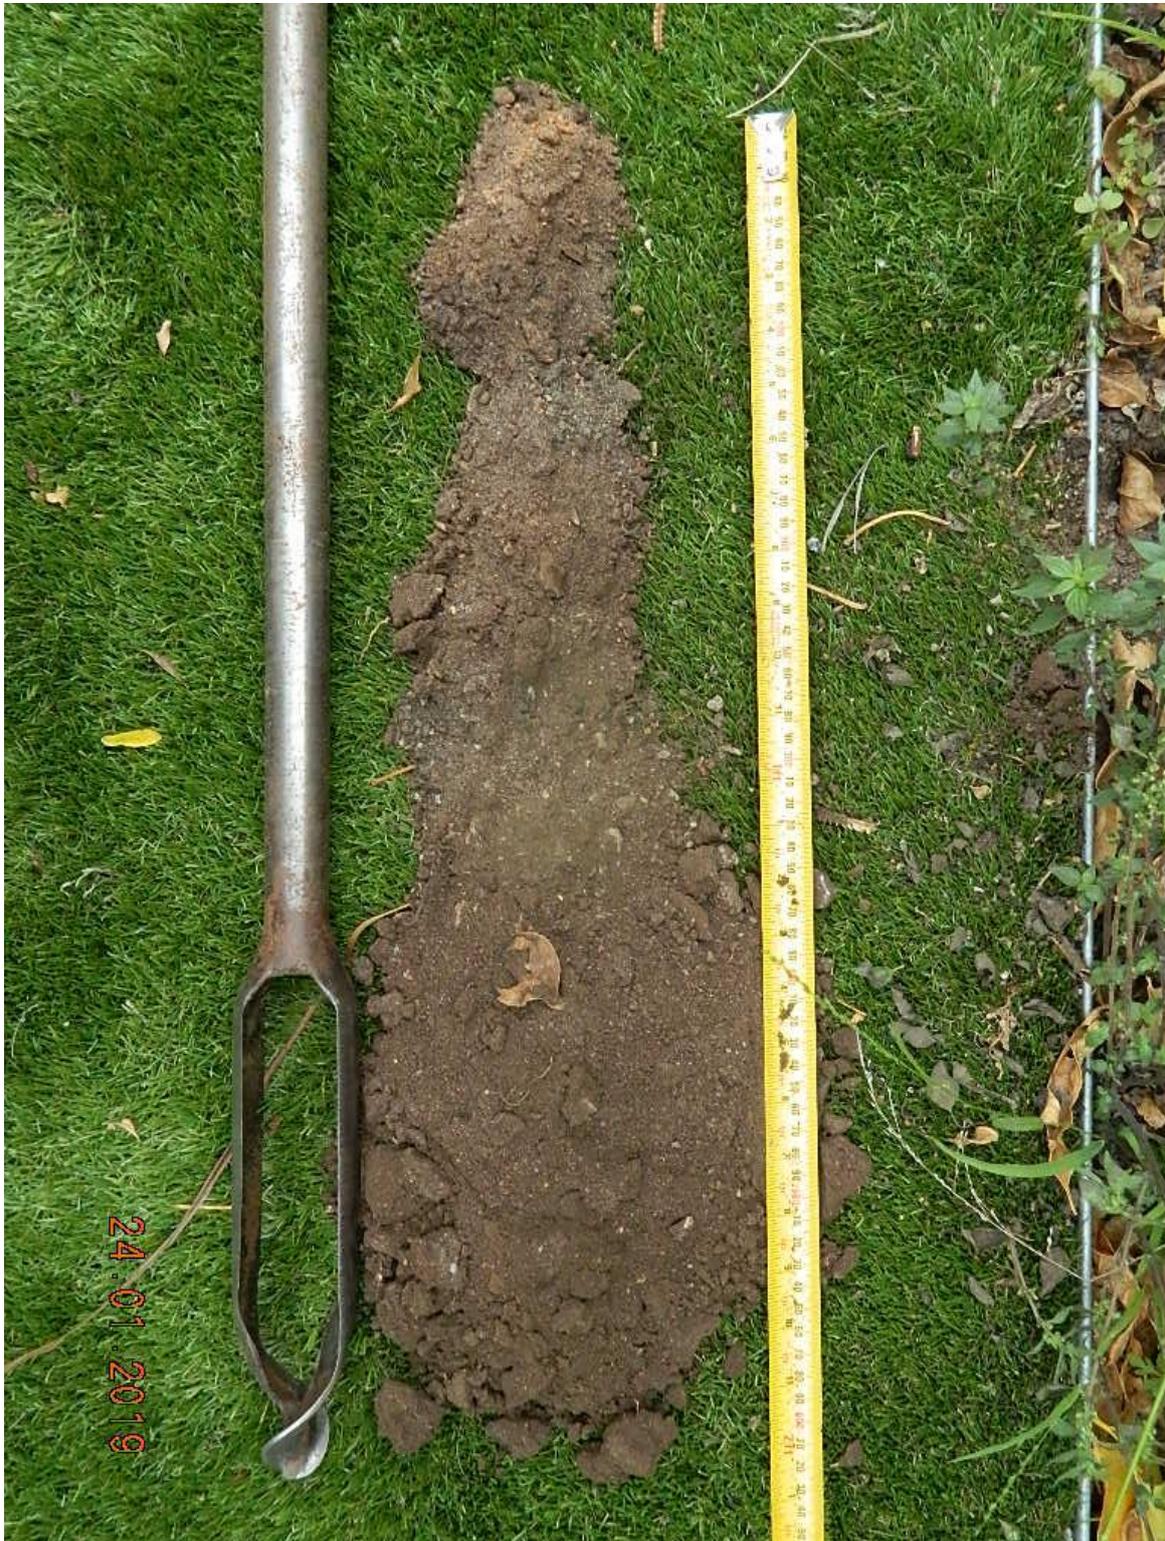
AUGER HOLE 1 (~RL52.3) – AH1 (Photo 7)

Depth (m)	Material Encountered
0.0 to 0.4	FILL , disturbed sandy soil, light brown to brown orange, loose, fine to medium grained, rock fragments throughout, pebbles, dry.
0.4 to 0.6	SANDY SOIL , brown, loose, fine to medium grained, minor rock fragments, dry.

End of hole @ 0.6m in sandy soil. No watertable encountered.

Photo 7: Auger Hole 1. Top of Image is top of hole.

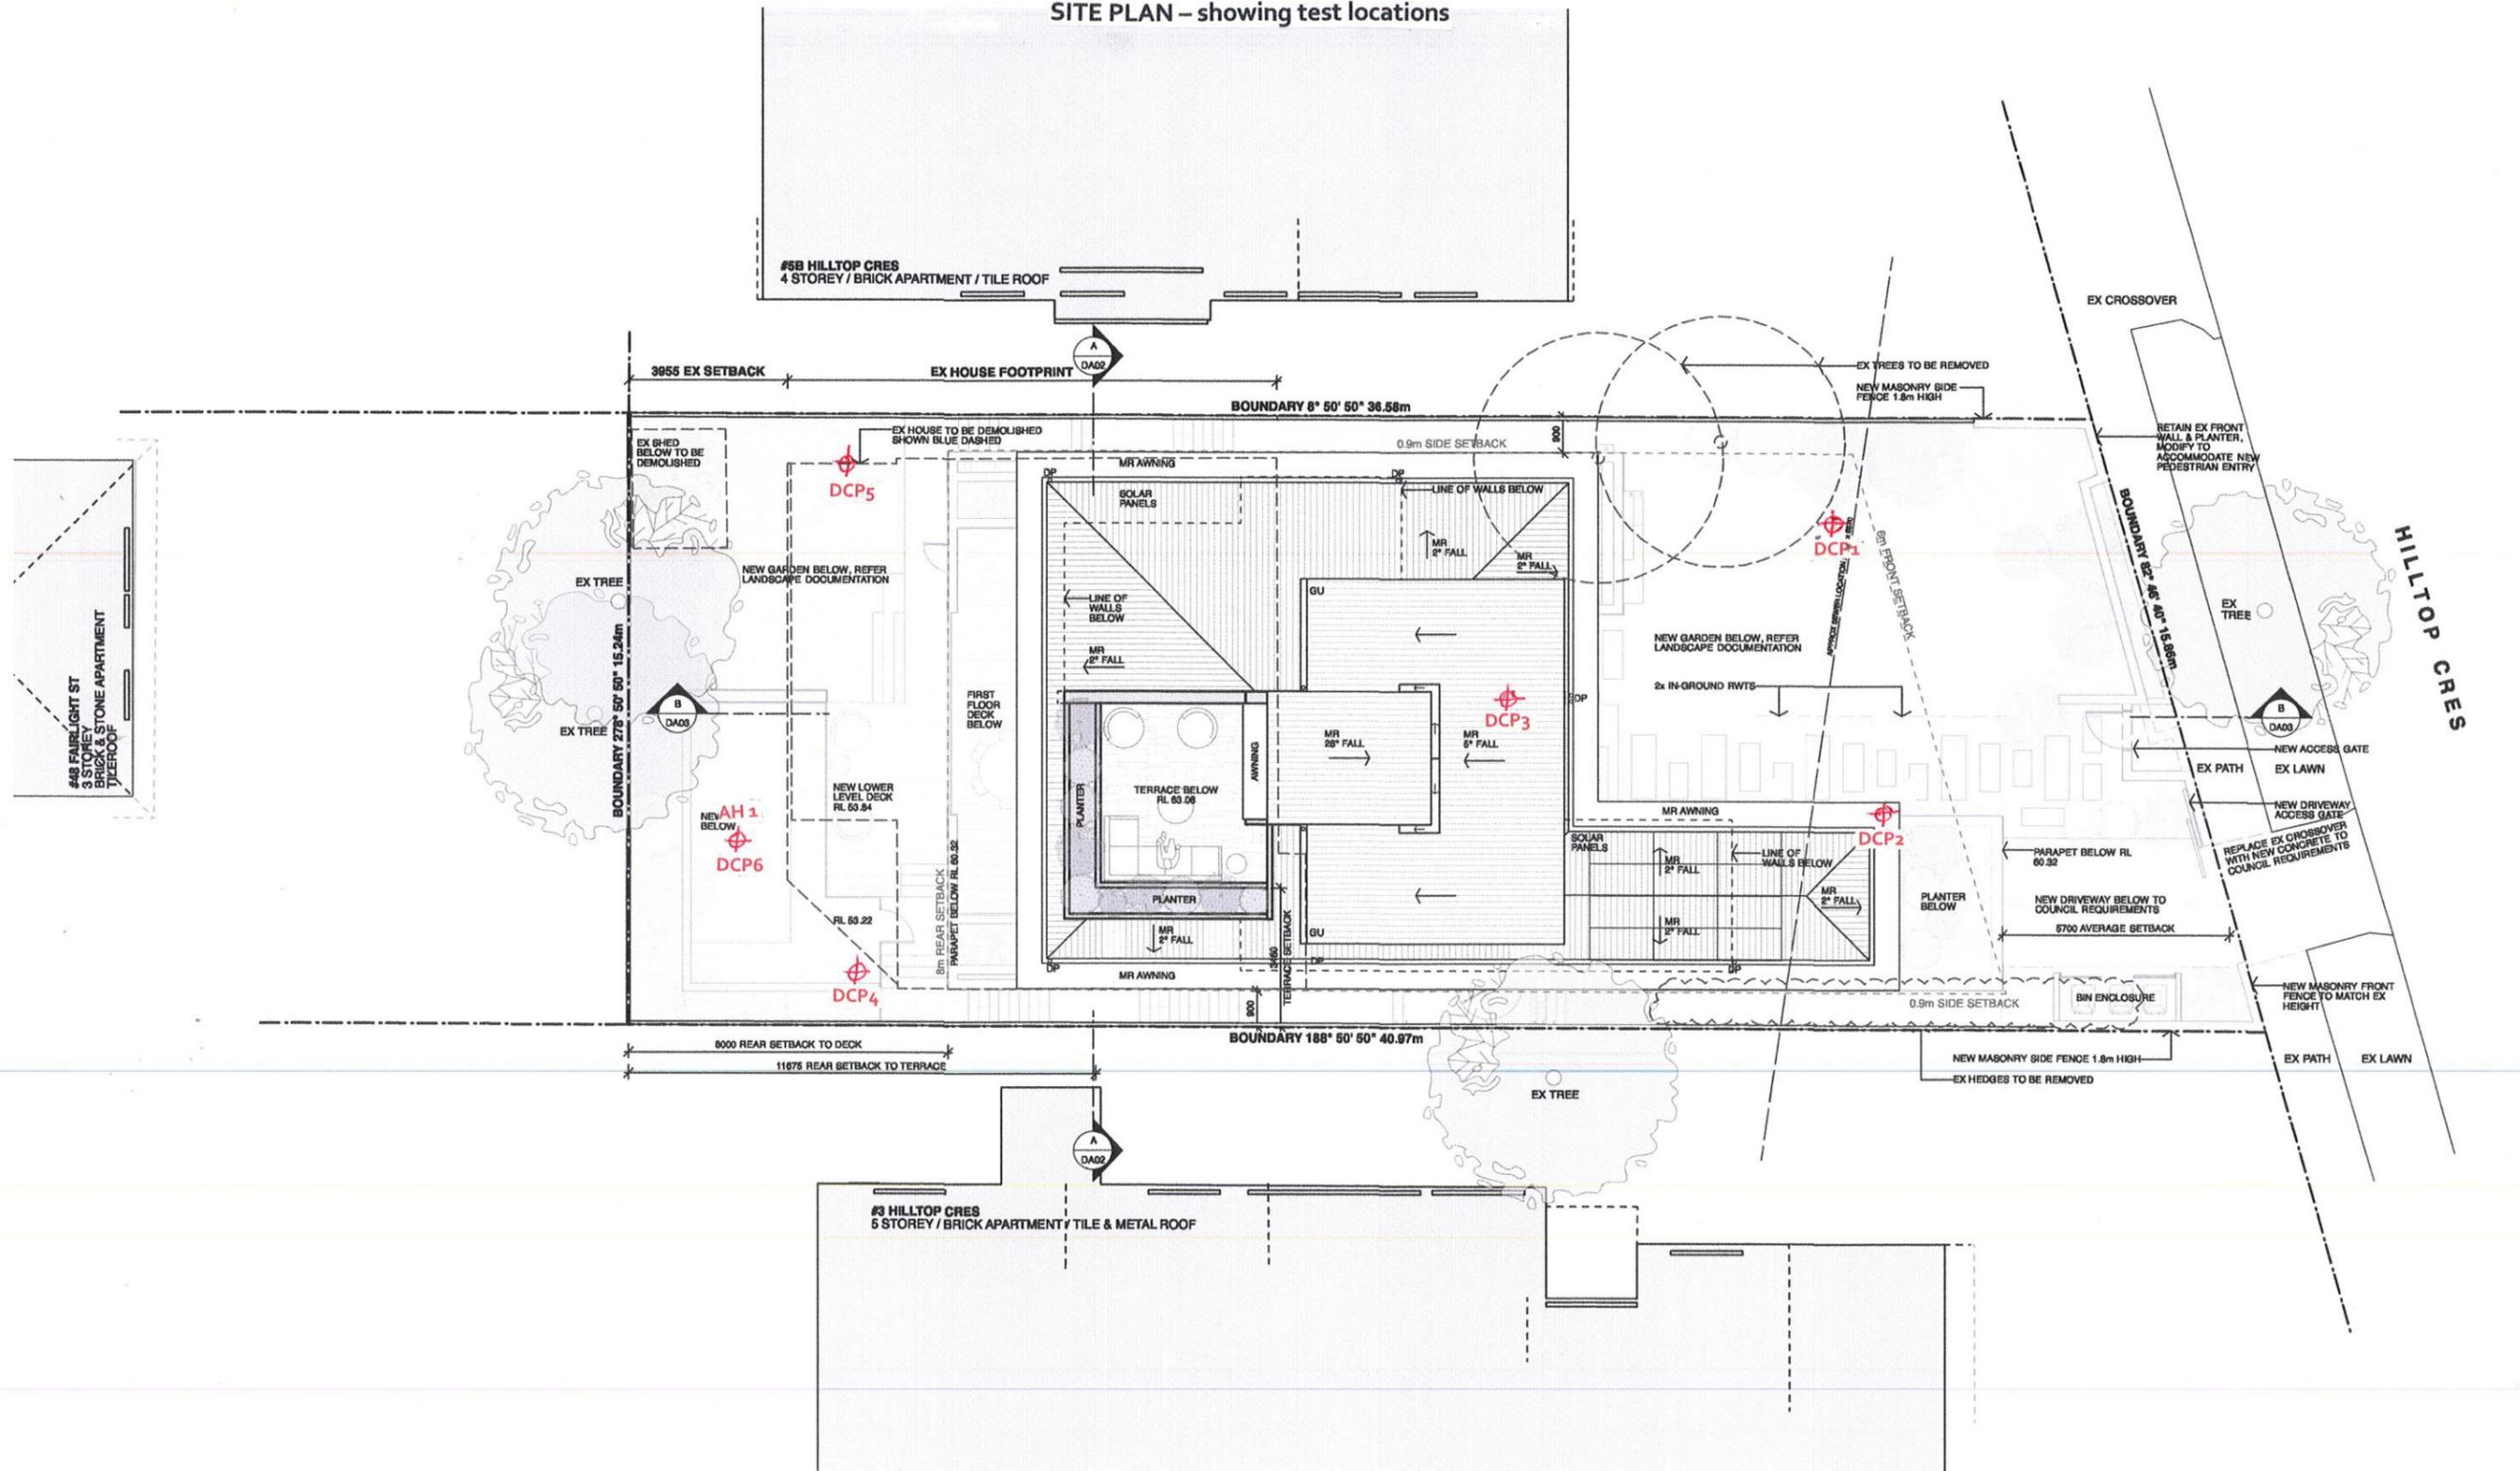
SITE PLAN – showing test locations

One Hand Auger Hole (AH) was put down to identify the soil materials. Six Dynamic Cone Penetrometer (DCP) tests were put down to determine the relative density of the overlying soil and the depth to bedrock. The locations of the tests are shown on the site plan. It should be noted that a level of caution should be applied when interpreting DCP test results. The test will not pass through hard buried objects so in some instances it can be difficult to determine whether refusal has occurred on an obstruction in the profile or on the natural rock surface. This is not expected to be an issue for the testing on this site and the results are as follows:

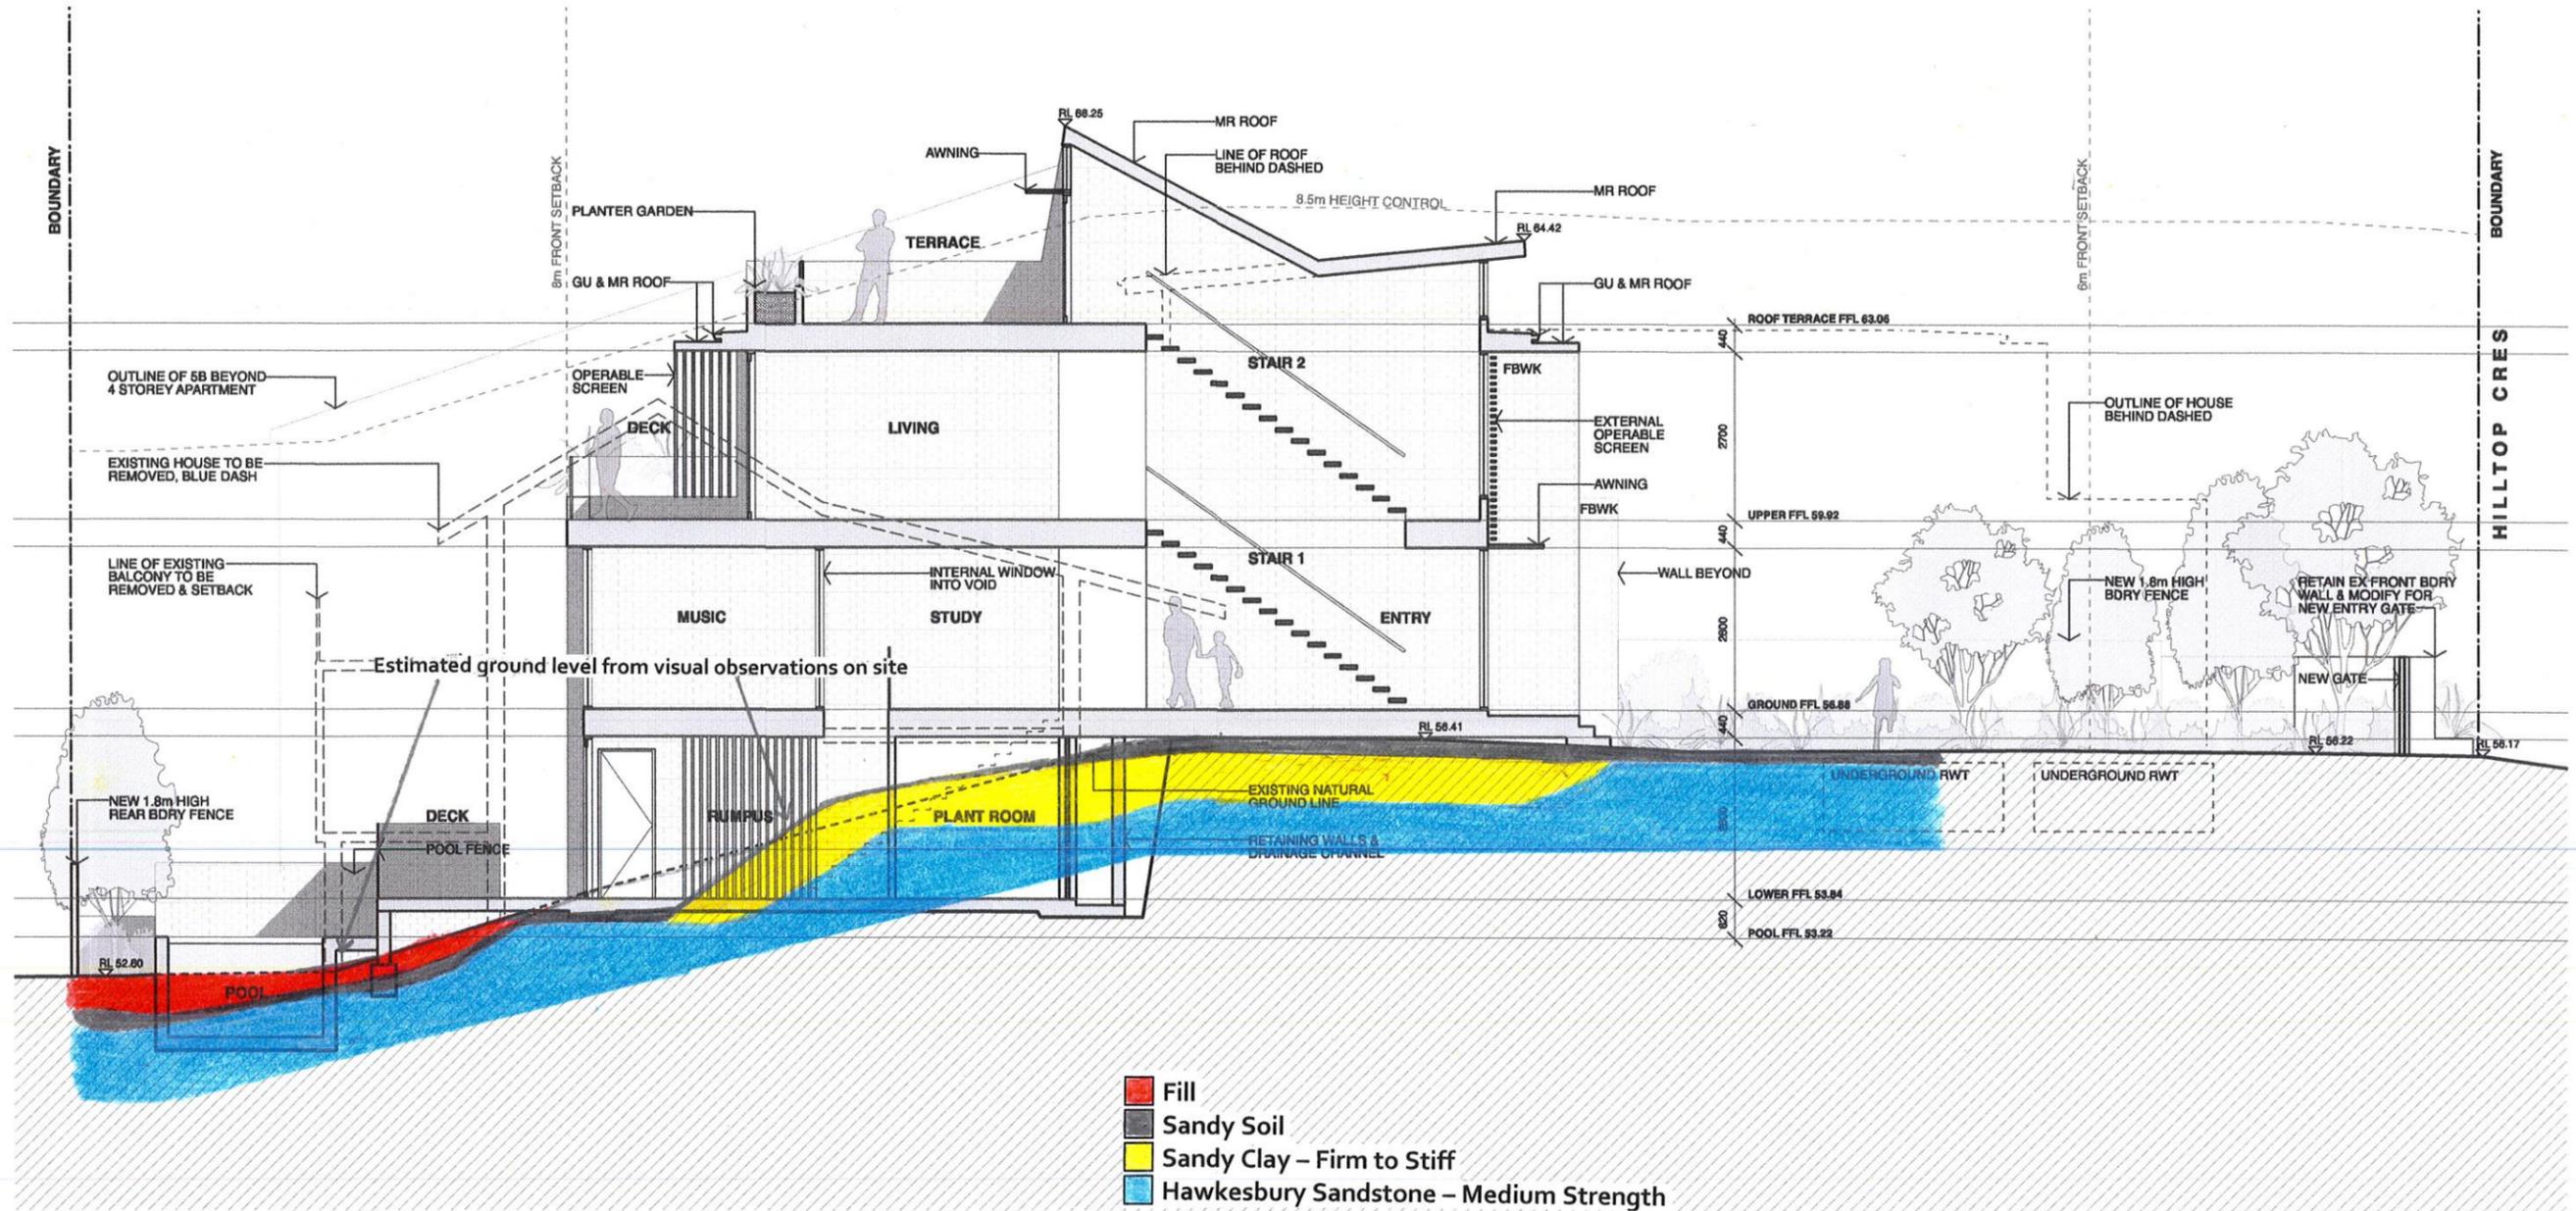
TYPE SECTION – Diagrammatical Interpretation of expected Ground Materials

The surface features of the block are controlled by the underlying sandstone bedrock that steps down the property forming sub horizontal benches between the steps. Where the grade is steeper, the steps are larger and the benches narrower. Where the slope eases, the opposite is true. Where the rock is not exposed, it is overlain by fill over sandy soils and firm to stiff sandy clays that fill the bench step formation. In the test locations, the depth to rock ranged between ~0.1 to ~0.9m below the current ground surface, being deeper where a shallow fill has been placed on the downhill side of the house. As the DCP bounced at the end

of every test, Medium Strength Sandstone is expected to underlie the entire site. See the Type Section attached for a diagrammatical representation of the expected ground materials.
