ARBORICULTURAL IMPACT REPORT

13A OCEAN ROAD
PALM BEACH NSW

29 MAY 2019

PREPARED FOR MICHELE MATTHEWS

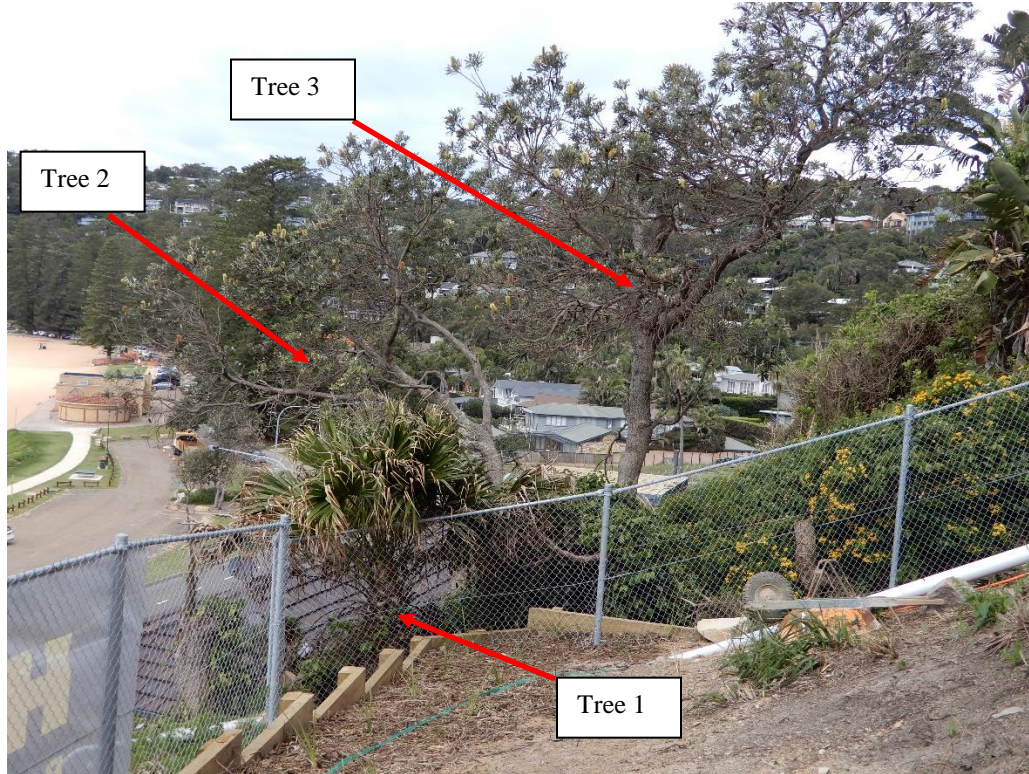
Photograph 1: Illustrating the location and context of trees 1, 2 and 3.

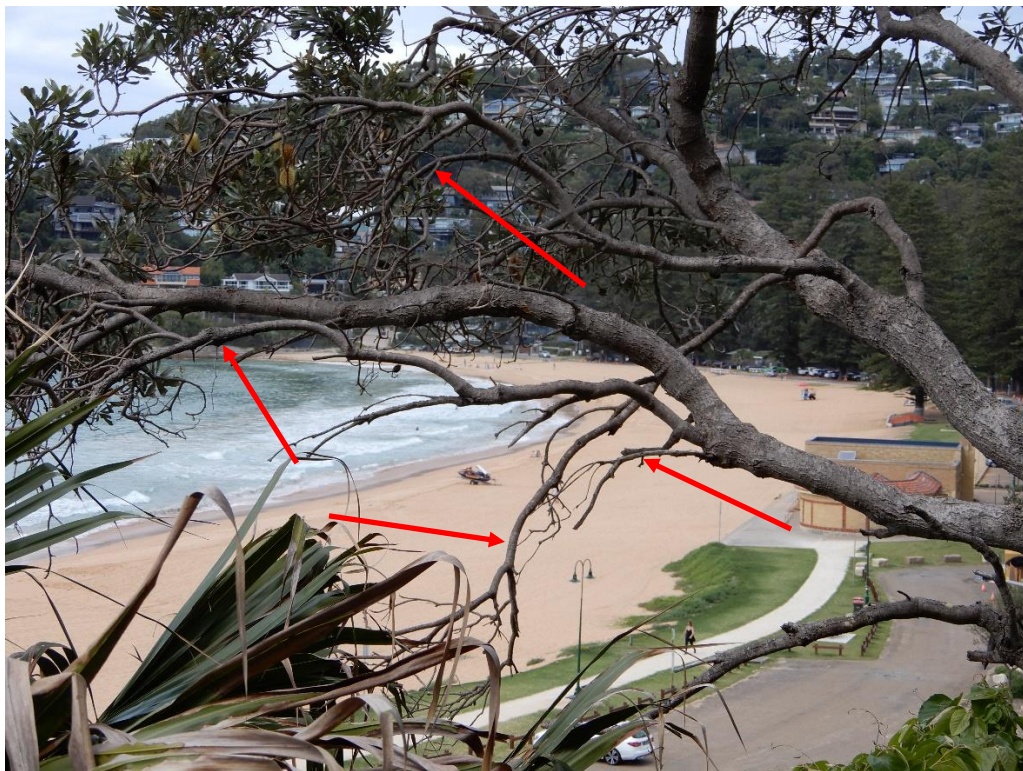
Photograph 2: Tree # 2 – Illustrating the dieback.

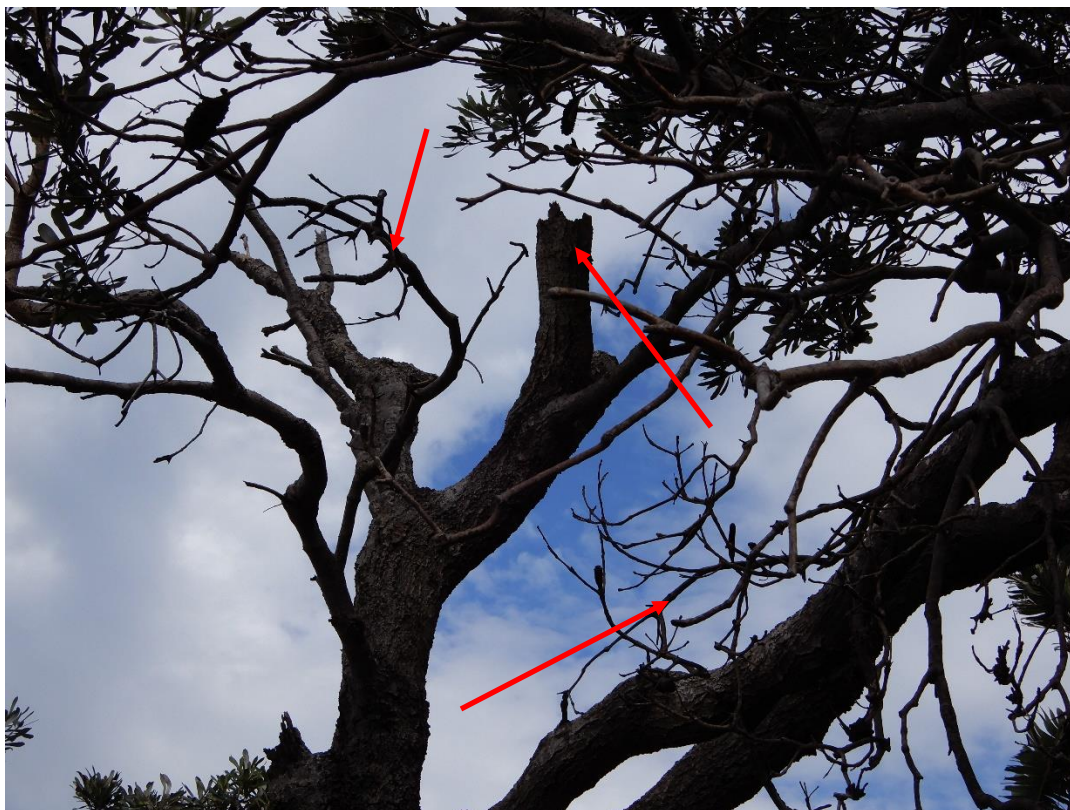
Photograph 3: Tree # 3 – Illustrating the past failure and dieback in upper crown.

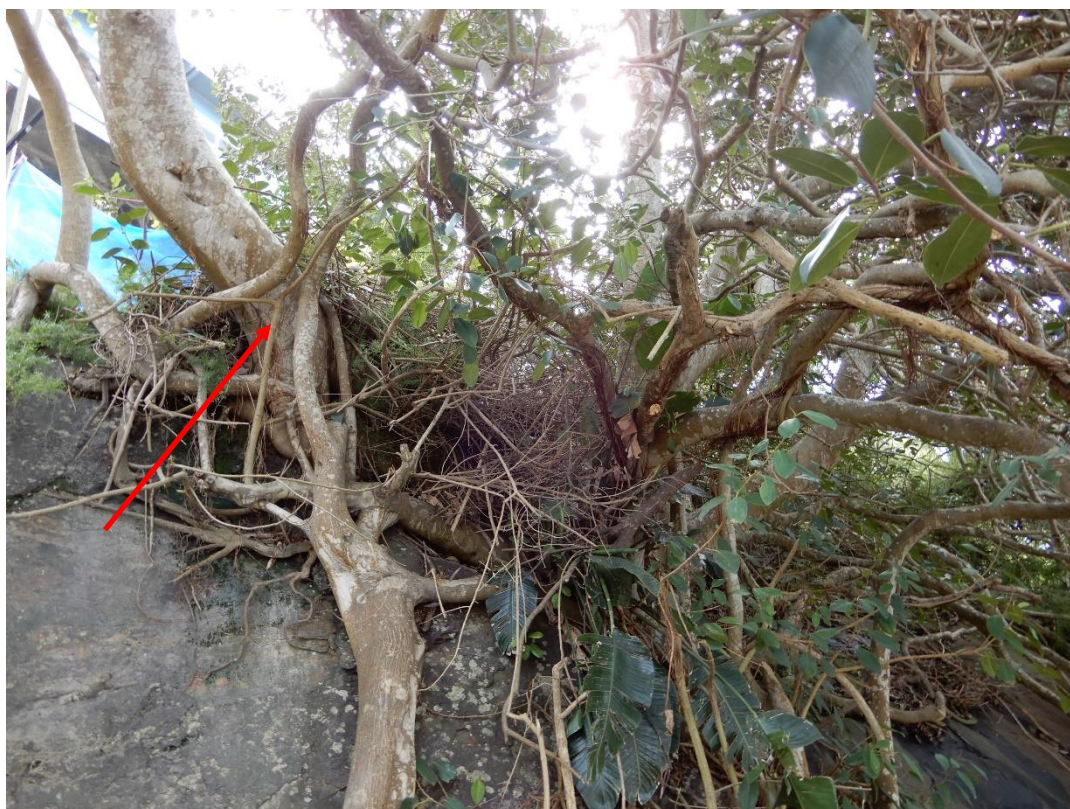
6	<i>Ficus rubiginosa</i> (Port Jackson Fig, Rusty Fig)	A mature, single trunked specimen approximately 6 metres in height with a canopy spread of 8 metres and a DBH of ca. 500mm. In good health and of moderate to high landscape significance. The tree's past canopy development has been suppressed. Located on top edge of exposed sandstone outcrop with large diameter exposed roots growing down the outcrop.
7	<i>Ficus rubiginosa</i> (Port Jackson Fig, Rusty Fig)	A mature, multi trunked specimen approximately 8 metres in height with a canopy spread of 16 metres and DBH of up to ca. 450mm (ca. 800mm above the root flare). In good health and of high landscape significance. Continued next page...

The tree's past canopy development has been suppressed (slight to moderate canopy bias to NE). Located on top edge of exposed sandstone outcrop with large diameter exposed roots growing down the outcrop. Th tree displays fair branch attachment with multiple leaders - limited view of junctions from low side of sandstone outcrop - structural integrity of junctions not able to be confirmed.
--	--	--

6	<i>Ficus rubiginosa</i> (Port Jackson Fig, Rusty Fig)	The proposed towel lawn is located 5.43 metres from the tree at the closest point and is calculated to encroach within 1.17m ² or 1.03% of the tree's identified TPZ – this is a low level of impact and within an acceptable threshold. The proposed steel mesh staircase is located 1 metre from the tree at the closest point – disturbance from this structure will be minimised as it is a lightweight structure supported by isolated piers – it is recommended the pier locations be determined by hand excavation under the direction of an AQF Level 5 arborist to avoid removal of, or damage to, any roots of 35mm diameter or greater.
7	<i>Ficus rubiginosa</i> (Port Jackson Fig, Rusty Fig)	The proposed towel lawn is located 4.48 metres from the tree at the closest point, the spa 7.5 metres from the tree and the pool 7.2 metres from the tree – these areas are calculated to encroach within

Photograph 4: : Tree # 6 – Illustrating the location and context.

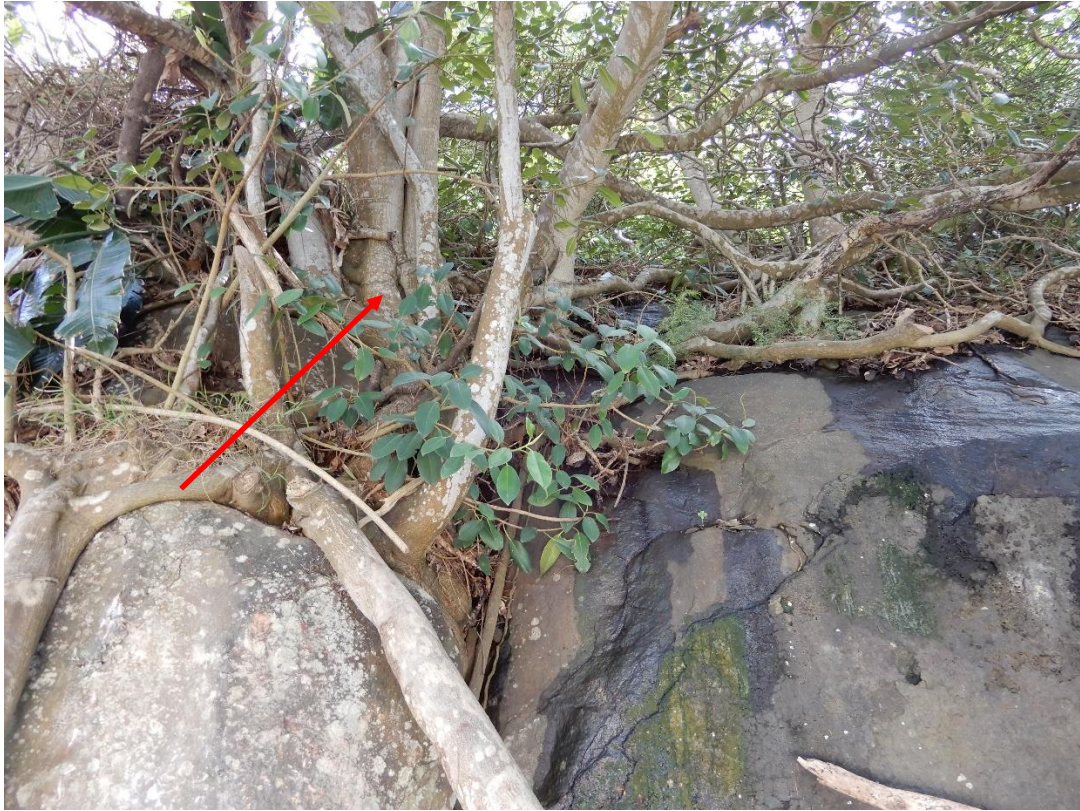
<p>23.23m² or 8.03% of the tree's identified TPZ – this is a low level of impact and within an acceptable threshold.</p> <p>The proposed steel mesh staircase is located 2.37 metres from the tree at the closest point – disturbance from this structure will be minimised as it is a lightweight structure supported by isolated piers – it is recommended the pier locations be determined by hand excavation under the direction of an AQF Level 5 arborist to avoid removal of, or damage to, any roots of 35mm diameter or greater.</p>
--	--	--

Photograph 5: : Tree # 7 – Illustrating the location and context.

- The proposed steel mesh staircase is located in close proximity to tree numbers 5, 6 and 7 – disturbance from this structure will be minimised as it is a lightweight structure supported by isolated piers – it is recommended the pier locations be determined by hand excavation under the direction of an AQF Level 5 arborist to avoid removal of, or damage to, any roots of 35mm diameter or greater from these trees.

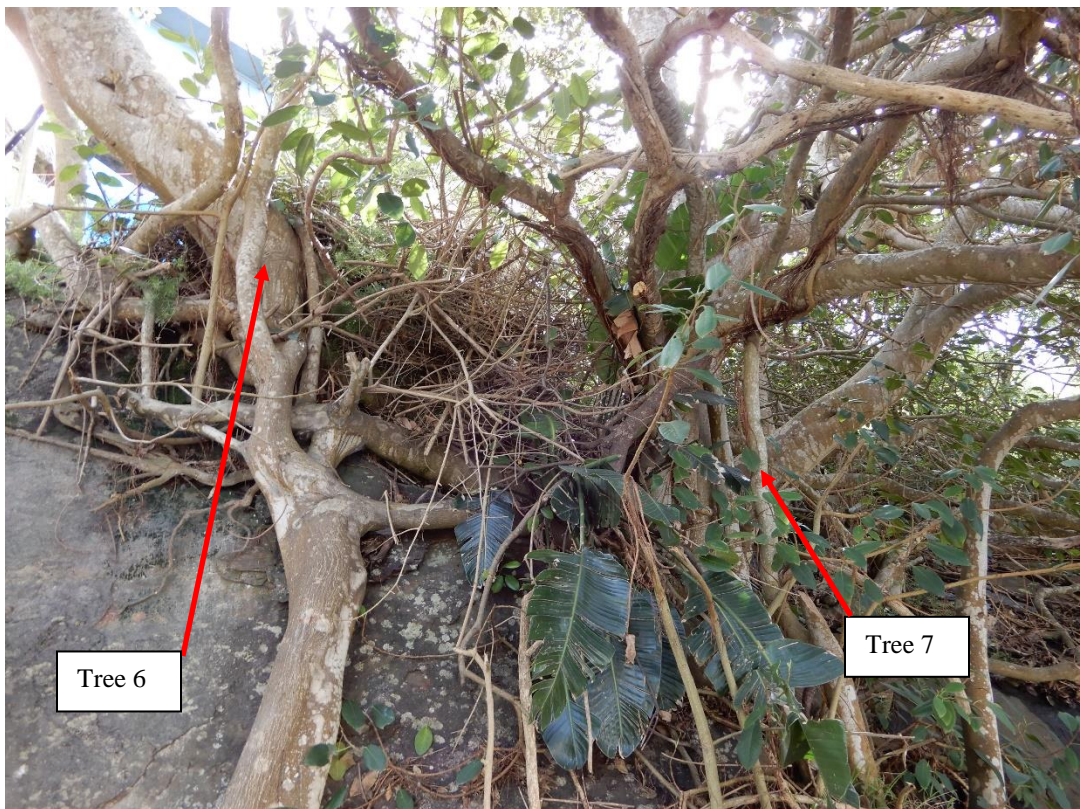
Photograph 6: Illustrating the location and context of tree numbers 6 and 7.
