Report Title: Geotechnical Report 30 Narrabeen Park Parade, Warriewood

Report Date: 26/6/19

## **GEOTECHNICAL INVESTIGATION:**

### **New Secondary Dwelling at 30 Narrabeen Park Parade, Warriewood**

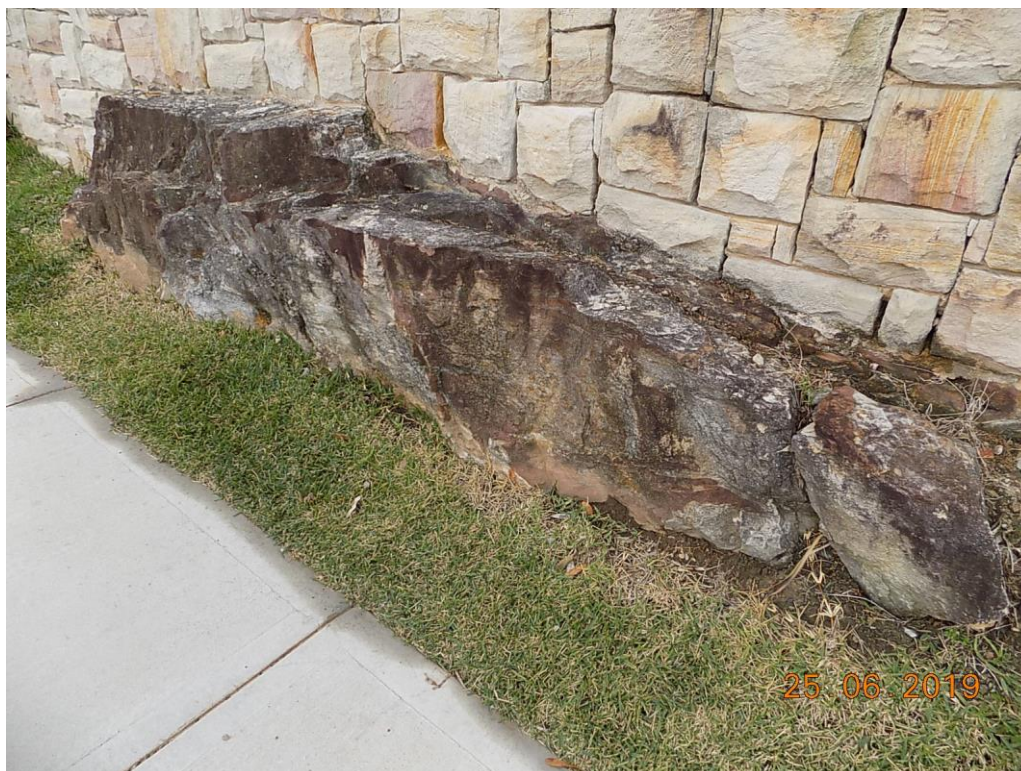
Photo 1

- 2.3** Low to Medium Strength Sandstone was observed to be outcropping on the opposite side of the road to the subject property (Photo 1). At the road frontage, a concrete driveway runs down the slope to a stable brick and clad garage on the uphill side of the property (Photo 2). The slope between the road frontage and the house is terraced with a series of stable brick, stack rock, and rendered masonry retaining walls (Photos 3 & 4). Some of these walls will be demolished as part of the proposed works. The single-storey brick house is supported on brick walls and brick piers (Photo 5). A near-level lawn-covered fill extends off the downhill side of the house to the lower

Sandstone bedrock outcrops on the opposite side of the road to the subject property (Photo 1) and the owner of the N neighbouring property informed us that he encountered sandstone during excavation works on the uphill side of his property. We interpret this to be a thick sandstone bed within the Narrabeen Group of rocks. The rock is overlain by a thin sandy soil and sandy clays. In the test locations, rock was encountered at depths of between 0.5 to 1.3m due to the terraced land surface and stepped nature of the rock. The sandstone that outcrops on the opposite side of the road is estimated to be low to medium strength and similar strength rock is expected to underlie the proposed works. See Type Section attached for a diagrammatical representation of the expected ground materials.

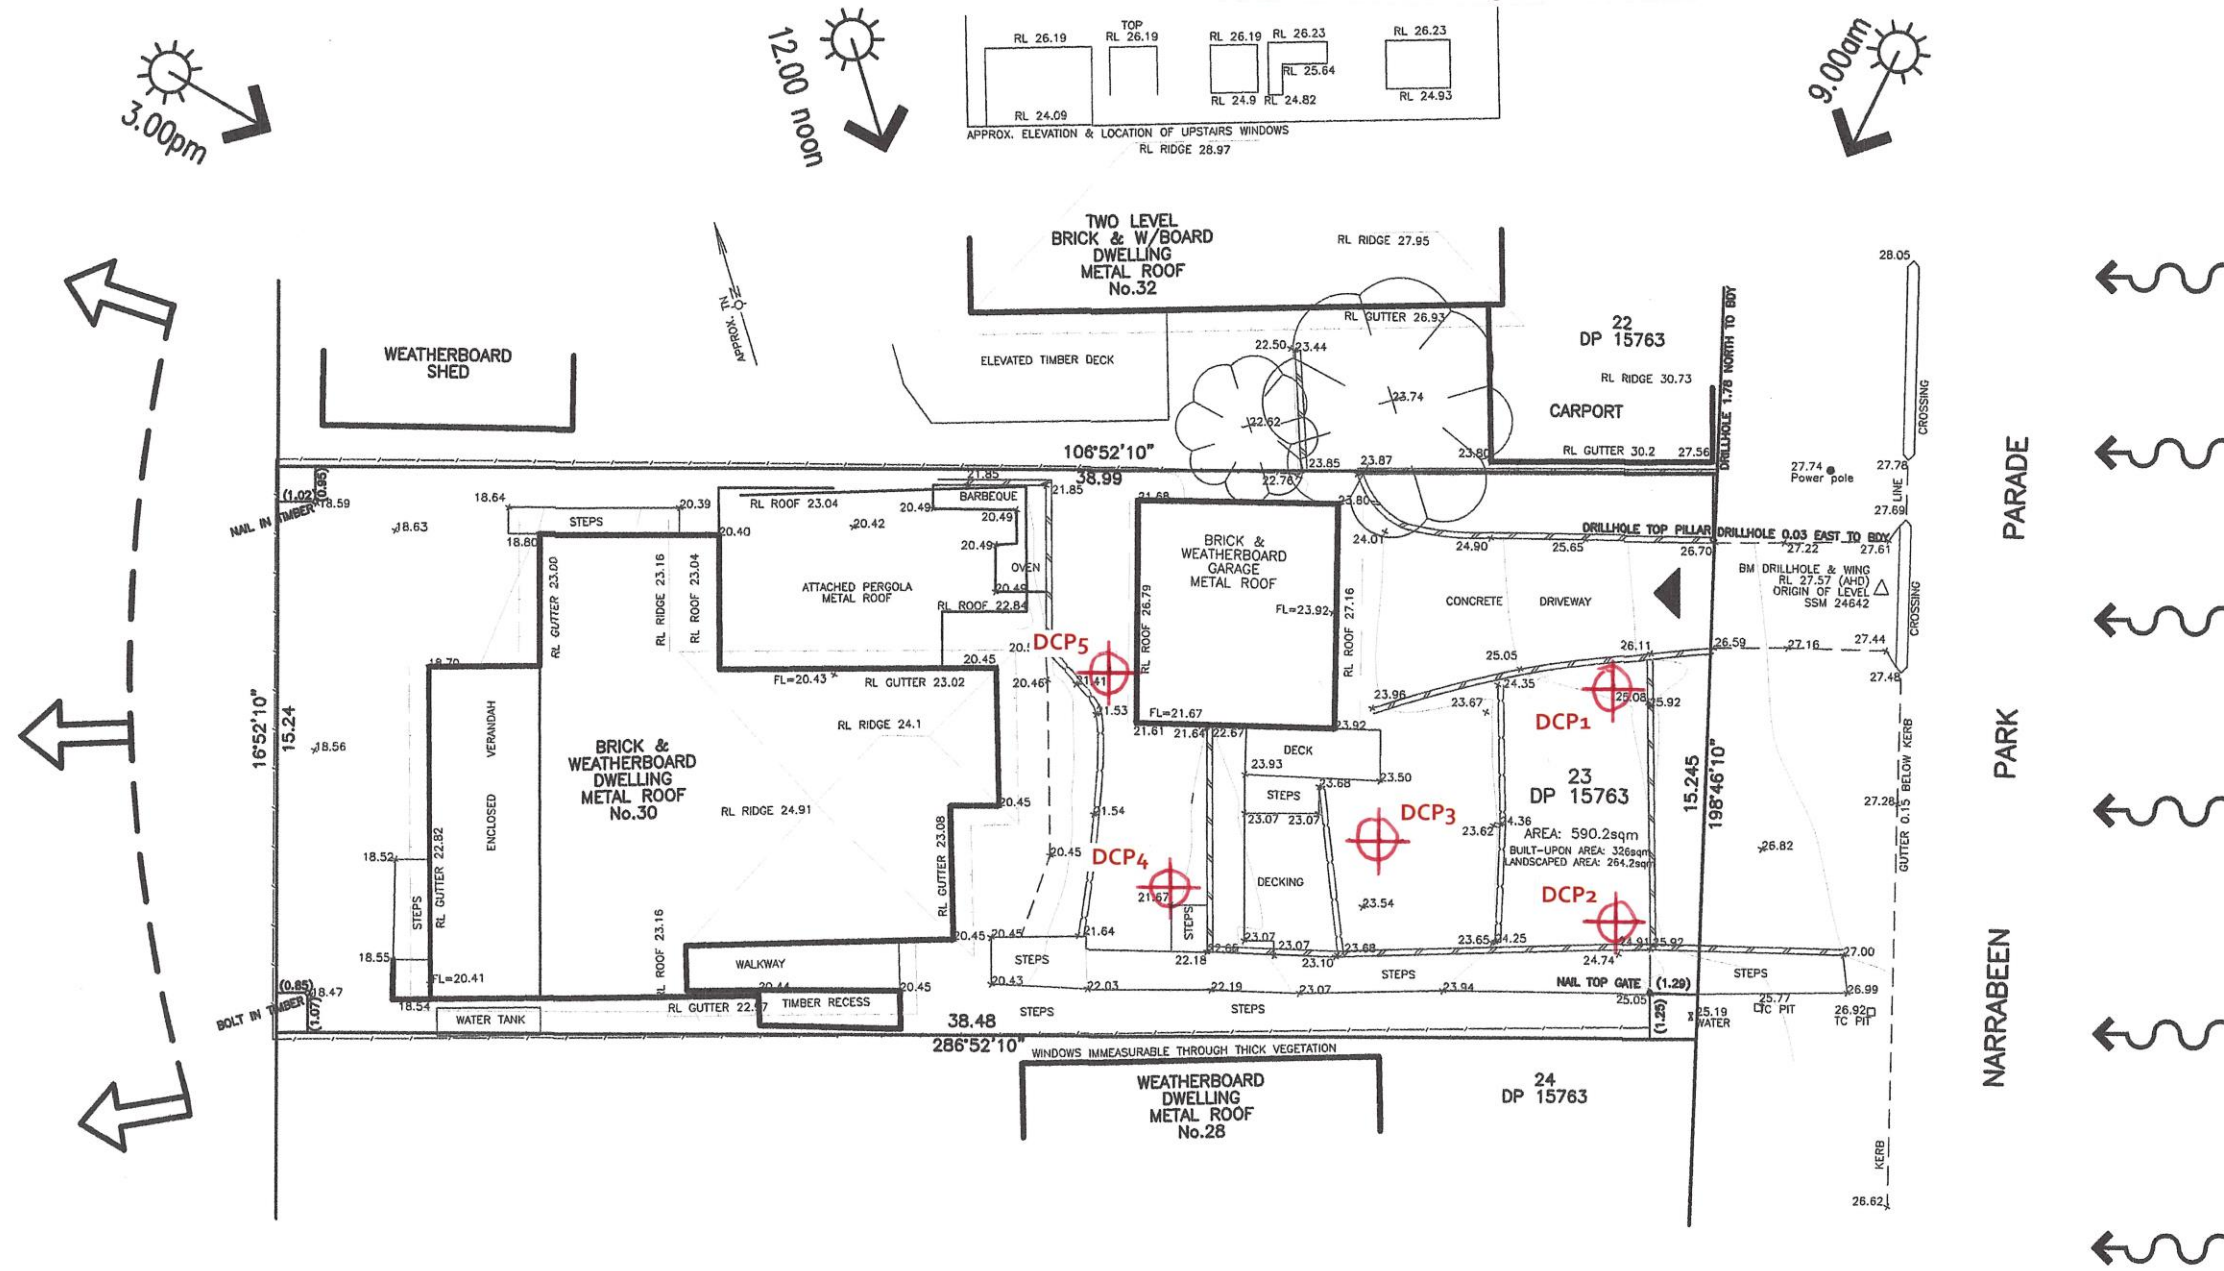
# SITE PLAN – showing test locations

Five DCP (Dynamic Cone Penetrometer) tests were carried out to determine the relative density of the overlying soil and the depth to bedrock. The locations of the tests are shown on the site plan. It should be noted that a level of caution should be applied when interpreting DCP test results. The test will not pass through hard buried objects so in some instances it can be difficult to determine whether refusal has occurred on an obstruction in the profile or on the natural rock surface. This is not expected to be an issue for the testing on this site and the results are as follows:

DCP1 – Refusal on rock @ 0.5m, DCP bouncing off rock surface, grey and maroon shale fragments on dry tip.

DCP2 – Refusal on rock @ 0.7m, DCP bouncing off rock surface, light brown shale fragments on dry tip.

DCP3 – Refusal on rock @ 1.3m, DCP bouncing off rock surface, clean dry tip, brown clay in collar above tip.

DCP4 – Refusal on rock @ 0.6m, DCP bouncing off rock surface, clean dry tip, brown clay in collar above tip.

DCP5 – Refusal on rock @ 1.0m, DCP thudding, brown clay on wet tip.
