GEOTECHNICAL RISK MANAGEMENT POLICY FOR PITTWATER

RISK ANALYSIS & MANAGEMENT FOR PROPOSED GARAGE & ALTERATIONS AND ADDITIONS AT 3 BEACONSFIELD STREET, NEWPORT

The work is to be carried out in accordance with the Risk Management Report PX 00005 dated 1st July, 2019.

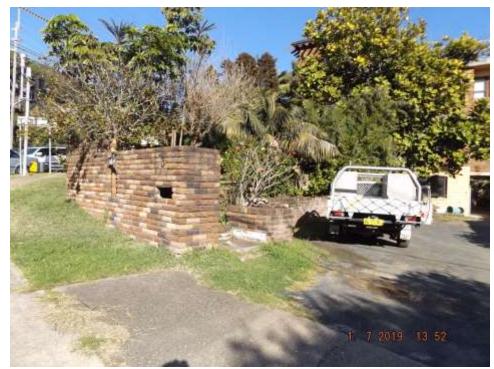
Photo 1

- 3.3 Access to the property is via the gravel driveway which starts from the edge of the Beaconsfield Street adjacent north western corner of the property, Photo 1. A terraced masonry retaining wall supports the cut on the eastern side of the driveway, Photo 2. A pathway from the side of the driveway provides pedestrian access to the main entrance, Photo 3. A level courtyard area is on the eastern side of the existing residence, Photo 4. On the western side of the existing residence the driveway continues to the south providing access to rear of the property changing into concrete, Photo 5. A series landscaping retaining walls are providing support at the south western corner of the property, Photo 6. These retaining walls are located on neighbouring properties and were observed to be in good condition with no signs of significant movement. A concrete block retaining wall supports the fill material at the north eastern corner of the property and was observed to be in good condition with no signs of significant movement, Photo 7.

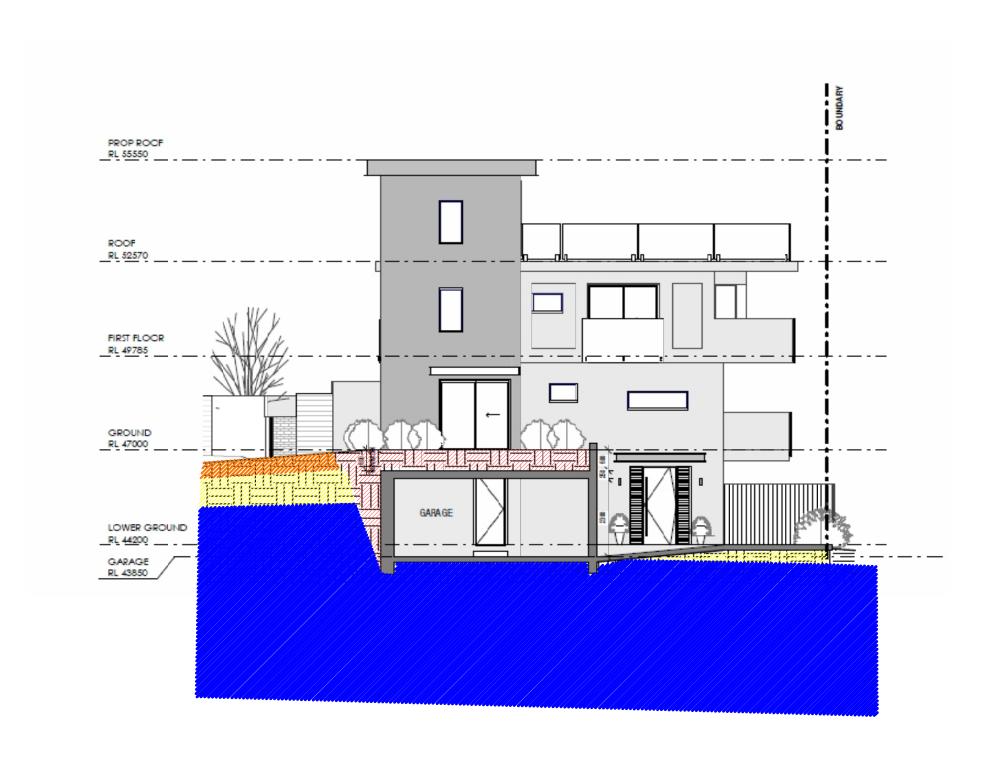
TYPE SECTION

NOTE
INTERPRETED SUB SURFACE SECTION ONLY.
ACTUAL GROUND CONDITIONS MAY VARY.
