GEOTECHNICAL INVESTIGATION:

Alterations and Additions at 50 Condoover Street, North Balgowlah

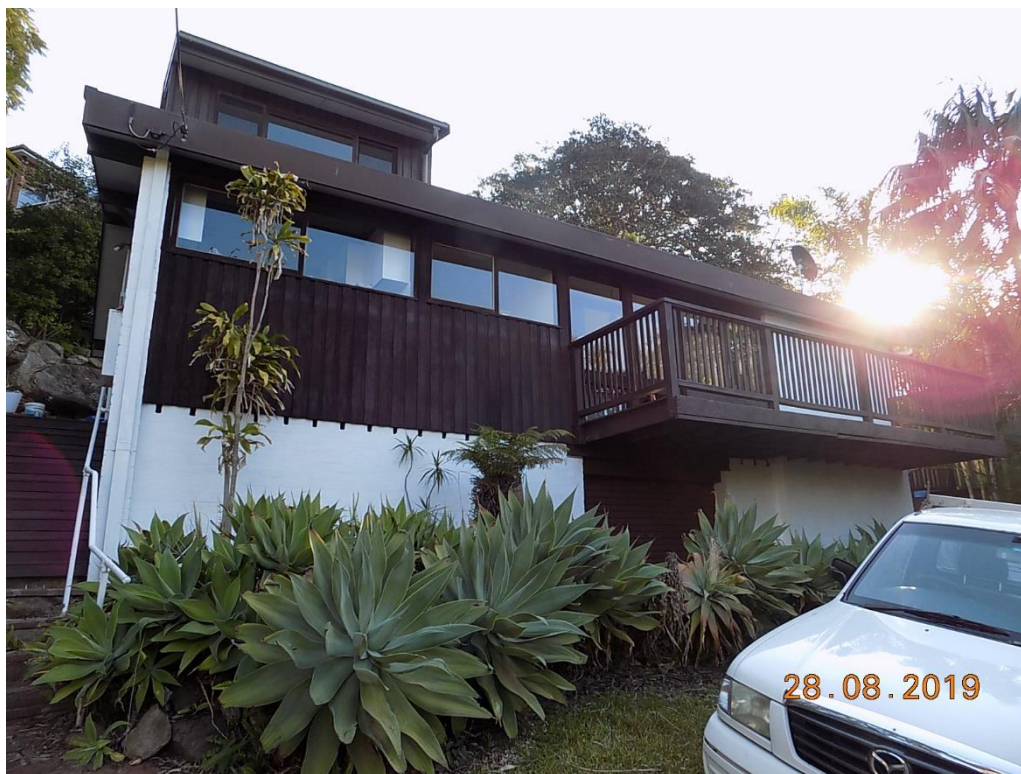
Photo 2

storey brick house is supported on brick walls and brick piers (Photo 2). No significant signs of movement were observed in the supporting brick walls and the supporting brick piers stand vertical. Some of the supporting walls and piers were observed to be supported directly off outcropping sandstone. A ~1.0m cut for the uphill side of the house is currently partially unsupported (Photo 3). The existing rough stack rock retaining wall is in the process of remediation and upgrade by the owner of the property. We were informed by the owner that they intend to complete the remediation works as soon as possible. Medium Strength Sandstone bedrock outcrops and steps up the slope above the cut (Photo 4). The outcropping rock is slightly undercut but has been underpinned in the past by the owner using concrete block and brick blade walls and piers mortared with non-shrink grout (Photo 5). A gentle to moderately sloping lawn rises above the outcrop to the road frontage with Kimo Street. Sandstone bedrock outcrops through this lawn in places (Photo 6).

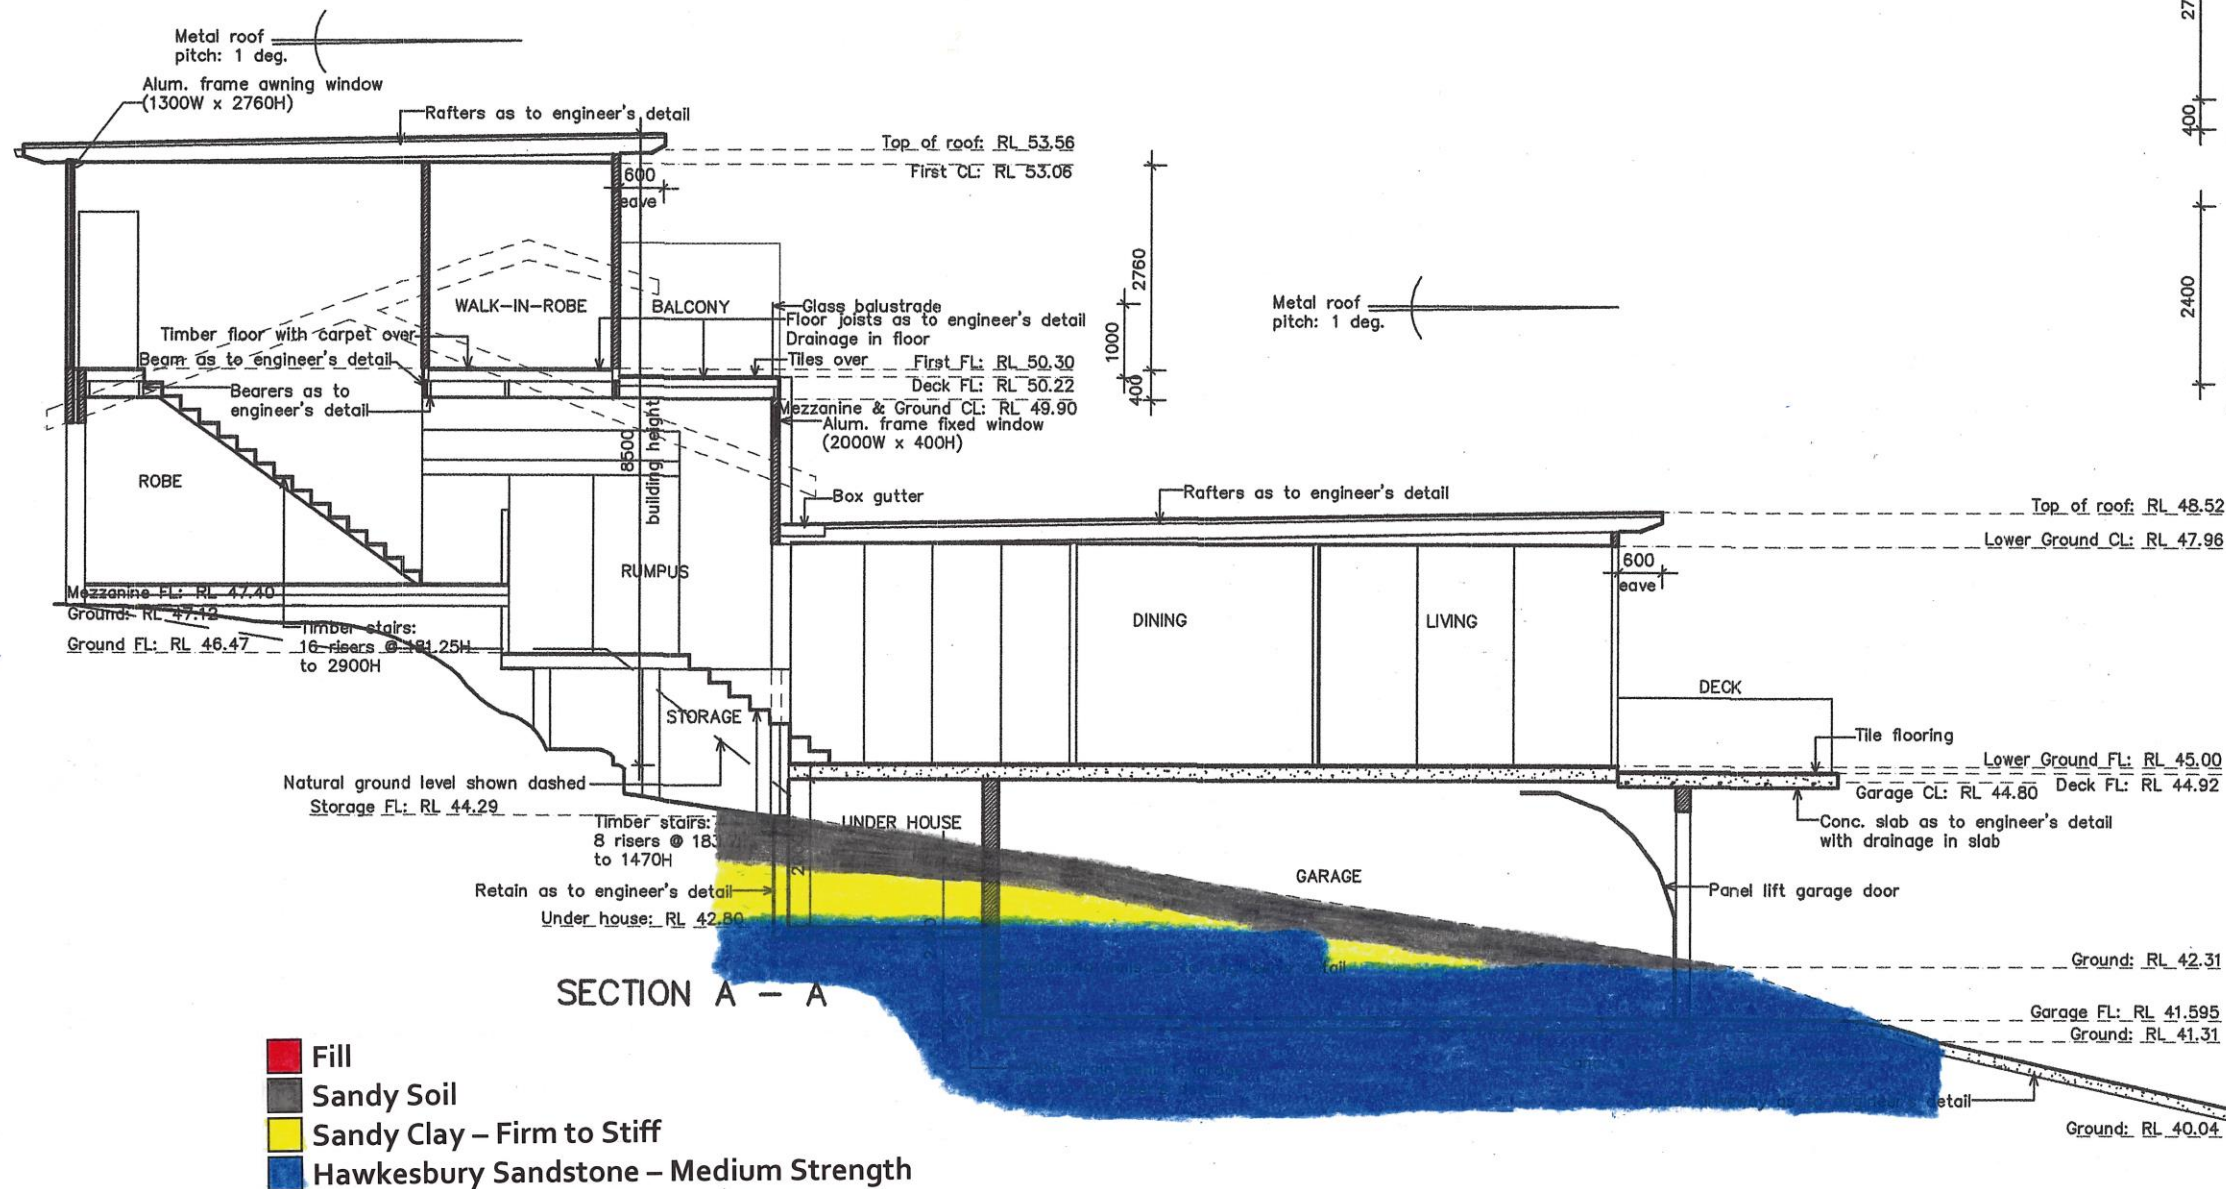
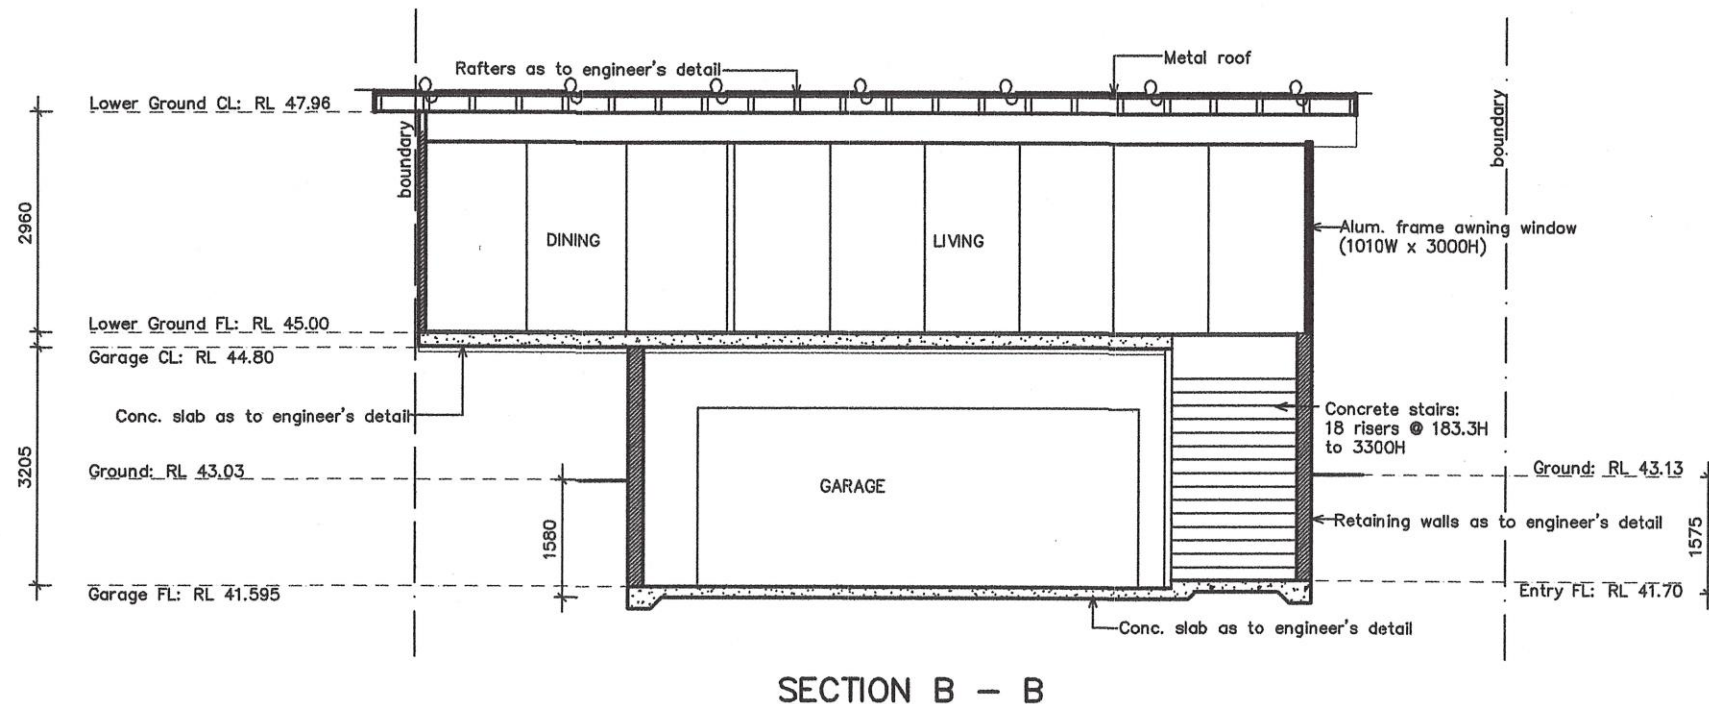
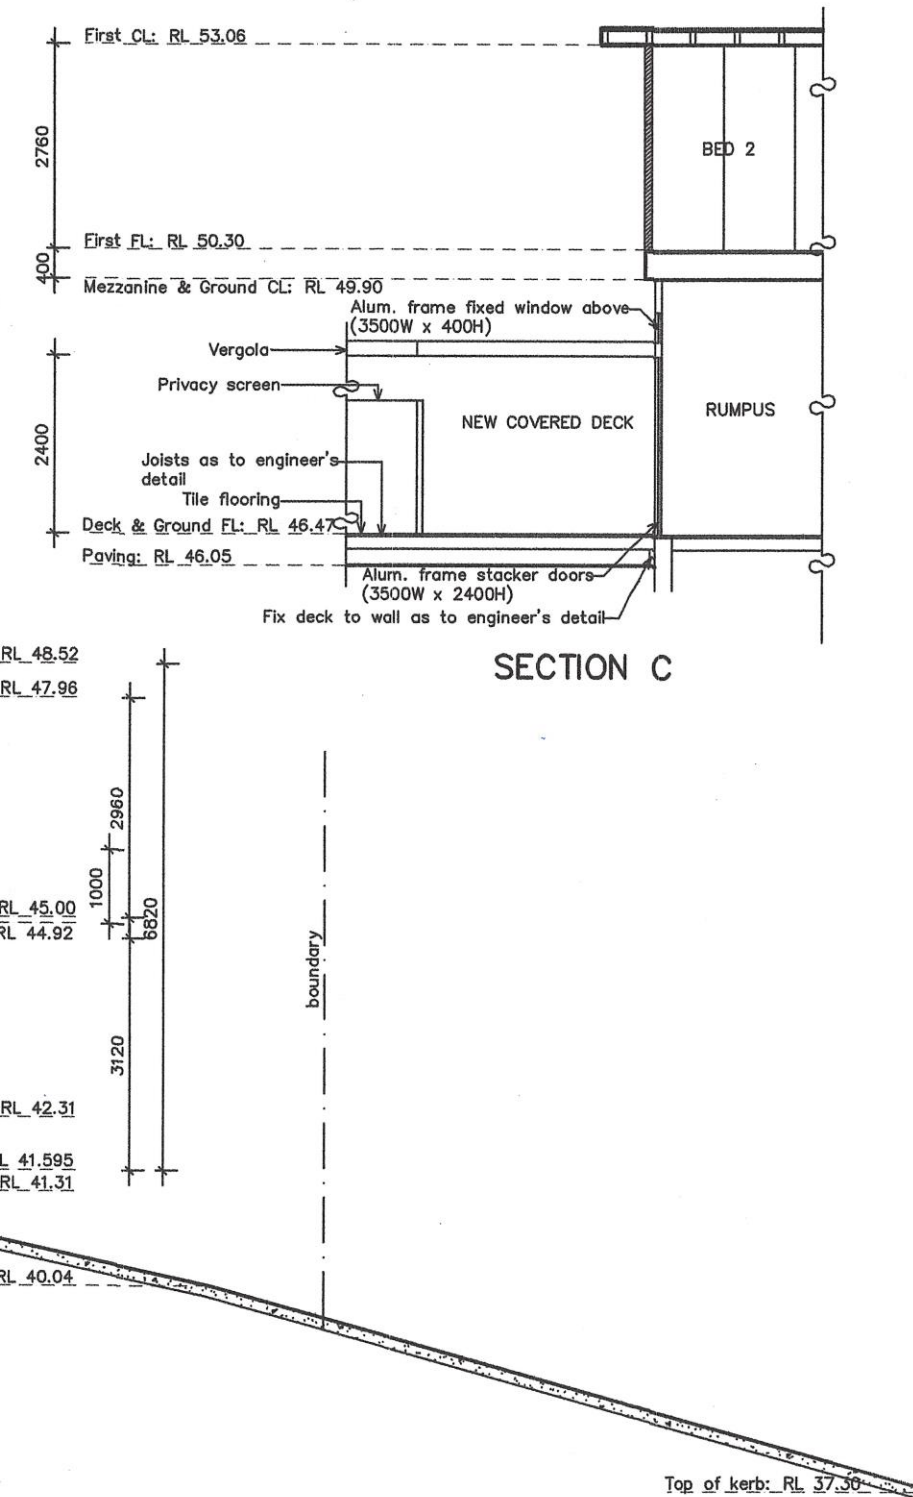
TYPE SECTION – Diagrammatical Interpretation of expected Ground Materials

Where the grade is steeper, the steps are larger and the benches, narrower. Where the slope eases, the opposite is true. Where the rock is not exposed, it is overlain by sandy soils and sandy clays that fill the bench step formation. In the test locations where rock was not exposed, the depth to rock ranged between 0.3 to 1.4m below the current surface, being slightly deeper due to the stepped nature of the underlying bedrock. The outcropping sandstone on the property is estimated to be medium strength or better and similar strength rock is expected to underlie the entire site. It is interpreted that a thin layer of Very Low Strength Sandstone overlies the buried rock as some of the tests ended after a high blow count. See the Type Section attached for a diagrammatical representation of the expected ground materials.
