25 August 2020

**RE: HAZARDOUS MATERIALS SITE INSPECTION
UNIT 3, 1 SYDENHAM ROAD, BROOKVALE NSW**

P. CLIFTON & ASSOCIATES PTY LTD

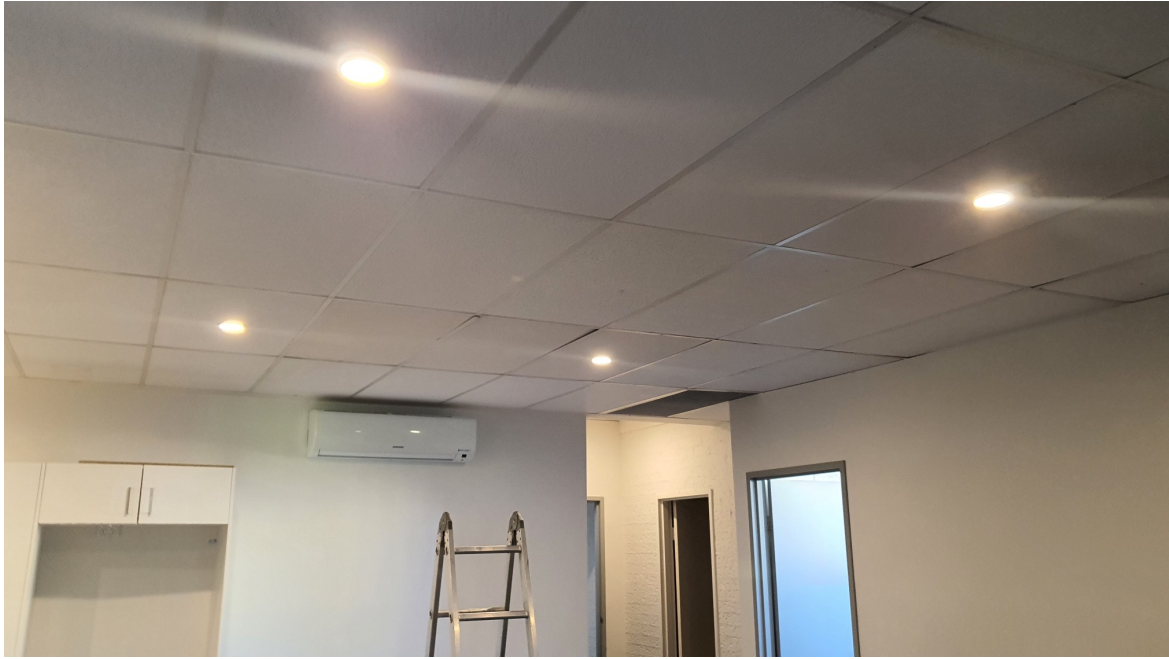
Construction materials present in the upper level Unit 3 area in the building include metal roof framing, suspended set plasterboard ceilings or suspended metal grid ceilings with drop in acoustic tiles, painted face brick walls with framed partition walls lined with plasterboard or asbestos free fibrous cement sheet and concrete floor that has carpet tile and ceramic tile floor finishes. See photograph No. 1.

Photograph No. 1: Acoustic SMF containing ceiling tiles in Unit 3

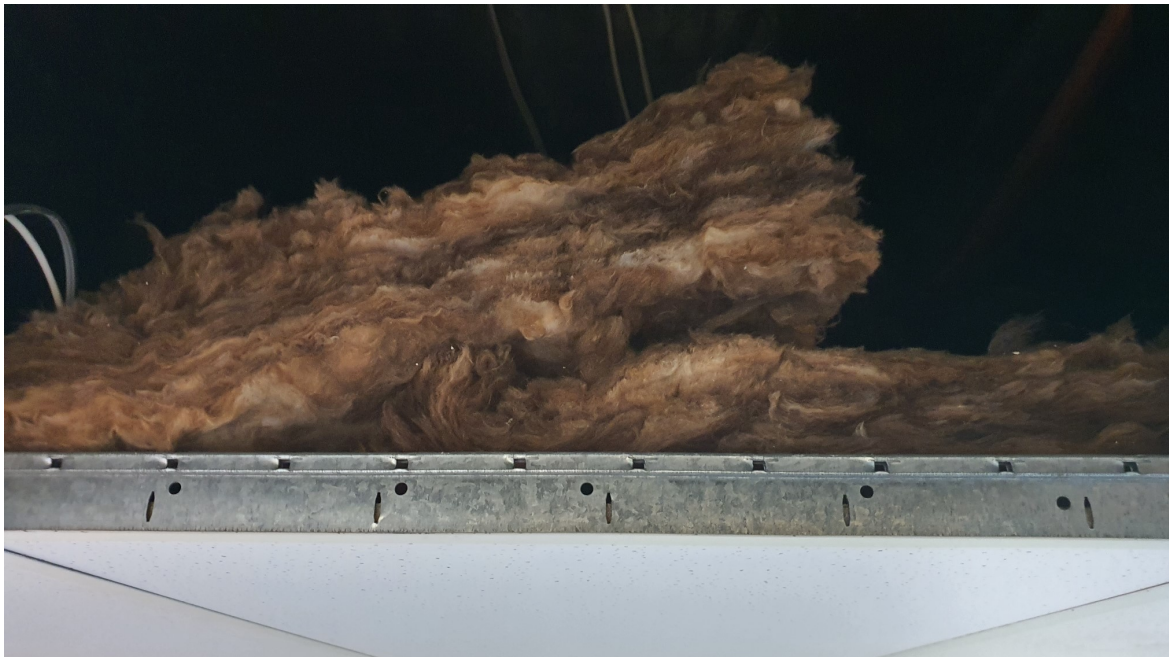
Within the ceiling / roof space there is foil backed SMF insulation blanket to the underside of the metal roof cladding and SMF insulation batts on the upper surface of the suspended ceilings. See photograph No. 2.

- Insulation to the underside of the metal roof cladding is foil backed SMF.
- SMF insulation batts are present on the upper surface of the suspended ceilings.

**Photograph No. 2: SMF insulation batts on upper surface
of ceiling tiles in metal grid ceiling**

SMF materials in the building are all in good condition and require no corrective action at the present time. When these materials require removal, they are to be removed in accordance with the National Occupational Health and Safety Commission (NOHSC) National Standard and National Code of Practice for Synthetic Mineral Fibres, 1990 (archived). SMF waste material removed from the building are to be disposed of at a NSW Environment Protection Authority (NSW EPA) licenced waste disposal facility.

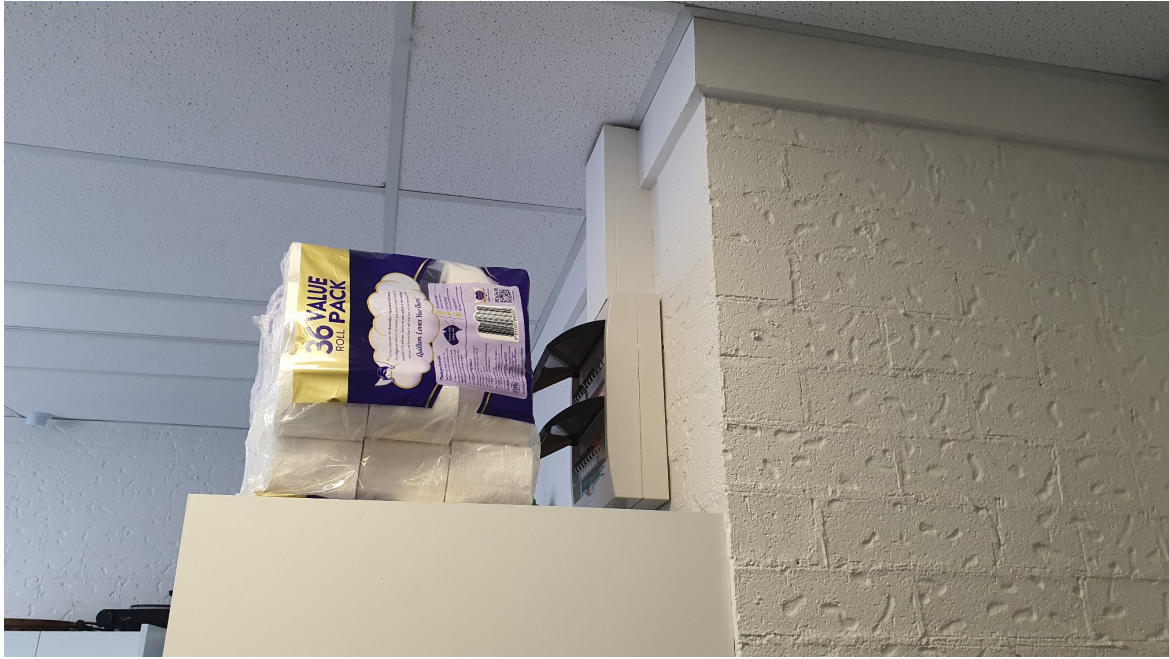
The electrical sub board located in the north east area of the upper level Unit 3 is a plastic switch box containing plastic circuit switches. See photograph No. 3. This sub board is free of asbestos.

**Photograph No. 3: Plastic asbestos free electrical sub board
on masonry wall in north east area in Unit 3**
