Geotechnical Assessment

Project: Alterations and Additions
13 Quinlan Parade, Manly Vale, NSW.

REF: AG 19049
23rd July, 2019

For Alterations and Additions at
13 Quinlan Parade, Manly Vale, NSW

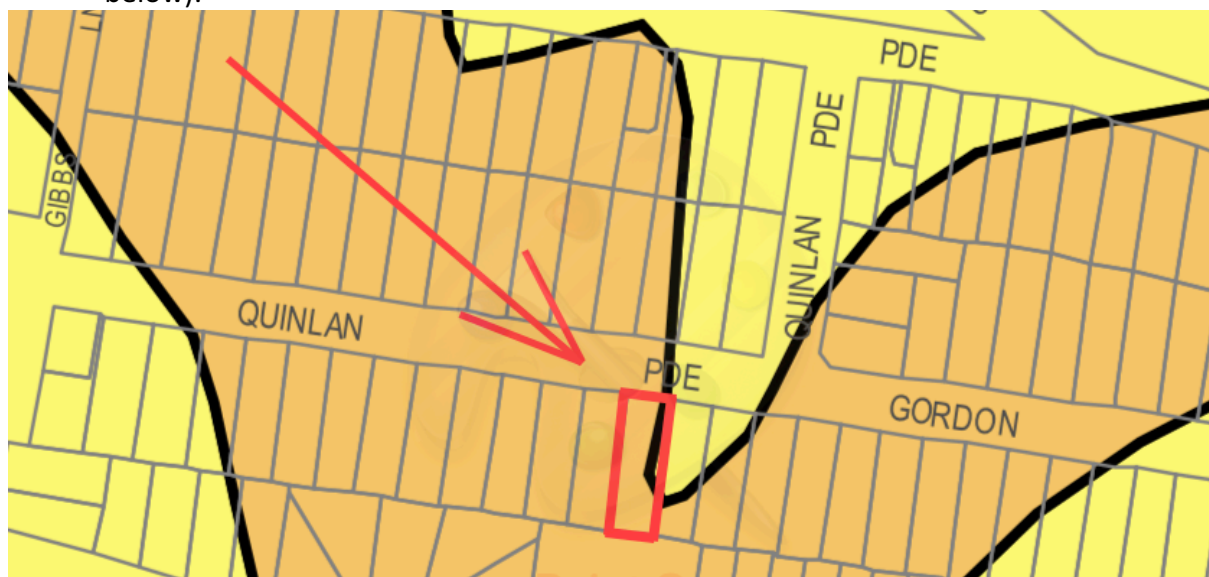
WARRINGAH LANDSLIP RISK MAP

- No evidence of significant soil creep, tension cracks or other indicators of slope instability were identified at the time of our inspection.
- The existing structures including retaining walls displayed no evidence of significant cracking or settlement that could be attributed to slope instability.
- The property is classified as **Area A & Area B** with reference to Northern Beaches Council WLEP Landslip Risk Map Sheet LSR_008 (WLEP Landslip Risk Map **Image 2** below).

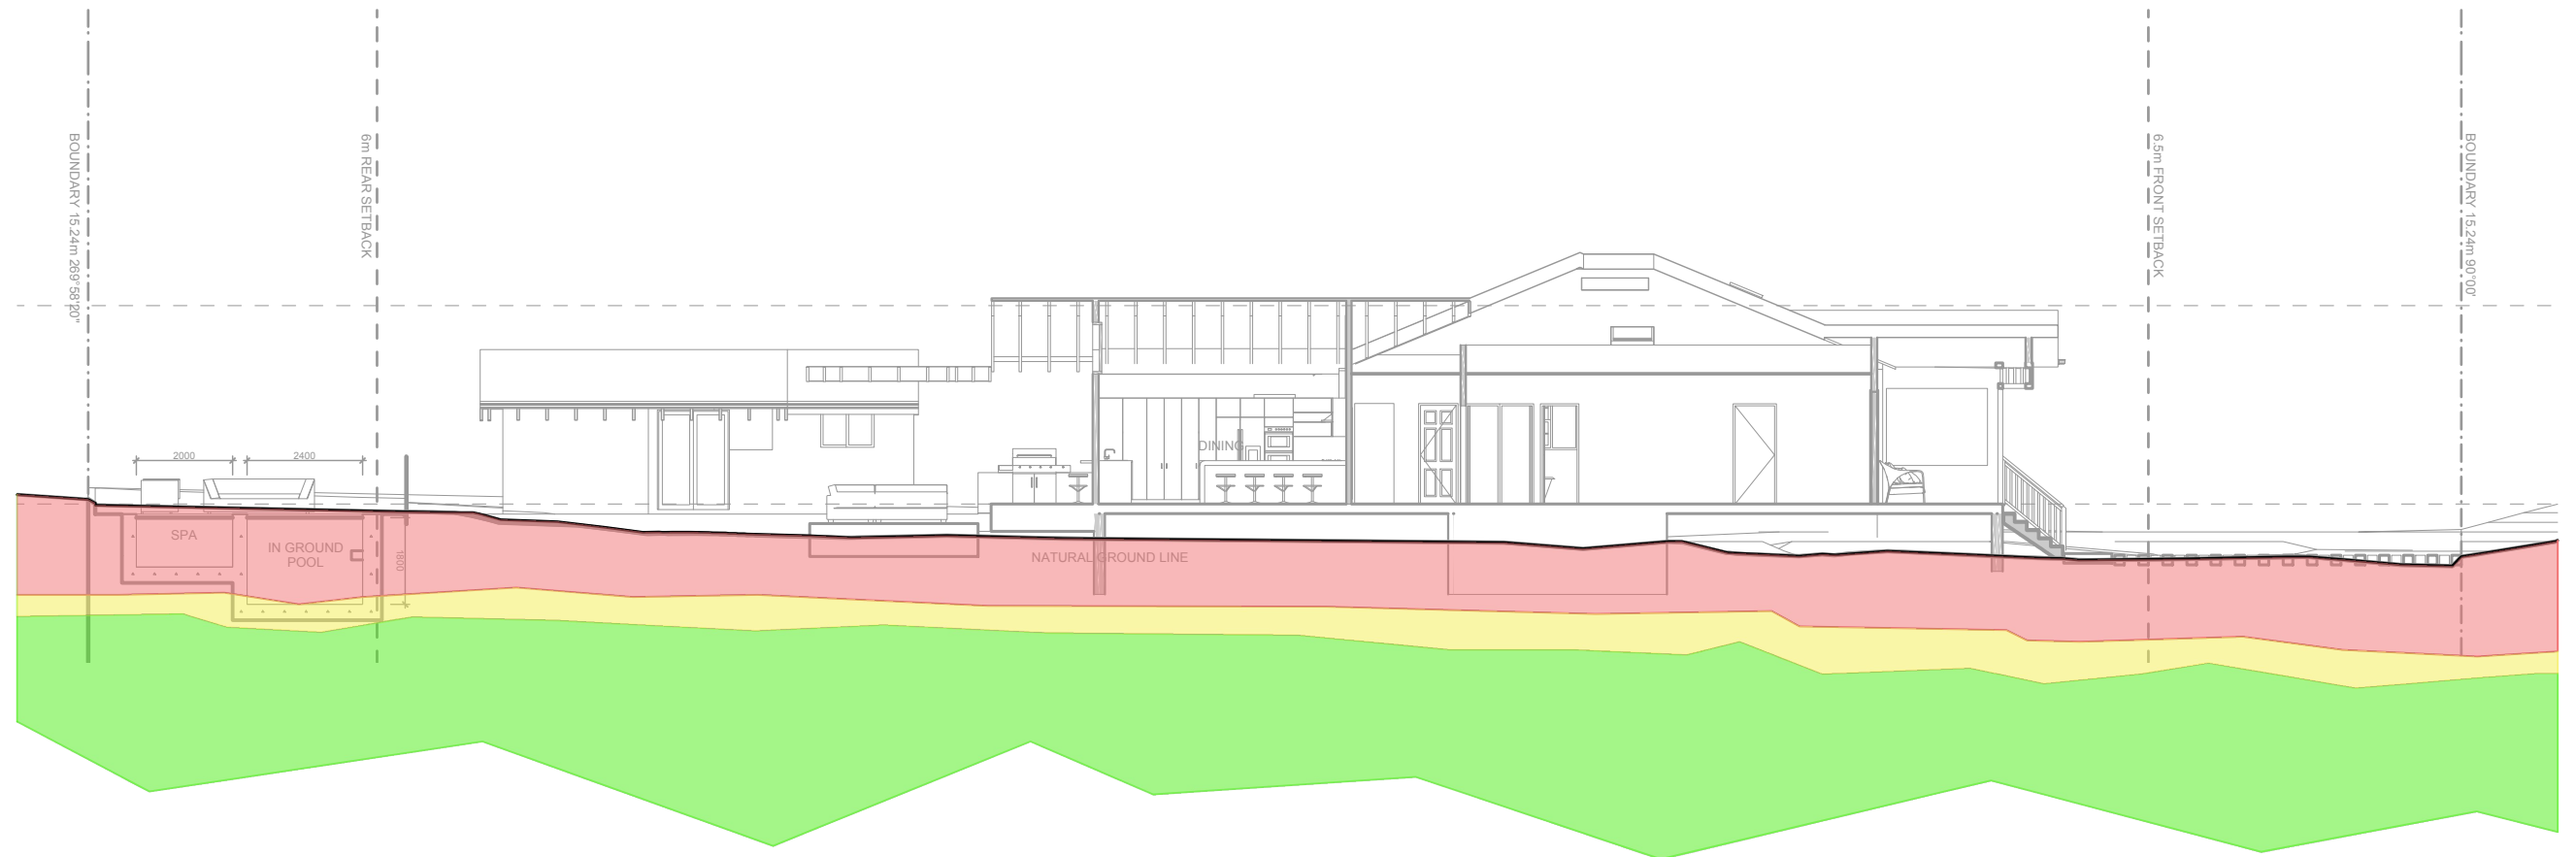
INFERRED GEOLOGICAL SECTION

INTERPRETED SUBSURFACE SECTION ONLY.
ACTUAL GROUND CONDITIONS MAY VARY.
