Report Title: Geotechnical Report 10 Grandview Drive, Newport

Report Date: 5/8/19

GEOTECHNICAL INVESTIGATION:

Alterations and Additions at 10 Grandview Drive, Newport

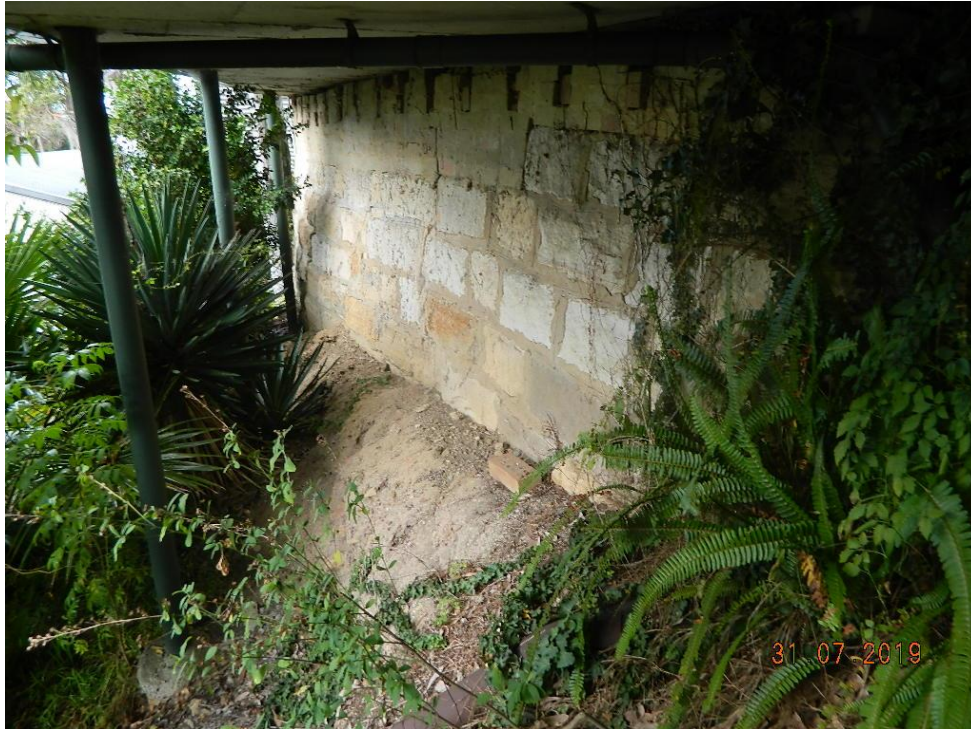
Photo 1

- 2.3** A right of carriageway runs from the road and provides access to a double garage near the upper boundary of the property. The garage can be seen to be supported on sandstone block walls and steel posts (Photo 1). The owner had the original plans available at the time of the inspection and these show the slab is also supported on three piers behind the wall (Photo 2). The sandstone block walls show cracks on the downhill face that rise from the base of the wall between the mortar and step up the face (Photo 3). The cracking appears to be from settlement and potentially tree roots. The wall shows little deflection and has shown no significant signs of movement from the last inspection in 2012, as such the wall is considered stable. Rough cut concrete steps run down the slope to a path and the main entrance

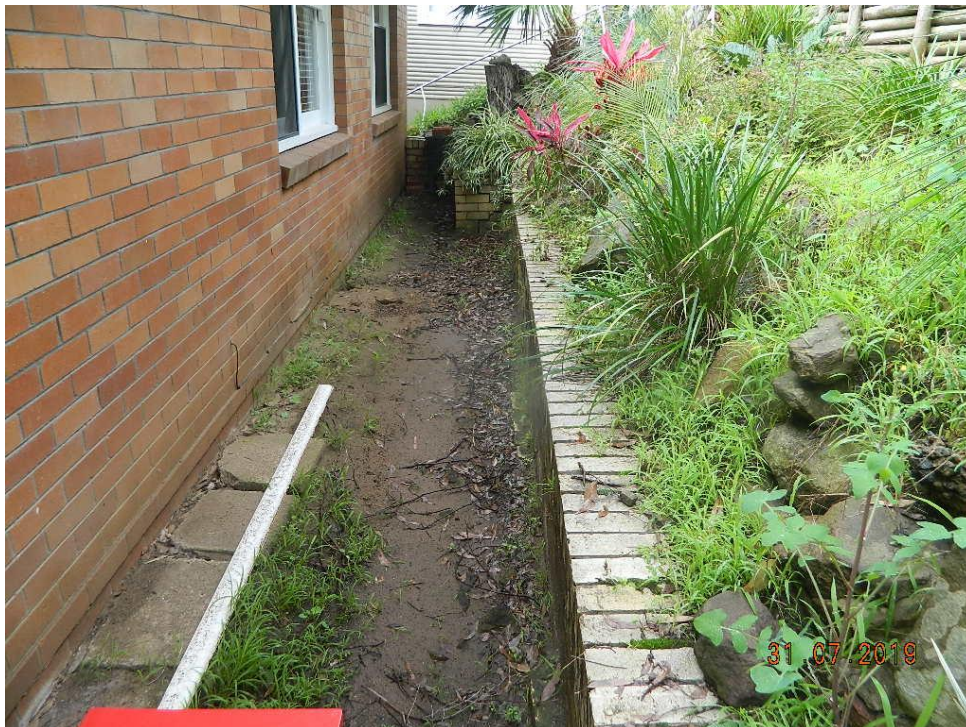
Photo 4

of the house. Downhill of the carport the slope has been terraced using timber and brick retaining walls. The lower brick wall has a slight bow midway along it and has cracked at its S end due to the roots of a tree that has since been cut down (Photo 4).

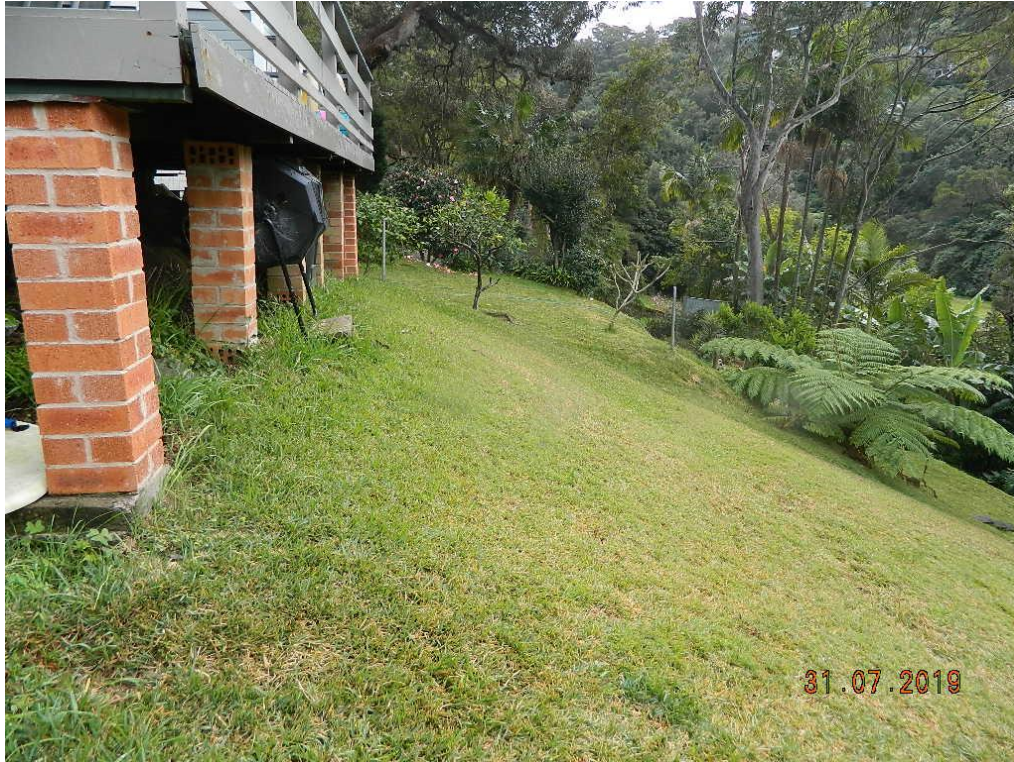
Photo 7

2.5 Access downhill of the house is by concrete paths either side of the property. A deck extends off the downhill side of the house. Two of the brick piers supporting the deck have been replaced and all stand vertical (Photo 7). The proposed work will extend the upper stories deck and roof by 1m and replace the posts. Beyond the deck a lawn covered slope drops at steep angles to the lower boundary. No signs of slope instability were observed on the grounds.

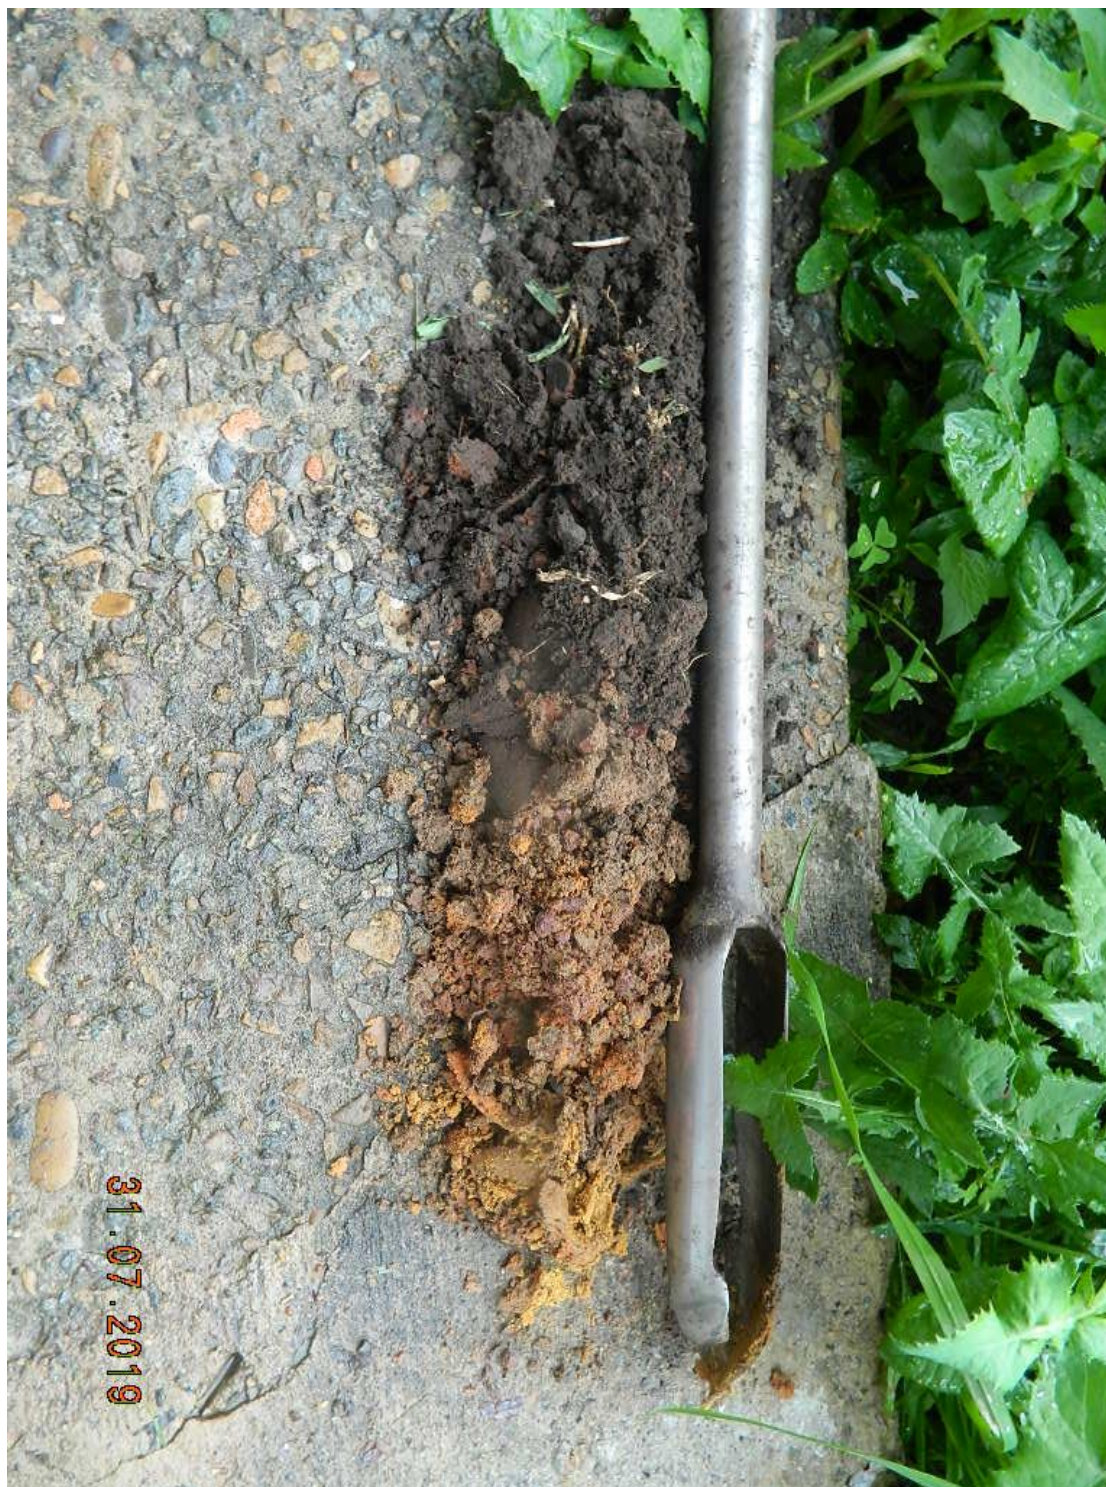
Photo 8 – Ah1

AUGER HOLE 1 (~RL25.0) – AH1 (Photo 8)

Depth (m)	Material Encountered
0.0 to 0.2	TOP SOIL , sandy soil, dark brown.
0.2 to 0.3	SILTY SAND , light brown, medium grained with shale fragments
0.3 to 0.4	CLAY , Light brown with mottled orange, friable
Refusal @ 0.4m. No watertable encountered.

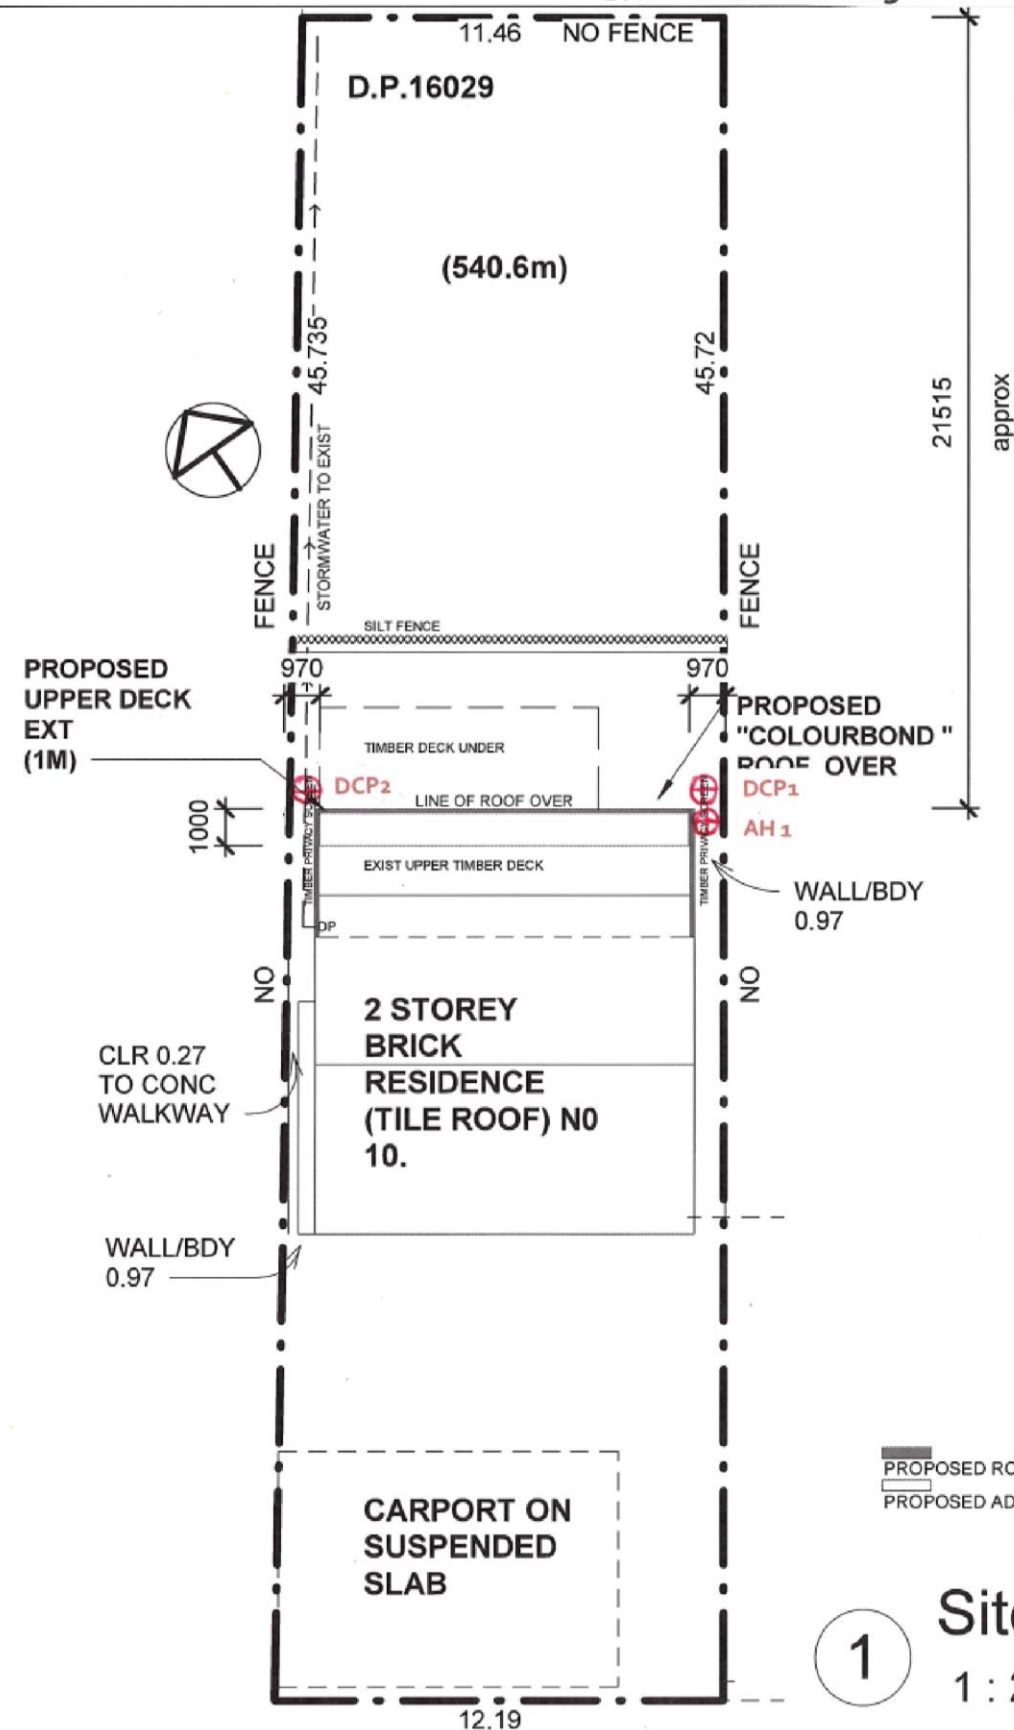
SITE PLAN – showing test locations

One auger hole was put down to identify the soil materials Two Dynamic Cone Penetrometer (DCP) tests were put down to determine the relative density of the overlying soil and the depth to weathered rock. The locations of the tests are shown on the site plan. It should be noted that a level of caution should be applied when interpreting DCP test results. The test will not pass through hard buried objects so in some instances it can be difficult to determine whether refusal has occurred on an obstruction in the profile or on the natural rock surface. The results are as follows:

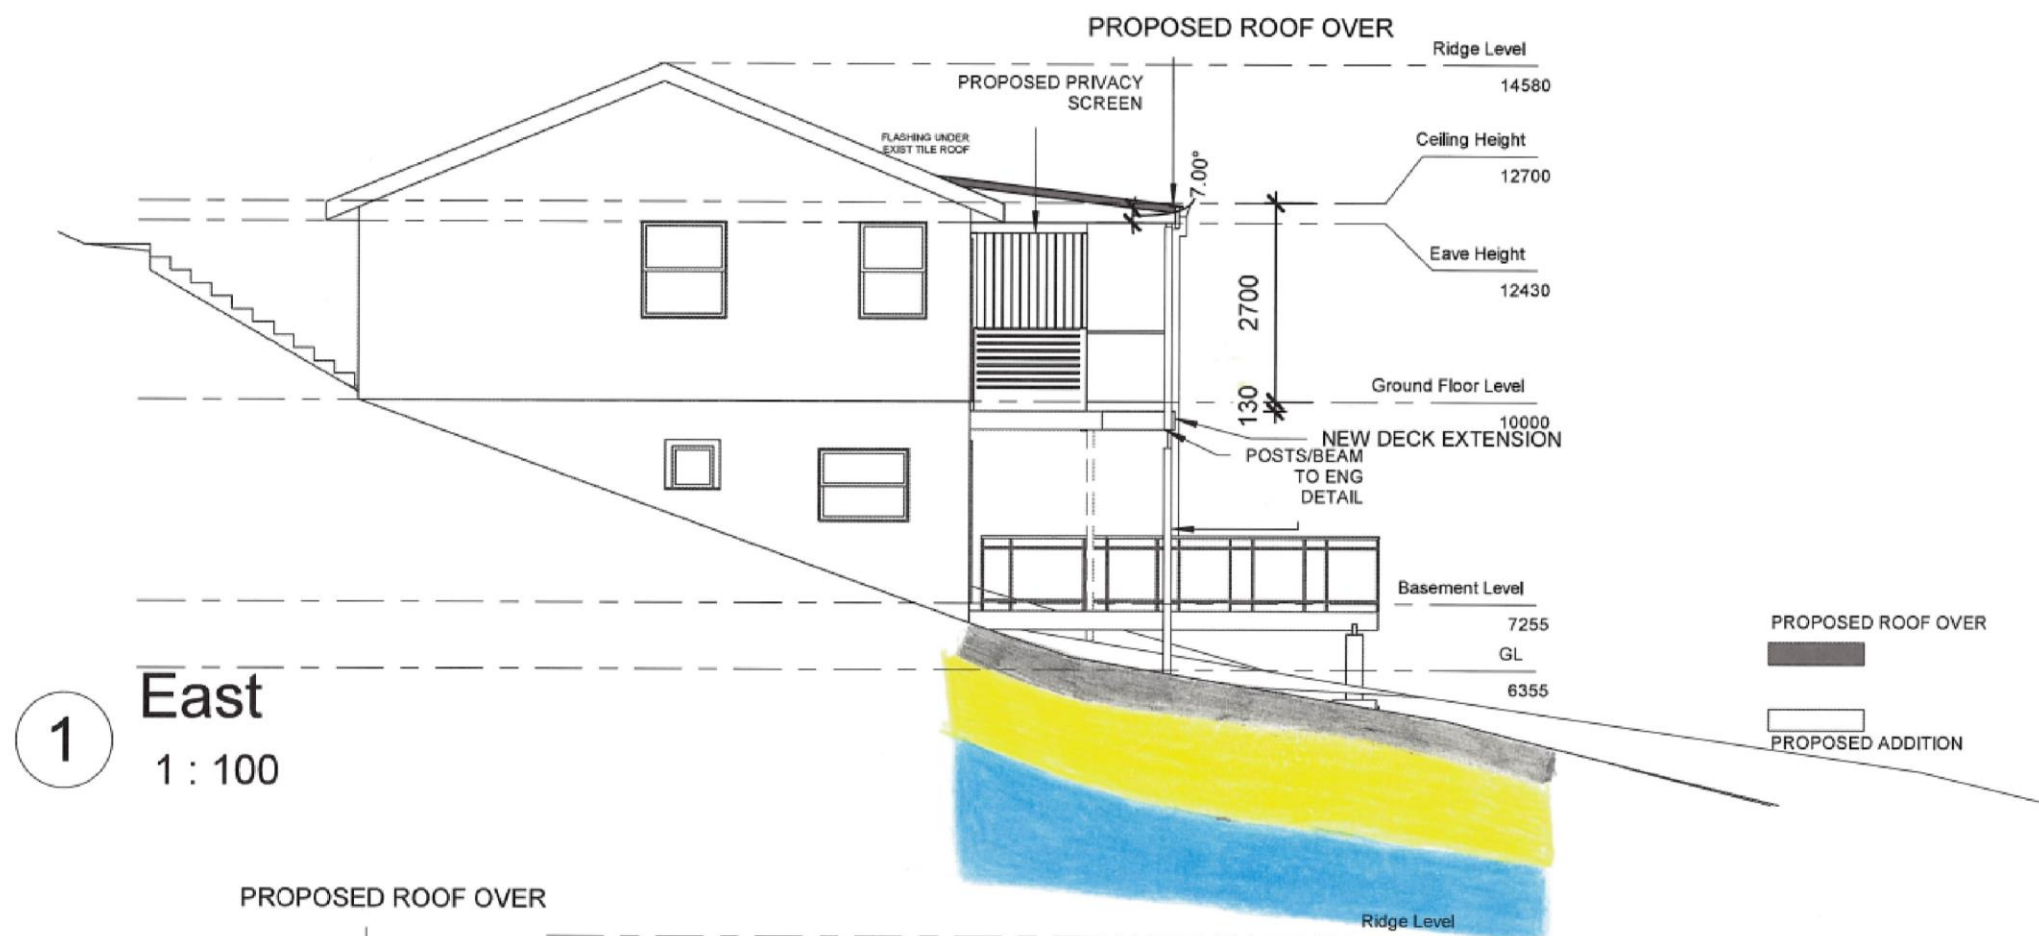
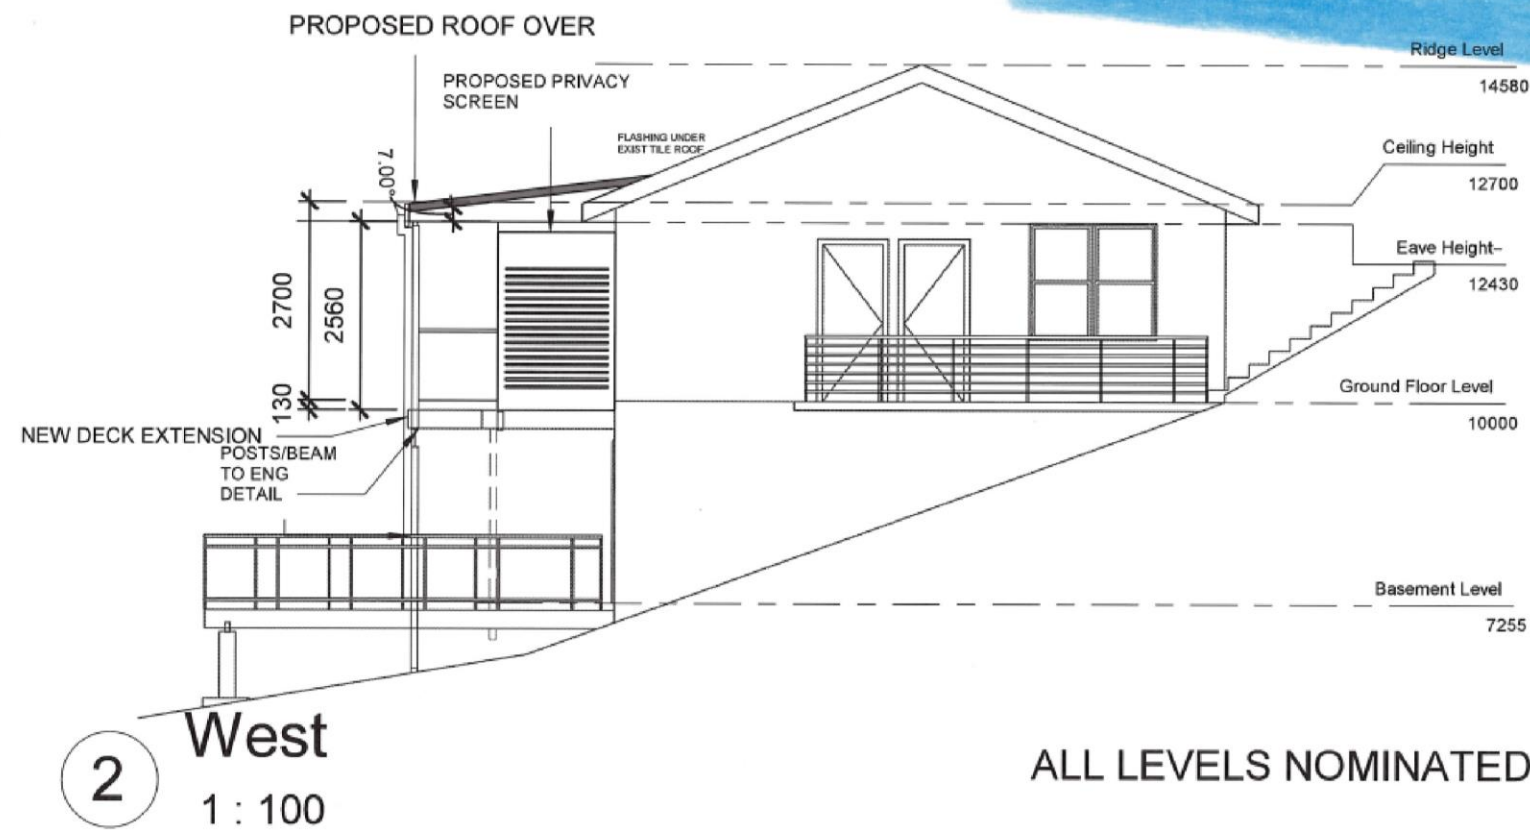
TYPE SECTION – Diagrammatical Interpretation of expected Ground Materials

The slope materials are colluvial at the near surface and residual at depth. In the location of the proposed works they consist of a manmade fill over sandy soil and sandy clays. In the test locations, the sandy clays merge into the weathered zone of the underlying shale at an average depth of ~1.8m below the current surface. The weathered zone is interpreted as Extremely Low Strength Shale. It is to be noted that this material can appear as a mottled stiff clay when it is cut up by excavation equipment. See Type Section attached for a diagrammatical representation of the expected ground materials.

Fill
Topsoil
Firm to Stiff Clay
Narrabeen Group Rocks – Very low to low Strength Shale - after being cut up by excavation equipment can resemble a stiff to hard clay.
