J2328. 9<sup>th</sup> September, 2019. Page 1.

# **GEOTECHNICAL INVESTIGATION:**

Secondary Dwelling and double garage at 42 Elanora Road, Elanora Heights

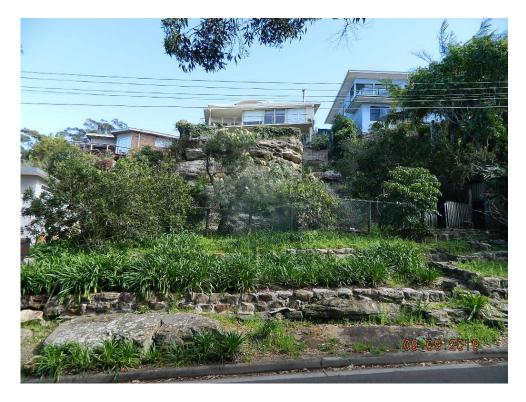
Photo 1

**2.3** From the road frontage two 0.4m high mortared sandstone block retaining walls on outcropping sandstone terrace the street frontage (Photo 1). These stable walls support garden beds. A rough sandstone block and cut stairway travels along the NE boundary granting access to the rear of the property (Photo 2). Where mortared sandstone blocks are not used to support the cut batters for the stairway it is cut into outcropping rock. Outcropping sandstone was visible across the site from the road frontage to the base of the house (Photo 3). A sandstone cliff some 7.5m high rises below the house. There is some minor undercutting around the upper bedding plane

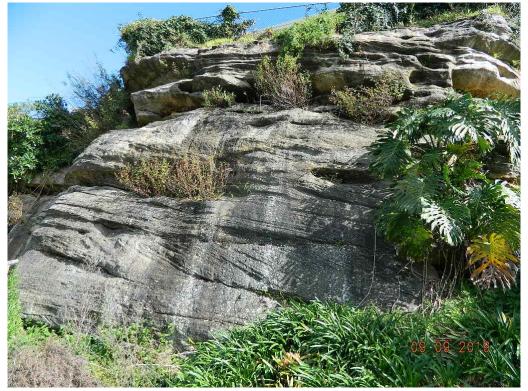
Photo 4

but no significant geological defects where observed in the rock that could impact of its stability. The rock making up the cliff is Medium Strength or better and the formation is considered stable (Photo 4). Above the face a level lawn and paved terrace extend to the foot of the house (Photo 5). The 2 storey brick house shows no signs of movement or any visible cracking in its external walls and is considered stable. A paved parking area extends uphill of the house to a garage. A concrete paved right of way carriageway (ROW) enters the property form Dewrang Ave to the N (Photo 6).

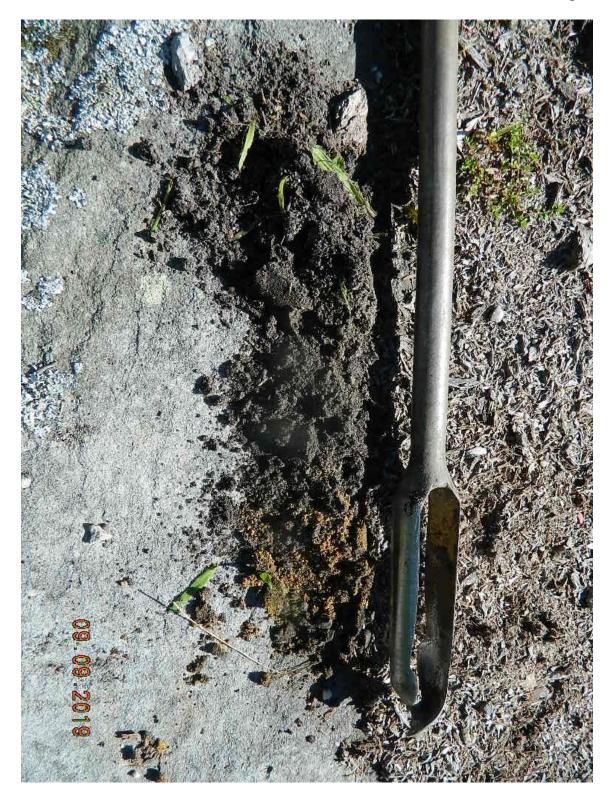
Photo 7 – AH1

# AUGER HOLE 1 (~RL76.3) - AH1 (Photo 7)

Depth (m)	Material Encountered
0.0 to 0.4	SANDY SOIL, dark brown, medium grained with trace organic matter.
0.4 to 0.5	SAND, medium to coarse grained with gravel, orange to yellow.

End of hole @ 0.5m in gravel. No watertable encountered.

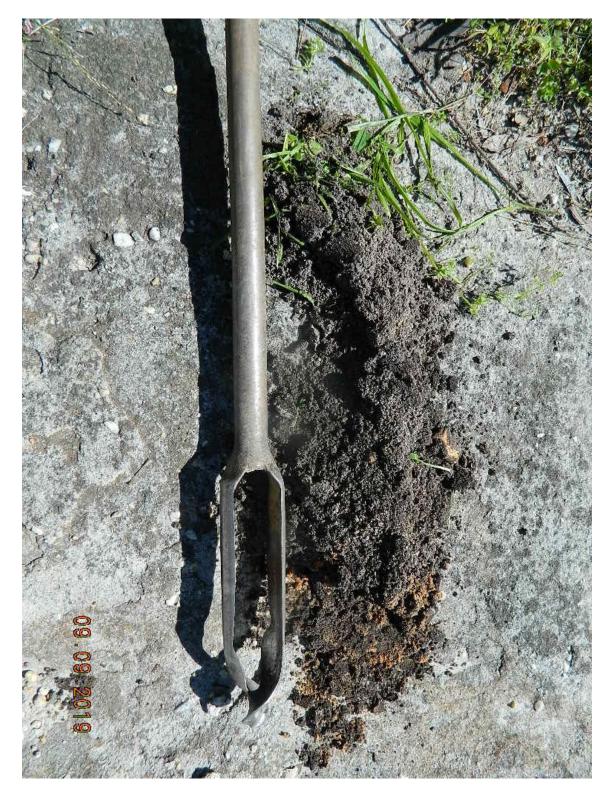
Photo 8 – AH2

#### AUGER HOLE 2 (~RL78.3) - AH2 (Photo 8)

- Depth (m) Material Encountered
  0.0 to 0.5 SANDY SOIL, dark brown, medium grained with fine trace organic matter.
  - 0.5 to 0.6 **SAND**, medium to coarse grained with gravel, orange to yellow.

Refusal @ 0.6m grinding on rock. No watertable encountered.
