ARBORICULTURAL IMPACT REPORT

29 BILKURRA AVENUE
BILGOLA PLATEAU NSW

12 AUGUST 2019

PREPARED FOR MR AND MRS NICOL

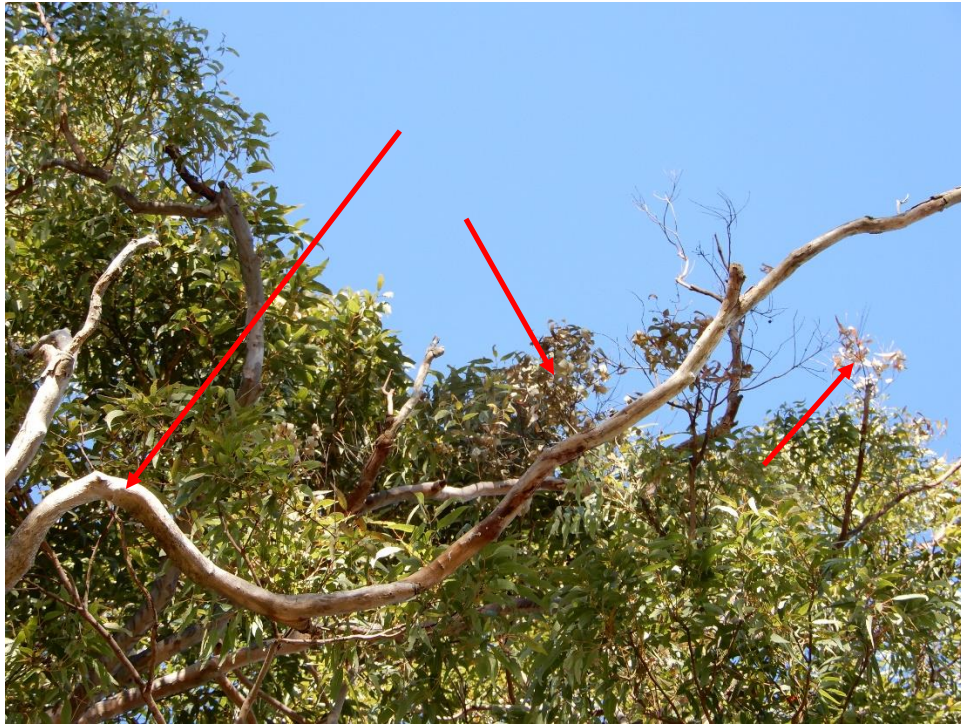
However, tree number 2 is of declining health and vigour and has a short useful life expectancy (ULE). Tree number 4 (Jacaranda) is exempt from protection under Northern Beaches tree management controls.

Photograph 1: Tree # 2 - Illustrating the dieback.

2	<i>Angophora costata</i> (Smooth Barked Apple, Sydney Red Gum)	8	7	290	290	340	Fair foliage condition	Semi Mature	Single trunk	Upright trunk	Majority of canopy to the north	No evidence of significant past pruning	Appears stable	Fair branch attachment	Moderate health	Fair vigour	10 to 15%	Longicorn Beetle larvae activity	3 Short (5 to 15 years)	Moderate landscape significance	3	The tree's past canopy development has been suppressed. Longicorn Beetle larvae activity. At the time of inspection the tree was of moderate health and fair vigour and exhibited moderate to high levels of dieback - short ULE.
3	<i>Angophora costata</i> (Smooth Barked Apple, Sydney Red Gum)	20	15 x 17	Up to 570 (1050 x 1520 above the root flare)	1285	1285	Good foliage condition	Mature	Multi trunked	Slight trunk lean to the NW	Majority of canopy to the NW	Lower limbs pruned in past to 3 metres, lower branches pruned through centre for OH wires	Appears stable	Fair branch attachment	Good health	Good vigour	5%	No visual evidence of significant pest or disease	2 Medium (15 to 40 years)	High landscape significance	1	Recent NBN works in TPZ and SRZ. Evidence of recent minor wounding (mechanical injury) to tissue on lower leader. The tree displays fair branch attachment with multiple leaders - not considered at risk of failure in the short term. Minor cracking in 2 lower leaders on west side - possibly torsional stress cracks under wind loading - monitoring recommended.

- The proposed driveway and garage will impact on 28.95% and 30.16% the identified TPZs of tree numbers 1 and 2 - while this is a high level of encroachment if the driveway and can be installed on a shallow bed of sand on top of existing grade (no excavation or compaction) then the impacts can be minimised. Notwithstanding this, it is considered long term retention tree number 2 may be problematic (it is noted this tree has a short ULE).

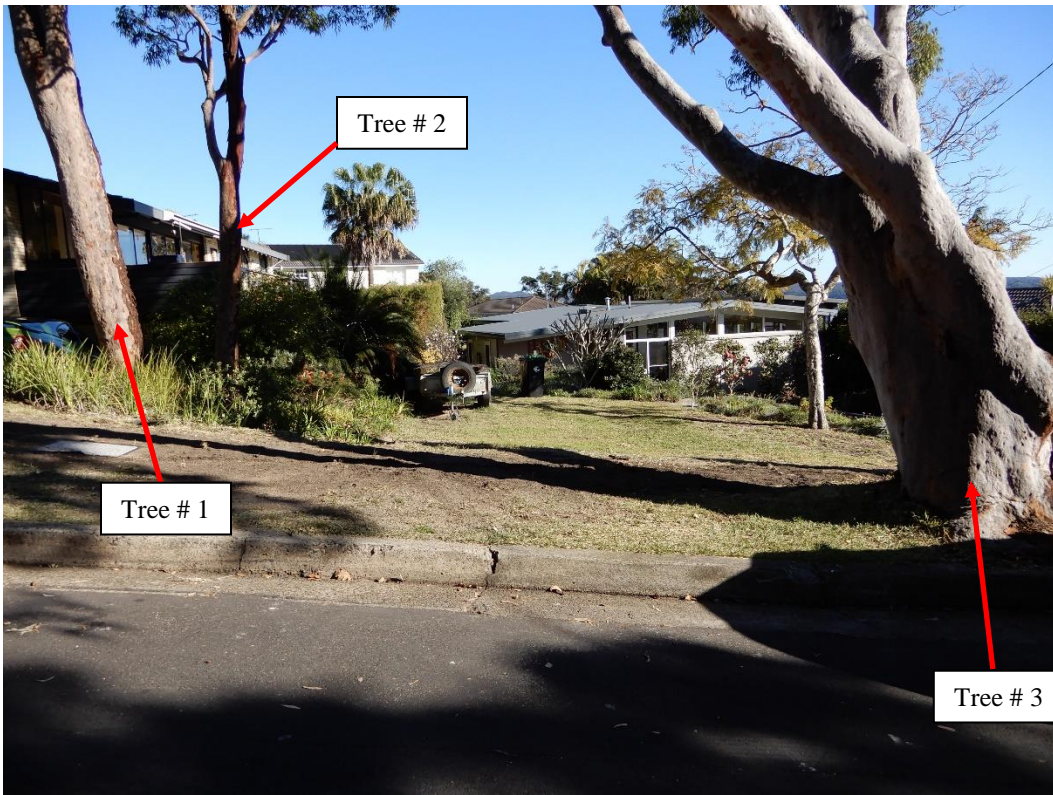
Photograph 3: Illustrating the general location of the proposed driveway.

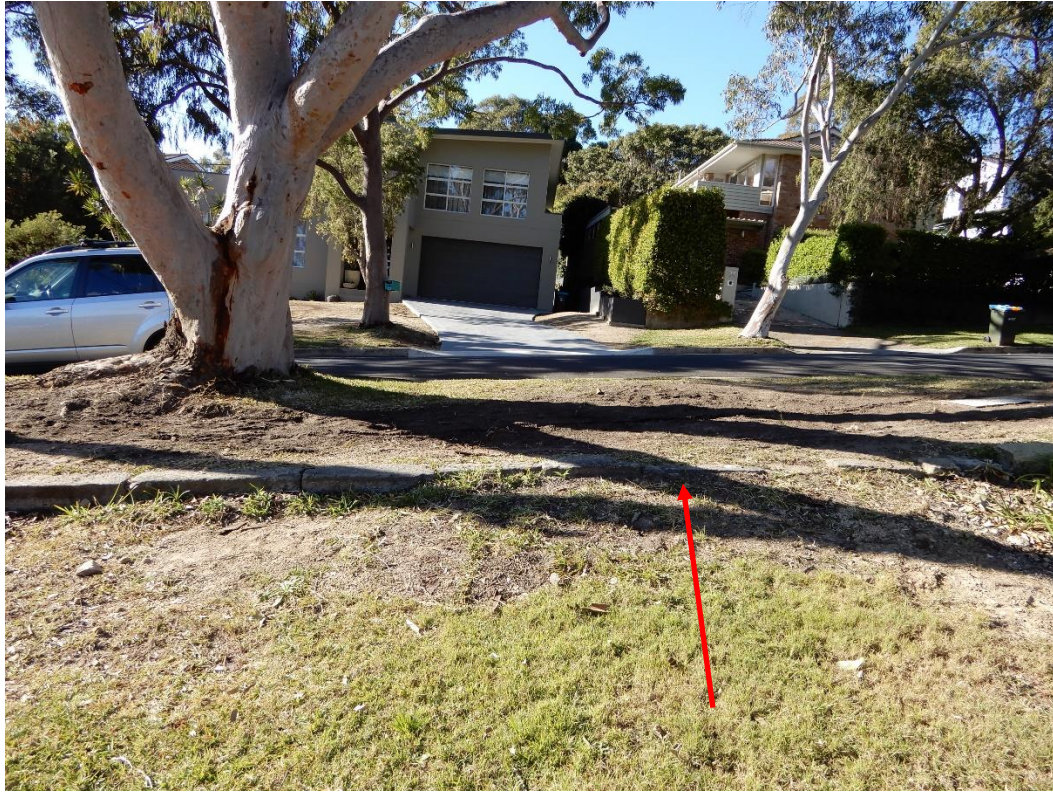
- The proposed works will impact on 13.81% the identified TPZ of tree number 3 – this is a low to moderate level of impact and within an acceptable threshold for the tree. However, it is noted the actual impacts will be greater than the calculated encroachment due to the restriction to root growth due to the road which will have resulted in greater root growth in other areas including the area potentially impacted. In addition, the driveway crossing is within the tree’s SRZ and some excavation will be required to achieve an acceptable gradient from the existing road level. However, if the remainder of the driveway and can be installed on a shallow bed of sand on top of existing grade (no excavation or compaction) then the impacts can be minimised. The proposed stormwater pipeline, if installed using traditional trenching methods, could impact a further 3.53% of the tree’s identified TPZ located between the pipeline and the existing masonry retaining wall along the existing driveway – it is recommended the pipeline be installed by hand excavation under the direction of the site arborist to ensure roots of 30mm or greater diameter are retained and protected (tunneled under).

Photograph 4: Tree # 3 – Illustrating existing conditions in the area of the proposed driveway.

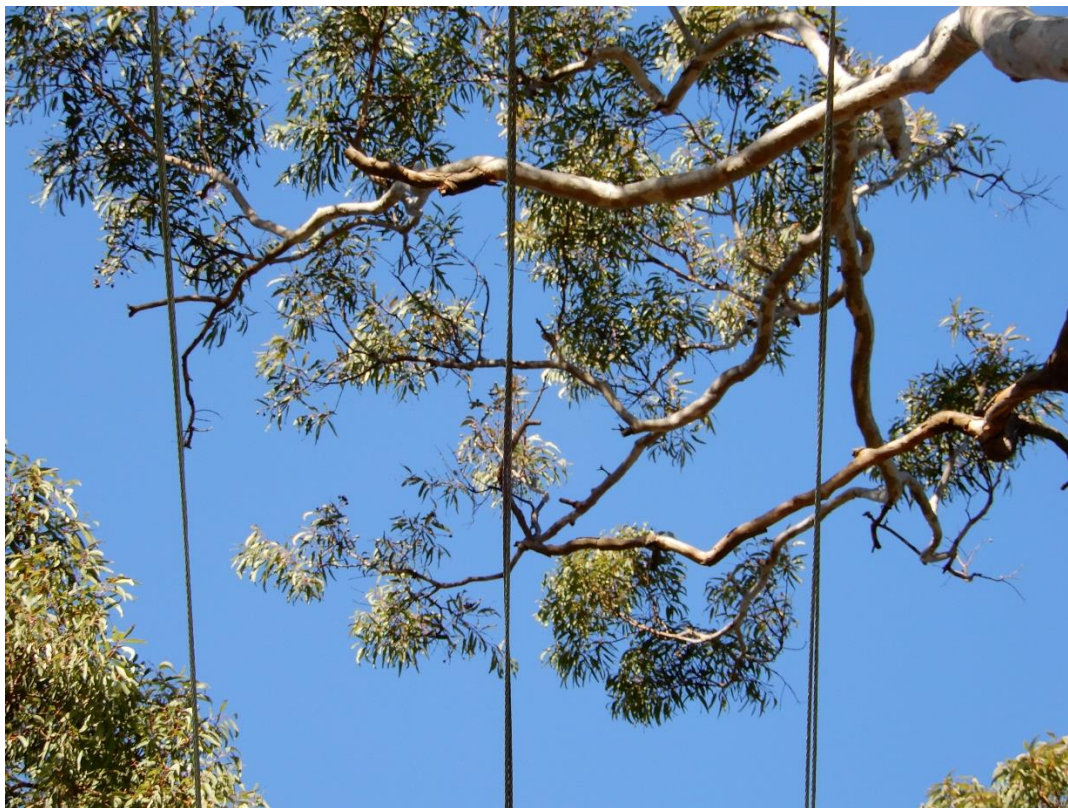
Photograph 5: Tree # 3 – Illustrating low levels of dieback in outer canopy areas.

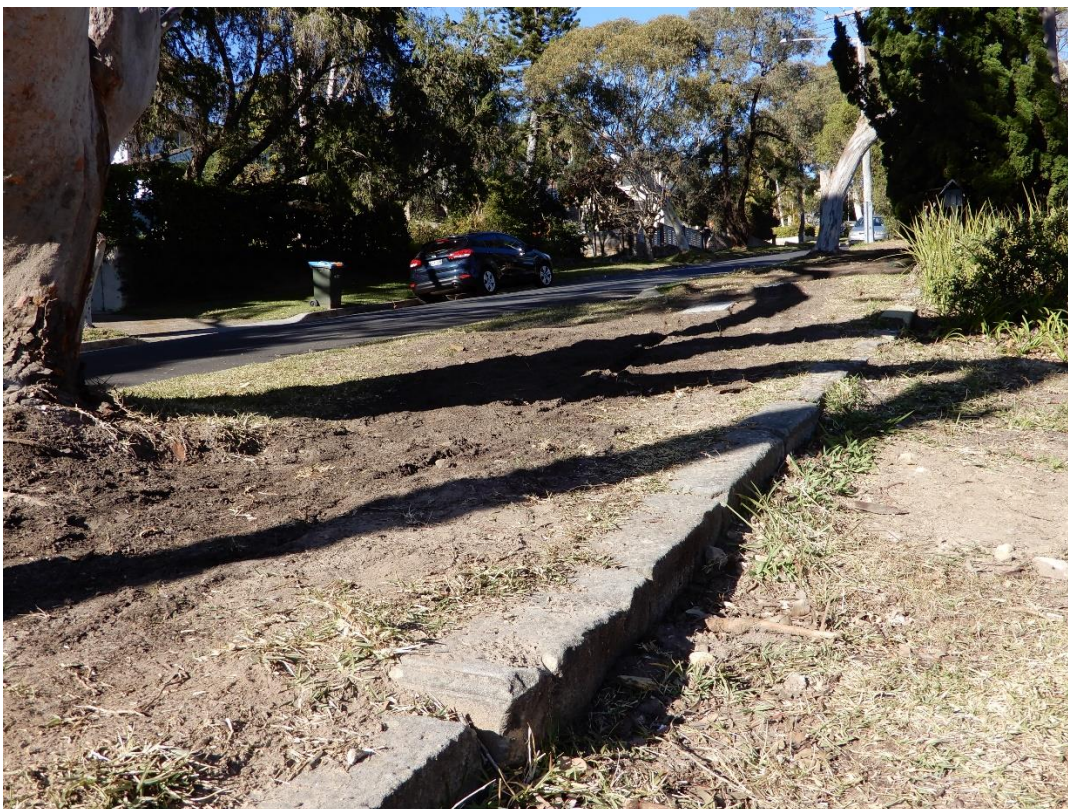
Photograph 6: Tree # 3 – Illustrating the level drop into the site in TPZ/SRZ of the tree.

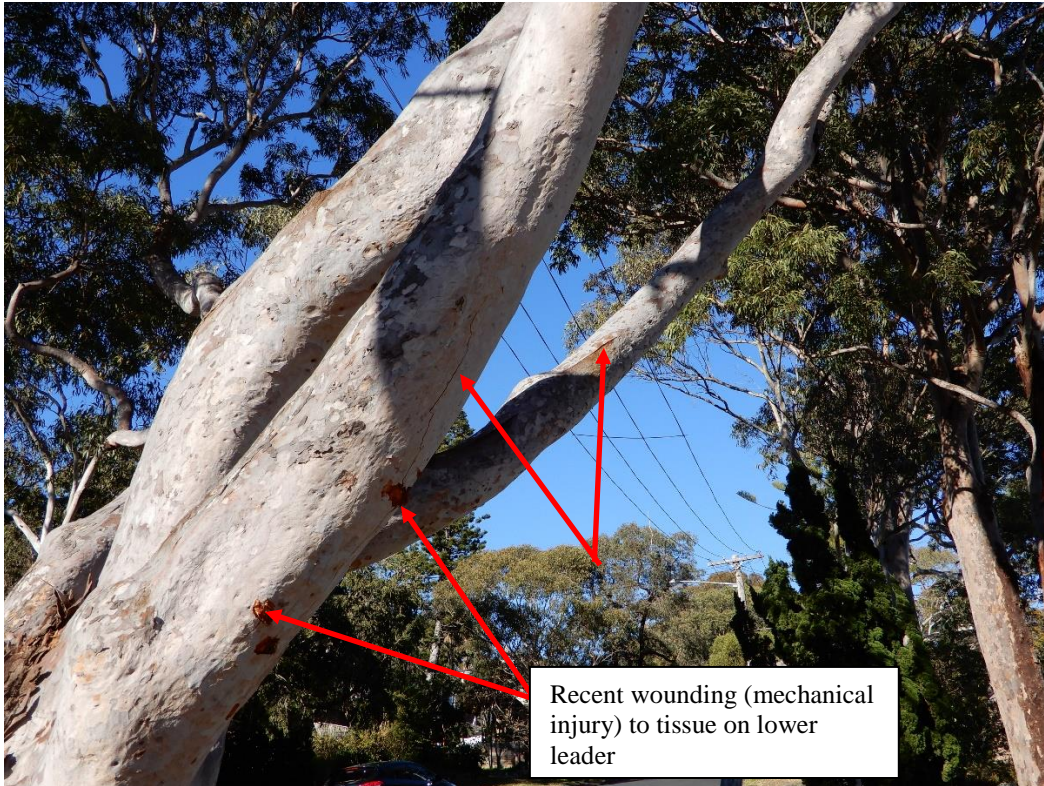
Photograph 7: Tree # 3 – Illustrating minor cracking in 2 lower leaders on west side.

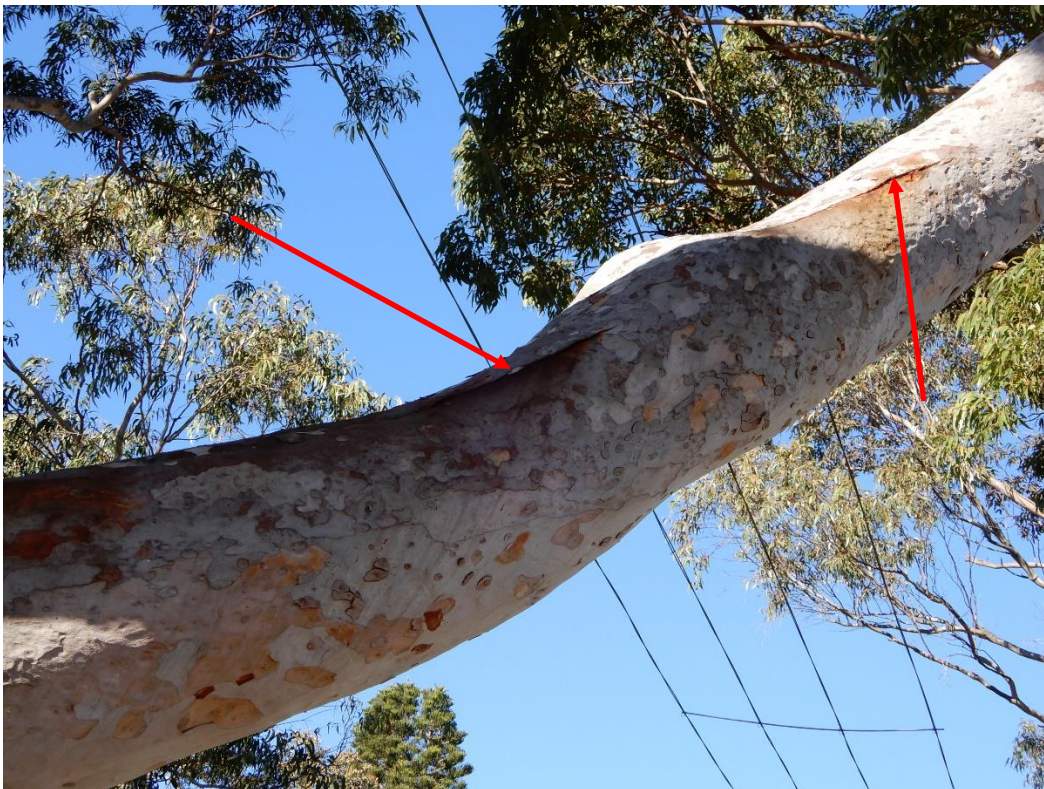
Photograph 8: Tree # 3 – Illustrating a closer view of the minor cracking in lower leaders on west side
