REPORT ON GEOTECHNICAL ASSESSMENT

PROPOSED ALTERATIONS AND ADDITIONS

26 BUNGOONA AVENUE, ELANORA HEIGHTS

Project No.: 2017-230

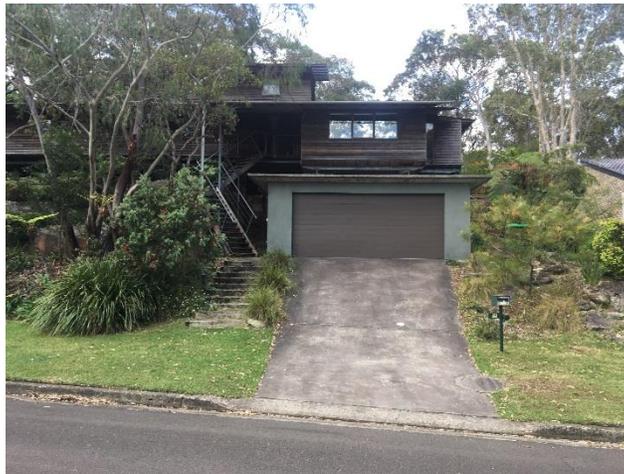
Photos of the front of the site taken from the road reserve is supplied below.

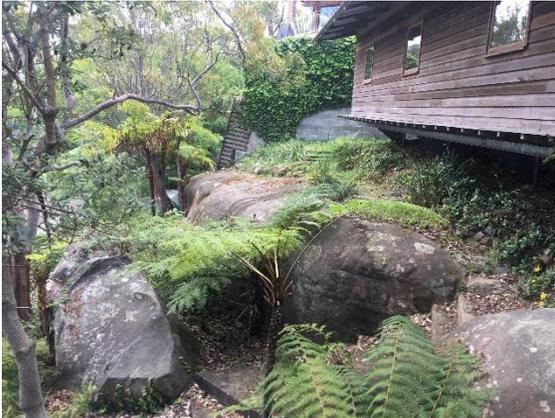
The front of the site contains a gently dipping near natural garden with dense vegetation and numerous medium to large size sandstone boulders. These boulders have separated from a 2.00m to 5.00m high sandstone bedrock cliff that strikes across the site from the rear edge of the garage, in a south-west direction, towards the sites south-west corner. A concrete driveway provides access up to a two car masonry garage structure that is formed up to the cliff face in the south-east corner of the site. The soil/garden slopes and boulders generally appear stable in their current position. The garage may have involved some minor excavation for its construction and adjacent to its north-west corner the end of one boulder is exposed along with a clayey sand residual soil below its base, see photos below:

Front yard of site showing bedrock and boulders

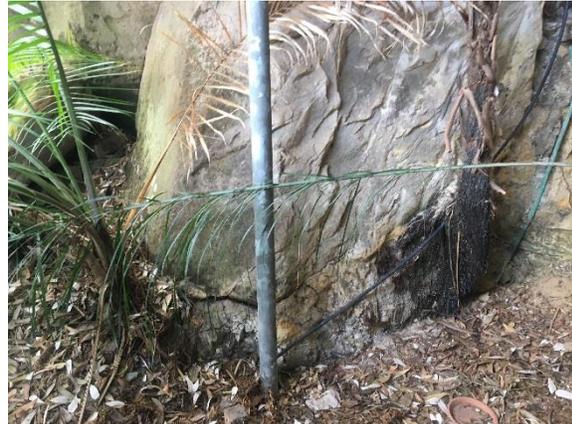
Base of boulder adjacent to garages north-west corner

The boulder located adjacent to the lift location is long (5.00m) and its stability will not be affected by the excavation due to the separation distances. Should excavation for the lift be widened for any reason then an underpinning of concrete or brick to below excavation level will ensure no movement occurs.

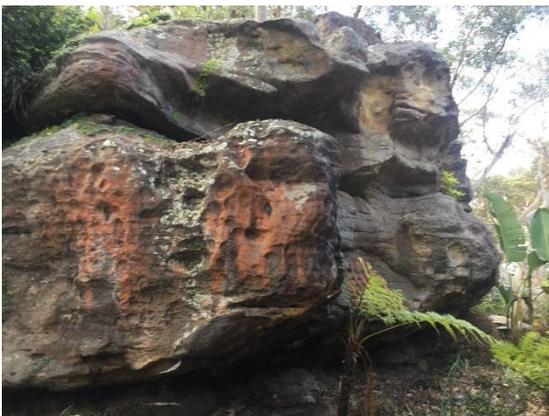
Cliff in rear north-west corner, slight overhang

- A. Landslip (rock fall 20m³) from rear cliff line due to erosion of cliff base
- B. Landslip (rock fall 2m³) boulder from crest of rear cliff line

HAZARD	Description	Impacting	Likelihood	Spatial Impact	Occupancy	Evacuation	Vulnerability	Risk to Life
A	Landslip (rock fall 20m ³) due to overhang in rear cliff	a) Garden area downslope b) Site house	Cliff contains 2.0m deep undercut at base, no significant destabilising defects and overhanging unit is capable of support Unlikely	a) Roll into half of garden area, b) May reach edge of house and impact very small portion	a) Person in garden (1hr/month average), b) Person in house 20hrs/day.	a) Likely to not evacuate b) Unlikely to not evacuate	a) Person in open space crushed, b) Person in building no collapse

Structure	Maintenance/ Inspection Item	Frequency
Stormwater drains.	Owner to inspect to ensure that the drains and pipes are free of debris & sediment build-up. Clear surface grates and litter.	Every year or following each major rainfall event
Retaining Walls	Owner to inspect walls for deviation from as constructed condition.	Every two years or following major rainfall event
Large Trees on or adjacent to site	Arbourist to check condition of trees and remove as required	Every five years
Slope Stability	Geotechnical Consultant to check stability of rear cliff overhang	Every ten years

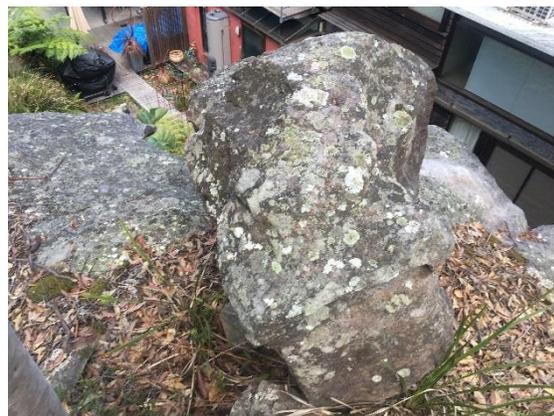
The backyard contains an inground swimming pool in the rear north-east corner with a sloping bedrock outcrop rising up from the rear of the site to a gently sloping lawn area in the adjacent land. This outcrop which forms a low cliff extends towards the east. Towards the west a low cliff strikes south through the adjacent land and then turns west within the site to form an approximately 5.00m high cliff within the north-west corner of the site. The cliff shows some separation along joint defects and the lower cliff face is undermined by weathering. A small boulder is also located above the cliff crest.

Small boulders above cliff.
