TREE REPORT

STEPHEN SCAHILL (Project arborist level V).

SAS LANDSCAPE AND TREE SOLUTIONS.

3 Beaconsfield St Newport

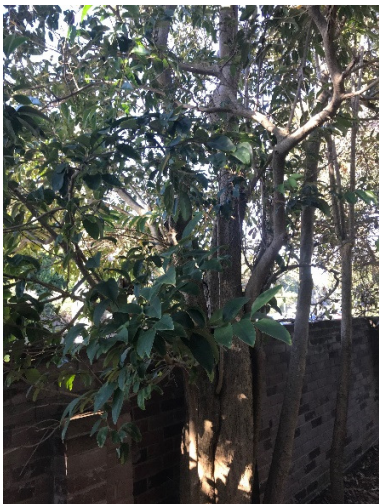
TREE NO. 4 privet multi branched requires total removal and stump grinding.

- Noxious specimens such as the multi stemmed privet require total removal so as not to leave any chance of epicormic re- sprouting . Figure 1
- Install the following Tree Protection Measures around the retained trees: Tree protection measures shall be a temporary fence of chain wire panels 1.8 metres in height (or equivalent), supported by steel stakes or concrete blocks as required and fastened together and supported to prevent sideways movement. (if required).

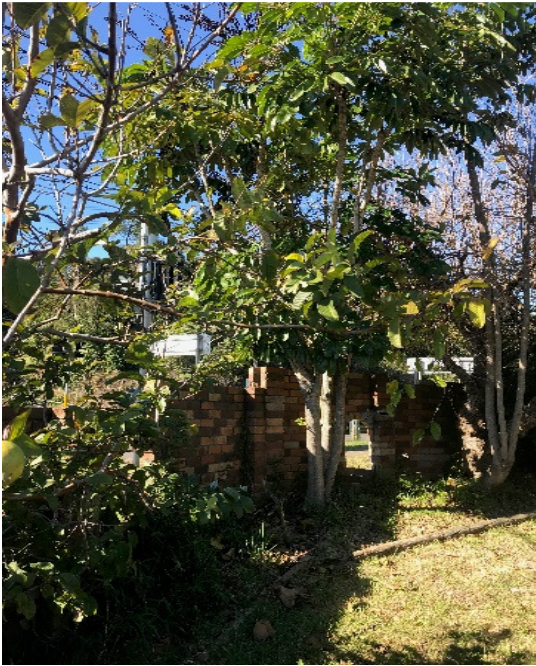
1 Various along fence . Showing the poor pruning practices and proximity to each other .

Figure 2 - Recommend total removal.

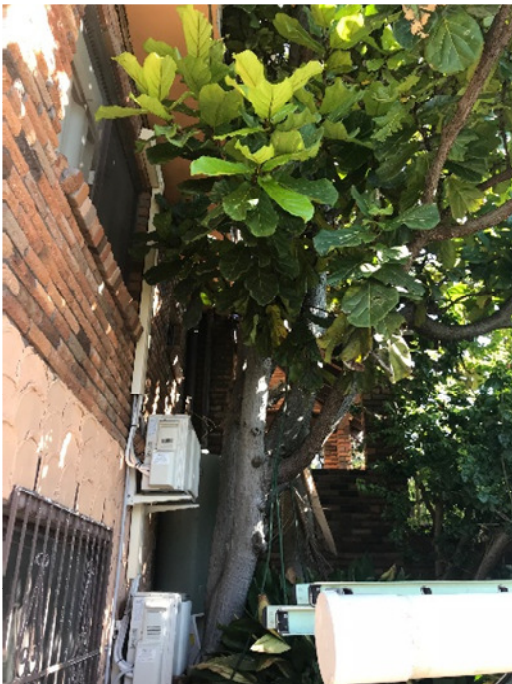
.Figure 3 - Ficus and palm near building .

Clearly these are planted too close to building structure . Over- mature Ficus Lyrata.
Palm and tree are already rubbing .This will lead to real problems over time .
This can and will eventually lead to included bark areas and structural weakness . Recommend total removal.

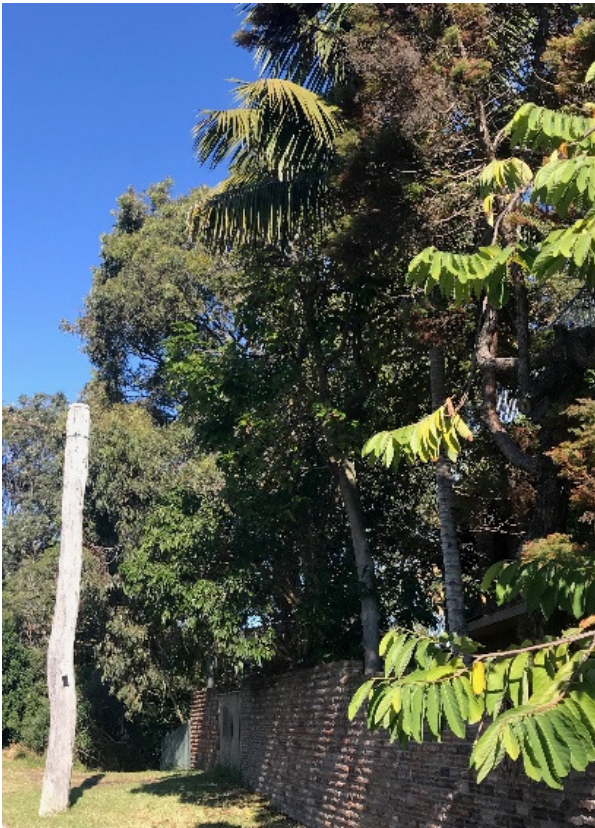
Figure 4 fence and powerline issues .

It is evident in figures 3 & 4 the issues with the conifer and the crowding of the various species along the boundary fence as well as their proximity to power lines etc .

Recommend total removal.

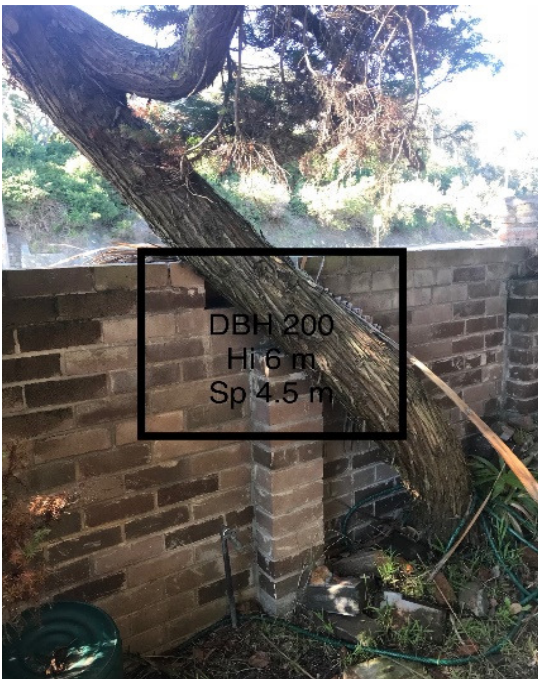
Figure 5 pinus with severe lean against fence .
