INTERNATIONAL MOUNTAIN BICYCLING ASSOCIATION AUSTRALIA

Trail Audit Documentation

Manly Dam (Manly Warringah War Memorial Park)

- Warringah Council

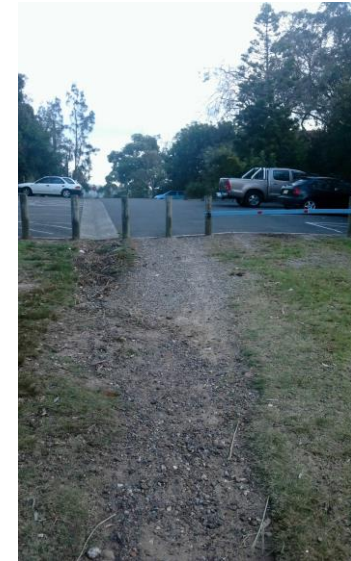
WP1.05: Run-off from the carpark is causing erosion of the tread (above).

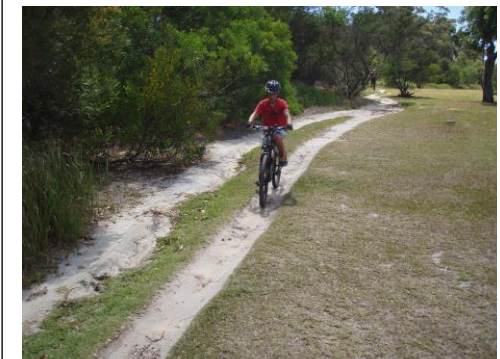
WP1.25 The original trail lacks drainage features and corrals so riders have worn in a new line. Drainage features and corrals are required on the new tread to avoid the same problem re-occurring.

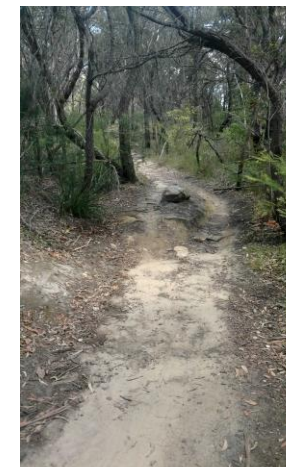
WP1.28 (above) – From this point the trail climbs on a fall line gradient and as a result is heavily degraded. Remediation is required to avoid further degradation.

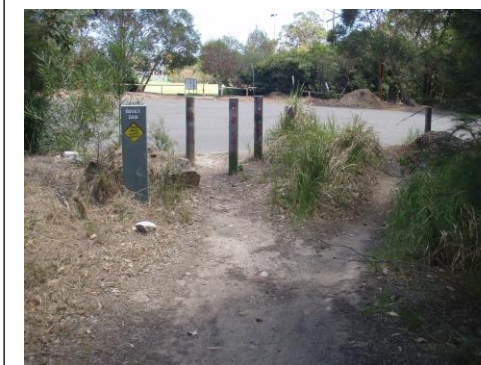
WP1.31 – Trail junction with roadway should be consolidated with corrals to avoid development of social trails like the one on RHS. Bollards should be at appropriate width for MTB handlebars.

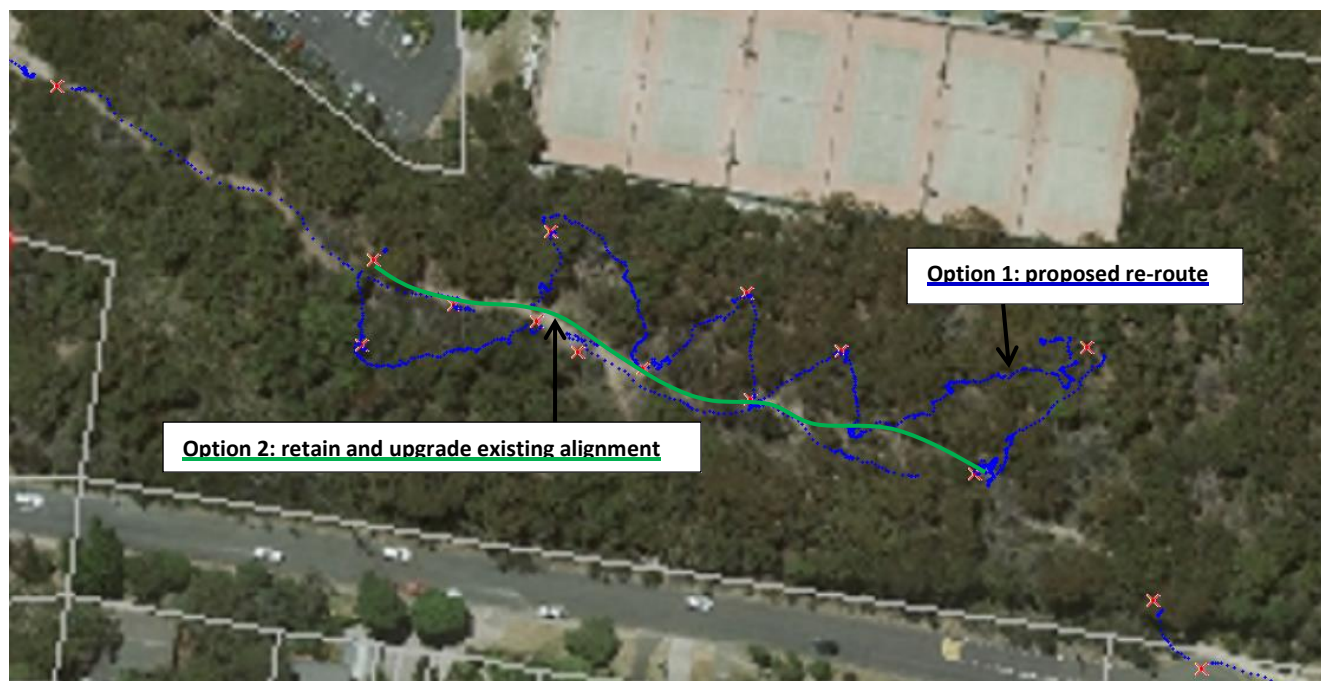
Although the side-slope gradient is modest (approx. 12%) the trail is eroding due to its alignment on the fall-line.

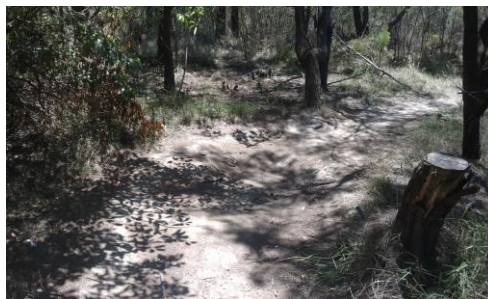
WP3.02 – This first section of the short cut trail has drainage problems, but a minor re-route is easily achieved and the rest of the trail is quite sound.

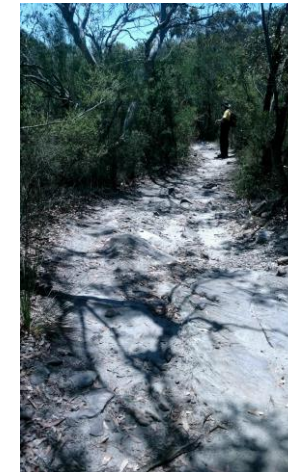
WP1.44 – Classic example of trail widening. Installation of a substantially sized corral stone will consolidate the ride line, although in this particular example the problem is unlikely to worsen.

3	Monitor	Natural surface / rock section - monitor for degradation and repair with stone armour &/or corrals - only if required	WP1.44

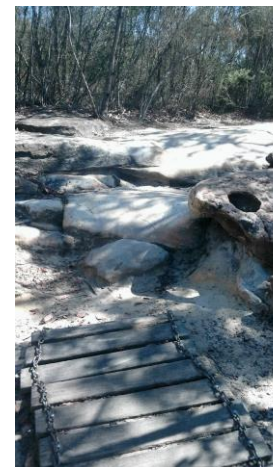
WP2.01 – Timber & chain 'Dutch ladders' have been used very effectively throughout the Manly Dam loop. Armouring their start & end points with stone should lengthen their life. In the long term however they should be replaced entirely with stone.

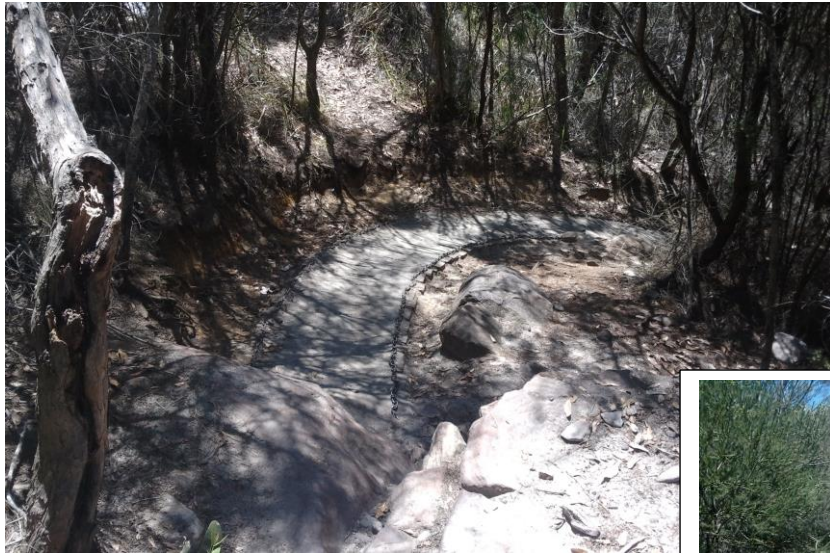
WP1.49 (above) – Entry into the chute is quite technically challenging and thus an effective filter. Signage is required to caution users of the technical challenge ahead, (and highlight the B-line option if it is approved / developed).

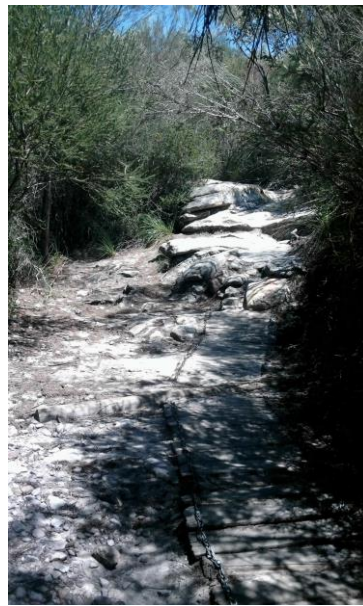
WP1.50 (right) – Exit of chute section. The Dutch ladder has been used effectively here to protect from braking impacts on the exit but trail widening has occurred. Again the long term recommendation is to replace all Dutch ladders with stone armouring eventually.

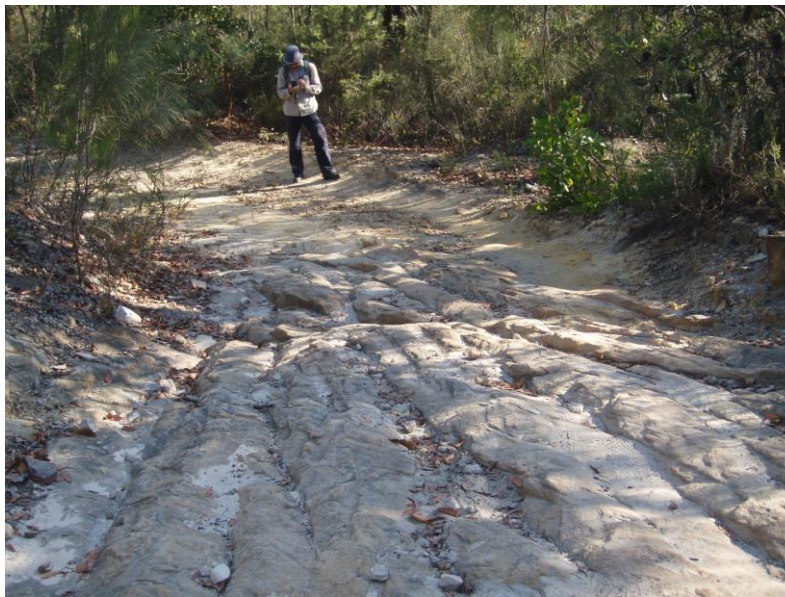
A typical scene (left) on the management track descent between WP4.02 and WP4.11. The tread consists of bedrock interspersed with natural surface sections, the gradient is often steep and sight lines on corners are quite poor in many cases. These factors combine to make it a priority project as there is a need to address risk to user safety.

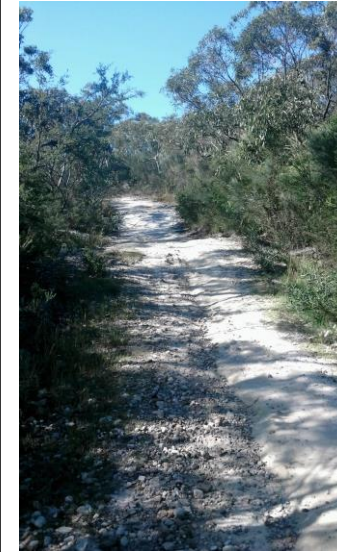
WP4.10 – Irrespective of the development of a single-track re-route the management track has drainage problems that should be addressed. The existing water-bars such as the one shown here should be rebuilt longer and higher to ensure they provide effective drainage but not become a hazard for MTB riders or problematic for management vehicles.

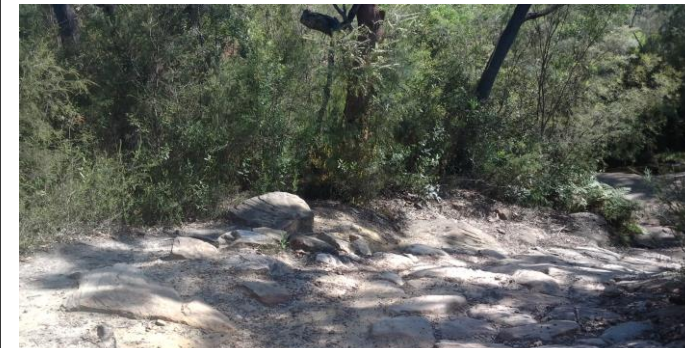
WP4.12 – The management track is very well armoured into the creek crossing which is itself natural bedrock. The armouring however has a rough finish and is potentially hazardous for riders travelling at high speed. With the proposed re-route riders would enter this section at greatly reduced speed thus reducing overall risk.

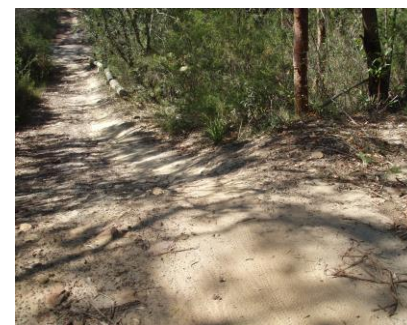
WP4.16 – Waterbars are providing a good drainage solution on the management track but could be upgraded to lengthen their life and increase their effectiveness. The track is quite steep and fast into a sometimes slippery creek crossing so a short re-route option is recommended.

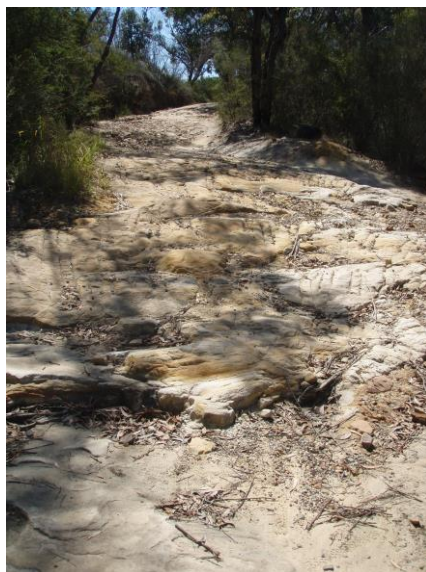
WP4.22 – Natural bedrock in a steep climbing section of the management track. The ride line snakes back and forth across the track and has caused widening in some sections. Some stone armouring would be an effective and relatively simple measure to remediate what are in any case relatively minor impacts.

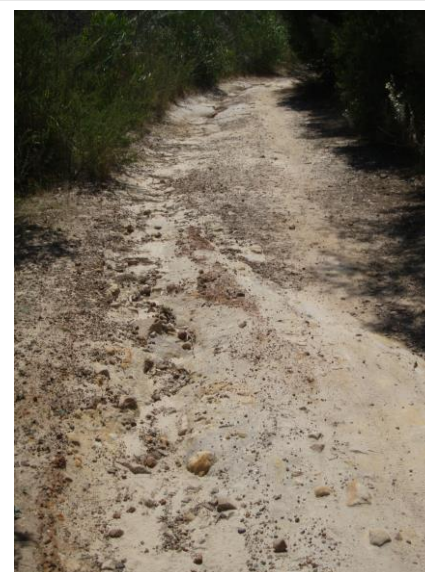
Typical view of Section 6 management track. This photo shows that even on relatively gentle topography, trails without regular drainage features can still easily erode or in this case, become cupped. Fortunately it is quite easy to fix this kind of impact; some resurfacing and installation of drainage features will provide a sound tread for a long time to come.

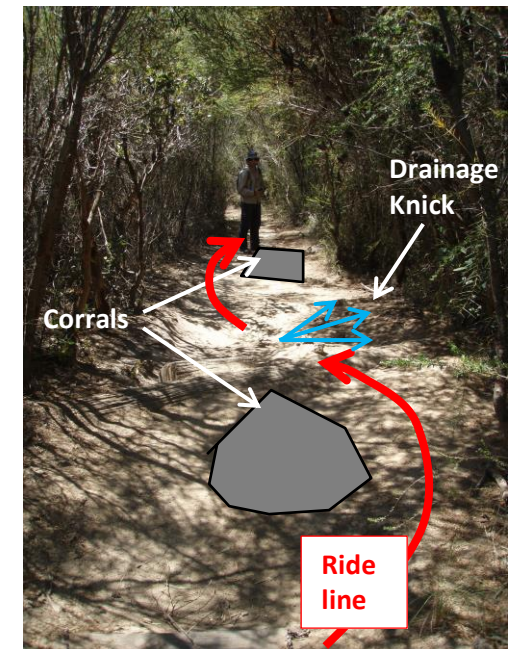
Between WP4.25 and WP4.27 the trail is on a shallow sideslope but follows the fall line. It is recommended to retain the trail within the existing corridor and use rock and potentially road base to create RGDs and knicks. Stone corrals and chokes can be installed to add some 'wiggle' to the trail within the existing corridor. These actions will solve multiple issues: make this trail section more erosion resistant, reduce drainage impacts on both this section itself and on the next section, and moderate rider speed to enhance the user experience and improve safety.

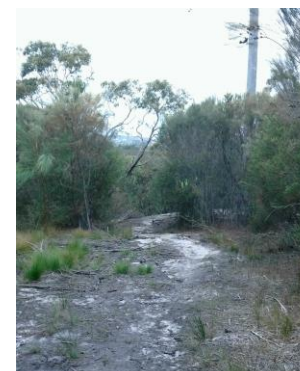
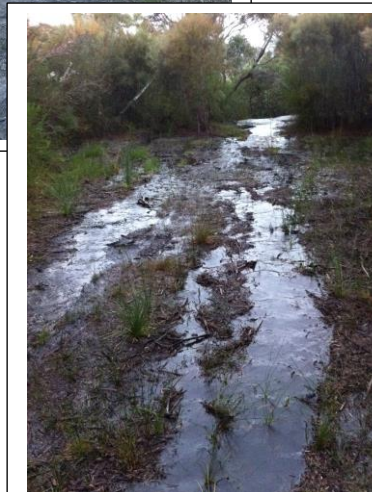
These photos (above) highlight the volume of run-off emanating from the management track directly north of the 19th Hole during rainfall events. Much of the erosion at the base of the 19th Hole is caused by a drainage problem that starts here. Waterbars &/or other drainage features need to be installed to address this problem.

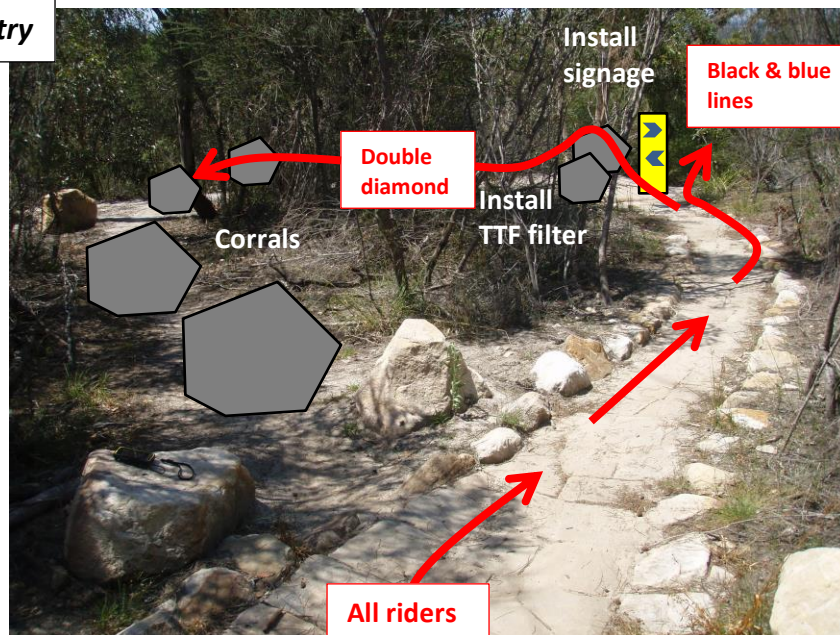
Entry

WP4.27 – 'Top of 19th Hole'. The stone armouring on RHS line is excellent. All riders should be directed onto the RHS line. The LHS (straight) line is the more obvious / natural line to ride yet leads directly to the most technically difficult feature. Very large un-movable corral stones should be placed to completely block the LHS ride line. A new junction should be created forcing riders seeking the double-diamond line to consciously choose it by deviating from the main ride line and riding a challenging Technical Trail Feature (TTF) that will act as a trail filter.

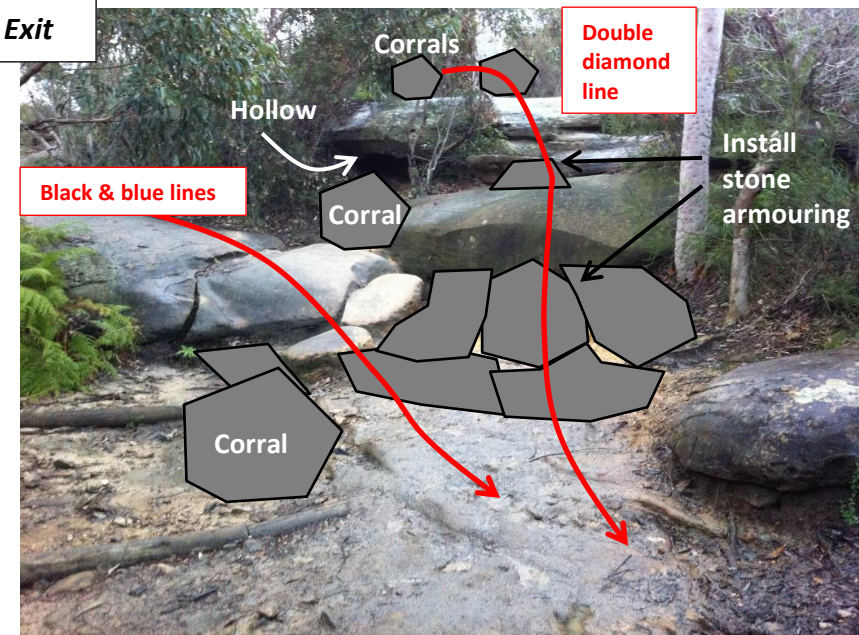
Exit of 19th Hole – Substantial stone armouring is required to improve the transition and protect the impact zone on the exit of all lines. Corrals are also required to consolidate the exit. The entry to the double-diamond line should be better defined with additional corrals.

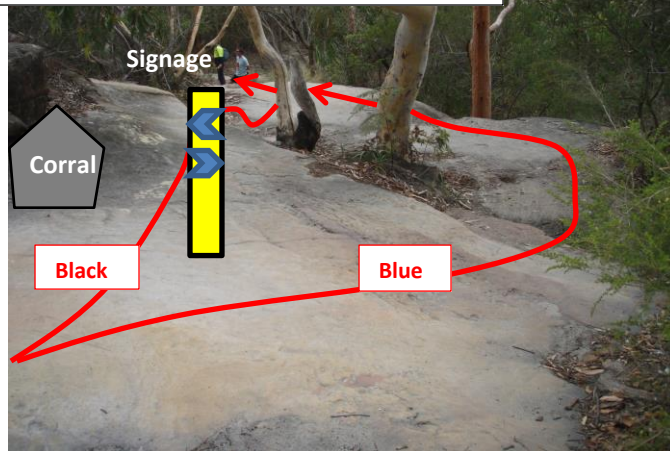
(Left) – View looking down black-diamond and blue-square lines. Signage and corrals should be installed.

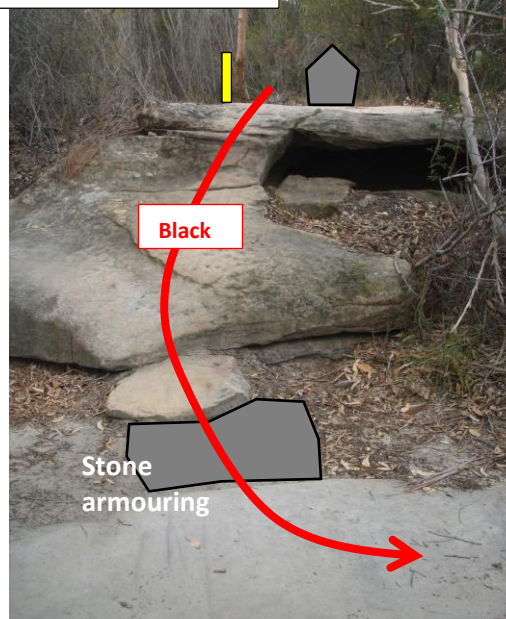
(Left) – View looking up black-diamond line. Some minor stone armouring will enhance this line.

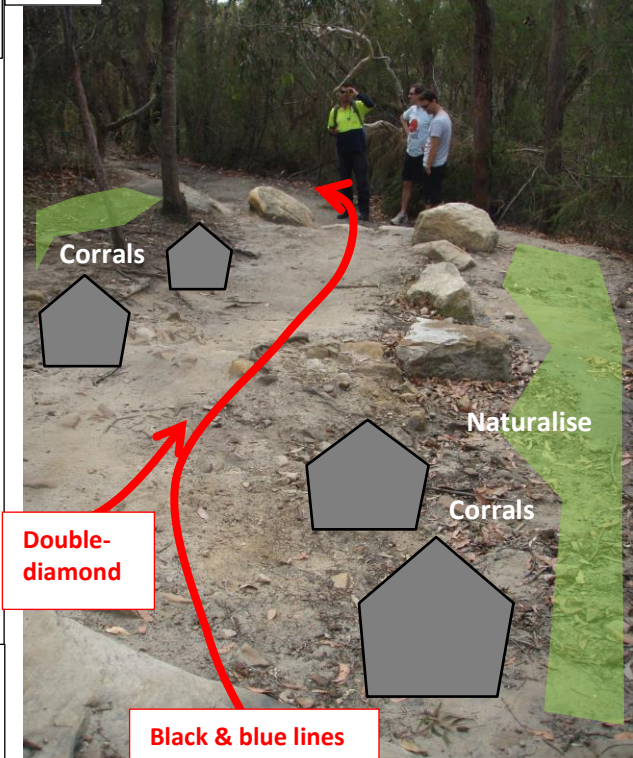
Exit

(Above) - 4-5 large corrals are required at the exit to consolidate the ride line and contain the trail widening. Some naturalisation will speed up the regeneration process.

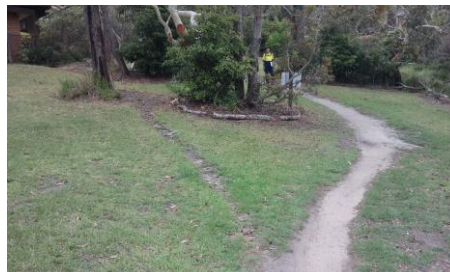
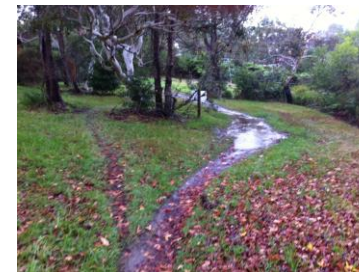
WP6.09 in dry conditions (left) and wet conditions (right). The trail is cupped and there is minimal sideslope with which to create outslope on the tread. The LHS ride line should be formalised but may need tread hardening over time to avoid the same fate as the RHS line, which should be closed with corral installation.

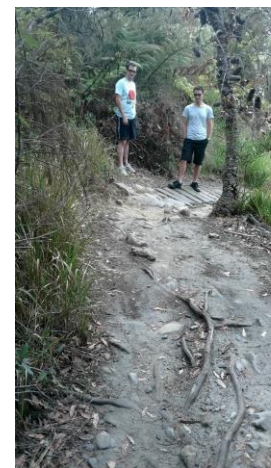
WP6.03 is typical of much of Section 8. Minor trail widening and erosion can be remediated with installation of stone armouring and corrals, achievable by volunteers in most cases.

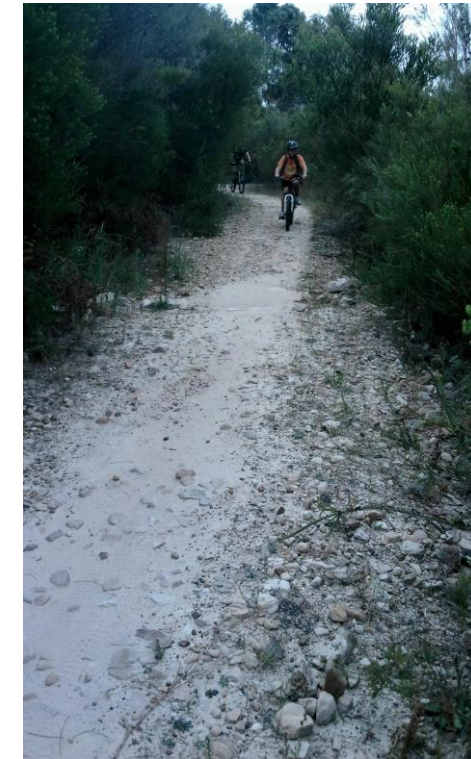
WP6.20 – This part of Section 9 is quite fast for riders but is a high use area for pedestrians too. Some larger and longer rollers and possibly some corrals will improve drainage and add ‘wobble’ and texture to the trail to help moderate rider speed.

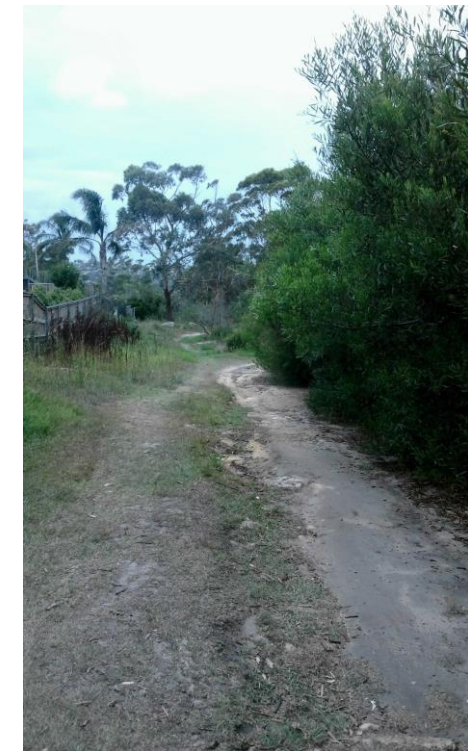
WP6.28 (above) – Rolling Grade Dips are required through this section to ensure adequate drainage. A lack of pruning has contributed to the emergence of a ride line on the left. Some 'wiggle' in this trail reinforced with corrals would improve its flow and help moderate user speed.
