# MANLY DAM WALKING TRACKS AUDIT

for  
**Northern Beaches Council**  
May, 2017

CONTROLLED DOCUMENT  
**“Manly Dam Walking Tracks Audit”**

**FINAL ISSUE**

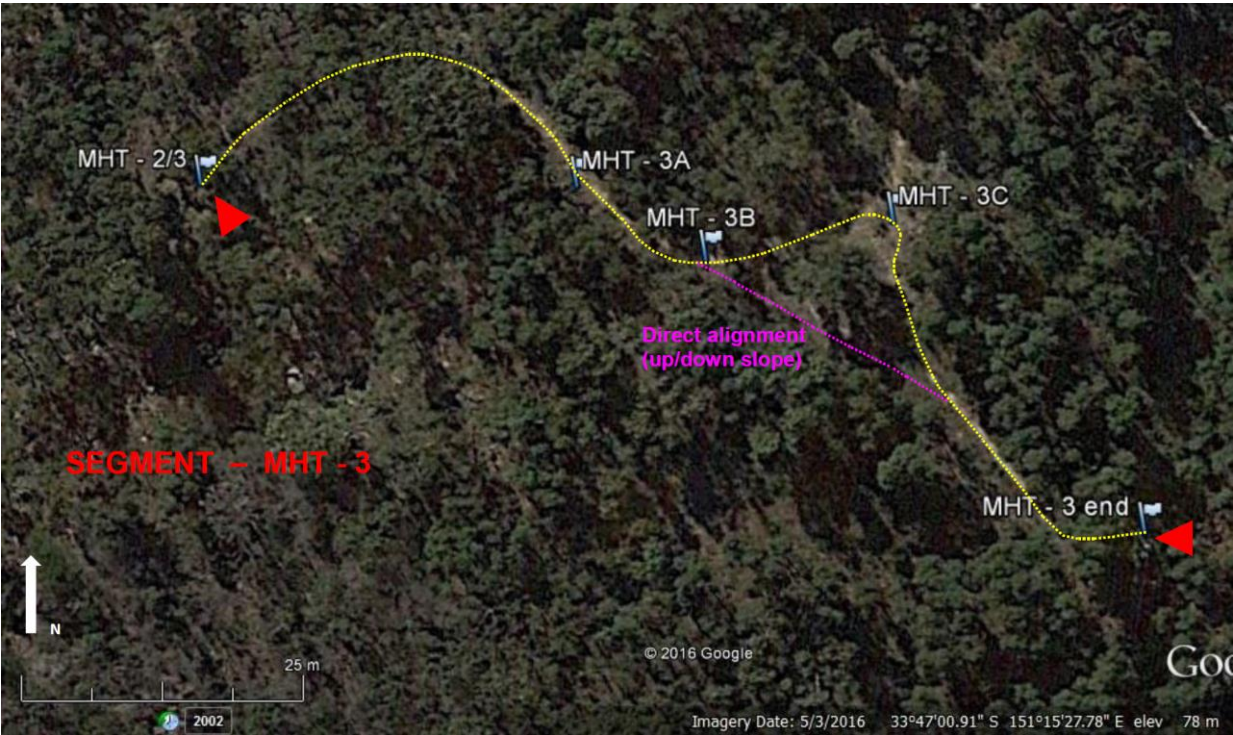
SEGMENT McCOMB HILL TRACK - 3

<b>SEGMENT: MHT - 3</b>	
<b>Start Point: 338645 6260486</b>	<b>End Point: 338725 6260458 (at Trig Station)</b>
<p><i>General Description and Condition:</i> Very well-defined track (110m approx.) across and sharply up/down slope to hill summit, with some loose rocky sections and “loop” around small stand of trees on crest, through recovering open Eucalypt woodland with a grassy understorey. Fair/good condition.</p> <p><i>Tread Width (mm):</i> Mostly 900-1,200mm, widens up to 1.8m around “loop” on crest.</p> <p><i>Track Surface:</i> Mostly compacted sand with some sandy/clay on upper/E section with regular laterite gravels and embedded rocks, gently sloped rock outcrops with small ledges as “natural” steps on lower/W end, increasing embedded and broken rock on upper/W section (including minor areas of laterite capping). Drainage down track with only limited scour on lower (flatter) sections but up to 50-75mm deep on upper (steeper) sections.</p> <p><i>Gradient (degrees):</i> Gentle/moderate, 4-5° on lower/W section and to 6° on upper/E section.</p> <p><i>Alignment:</i> Gently curving across slope in W then more sharply up/down slope in E two-thirds, includes “loop” around small copse of Eucalypts on crest in E.</p> <p><i>Terrain:</i> Upper hillslope and crest.</p> <p><i>Soil:</i> Hawkesbury (Colluvial) on rugged, rolling to very steep hills on Hawkesbury Sandstone.</p> <p><i>Vegetation:</i> Bloodwood-Scribbly Gum Woodland (part of Sydney Coastal Dry Sclerophyll Forest).</p> <p><i>Track Works and Improvements:</i> 4 sleeper waterbars and 2 sleeper waterbars/steps, most full of sediment and failed with drainage flows over.</p>

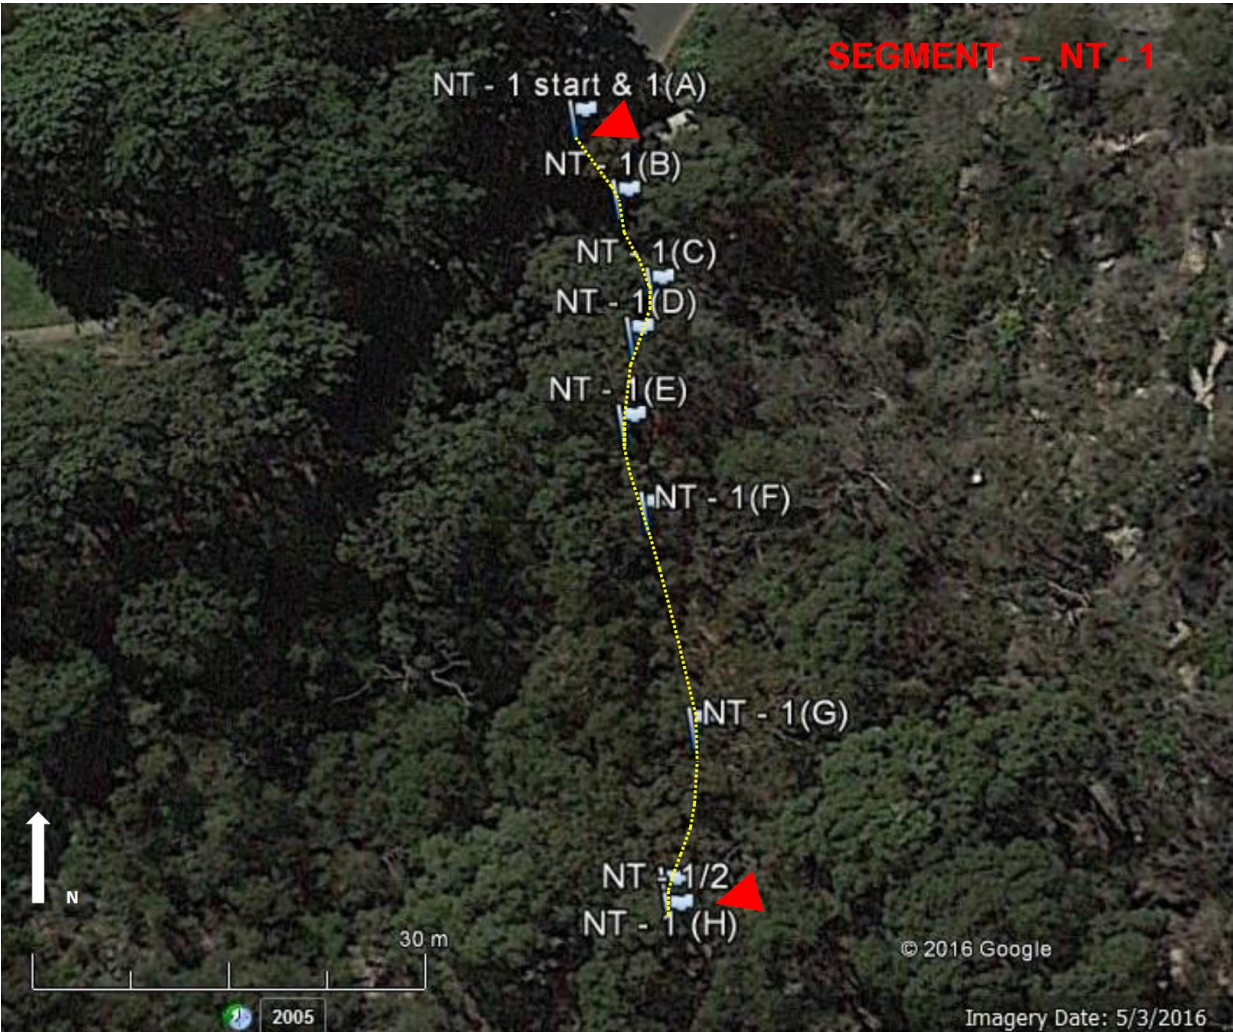
SEGMENT NATURE TRAIL - 1

<b>SEGMENT: NT - 1</b>	
<b>Start Point: 338476 6260524</b> <b>Nature Trail trackhead (East), at park access road (Sir Roden Cutler VC Memorial Drive)</b>	<b>End Point: 338487 6260462</b>
<p><i>General Description and Condition:</i> Short (65m approx.) section of broad well-defined track from a trackhead off the main park access road along a gentle, then gentle/moderate, slope on W side of a valley to the base of a rock ledge climb, through attractive open Eucalypt forest (with medium shrub storey to the W, but open burnt understorey to the E and powerlines upslope). Frequent and effective track treatments and new trackhead signage. Good condition.</p> <p><i>Tread Width (mm):</i> Mostly 1,200-1,800mm, some sections narrow to 900mm while others widen to 2,400mm.</p> <p><i>Track Surface:</i> Mix of loose/deposited sand on lower sections and compacted sand on upper section, areas of loose and embedded laterite gravel. Slightly dished in places. Drainage down much of track surface, but few erosion issues due to regular treatments.</p>

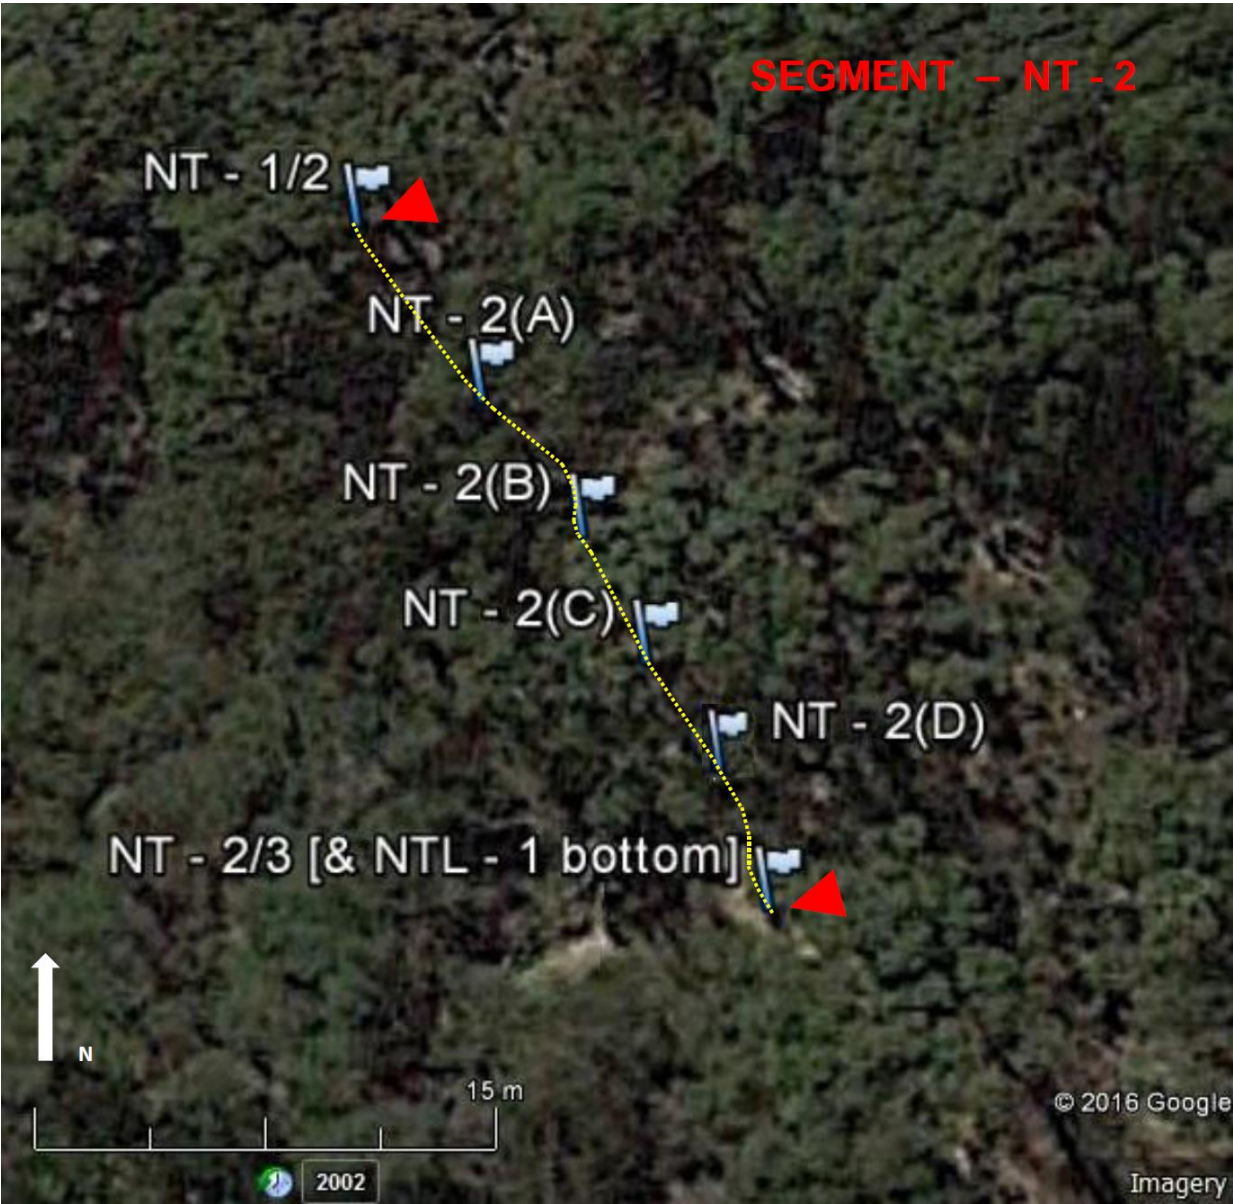
SEGMENT NATURE TRAIL - 2

<b>SEGMENT: NT - 2</b>	
<b>Start Point: 338487 6260462</b>	<b>End Point: 338501 6260440</b> <b>Junction with Nature Trail Link Track</b>
<p><i>General Description and Condition:</i> Short (35m approx.) steep section of track up/down a rock ledge (below) and rocky slope (above) almost entirely on rock outcrops, with numerous stone steps and a built rock wall near the upper/S end (where the Nature Trail Link Track joins from the SE upslope, and Nature Trail bends 90° to W/SW as Segment NT-3). Drainage flows down almost the entire segment, with several erosion/scour issues. . Through attractive open Eucalypt forest (with medium shrub storey to the W, but open burnt understorey to the E and powerlines upslope). Fair condition only, and some potential user hazards.</p> <p><i>Tread Width (mm):</i> 350-1500mm, varies between narrow stone steps and wider rock outcrops.</p>

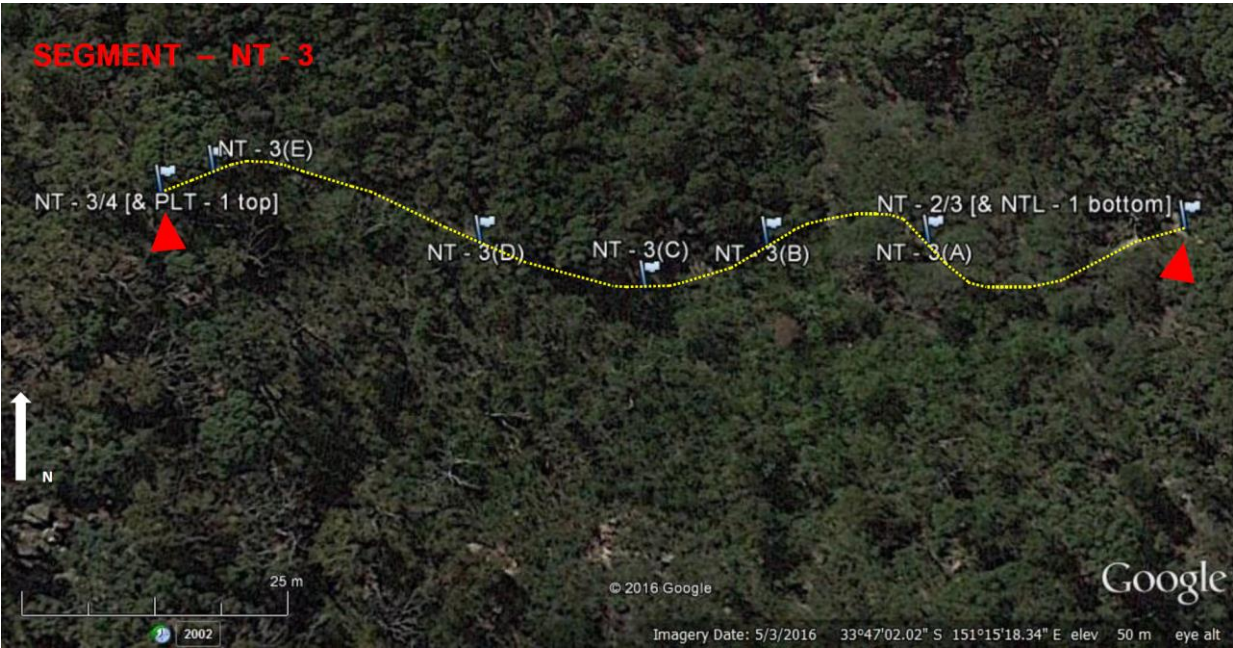
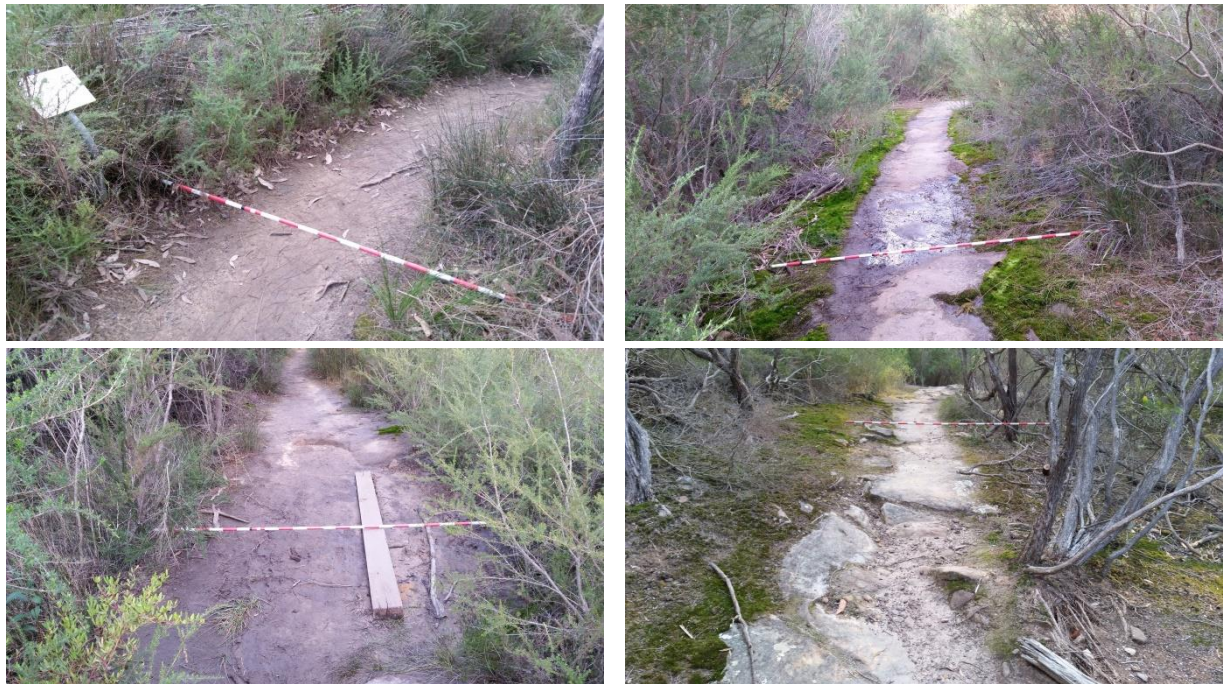
SEGMENT NATURE TRAIL - 3

<b>SEGMENT: NT - 3</b>	
<b>Start Point: 338501 6260440</b> <b>Junction with Nature Trail Link Track</b>	<b>End Point: 338390 6260443</b> <b>Junction with Picnic Area Link Track</b>
<p><i>General Description and Condition:</i> Well defined track (125 m approx.) mostly gently undulating across slope along contour, with short section up/down rock outcrop/pavement near E end. Areas of rock pavements (mainly in E) and several ponding/wet areas (mainly in centre) with temporary/informal treatments. Mixed low Banksia heath upslope with occasional Eucalypt and previously burnt areas, tall heath and scattered Eucalypts downslope. Generally good condition, but ponding /wet areas are fair condition only.</p> <p><i>Tread Width (mm):</i> Mostly 600-800mm, widening to 1200-1500mm at obstacles or up to 1,900mm where walkers avoid ponding/wet areas.</p> <p><i>Track Surface:</i> Mostly compacted sand, moist in ponding/seepage areas, gently dished to 50-75 mm in places. Angled/uneven rock pavements and large/flat outcrops on upper E end and slope (site NT-3(A)), occasional protruding lip/edge to outcrops and pavement (especially at E end). Three ponding seepage wet areas (14m, 3m and 4m long) in centre, and seepage over rock outcrops/pavement in places. Occasional rock outcrops, roots and areas of laterite gravel (towards W end).</p> <p><i>Gradient (degrees):</i> Mainly gentle gradients, &lt;1-3° to 4° in places, with dips/low points (ponding/seepage areas). Short steeper section 8-12° over rock outcrop/pavement in E.</p> <p><i>Alignment:</i> Gently curving alignment across slope, mostly undulating along contour.</p> <p><i>Terrain:</i> Mid hillslope.</p> <p><i>Soil:</i> Hawkesbury (Colluvial) – rugged, rolling to very steep hills on Hawkesbury Sandstone.</p> <p><i>Vegetation:</i> Mostly sandstone heath with area of Bloodwood-Scribbly Gum Woodland (part of Sydney Coastal Dry Sclerophyll Forest) at W end.</p> <p><i>Track Works and Improvements:</i> Run of 4 wide boxed timber steps (good condition, with some imported fill in treads). Several loose planks (and lain branches) as ad hoc/informal wet area crossings.</p>

**Key Issues:** Drainage and seepage capture with wet areas for long periods after rain, track widening to avoid wet areas, informal track works by user at wet areas, minor trip hazards on protruding rock lips/edges.

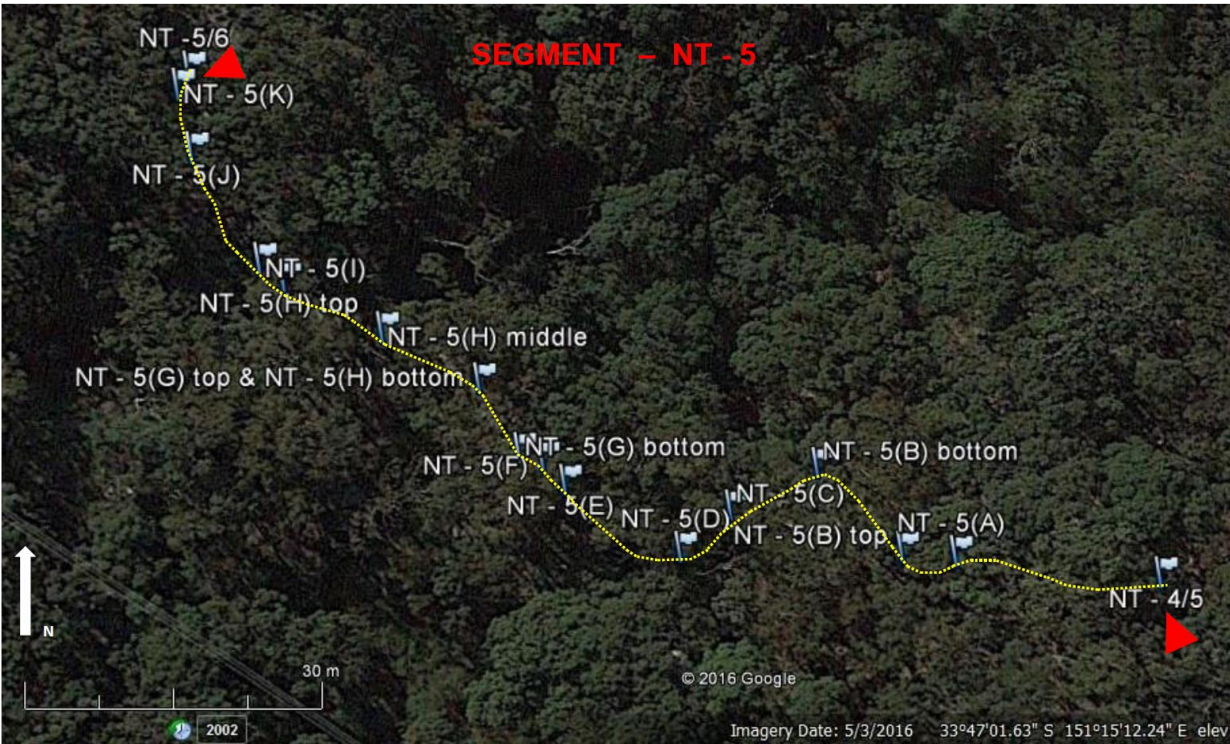
SEGMENT NATURE TRAIL - 5

<b>SEGMENT: NT - 5</b>	
<b>Start Point: 338337 6260414</b>	<b>End Point: 338226 6260470</b>
<p><i>General Description and Condition:</i> Short (130m approx.) section of mostly steep track angled sharply across (up/down) a moderate to steep rocky hillslope, crossing small drainage line in SE. Mostly poor to very poor condition NW of drainage line, and fair condition E of drainage line. Through open Eucalypt forest with a mixed medium understorey on moderate slope with numerous rocky outcrops.</p> <p><i>Tread Width (mm):</i> Mostly 600-1300, widening to 1500mm around obstacles or steps.</p> <p><i>Track Surface:</i> Predominately embedded and protruding rocks, roots and some loose rocks (hazards) in uneven compacted/eroded sand on steeper rocky slopes between rock ledges and benches – mainly NW of drainage line/bridge. Drainage flows down track, deeply scoured in places. Widening/detouring around obstacles or step avoidance. Compacted sand and embedded rock, benched high side to 200mm in parts, E of drainage line/bridge.</p> <p><i>Gradient (degrees):</i> Predominately moderate to steep (10° to 19° gradient), smaller areas of gentle to moderate slopes (to 4° to 6° gradient) mainly E of drainage line/bridge.</p> <p><i>Alignment:</i> Predominately a “kinked” alignment stepping up/down the moderate or steep rocky slope NW of drainage line/bridge with steep angled sloped section linking minor flatter runs, and winding alignment on lower slopes (mainly E of drainage line/bridge).</p> <p><i>Terrain:</i> Mid hillslope (moderate to steep, with small drainage line/valley)</p> <p><i>Soil:</i> Hawkesbury (Colluvial) – rugged, rolling to very steep hills on Hawkesbury Sandstone.</p> <p><i>Vegetation:</i> Bloodwood-Scribbly Gum Woodland east of drainage line/bridge, and Peppermint Angophora Forest on steep rocky slope NW of drainage line/bridge (both part of Sydney Coastal Dry Sclerophyll Forest).</p> <p><i>Track Works and Improvements:</i> Low timber bridge over drainage line (at 338273 6260419), good condition, 900mm wide with post/log railing on downstream side above 800 drop to</p>

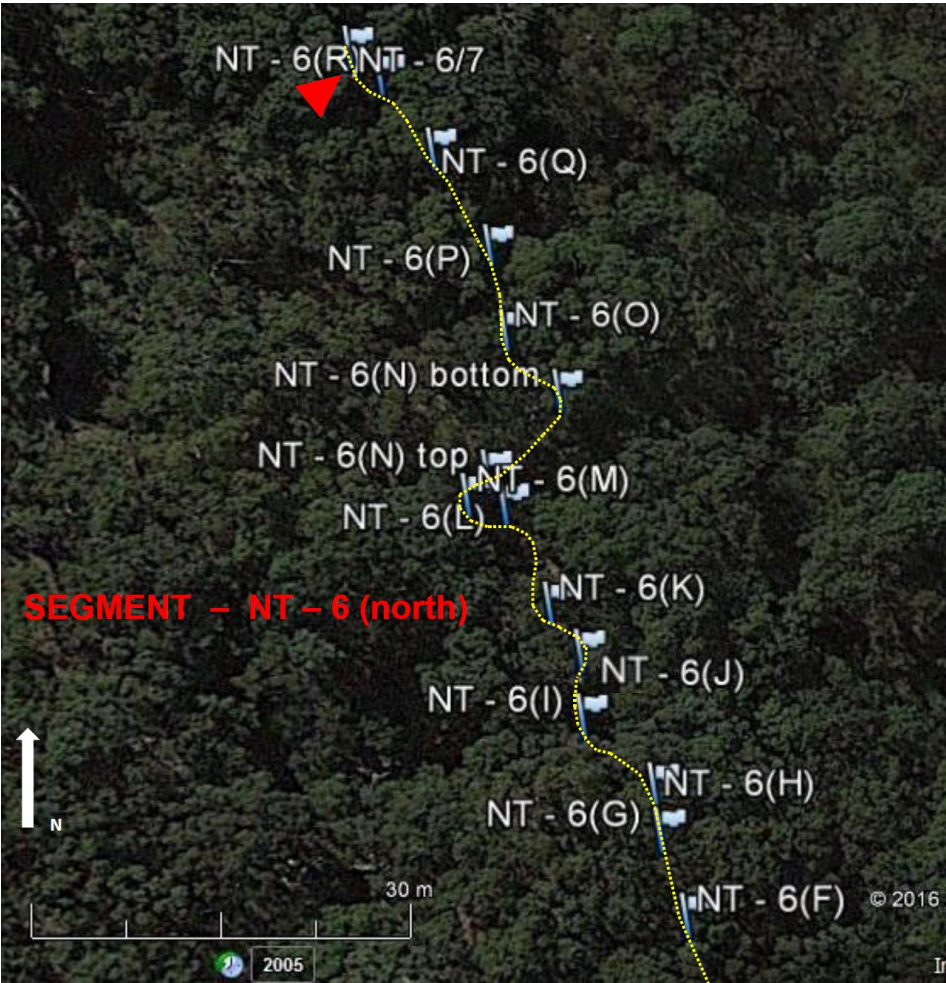
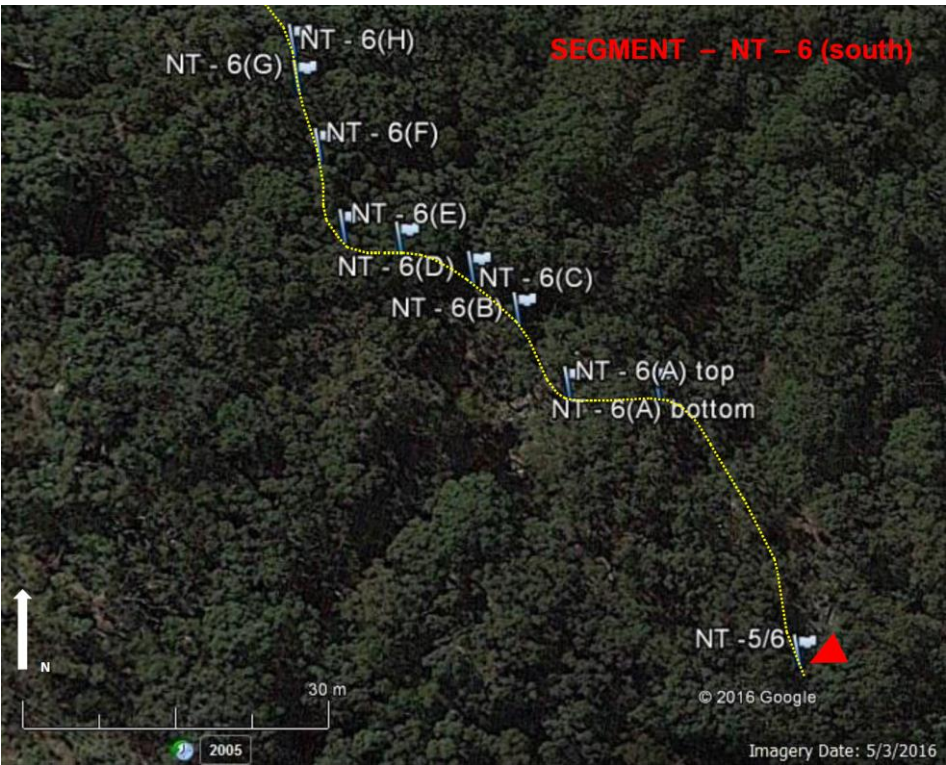
SEGMENT NATURE TRAIL - 6

<b>SEGMENT: NT - 6</b>	
<b>Start Point: 338226 6260470</b>	<b>End Point: 338127 6260623</b>
<p><i>General Description and Condition:</i> Well defined rocky track (170m approx.), mostly along contour but with several moderately sloped undulating sections, across mid-slope through open Eucalypt and Angophora forest with a medium understory downslope and an open understorey upslope, and below a line of rock ledges/cliffs upslope in places. Several short steep and eroded rocky sections. Few track treatments. Generally fair condition only.</p> <p><i>Tread Width (mm):</i> Mostly 600-1,00mm, but several sections of widening and braiding on steeper sections to 1,800mm.</p> <p><i>Track Surface:</i> Compacted sand and sandy/clay with very frequent embedded and protruding rock, rock outcrops and boulders, and regular rock ledges adjacent to track. Some rock pavement, mainly at S end. Regular loose rock and protruding roots, areas of dished track and frequent drainage capture (chiefly on more sloping sections). Benched to 400mm on upslope side of track in places, but more usually 100-200mm.</p> <p><i>Gradient (degrees):</i> Mostly gentle to gentle moderate slopes (1° to 5° gradients), with some short flat runs and some moderate slopes (mostly to 10° gradients) on short rocky slopes (and a few steep sections to 19° gradient over rock ledges).</p> <p><i>Alignment:</i> Mostly winding across slope, but with minor sharp curving sections up/down short steeper rocky slopes.</p> <p><i>Terrain:</i> Mid to upper hillslope.</p> <p><i>Soil:</i> Hawkesbury (Colluvial) – rugged, rolling to very steep hills on Hawkesbury Sandstone.</p> <p><i>Vegetation:</i> Bloodwood-Scribbly Gum Woodland (part of Sydney Coastal Dry Sclerophyll Forest).</p> <p><i>Track Works and Improvements:</i> Several placed rock steps on steeper sections (regularly avoided and widened/braided track), and occasional log waterbars (most full of sediment and failed, or only part-way across track).</p> <p><i>Signs and Wayfinding:</i> Occasional metal directional arrows on rocks. 4 older style small interpretation panels (poor condition).</p> <p><i>User Experience:</i> Pleasant walking through open forest with filtered views to the Allambie skyline/housing and dam, but requiring caution to watch footing on short steep and/or rocky section. Attractive boulders and rock overhangs along upslope side of track in places, and interesting line of rock ledges/cliffs upslope for part of segment.</p> <p><i>Key Issues:</i> Continued drainage capture and scour, and undercutting of rock steps. Unstable rocky sections. Track widening/braiding to avoid obstacles and steps, and associated environmental impacts. Moderate maintenance section. Major stormwater inflow from upslope drainage path, and informal dis-used track, at Sites NT - 6(A) and NT - 6(B).</p>

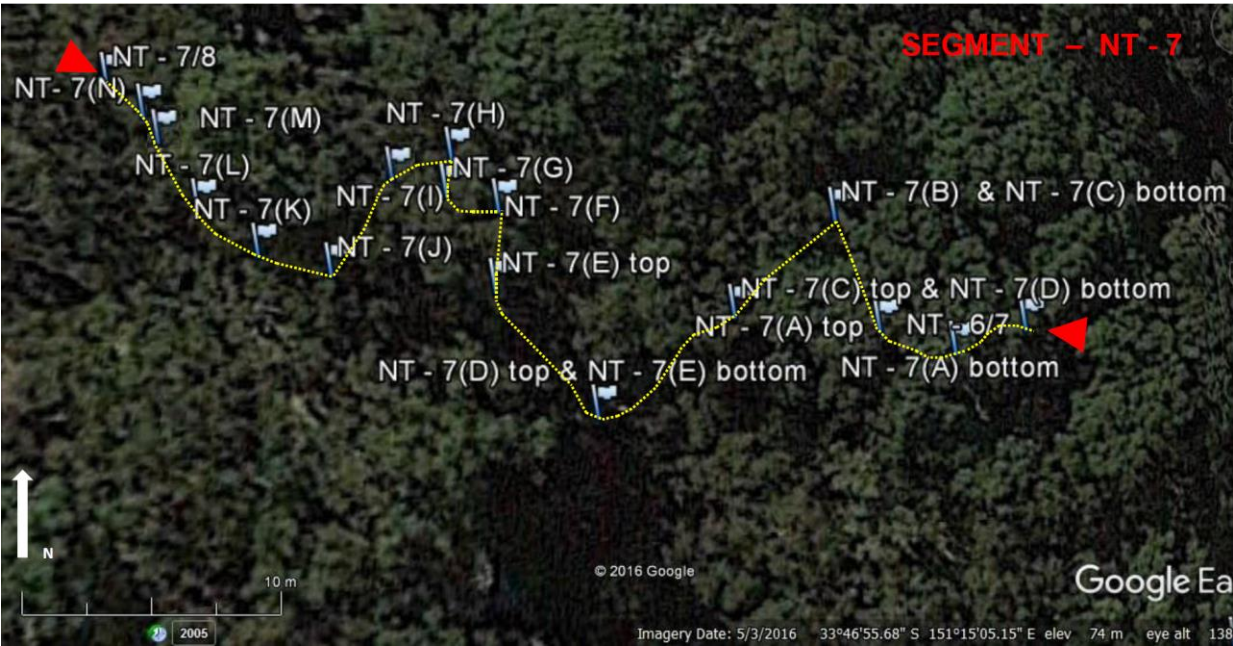
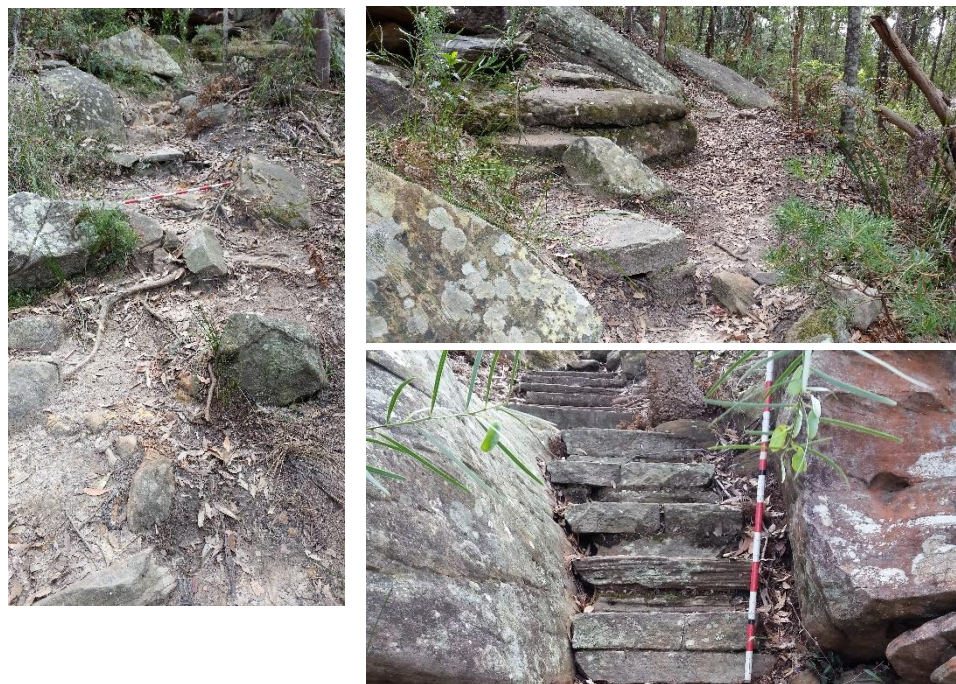
SEGMENT NATURE TRAIL - 7

<b>SEGMENT: NT - 7</b>	
<b>Start Point: 338127 6260623</b>	<b>End Point: 338075 6260635</b>
<p><i>General Description and Condition:</i> Short (90m approx.) section of rocky track climbing sharply up/down steep hillslope with ephemeral drainage lines and cliffline at top, several sections of track on steep rocky hillslope are in poor condition only, but section up/down cliffline is fair to good condition (although some hazard points/issues). Through open Eucalypt and Angophora forest with an open to medium low understory.</p> <p><i>Tread Width (mm):</i> Variable - 400-900mm wide on rock steps up/down cliffline and rock ledges, 600-1,000mm on minor flatter compacted sand sections, widening/braiding to 1,700mm on rocky slopes and avoiding steps/obstacles.</p> <p><i>Track Surface:</i> Considerable embedded and protruding rock, outcrops and boulders set in compacted sand and sandy/clay. Areas of hardened track with built stone steps and rock ledges. Minor sections of dished or benched track, benched-in to 250mm on high side. Frequent drainage capture and flows down track, with scour to 300-400mm below NSL. Frequent protruding roots. Track intersects and “captures” flow from ephemeral drainage line at one point (Site NT - 7(D)).</p> <p><i>Gradient (degrees):</i> Mostly moderate to steep (11° to 17° gradient) with several short steep or very steep sections at stone steps at cliffline and rock ledges (25° to 32° gradient). Minor short flat/gentle runs between steeper track sections.</p> <p><i>Alignment:</i> Tightly curving track winding up/down steep rocky slope and cliffline at top, includes several 90° (or tighter) turns.</p> <p><i>Terrain:</i> Upper hillslope and summit cliffline.</p> <p><i>Soil:</i> Hawkesbury (Colluvial) – rugged, rolling to very steep hills on Hawkesbury Sandstone.</p> <p><i>Vegetation:</i> Bloodwood-Scribbly Gum Woodland (part of Sydney Coastal Dry Sclerophyll Forest).</p> <p><i>Track Works and Improvements:</i> Multiple track treatments – 25-30 stone steps (some avoided/detoured), 6 sleeper steps, and 4 log waterbars (all failed).</p>

**Key Issues:** Continued drainage capture and scour, and undercutting of rock steps. Unstable rocky sections. Track widening/braiding to avoid obstacles and steps, and associated environmental impacts. Unmarked junctions with informal tracks, and enforcing informal track closures. High/moderate maintenance section. Track intersects and "captures" flow from ephemeral drainage line at Site NT - 7(D).

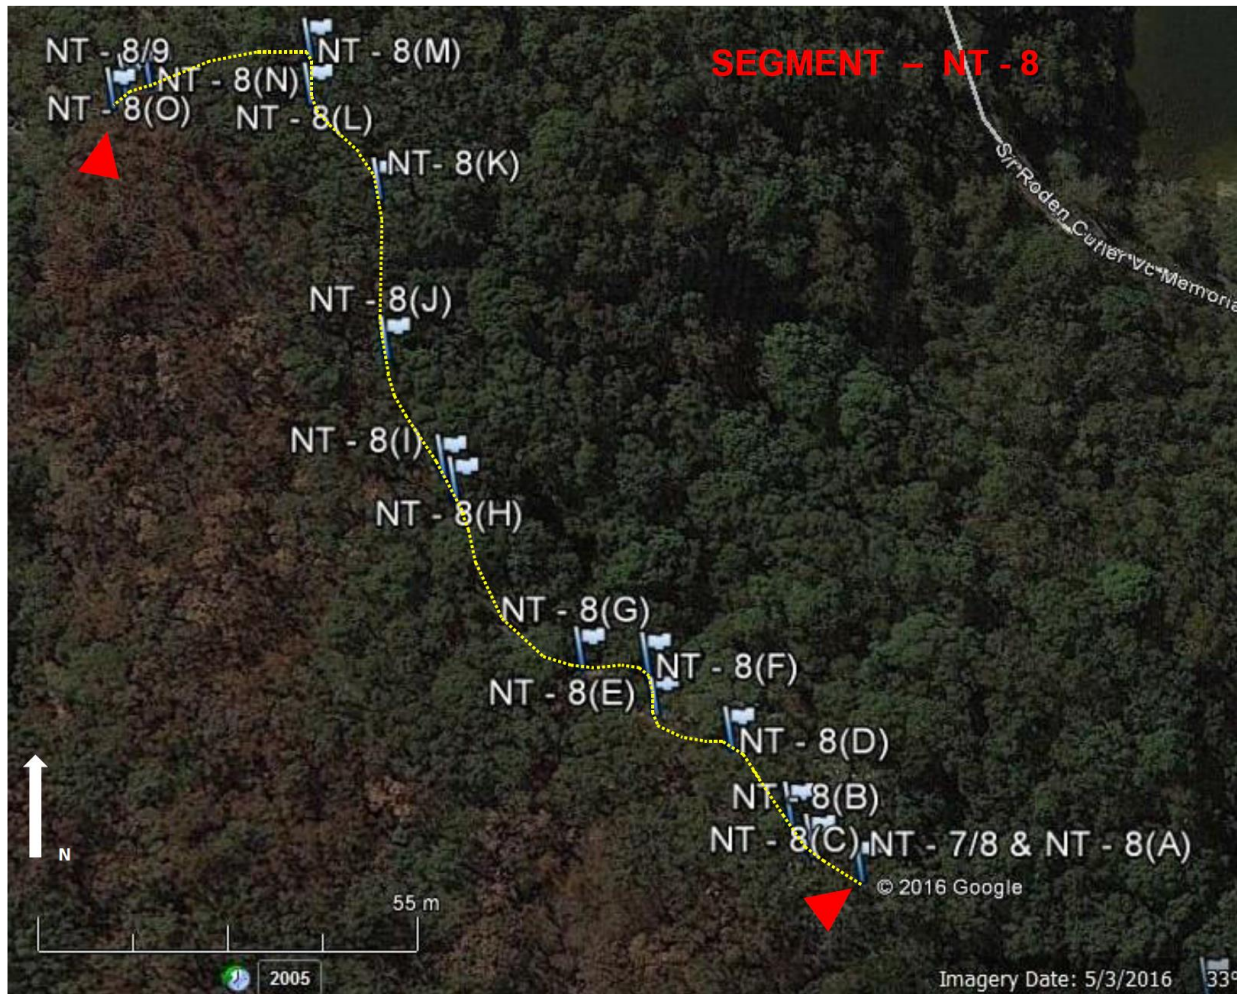
## SEGMENT NATURE TRAIL - 8

<b>SEGMENT: NT - 8</b>	
<b>Start Point: 338075 6260635</b>	<b>End Point: 337943 6260763</b>
<p><i>General Description and Condition:</i> Well-defined section of gently winding and gently undulating track (235m approx.) along ridgeline, through open Eucalypt and Angophora forest with an open mixed understory downslope and very open fire-impacted understorey upslope. Good condition.</p> <p><i>Tread Width (mm):</i> 600-1,000mm.</p> <p><i>Track Surface:</i> Mostly compacted sand with some gravels, often slightly dished with small windrows on low side, seepage and minor ponding in places, regular low often angled rock outcrops, mainly in SE, with occasional outcrop or rock bar in NW. Occasional protruding roots (minor).</p> <p><i>Gradient (degrees):</i> Mix of gently sloped of flat (&lt;1° to 3° gradient) section with occasional gentle/moderate shorter slopes (4° to 6° gradient).</p> <p><i>Alignment:</i> Gently curving track along edge of hilltop/ridgeline, above cliffline to NE (at SE end).</p> <p><i>Terrain:</i> Hilltop/ridgeline.</p> <p><i>Soil:</i> Hawkesbury (Colluvial) – rugged, rolling to very steep hills on Hawkesbury Sandstone.</p>

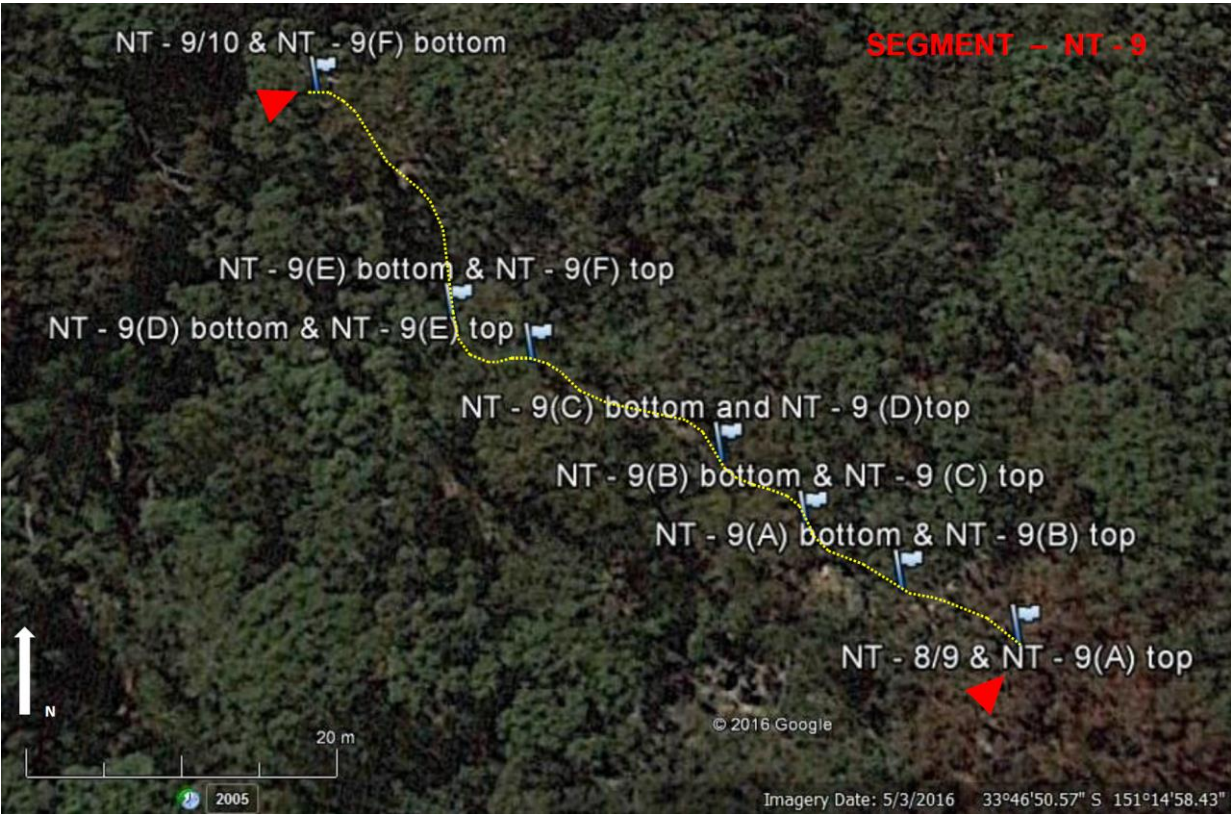
# SEGMENT NATURE TRAIL - 9

SEGMENT: NT - 9	
Start Point: 337943 6260763	End Point: 337895 6260799
<p><i>General Description and Condition:</i> Short steep rocky track (85m approx.) sharply up/down a steep rocky slope with significant drainage and erosion issues, track markedly widened/braided in places, rock ledges and scarp at top end, through mixed Eucalypt and Angophora forest and medium understory. Poor condition on upper two thirds with no track treatments, fair to good condition on lower third with frequent track treatments on less aggressive slope.</p> <p><i>Tread Width (mm):</i> Very varied, from 500mm at narrow steps/gutters to 2,100mm around large embedded and protruding boulders/rocks and outcrops.</p> <p><i>Track Surface:</i> Rocky - embedded and protruding rocks, several “pedestal” rocks, large boulders, large rock ledges and rock faces (mainly in upper half), considerable areas of exposed/protruding and retaining roots throughout, compacted sand/clay, loose stones and gravels. Drainage down track across the entire segment, with gutters or entrenched track to 500mm below NSL in places (more usually 350-400mm deep).</p> <p><i>Gradient (degrees):</i> Steep, overall 21° gradient (slopes vary from 16° to 27° gradients), very little gently sloped track.</p> <p><i>Alignment:</i> Almost directly up/down steep rocky slope with rock ledges/scarp in upper third.</p> <p><i>Terrain:</i> Upper hillslope, and rock ledges along edge of ridgeline above.</p> <p><i>Soil:</i> Hawkesbury (Colluvial) – rugged, rolling to very steep hills on Hawkesbury Sandstone.</p> <p><i>Vegetation:</i> Bloodwood-Scribbly Gum Woodland (part of Sydney Coastal Dry Sclerophyll Forest).</p>

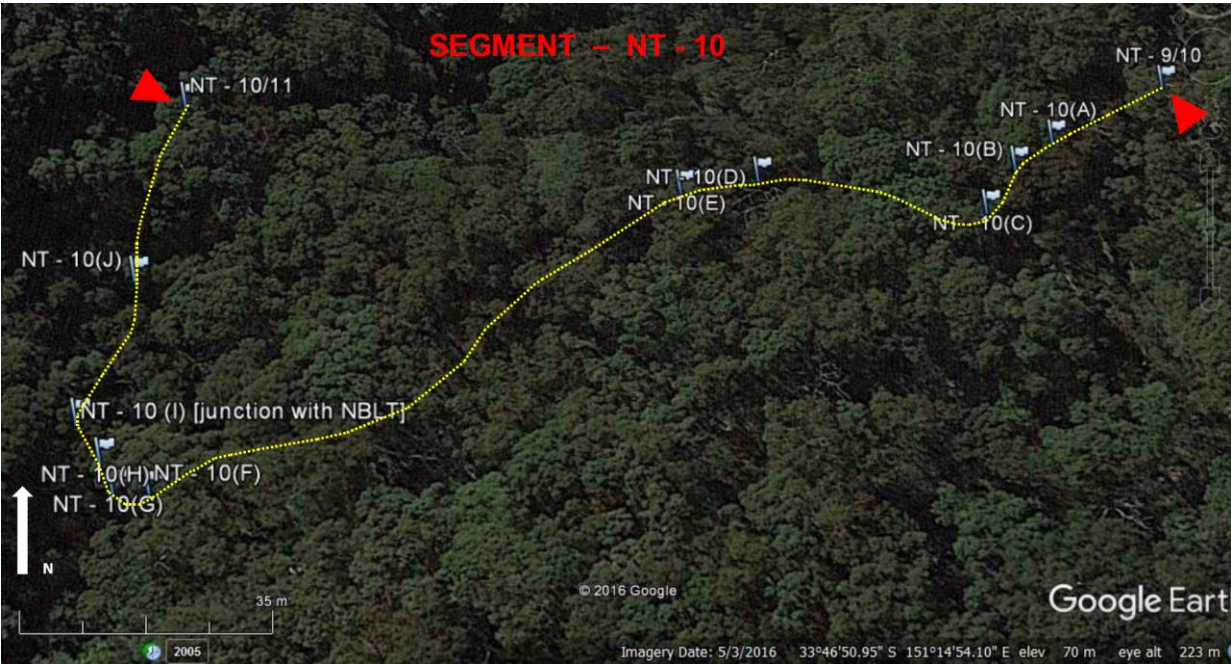
SEGMENT NATURE TRAIL – 10

<b>SEGMENT: NT – 10</b>	
<b>Start Point: 337895 6260799</b>	<b>End Point: 337754 6260791</b>
<p><i>General Description and Condition:</i> Well defined section of track (255m approx.) in good condition with few issues/obstacles, along contour on the slopes of a small broad valley. Large tributary crossing and signposted track junction (with the North Balgowlah Link Track) in the SW. Through mixed Eucalypt and Angophora forest, with occasional Casuarinas, and a medium/dense understorey.</p> <p><i>Tread Width (mm):</i> Mostly 500-900mm, occasionally to 1,200mm for short sections.</p> <p><i>Track Surface:</i> Chiefly compacted sand with occasional embedded rock and protruding roots, occasional laterite gravel. Frequently slightly dished track surface to 75mm, minor windrows low side and benched to 50-75mm on high side in places, but drainage capture only a localised/occasional issue. Area of loose/deposited sand at NE end (run-on area below Site NT -9(E)). Occasional faint trample tracks low side in E middle third of segment to low rock outcrops above small broad valley, and in NW third to small creekline and “wet” gully downslope.</p> <p><i>Gradient (degrees):</i> Predominantly gently sloping (&lt;3-4° gradient), occasional short sections to 5° to 8° gradient.</p> <p><i>Alignment:</i> Very gently curving alignment, largely along contour across a moderate hillslope and around the head of a small broad valley.</p> <p><i>Terrain:</i> Mid hillslope, along sides of small broad valley.</p> <p><i>Soil:</i> Mostly Lambert (Erosional) – undulating to rolling low hills on Hawkesbury Sandstone. Area of Hawkesbury (Colluvial) – rugged, rolling to very steep hills on Hawkesbury Sandstone – at E end.</p> <p><i>Vegetation:</i> Bloodwood-Scribbly Gum Woodland in E (until just E of larger drainage line) and Sclerophyll Forest Peppermint Angophora Forest in W – both part of Sydney Coastal Dry Sclerophyll Forest.</p>

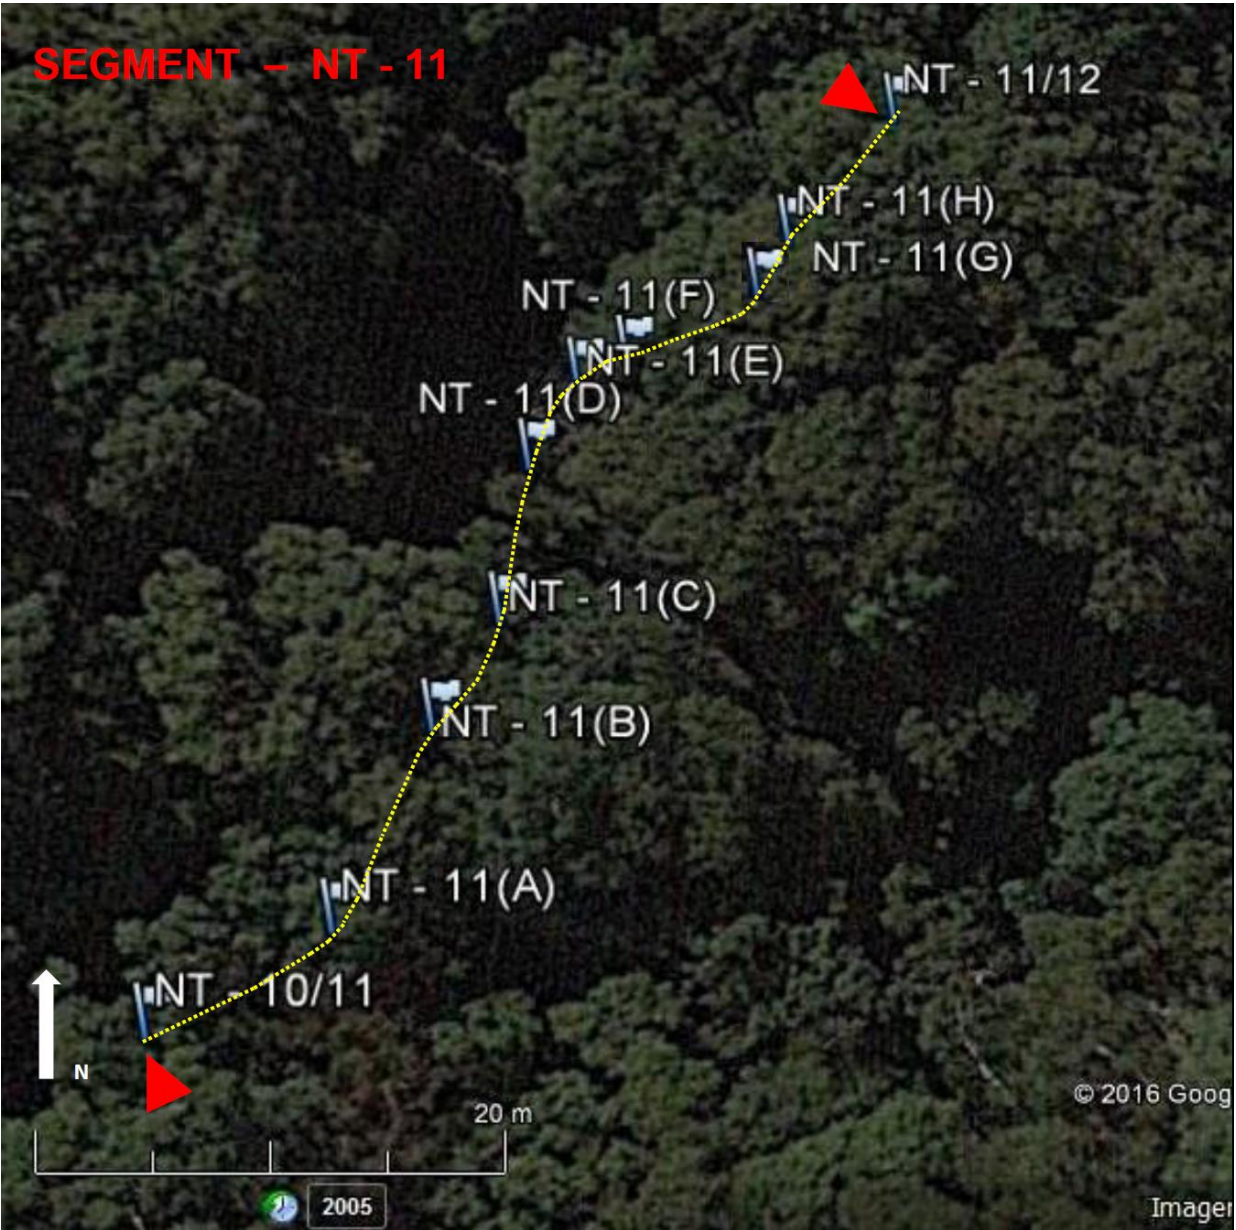
SEGMENT NATURE TRAIL - 11

<b>SEGMENT: NT - 11</b>	
<b>Start Point: 337754 6260791</b>	<b>End Point: 337786 6260835</b>
<p><i>General Description and Condition:</i> Well-defined track (70m approx.) featuring an almost continuous run of steps and steps/waterbars angling across contour up/down a moderate hillslope on the W side of a small broad valley, through Eucalypt and Casuarina forest with a mixed open understorey (including ferns on downslope side towards creek). Good condition overall (with isolated fair or poor condition sites where treatments missing or failed).</p> <p><i>Tread Width (mm):</i> 900-1,600mm.</p> <p><i>Track Surface:</i> Compacted sand with some embedded stone and gravel, predominately as tread between sleeper steps. Track surface benched-in (sloping) on high side, usually to 75-100mm high but occasionally to 200mm high, and usually boxed/retained on low side of track between steps. Occasional embedded rock, and some protruding rocks, mainly on</p>

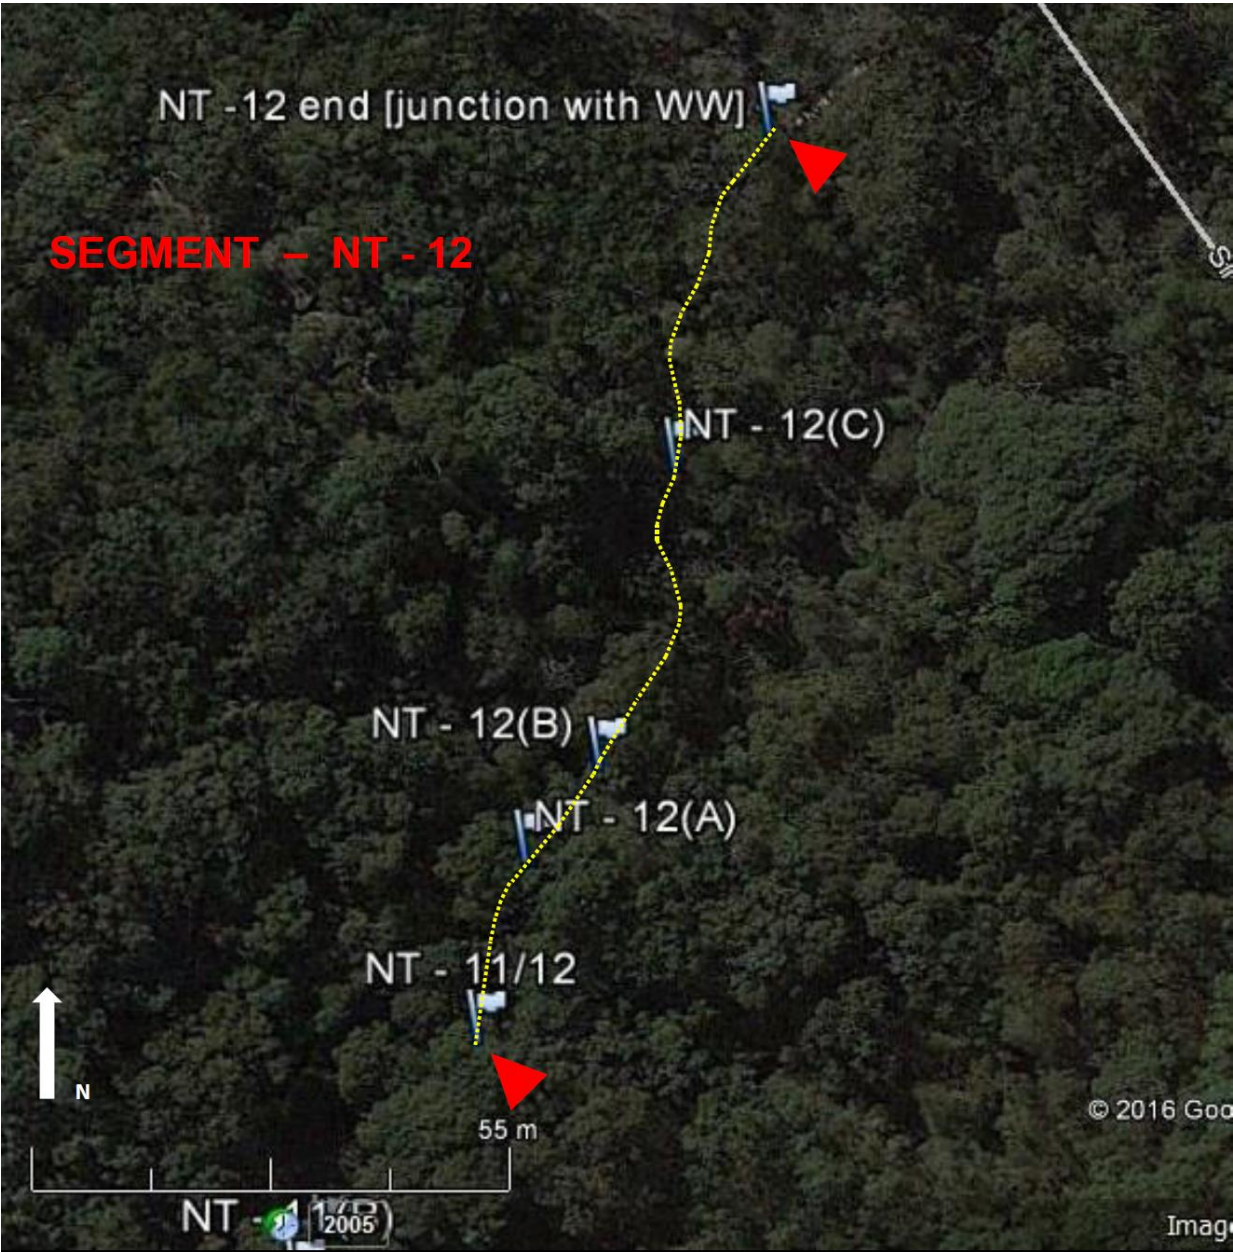
SEGMENT NATURE TRAIL - 12

<b>SEGMENT: NT - 12</b>	
<b>Start Point: 337786 6260835</b>	<b>End Point: 337819 6260958</b>
<p><i>General Description and Condition:</i> Well-defined gently undulating track (145m approx.) gently curving along contour across a gentle/moderate lower hillslope on W side of broad open valley, through mixed open forest with an open understorey (including ferns on downslope side towards creekline), vegetation becoming lower and more open from S to N. Good condition. Joins Wildflower Walk at N end.</p> <p><i>Tread Width (mm):</i> Mostly 900-1,400mm, short section only 600mm wide near middle of segment.</p> <p><i>Track Surface:</i> Predominately compacted sand (tending to compacted sand/clay at N end), often with laterite gravel, and occasional embedded rock/outcrops and roots. Some areas of</p>
