# MANLY DAM WALKING TRACKS AUDIT

for  
**Northern Beaches Council**  
May, 2017

CONTROLLED DOCUMENT  
**“Manly Dam Walking Tracks Audit”**

**FINAL ISSUE**

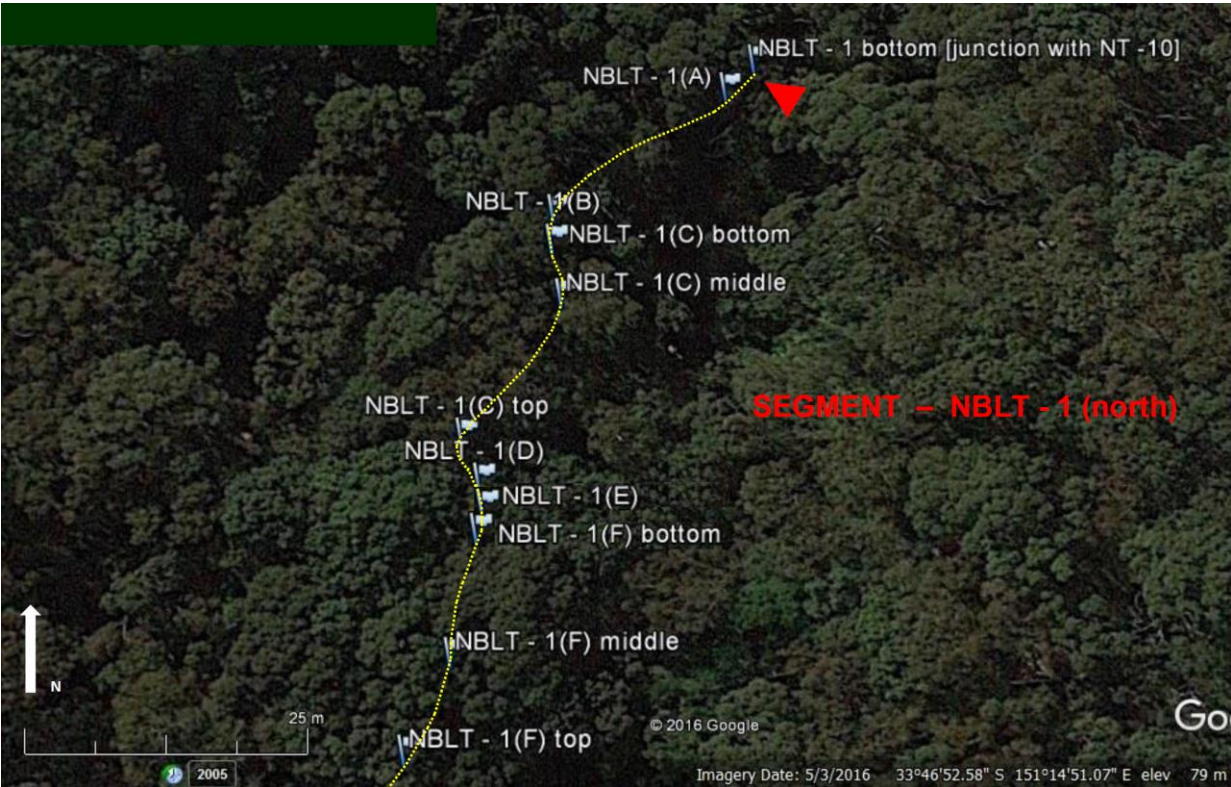
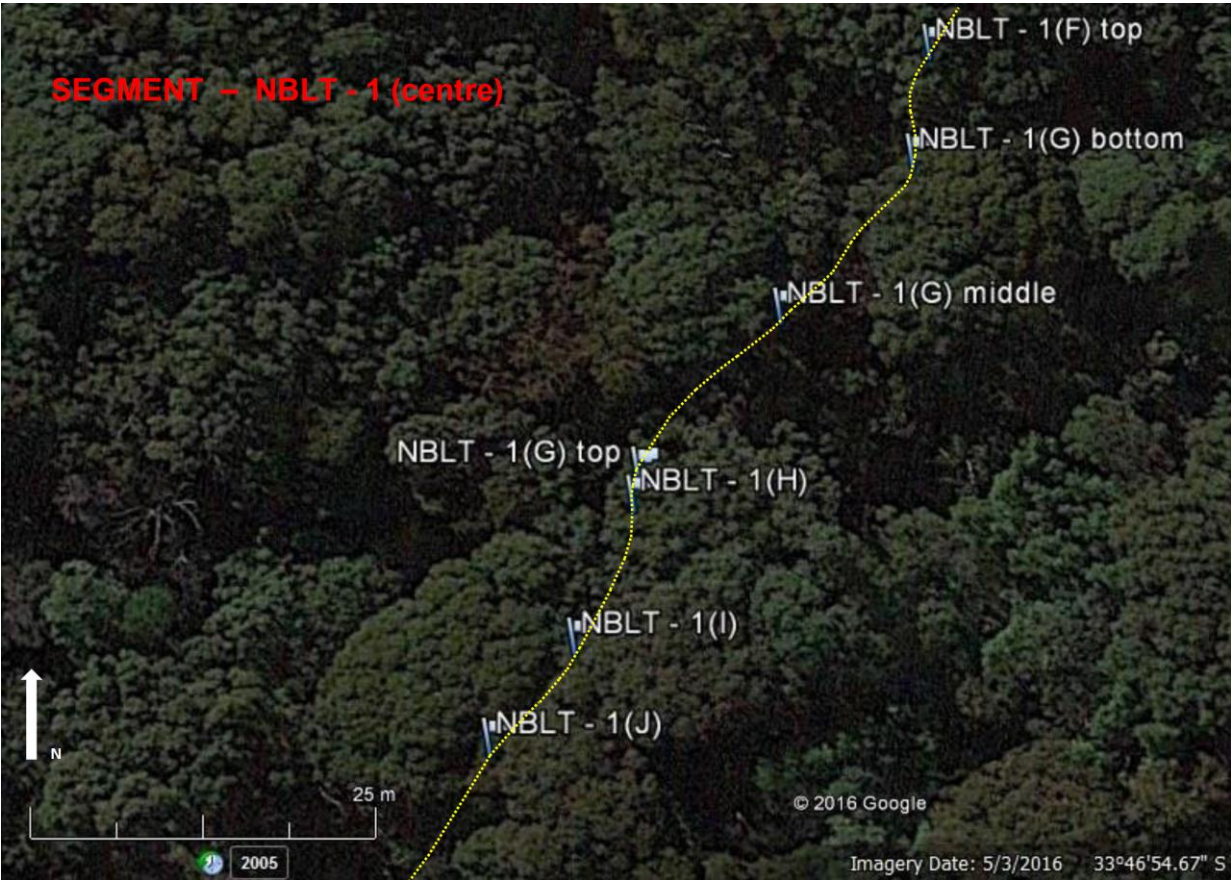
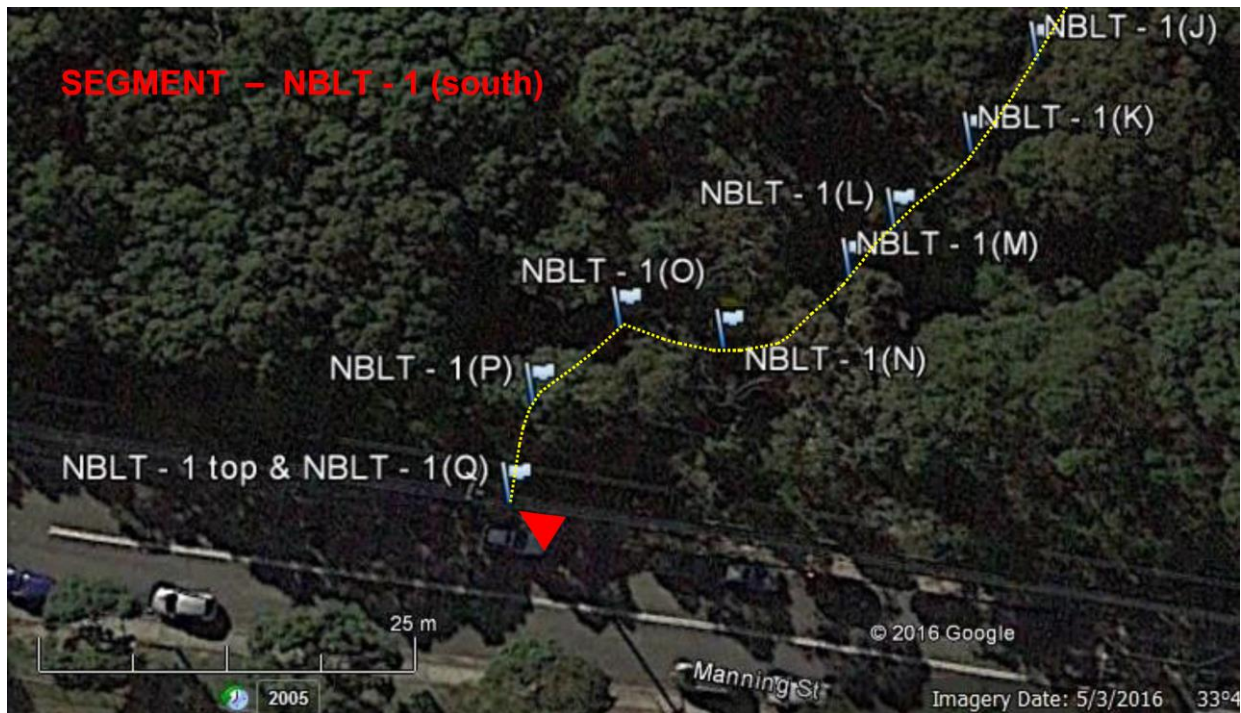
SEGMENT NBLT - 1

<b>SEGMENT: NBLT – 1</b>	
<b>Start Point: 337745 6260746</b> <b>(junction with Nature Trail - 10)</b>	<b>End Point: 337640 6260588</b> <b>(park boundary at Manning Street footpath)</b>
<p><i>General Description and Condition:</i> Well-defined track (245m approx.) with a large number of timber track treatments (steps and step-and-runs) running up/down the W side of a small steep-sided valley, lower two thirds is a series of steeper steps/step-and-runs sharply up/down and across contour with minor more gently sloped section of track, upper third has fewer treatments and is more gently/moderately sloped to the trackhead on Manning Street. Through an attractive mixed Eucalypt/Angophora/Casuarina forest with dense fern understory downslope and a mixed understory upslope. Generally good/fair condition, but numerous missing and rotten treatments.</p> <p><i>Tread Width (mm):</i> 700-1,600mm on lower two-thirds dominated by sleeper steps and step-and-runs, 400-1,000mm (mostly 600-900mm) on upper third.</p> <p><i>Track Surface:</i> Mostly compacted sand, occasional embedded rock, regular laterite gravel and frequent roots (mostly on upper third). Drainage flows down most of track, but little scour on lower two-thirds due to spacing/frequency of sleeper steps and step-and-runs (scour wash around end of treatments), however track dished for most of third to 150mm below NSL and occasional scour.</p> <p><i>Gradient (degrees):</i> Moderate to steep (from usually 10° to 18°, short section to 23°) with minor flatter areas on lower two-thirds - dominated by sleeper steps and step-and-runs). Gentle/moderate slope on upper third (4° to 10°)</p> <p><i>Alignment:</i> Gently curving up/down and across a moderate to steep valley side slope, especially on the lower/N two-thirds.</p> <p><i>Terrain:</i> Mid to upper hillslope</p> <p><i>Soil:</i> Lambert (Erosional), undulating to rolling low hills on Hawkesbury Sandstone.</p> <p><i>Vegetation:</i> Predominantly Duffys Forest (Silverback Ash – Brown Stringybark Forest), with minor area of Peppermint Angophora Forest (part of Sydney Coastal Dry Sclerophyll Forest) at N end.</p>

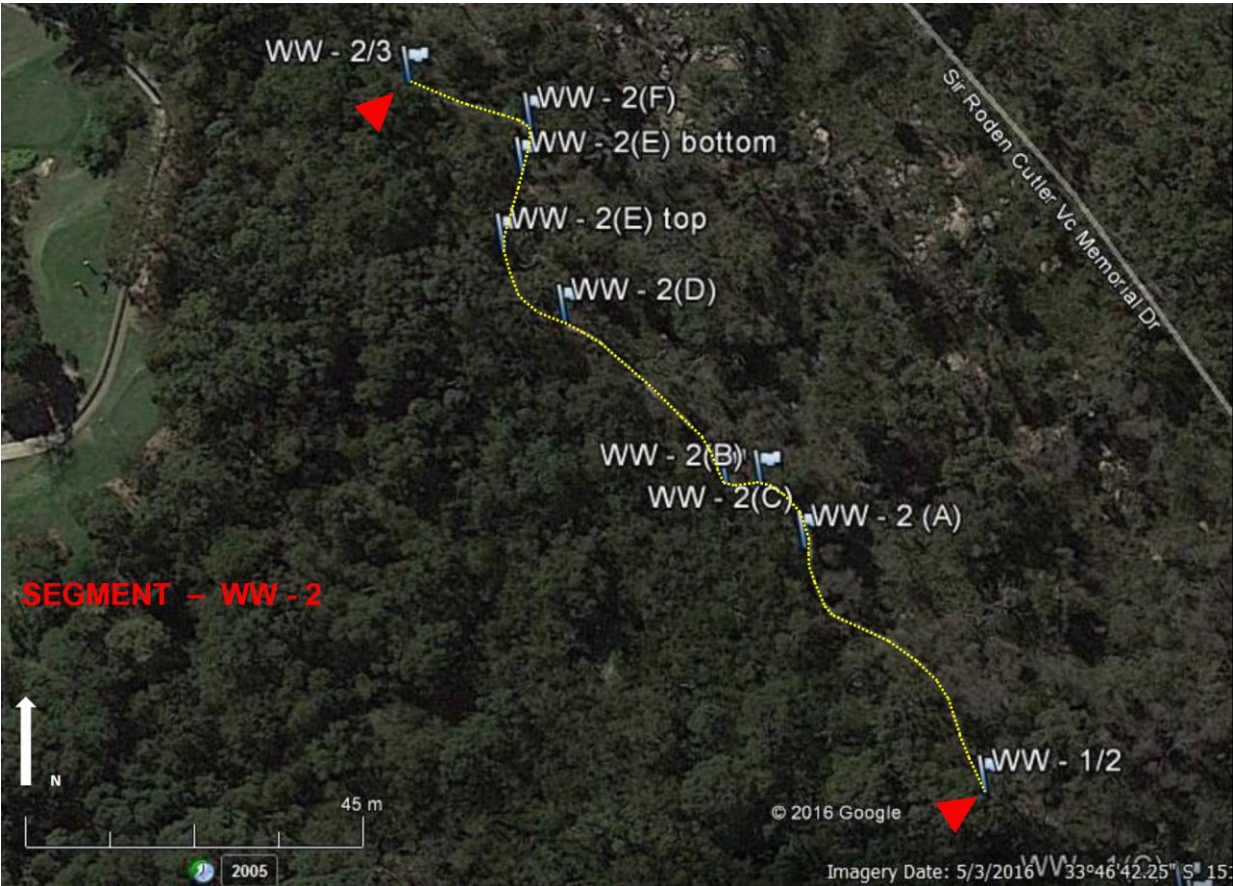
SEGMENT WW - 2

<b>SEGMENT: WW - 2</b>	
<b>Start Point: 337787 6260977</b>	<b>End Point: 337702 6261078</b>
<p><i>General Description and Condition:</i> Short (155m approx.) section of very well-defined narrow track, gently curving and undulating across slope largely along contour, with a short steeper rocky section up/down slope, through low open woodland (burnt downslope with grass/sedge regeneration beneath and extremely open in W, and intact but sparse woodland upslope with tall mixed understorey). Good condition overall.</p> <p><i>Tread Width (mm):</i> Mostly 500-800mm, 800-1,000mm at sleeper steps.</p> <p><i>Track Surface:</i> Compacted sand with considerable laterite gravel, regular embedded (mostly laterite) rocks, regular protruding roots, occasional flat/rounded sandstone embedded rocks, mostly dished (from gently dished to 75mm deep), short rocky section of outcrops and boulders up/down slope at W third (with minor run-on/deposition area of loose sand below).</p> <p><i>Gradient (degrees):</i> Gentle, mostly flat to 4° undulating along contour, short rocky section at 11-13°.</p> <p><i>Alignment:</i> Gently curving across slope, with a short steeper rocky section up/down slope.</p> <p><i>Terrain:</i> Lower hillslope.</p> <p><i>Soil:</i> Lambert (Erosional) – undulating to rolling low hills on Hawkesbury Sandstone.</p> <p><i>Vegetation:</i> Bloodwood-Scribbly Gum Woodland (part of Sydney Coastal Dry Sclerophyll Forest).</p>

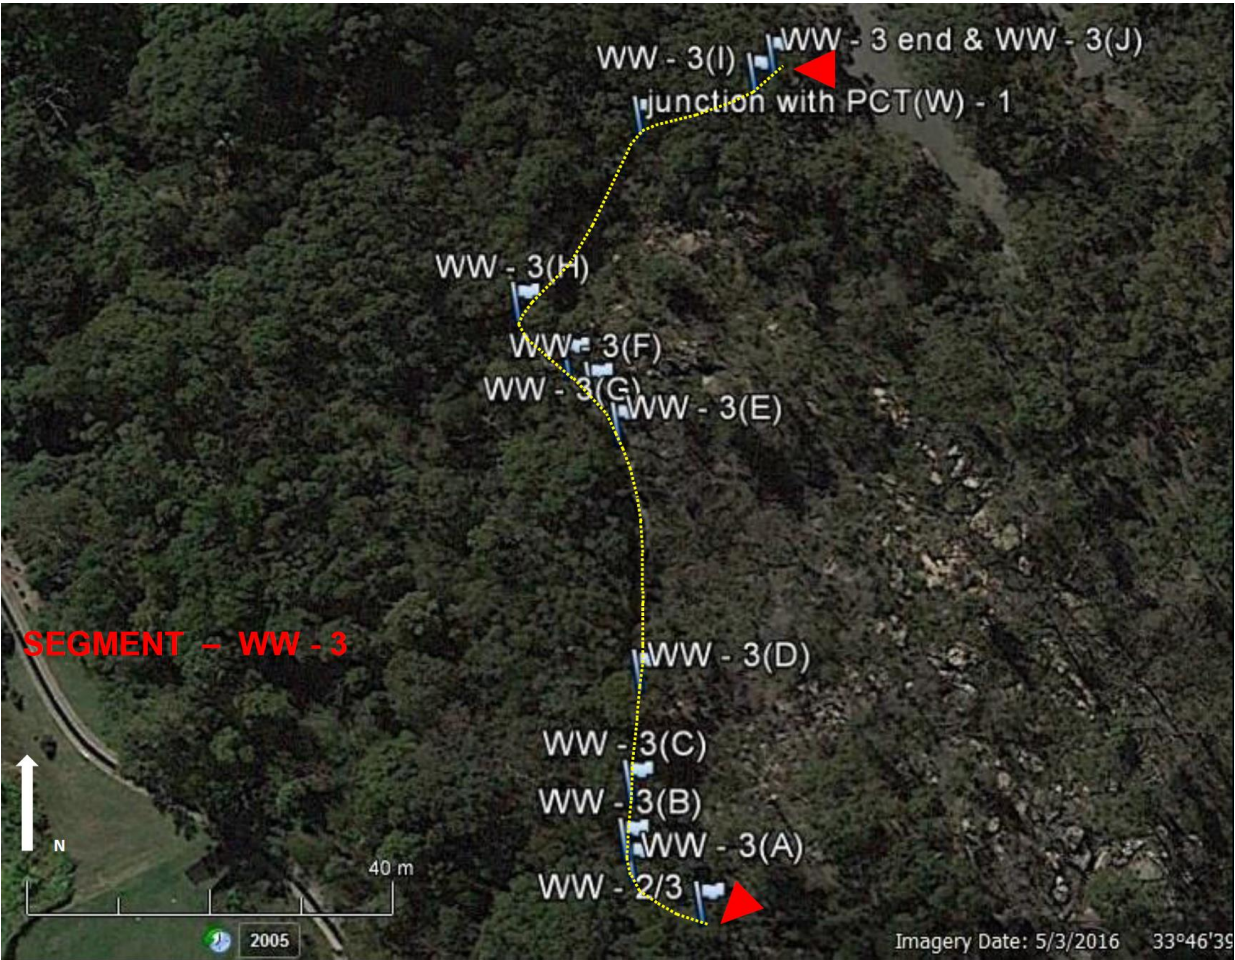
SEGMENT WW - 3

<b>SEGMENT: WW - 3</b>	
<b>Start Point: 337702 6261078</b>	<b>End Point: 337707 6261166</b> <b>Trackhead (West), at carpark and park access road (Sir Roden Cutler VC Memorial Drive)</b>
<p><i>General Description and Condition:</i> Short (120m approx.) section of very well-defined track with multiple treatments, gently curving across and up/down slope (across contour) before turning to run more sharply up/down slope to trackhead, through low woodland (burnt downslope/E with grass/sedge regeneration beneath, and intact but low woodland upslope with tall understorey). Good condition overall.</p> <p><i>Tread Width (mm):</i> Mostly 800-1,400mm, minor sections narrow to 600mm and 1500-1700mm at N end approaching junction with Park Circuit Track (West) and NE trackhead.</p> <p><i>Track Surface:</i> Mostly compacted sand with some laterite gravel, occasional embedded rock and rock pavement/outcrop, gently dished in places (especially at NE end), large benched rock ledge in centre of segment, minor loose sand at N end approaching junction with Park Circuit Track (West).</p> <p><i>Gradient (degrees):</i> Gentle/moderate, 4°to 8°.</p> <p><i>Alignment:</i> Gently curving across slope in E (across and along contour), before turning to NE and running more sharply up/down slope to trackhead.</p>

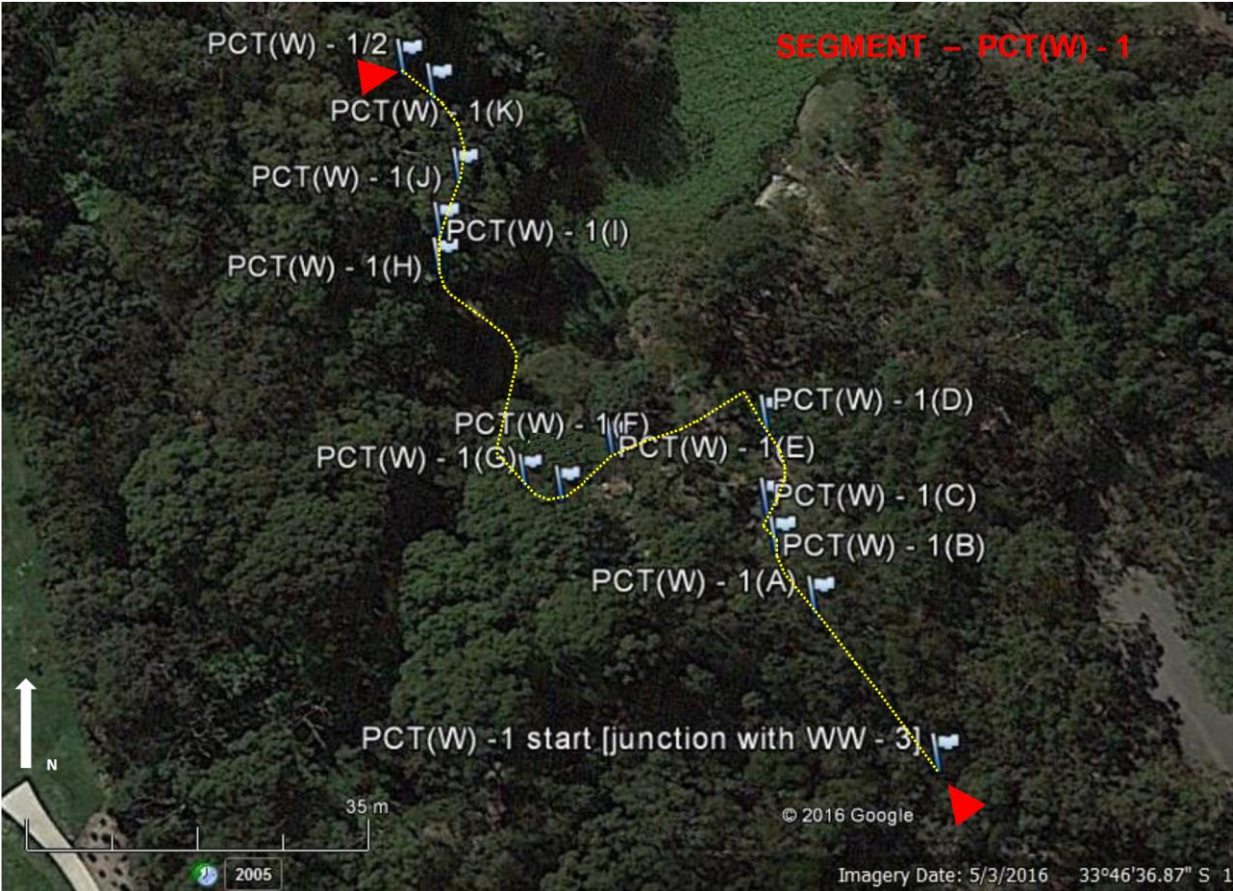
<b>SEGMENT: PCT(W) - 1</b>	
<b>Start Point: 337693 6261159</b> <b>(junction with Wildflower Walk)</b>	<b>End Point: 337634 6261232</b>
<p><i>General Description and Condition:</i> Short section (130m approx.) of well-defined track, with multiple and varied track treatments, winding past a picnic site and around the head of small creek/inkle and along the dam edge, subject to higher levels of use. Attractive section through low open Eucalypt/Angophora forest over a tall mixed understorey at E end, then an open understorey with few trees and new plantings past the picnic site, then fern banks and tree ferns around the creek/inlet margins, and an open Eucalypt/Angophora forest over moist understorey species grading to ow open understorey on gentle rocky slopes at W end. Generally good condition, but some sections and older treatments good/fair condition.</p> <p><i>Tread Width (mm):</i> Mostly 600-1,000, some sections to 1,200mm.</p> <p><i>Track Surface:</i> Varied. Mostly compacted sand with regular exposed/protruding roots (abundant/dense in places). Regular flat outcrops or minor pavement, and larger outcrops/boulders. Larger rock ledge at Site PCT(W)-1(C) and rock shelves N of low boardwalk along dam edge. Drainage flows down numerous sections of track and some ponding areas.</p> <p><i>Gradient (degrees):</i> Mostly flat to 2°, short steeper sections over rock ledges (Site PCT(W)-1(D) to 24°) and occasional sandy slopes to 9°.</p> <p><i>Alignment:</i> Winding down rock ledge and past a picnic site, then around the head (SW) of a small creek/inkle and along the dam edge gently curving up a gentle slope to the N.</p>

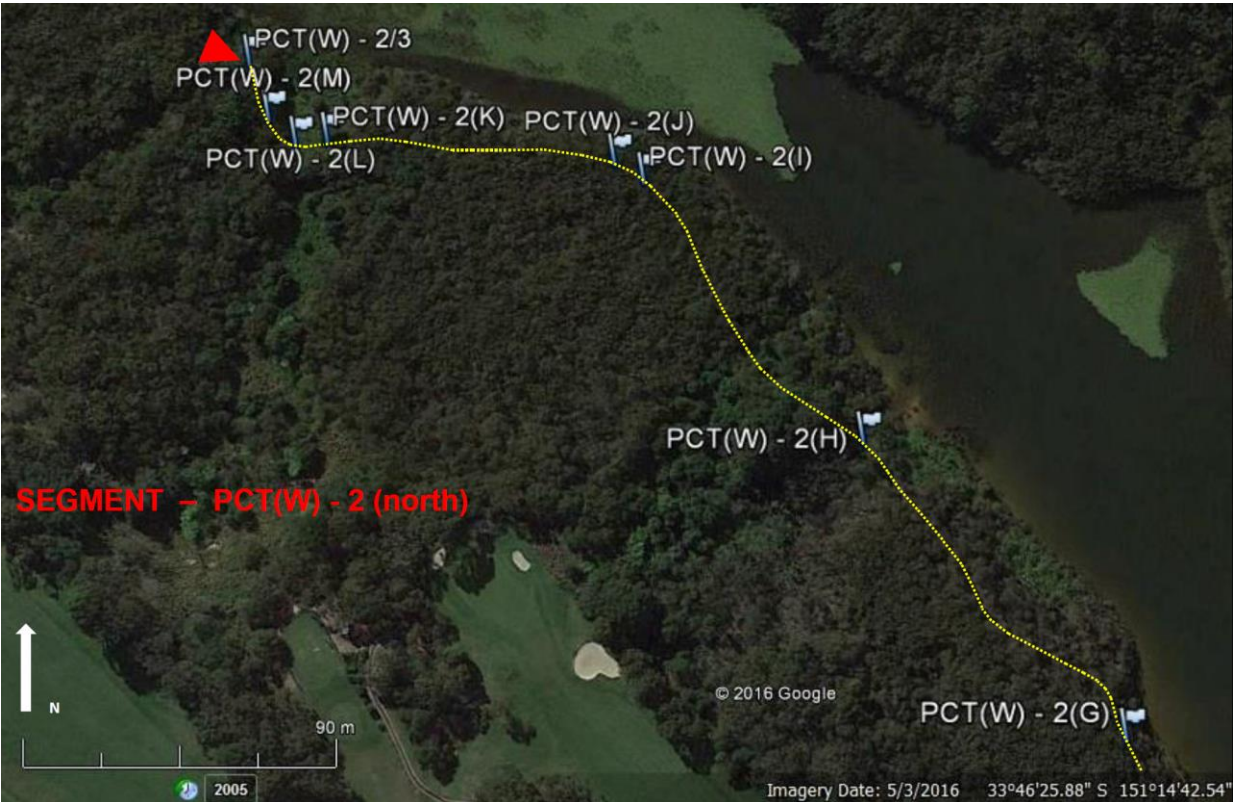
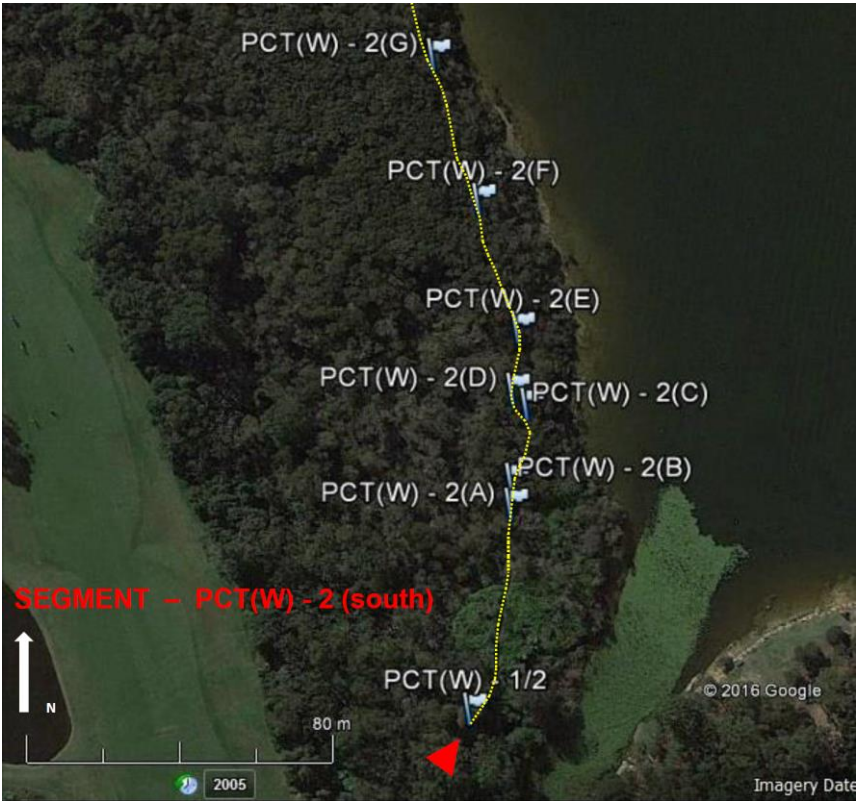
<b>SEGMENT: PCT(W) - 2</b>	
<b>Start Point: 337634 6261232</b>	<b>End Point: 337322 6261629</b>
<p><i>General Description and Condition:</i> Extended section (640m approx.) of very well-defined and wide track very gently curving along the dam margin, with frequent minor track treatments as well as sections of low boardwalk. Through open Casuarina heath and tall/open Casuarina/Banksia heath, ferns beds in places (both open fern beds, and under Eucalypts and Casuarinas at S end). Good condition.</p> <p><i>Tread Width (mm):</i> Mostly 800-1,400mm, but many wider areas to 1,800-2,000mm, narrows to 700 at far S end and to 700-1,000mm (occasionally 1,200) at shorter rocky sections.</p> <p><i>Track Surface:</i> Predominantly compacted sand, flat to gently dished (to 50mm deep, minor location to 100mm deep mainly at S end), some areas of moist sand, very occasional embedded rock and laterite gravel, short section of embedded ironstone with laterite gravels and short section of embedded rock (some slightly protruding and squarish) and flat pavement/outcrop, occasional protruding roots (especially in rockier sections),</p> <p><i>Gradient (degrees):</i> Predominantly flat or &lt;1° to &lt;2°, short sections to 3° and 3.5° over minor rocky areas.</p> <p><i>Alignment:</i> Very gently curving along dam margin, with extended straight sections.</p> <p><i>Terrain:</i> Dam margin and alluvial flat along lower hillslope.</p> <p><i>Soil:</i> Lambert (Erosional) undulating to rolling low hills on Hawkesbury Sandstone (and deposition/alluvial areas along dam margin and at drainage line/marshy flat).</p> <p><i>Vegetation:</i> Mostly Bloodwood-Scribbly Gum Woodland (part of Sydney Coastal Dry Sclerophyll Forest), with a 90-100mm section (near centre of segment, across drainage line/marshy flat) mapped as “disturbed” vegetation.</p> <p><i>Track Works and Improvements:</i></p> <p>Multiple treatments regularly spaced along segment.</p> <ul style="list-style-type: none"> <li>• Scored sleeper waterbars – x2, x2 (short on of upslope/W edge of track).</li> <li>• Log waterbars – x4, x1 (rotted)</li> <li>• Log steps – x3</li> <li>• “Short” waterbars/steps (across half track width or more) – x8 logs, x3 scored sleepers.</li> <li>• “Off-track” waterbars/steps (less than half track width, or only on track edge) – x3 scored sleepers.</li> <li>• Extended log and scored sleeper waterbar – x1</li> <li>• Low boardwalk (floating ?) of newer FRP for 19m in N and older timber for 28m in S (N end 337642 6261283, S end 337635 6261 242), 900mm wide, curving, FRP step on ground at N end, fern banks both side (with emergent small dead Banksias and Casuarinas beside boardwalk in N third) – FRP section in good condition, timber section in fair condition (several replaced planks).</li> <li>• Low FRP boardwalk (floating ?) curving with 5 single steps (N end 337648 6261311, S end 337644 6261294), 23m long 900mm wide, curves away from dam through tall Casuarina heath with fern bank along low side – good condition. Old log post with 2 bolts at N end (but nothing on it).</li> <li>• Low timber boardwalk (floating ?) with 5 single steps (N end 337494 6261542, S end 337546 6261490), 85m long and 900mm wide, ferns/sedges under Ti-tree and Casuarinas in N third with open woodland and bracken fern in S two-thirds, gently curving in S end – good/fair condition (several recently replaced planks).</li> </ul> <p><i>Signs and Wayfinding:</i> Log post with old meatal directional arrow near S end, but 1m off track and obscured by vegetation. Log post with 2 pictograms (“walkers” and “no bikes”) near S end of southernmost (FRP/timber) boardwalk – fair/good condition. No other waymarking en-route.</p>

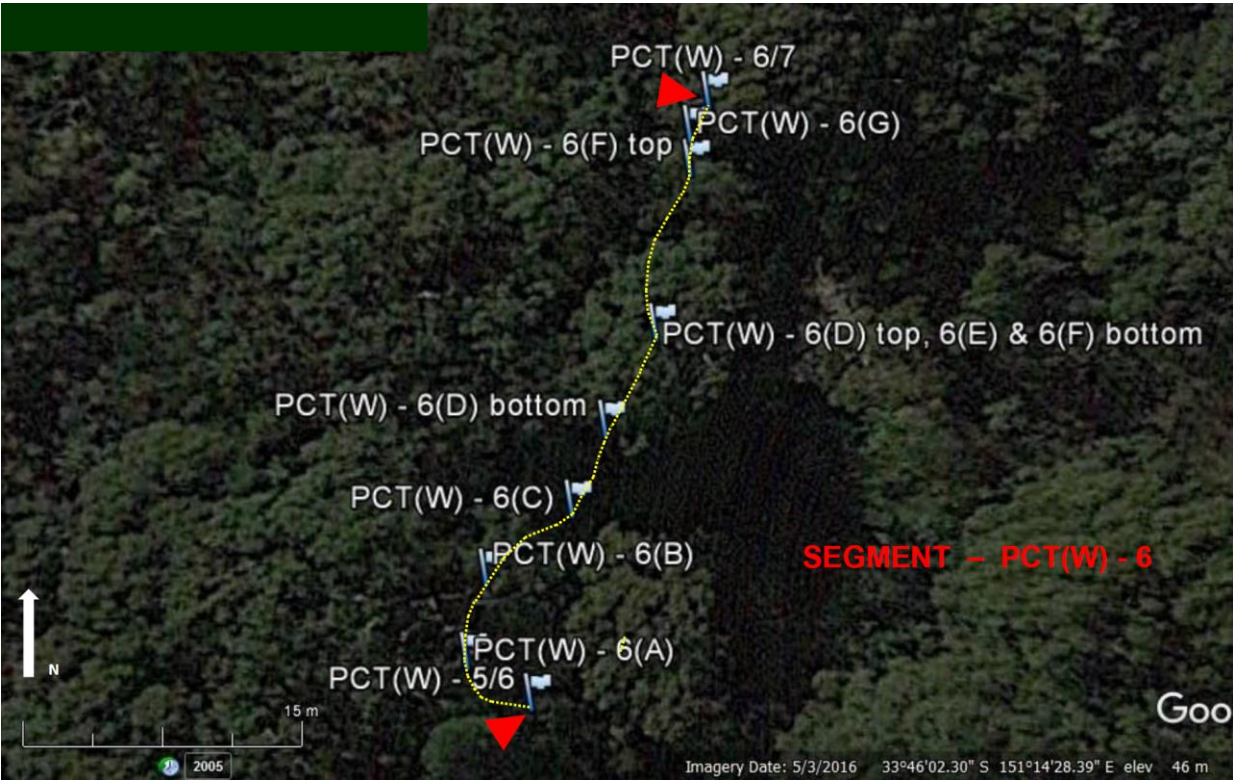
SEGMENT: PCT(W) - 6	
Start Point: 337119 6262233	End Point: 337130 6262270
<p><i>General Description and Condition:</i> Short (50m approx.) section of steep track up/down rocky slope with adjacent rock faces/ledges on W side of waterfall, rough uneven/rocky surface and wide in places with “rock hopping” and large rises/lips, handrail above steep slope/cliffline to pool below. Fair condition only, with some hazards.</p> <p><i>Tread Width (mm):</i> Varies - from 700mm on narrow benches to 2,400mm around boulders and rock ledges.</p> <p><i>Track Surface:</i> Compacted sand and sand/clay among extensive areas of large boulders and rock ledges, embedded rocks, areas of loose sand, abundant protruding roots including large roots running down and across track in several places, drainage down much of segment with frequent scour.</p> <p><i>Gradient (degrees):</i> Steep 15-20° with short flat or more gently benches.</p> <p><i>Alignment:</i> Sharp curve at bottom/S end, then winding sharply up/down rocky slope on W side of waterfall.</p> <p><i>Terrain:</i> Lower to mid hillslope, W side of waterfall.</p> <p><i>Soil:</i> Lambert (Erosional), undulating to rolling low hills on Hawkesbury Sandstone.</p> <p><i>Vegetation:</i> Peppermint Angophora Forest (part of Sydney Coastal Dry Sclerophyll Forest).</p> <p><i>Track Works and Improvements:</i> 5 old (short) sleeper steps at bottom/S end and 2 old sleeper steps on high side of central landing. Double safety railing (galvanised pipe) along low side of track 9m long (5m flat bench, then 4m on slope) 700-1,000mm high - Site PCT(W)-6(C).</p>

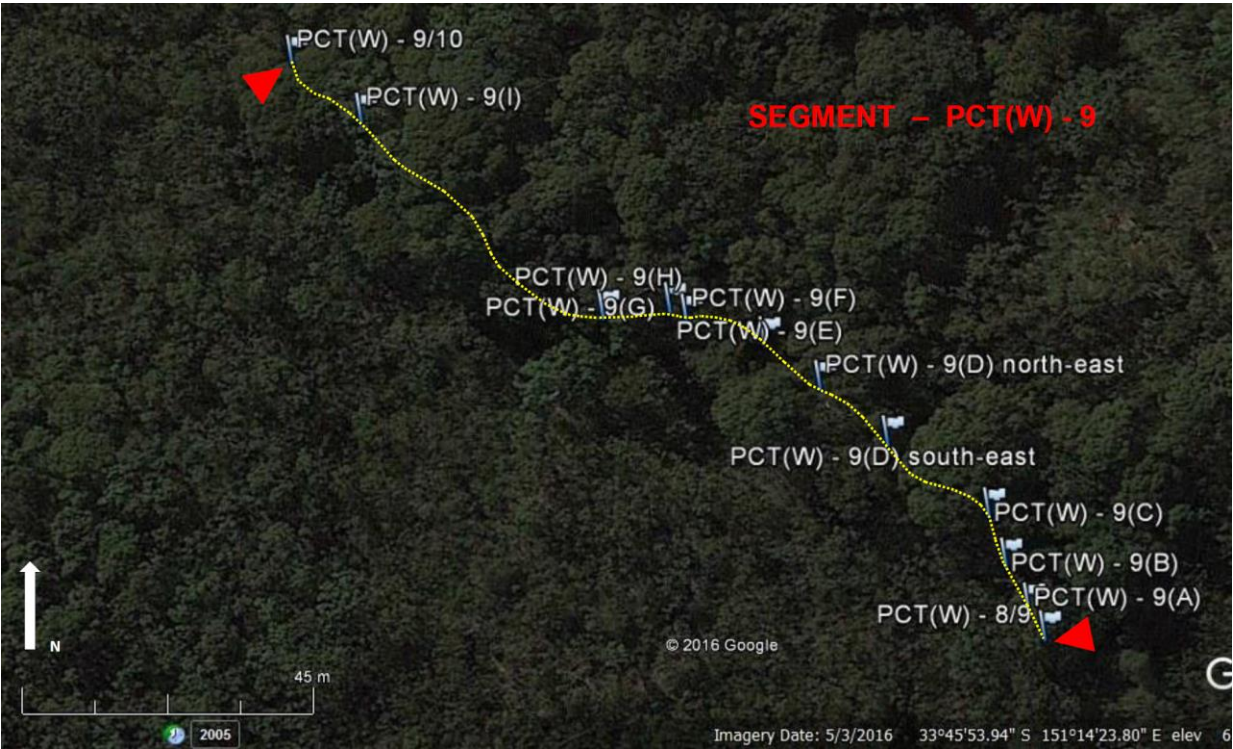
<b>SEGMENT: PCT(W) - 9</b>	
<b>Start Point: 337065 6262452</b>	<b>End Point: 336929 6262557</b>
<p><i>General Description and Condition:</i> Very-well defined section (200m approx.) of mostly flat sandy track, very gently winding along the creek bank and flood terrace for most of segment, with one section of boardwalk but few other track treatments, through attractive Eucalypts with a mixed understorey and creekside fern beds as well as views to cascades and pools along creek, sections off track subject to flooding/inundation. Good/fair condition.</p> <p><i>Tread Width (mm):</i> 700-1200mm, but regular wider areas to 1,800mm (and some track braiding)</p> <p><i>Track Surface:</i> Predominantly compacted sand, moist/wet in places, frequently dished (sometimes deeply dished, often closer to creek channel), regular exposed roots (some protruding to 300mm, and exposed by flooding/scour), flood levees of sand along creekside of track in places (mainly S half), occasional boulders or outcrops and embedded rock, small area of angled rock slabs/outcrops midway, and large/wide rock shelf at S end beside creek (stepped access to creek). Drainage down much of track with frequent ponding areas and capture/ponding of high flows/flooding in adjacent creek.</p> <p><i>Gradient (degrees):</i> Mostly flat to &lt;2, very short sections to 4-5°.</p> <p><i>Alignment:</i> Very gently winding along the creek bank and flood terrace for S two-thirds of segment, winds to/from creek side in N third before leaving creek channel/flood terrace at N end (at small knoll).</p> <p><i>Terrain:</i> Creek corridor – creek bank/flats and flood terrace, in broad midslope valley.</p> <p><i>Soil:</i> Lambert (Erosional), undulating to rolling low hills on Hawkesbury Sandstone.</p> <p><i>Vegetation:</i> Predominantly Peppermint Angophora Forest and entering Bloodwood-Scribbly Gum Woodland in far NW end (both part of Sydney Coastal Dry Sclerophyll Forest).</p>

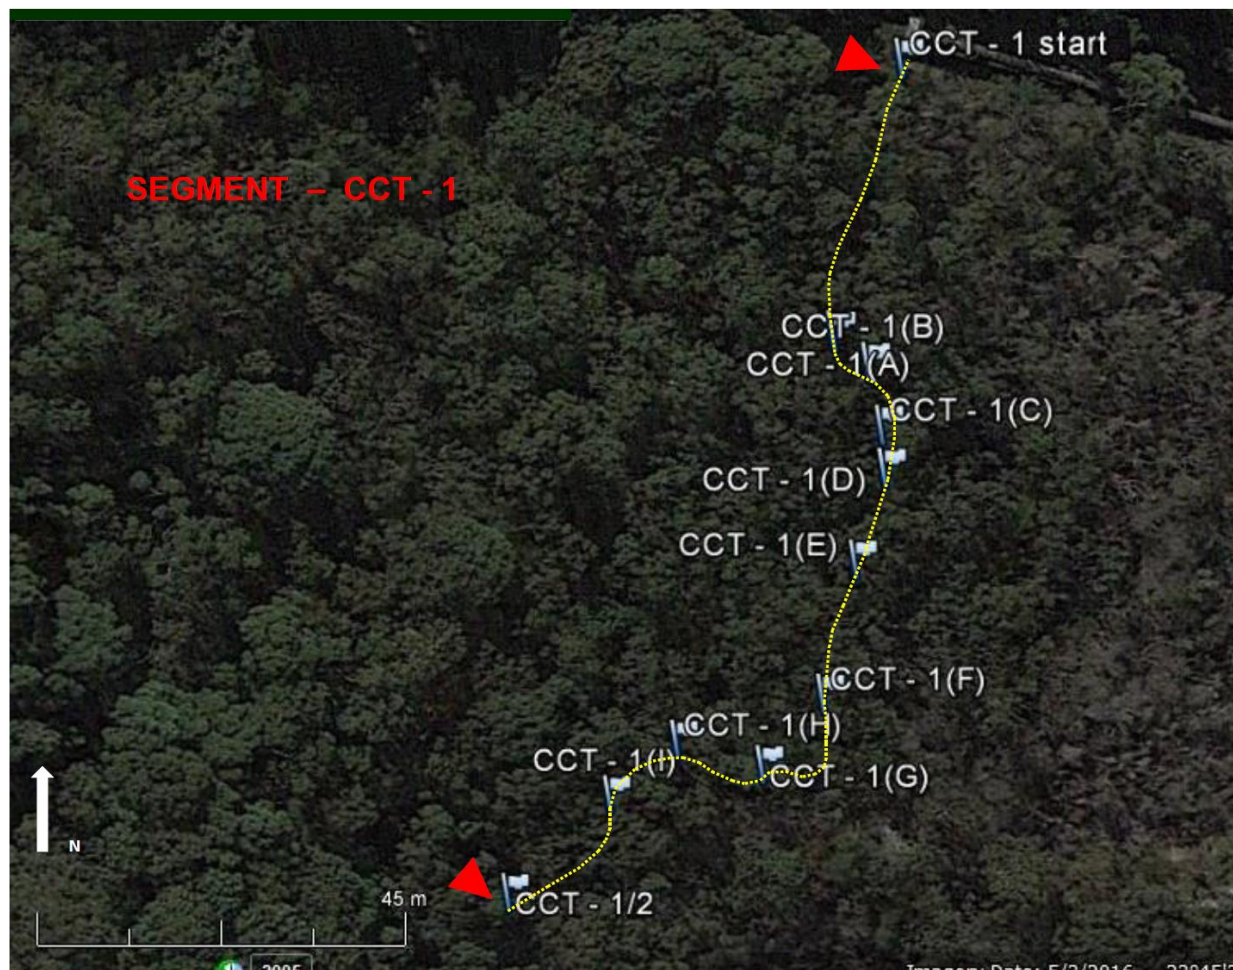
<b>SEGMENT: CCT - 1</b>	
<b>Start Point: 336737 6263218</b> <b>(S side of pipeline)</b>	<b>End Point: 336692 6263120</b>
<p><i>General Description and Condition:</i> Well-defined section of track (145m approx.) with regular track treatments curving up/down a gentle/moderate hillslope with occasional rocky sections, through tall open Eucalypt forest with a moderate dense understorey( more sparse, previously burnt, on high side on lower slope). Junction with old/dis-used loop track partially disguised, or not obvious, on lower slope - at 336726 6263138. Good condition (overall).</p> <p><i>Tread Width (mm):</i> Mostly 600-900mm.</p> <p><i>Track Surface:</i> Compacted sand with regular rock outcrops, embedded rock and occasional ledges. Protruding roots in places. Drainage capture on many sections with track surface entrenched 100-300mm below NSL, and flows over waterbars and steps, but little downside scour. Erosion potential reduced due to by regular rocky sections and waterbars/steps, as well as curved alignment.</p> <p><i>Gradient (degrees):</i> Generally gentle to gentle/moderate gradients of 2-6°, short steep sections over rock ledges have moderate to steep slopes of 17-23° gradients.,</p> <p><i>Alignment:</i> Gently curved up/down gentle/moderate hillslope with rocky ledges, more tightly curving on lower section, only short sections across/along contours.</p>

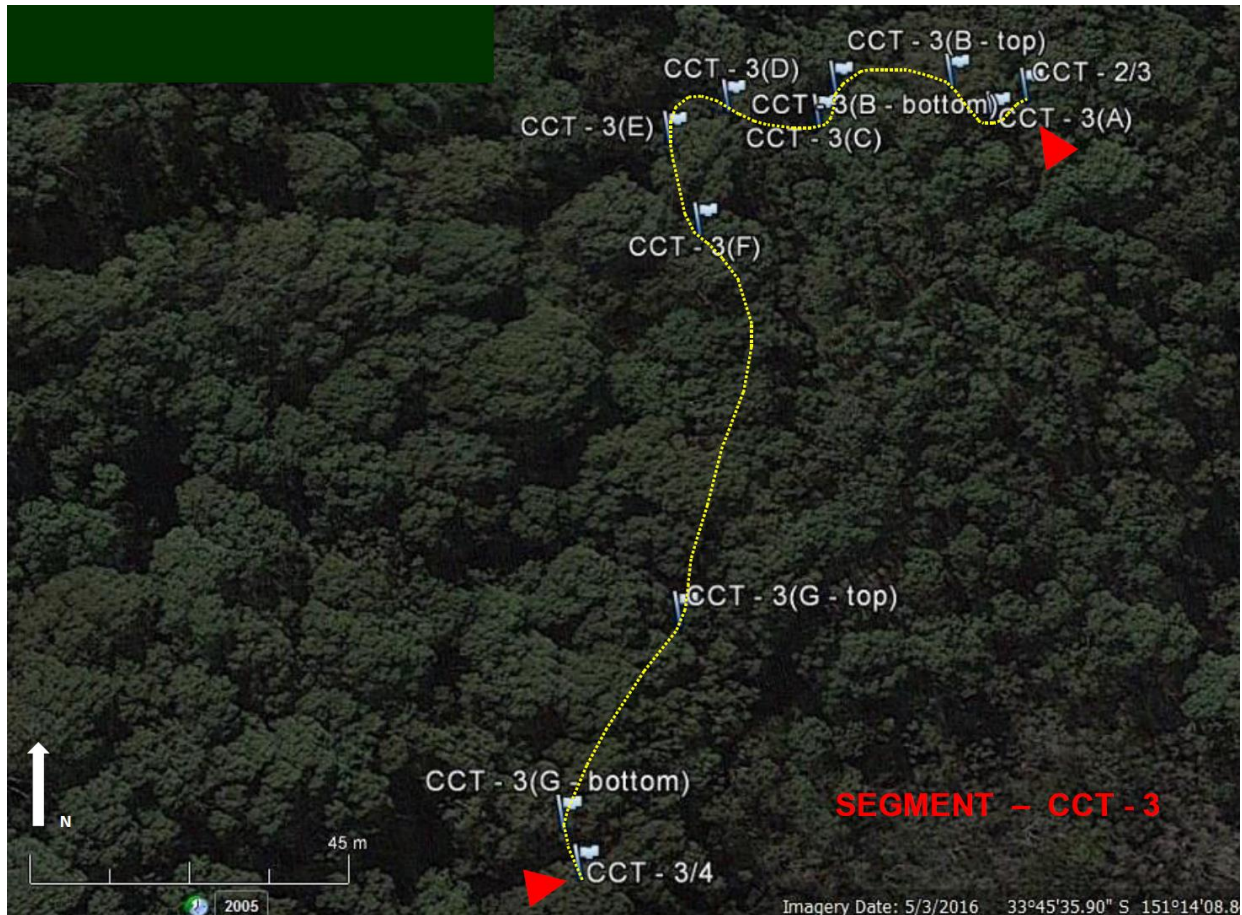
<b>SEGMENT: CCT - 3</b>	
<b>Start Point: 336647 6263113</b>	<b>End Point: 336582 6262996</b>
<p><i>General Description and Condition:</i></p> <p>Well-defined section of track (185m approx.) winding up/down and across moderate slopes on upper third, including two drainage line crossings, and more undulating along contour and obliquely up/down gentle/moderate slopes on lower two-thirds (along E side of valley slope with creekline below to W). Through attractive open Eucalypt and Angophora forest with low sparse understorey upslope, and medium understorey in valley below track. Junction with old/disused loop track, very obvious, at S end - at 336580 6263001. Good condition, with curving alignment with regular and effective track treatments on steeper slopes.</p> <p><i>Tread Width (mm):</i> Mostly 700-1,000mm wide, some sections narrow to 400mm for a short distances but more often widen to 1,200mm in places.</p> <p><i>Track Surface:</i> Compacted sand, with occasional embedded rocks or rock outcrops, and a few larger boulders, occasional laterite gravels. Frequent drainage down more sloping sections of track but no major erosion/scour issues due to curving alignment (spills flows off track) and frequent spacing of steps and waterbars (catches sediment and slows flow), well aligned on slopes. Minor benching on high side of track (where across slopes), only occasional sections of dished track, and minor entrenched track.</p>

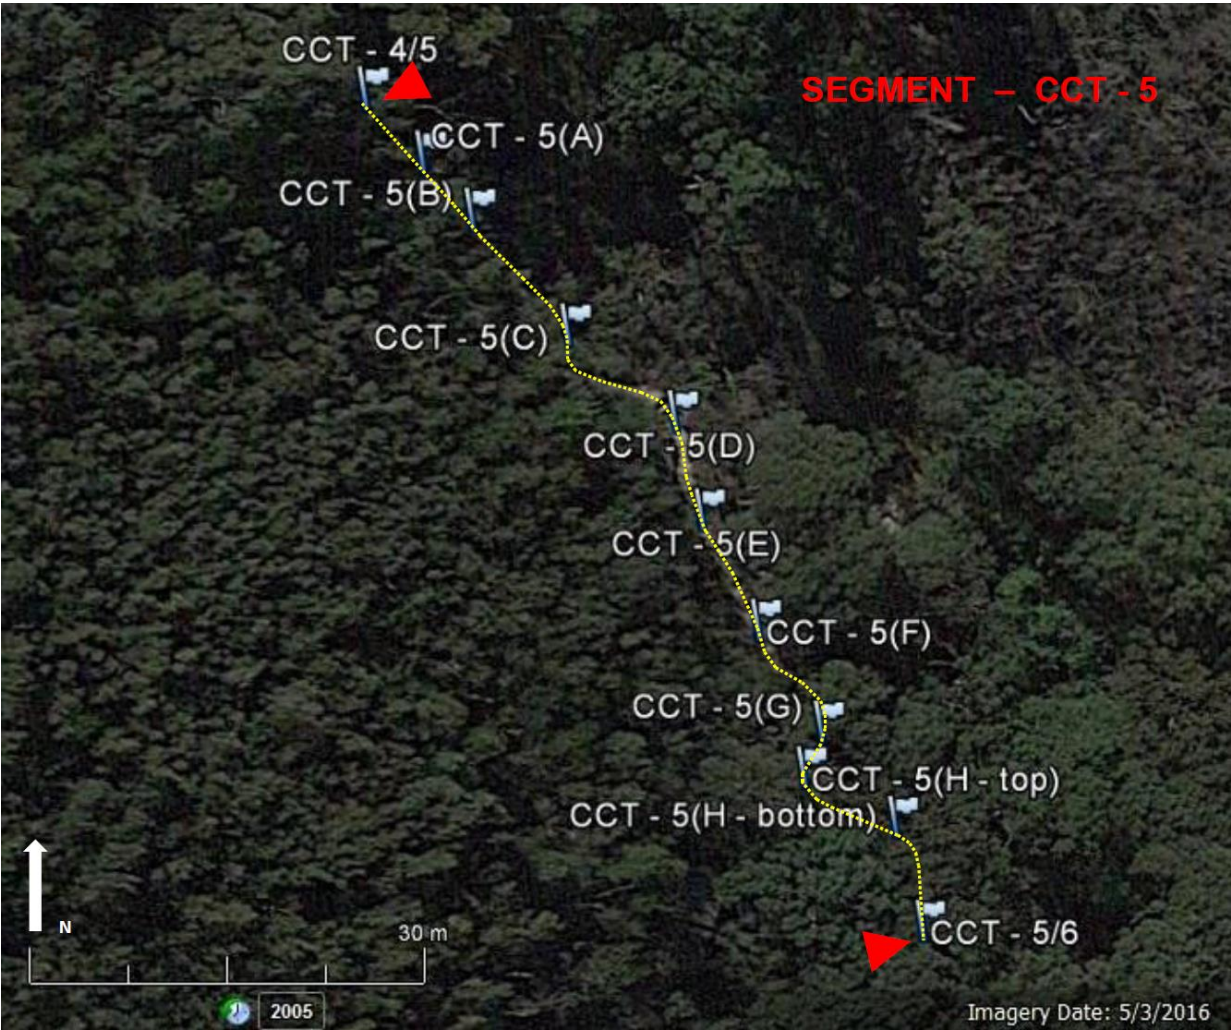
<b>SEGMENT: CCT - 5</b>	
<b>Start Point: 336620 6262869</b>	<b>End Point: 3366667 6262800</b>
<p><i>General Description and Condition:</i></p> <p>Well-defined section of track (95m approx.) gently winding along SW slope of broad open valley above, and paralleling, creekline. Track runs closer to creek corridor towards SE with views to rocky bed, pools and cascades before a short steep slope to join the flood terrace below a small waterfall – flooding during high flows likely to occur at SE end. Mostly through low open woodland with sparse to medium understorey, and slightly thicker vegetation long creekline – evidence of past fires. Good condition overall, but occasional sections fair only (especially rocky or steeper sections).</p> <p><i>Tread Width (mm):</i> Mostly 400-900mm, widening to 1,200mm around obstacles or over rocky sections.</p> <p><i>Track Surface:</i> Compacted sand (and some sandy clay) with regular embedded rocks and boulders as well as occasional rock ledges and pavements, occasional loose stone and gravel, occasional patches of loose/deposited sand, regular protruding roots (especially at SE end). Mostly slightly dished to 50mm below NSL, and benched-in 50-100mm on</p>

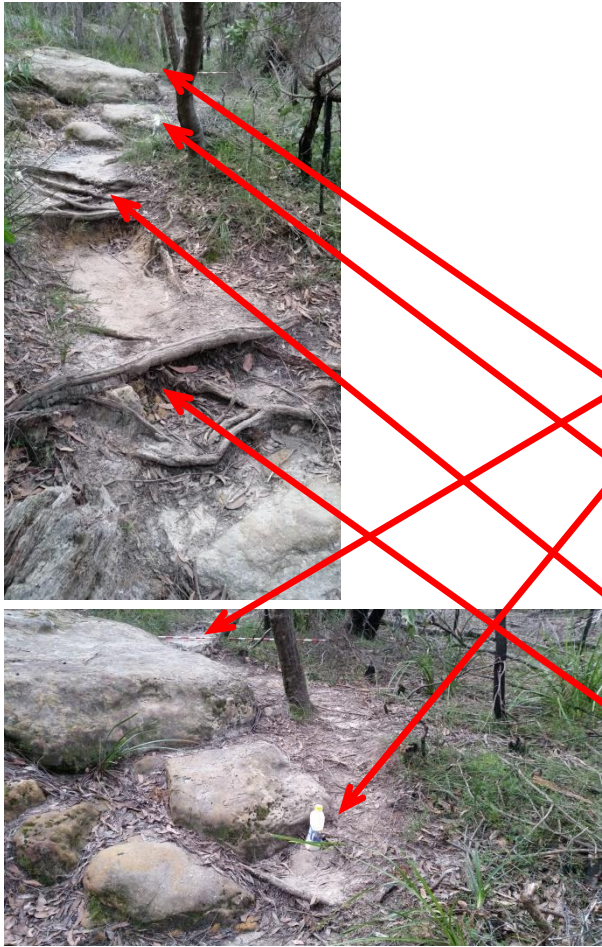
<p><b>Site ID: CCT – 5(F)</b></p> <p><i>Location:</i> 336652 6262826 13m length of compacted sand track, around low side of large flat rock outcrop at top (dead tree adjacent), then over embedded rocks and cluster of exposed/retaining roots (beside dead tree) with 400mm step off, larger exposed/retaining roots with 300mm step off, drainage capture and flows down track, 10° gradient overall.</p> <p><i>Works:</i></p> <ul style="list-style-type: none"> <li>Remove 2 dead trees (safety issue).</li> <li>Waterbar at top of site, before slope and above large flat rock outcrop.</li> <li>2 stone steps built onto embedded rocks, boxed on low side for containment, fill and compact upslope, with stone-lined invert above.</li> <li>3 stone steps below upper/clustered roots, backfill above (over roots) and compact/level.</li> <li>2 stone steps below lower roots, built onto upper end of rock outcrop below, boxed on low side for containment, backfill behind (over roots) and compact/level.</li> </ul> <p><b>(Medium - for passability/safety issues, remove dead trees as minimum treatment)</b></p>

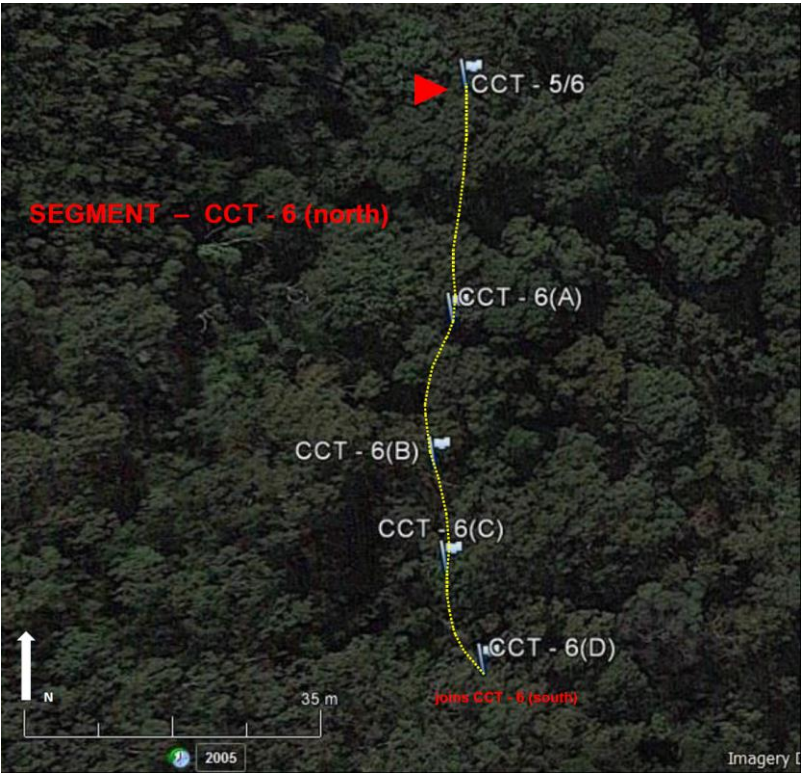
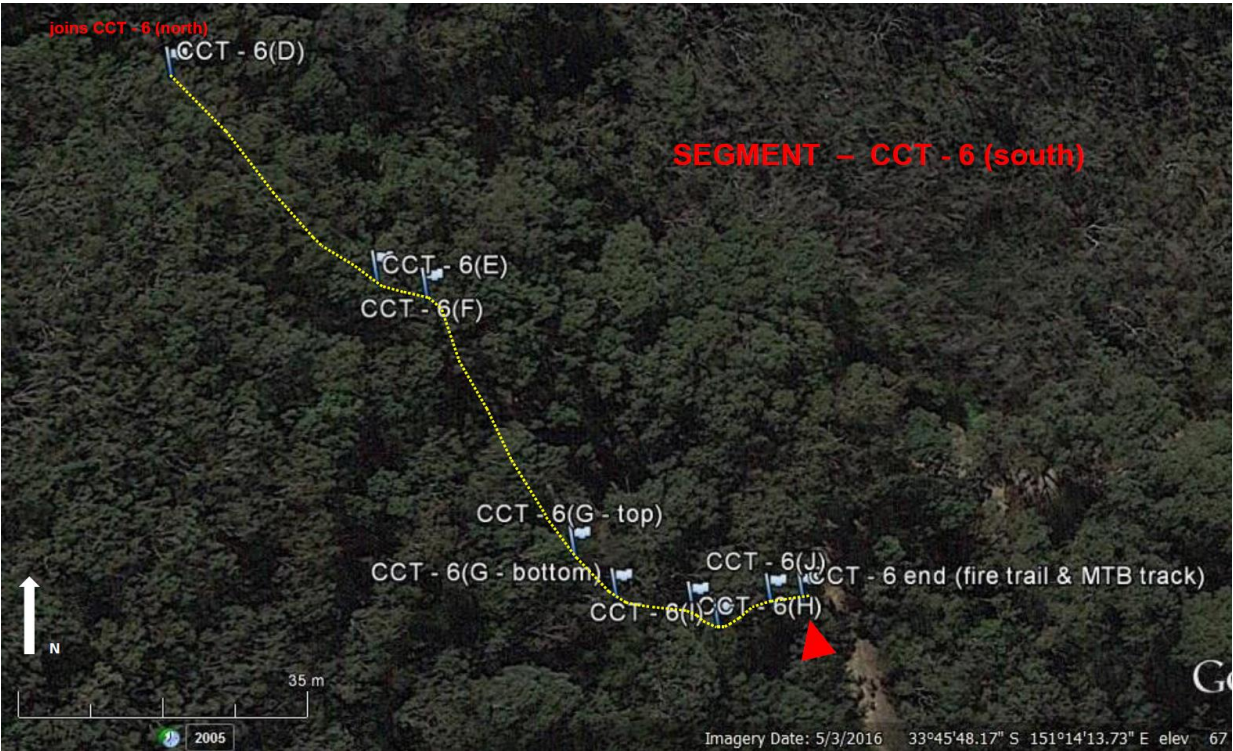
<b>SEGMENT: CCT - 6</b>	
<b>Start Point: 3366667 6262800</b>	<b>End Point: 336759 6262645</b> <b>(Perimeter Fire Trail and Shared Path, just SW of creek crossing, and opposite N trackhead of Park Circuit Track -West)</b>
<p><i>General Description and Condition:</i></p> <p>Well-defined section of track (185m approx.) gently winding along contour on W and SW slope of broad open valley above, and paralleling, creekline for most of segment with views to rock pool and small cascades from central section. Flood terrace at far N end, and crosses small (wet) tributary in SE third. Mostly through open mixed Eucalypt woodland (with evidence of past fire) and open understorey (including sedges) in N and medium more mixed understorey towards SE. Joins Perimeter Fire Trail and mountain bike/shared path at SE end, with connection to N end of Park Circuit Track (West) opposite. Good condition overall.</p> <p><i>Tread Width (mm):</i> Mostly 600-1,00mm, some narrow section at 300-400mm for short distances (such as narrow benched track past obstacles on side-slopes) or wider section to 1,200mm around obstacles.</p> <p><i>Track Surface:</i> Compacted sand with regular embedded rocks and rock outcrops/boulders (typically low or flat outcrops), occasional stones and laterite gravel, frequent exposed/protruding roots and occasional stump (some up to 250mm high in places). Track frequently dished 50-100mm below NSL, and drainage flows down in many places with occasional deeper gutters (to 300-350mm below NSL). Benched-in 50-200mm on highside in places (depending on degree of side-slope). Areas of sandy loam close to creek along flood terrace at N end, and increasing amounts of sandy clay in SE third.</p> <p><i>Gradient (degrees):</i> Undulating across slope with mainly gentle &lt;1-2.5° gradients and some gentle/moderate slopes (5-7.5° gradients) including over rock ledges/outcrops.</p> <p><i>Alignment:</i> Short section along flood terrace (beside creekline - likely to be impacted by high creek flows)) at N end, then climbing slightly to run in a very gently curving alignment across/along a mostly gentle valley side slope (mostly along contour) on W side of open valley, with views into creek corridor, gradually dropping down to S.</p> <p><i>Terrain:</i> Valley on lower hillslope.</p> <p><i>Soil:</i> Lambert (Erosional) – undulating to rolling low hills on Hawkesbury Sandstone.</p> <p><i>Vegetation:</i> N third of track runs along boundary of Peppermint Angophora Forest and Bloodwood-Scribbly Gum Woodland, S two-thirds of track runs along boundary of Peppermint Angophora Forest and Sandstone Heath.</p> <p><i>Track Works and Improvements:</i> Occasional scored timber sleeper steps/waterbars scattered along most of segment, more frequent and loosely grouped in SE third.</p> <p><i>Signs and Wayfinding:</i> New signage/directional totem at SE junction with Perimeter Fire Trail / shared path (opposite N trackhead of Park Circuit Track –West). Totem identifies Mountain Bike Circuit (and Fire Trail) and Park Circuit Track (West) to S, but no identification or orientation information for Curl Curl Track. No wayfinding en-route.</p> <p><i>User Experience:</i> Easy walking on well-defined and maintained track in a broad valley setting with mostly open vegetation. Regular views into creek – including creek in close proximity at N end and attractive views to pools and riffles/shelves along creekline (10-20m below track) in N and central sections. Vegetation less enclosed, and attractive, than upslope segments of Curl Curl Track to N. Moderate slope below track in places but minor/low hazard only (mainly when track narrows to 300-400mm wide).</p> <p><i>Key Issues:</i> Potential for flooding and undercutting or erosion damage by adjacent creek at N end, protruding roots (trip hazards), drainage capture, erosion/guttering, scour over and</p>
