# MANLY DAM WALKING TRACKS AUDIT

for  
**Northern Beaches Council**  
May, 2017

CONTROLLED DOCUMENT  
**“Manly Dam Walking Tracks Audit”**

**FINAL ISSUE**

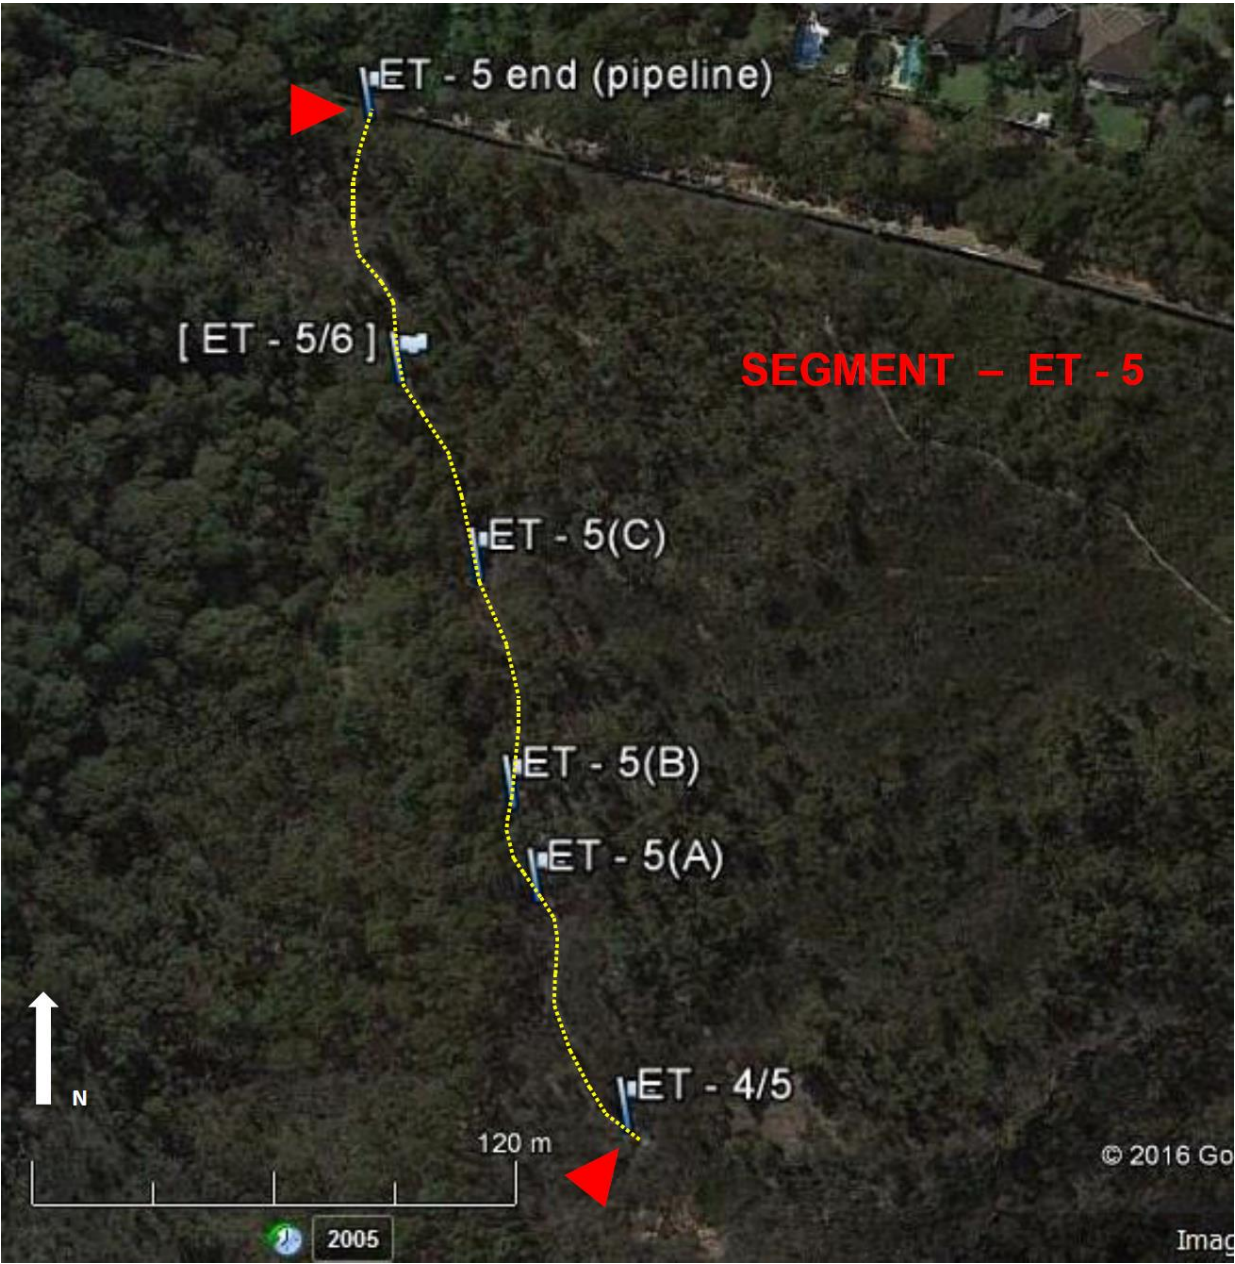
SEGMENT: ET - 5	
Start Point: 336963 6262952	End Point: 336894 6263179 (S side of pipeline)
<p><i>General Description and Condition:</i> Long section of well-defined track (290m approx.) across and around slope, mostly undulating along contour on gentle gradients, through tall heath (mostly burnt/dead) and occasional Eucalypts for most part with open Eucalypt forest in N. Junction in N end with link track (ET – 6), at 336904 6263118, connecting to N arm of Eva’s Track loop. Good condition (overall).</p> <p><i>Tread Width (mm):</i> 600-1,000mm, occasional wider sections at rock ledges/obstacles.</p> <p><i>Track Surface:</i> Compacted sand with occasional laterite gravels, often dished or benched into upslope side to 50-100mm, drainage capture in places and considerable seepage from</p>

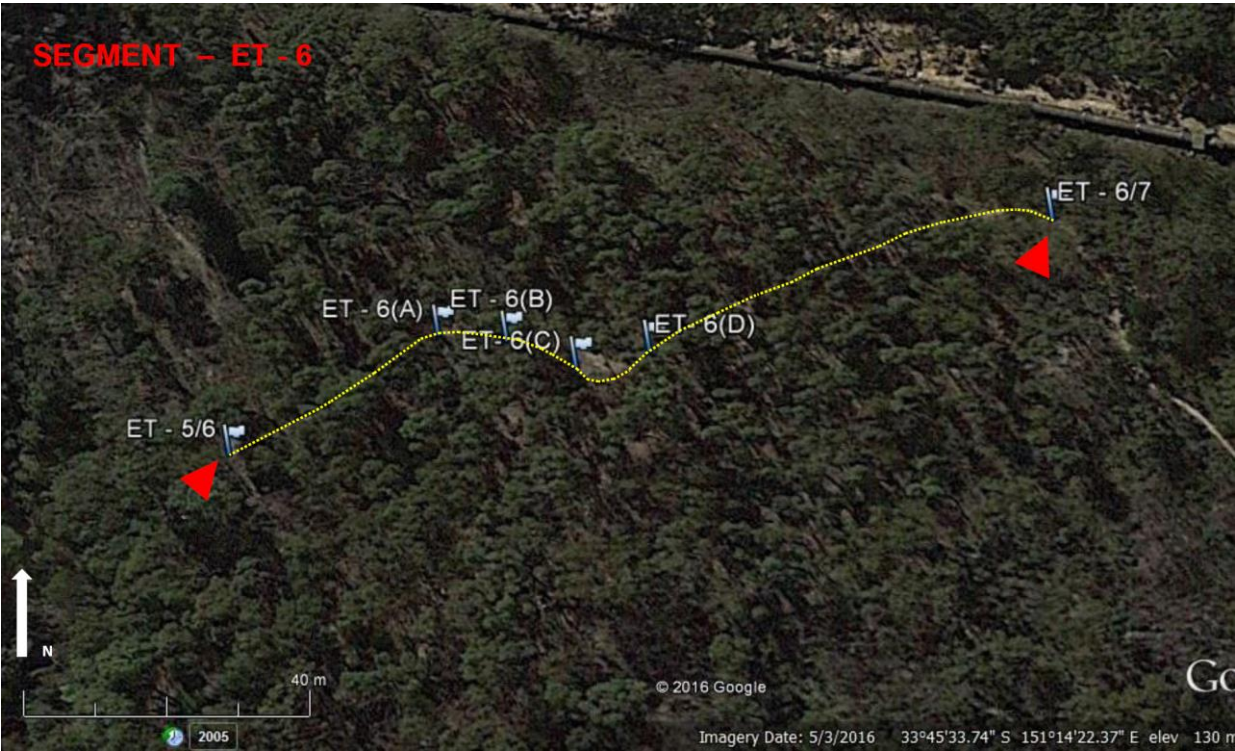
<b>SEGMENT: ET - 6</b>	
<b>Start Point: 336904 6263118</b> <b>(junction with ET - 5)</b>	<b>End Point: 336996 6263143</b> <b>(junction with ET - 7)</b>
<p><i>General Description and Condition:</i> Reasonably well-defined, but less frequently maintained, short (120m approx.) section of track sharply up/down a gentle to gentle/moderate rocky slope between the W and E arms of the Eva’s Track “loop” (between ET – 5 in the W, and ET – 7 in the E) – used as an alternative to the pipeline service access – through open Eucalypt woodland. Fair condition.</p> <p><i>Tread Width (mm):</i> Mostly 400-800mm wide, some sections to 1,300mm on rocky slopes.</p> <p><i>Track Surface:</i> Compacted sand, slightly dished in places, with some laterite gravel and embedded rock, occasional larger rock outcrops and ledges, more embedded rocks and gravels on upper/E section, drainage capture and flows downs track but areas of erosion and guttering only on steeper slopes in middle section (timber waterbars/steps limit erosion elsewhere, even where full/failed).</p> <p><i>Gradient (degrees):</i> Gentle/moderate slope in lower/W (5-9° gradient) and upper/E (9° gradient) sections, with moderate slope (14° gradient) in middle section.</p> <p><i>Alignment:</i> Slightly curving up/down rocky hillslope.</p> <p><i>Terrain:</i> Upper hillslope.</p> <p><i>Soil:</i> Lambert (Erosional) undulating to rolling low hills on Hawkesbury Sandstone.</p> <p><i>Vegetation:</i> Bloodwood-Scribbly Gum Woodland.</p> <p><i>Track Works and Improvements:</i> 15 timber sleeper waterbars/steps and waterbars, all full of sediment and failed with flows over but only limited downside scouring, some older log waterbars/steps most burnt/unserviceable (and some log treatments located off track - former alignment ?).</p>

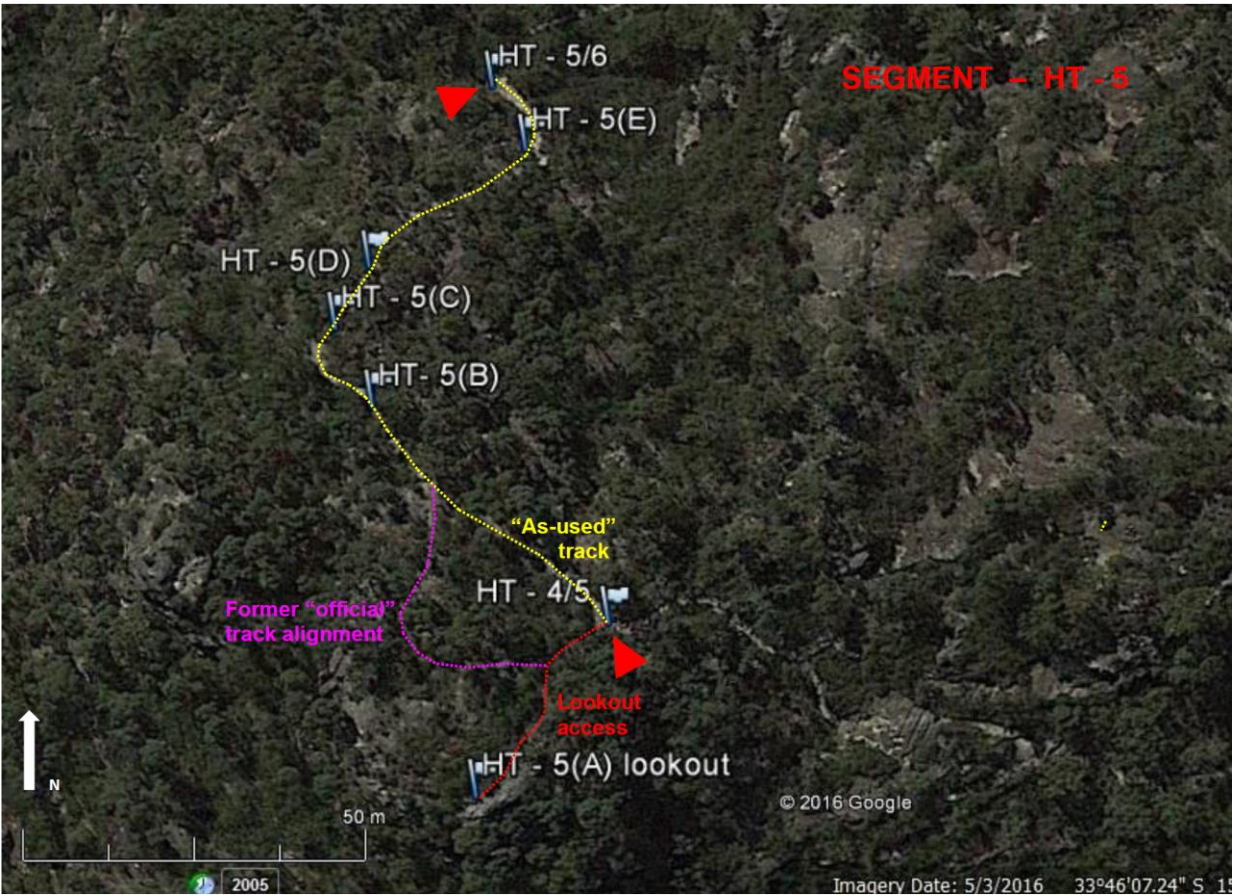
<b>SEGMENT: HT - 5</b>	
<b>Start Point: 337528 6262081</b>	<b>End Point: 337511 6262149</b>
<p><i>General Description and Condition:</i> Section of mainly rocky track (120m approx.) up/down and across a gentle/moderate gradient rocky slope off N side of rocky knoll, passes below rock ledge at N end. Good condition overall, short sections up/down rocky outcrops/ledges in fair condition only. Former alignment of Heath Track, now largely dis-used, off S end of segment looping over top of crest on rocky knoll.</p> <p><i>Tread Width (mm):</i> 700-1,200mm, with wider sections to 1,800mm around obstacles (or step avoidance).</p> <p><i>Track Surface:</i> Extensive rock outcrops and pavement especially in S, frequent "natural" rock steps, sections of compacted sand and occasional roots more frequent in N. Regular drainage capture and flows down track, but limited erosion due to surface rockiness.</p> <p><i>Gradient (degrees):</i> Gentle/moderate gradient overall (3-5° gradients) but short rocky outcrops/ledges at moderate slopes (10-11° gradients). Flatter section in N where track runs below base of rock ledge.</p> <p><i>Alignment:</i> Mostly straight up/down slope in upper S section, curving up/down rocky hillside in lower N section.</p> <p><i>Terrain:</i> Upper hillslope, and ridge/crest in S.</p> <p><i>Soil:</i> Lambert (Erosional) undulating to rolling low hills on Hawkesbury Sandstone.</p> <p><i>Vegetation:</i> Mostly Bloodwood-Scribbly Gum Woodland, enters Sandstone Heath at N end.</p>

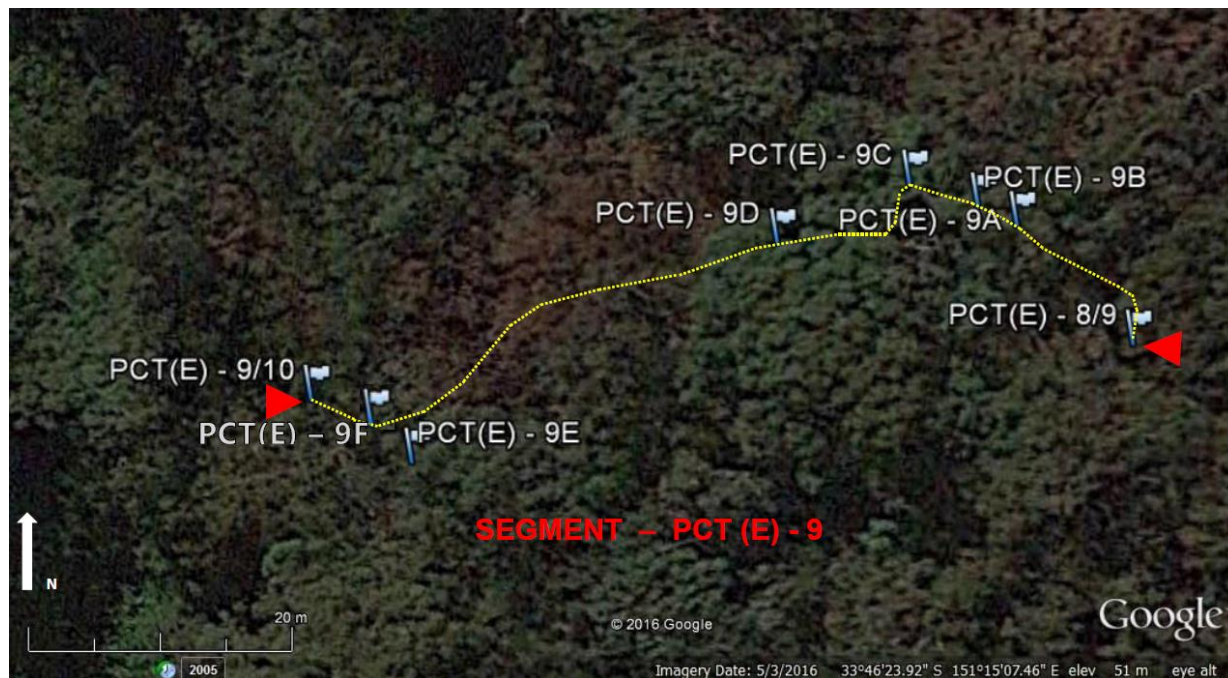
<b>SEGMENT: PCT(E) - 9</b>	
<b>Start Point: 338172 6261603</b>	<b>End Point: 338124 6261598</b> <b>(junction with Segment DSB - “Dam Shoreline Boardwalk”)</b>
<p><i>General Description and Condition:</i> A 60m (approx.) section of track up/down a lower hillslope (from dam level) with two distinct sections - a short section of steep braided/dual track around rock outcrops and steep rocky chutes at the upper/E end, and a longer more moderate/gentle slope below. Junction with the “Dam Shoreline/Boardwalk” at the lower/W end. Trample track and eroded gutter joins from upslope (N-NE) above upper rocky section.</p> <p><i>Tread Width (mm):</i> 700-1500mm (varies abruptly through upper rocky section).</p> <p><i>Track Surface:</i> Moist sandy/loam and roots on upper section; then embedded sandstone boulders/rocks and outcrop/ledges with compacted sand and gravels on steep rocky section; to compacted and loose sand with occasional rocks on lower section.</p> <p><i>Gradient (degrees):</i> Steep and very steep drops (+25°) over rock ledges and chutes on upper section (although overall grade is gentle/moderate, approx. 7-8.5°); and gentle grades (5°) on lower section.</p> <p><i>Alignment:</i> Sharp turn downslope (W) from Segment 9 at top, then curving alignment on slope.</p> <p><i>Terrain:</i> Lower hillslope beside drainage line.</p> <p><i>Soil:</i> Lambert (Erosional) – undulating to rolling low hills on Hawkesbury Sandstone.</p> <p><i>Vegetation:</i> Bloodwood Scribbly Gum Woodland.</p> <p><i>Track Works and Improvements:</i> Long series of step-and runs on lower slope (mainly timber sleepers, some stone and logs).</p> <p><i>Signs and Wayfinding:</i> Old directional arrows on log posts.</p>

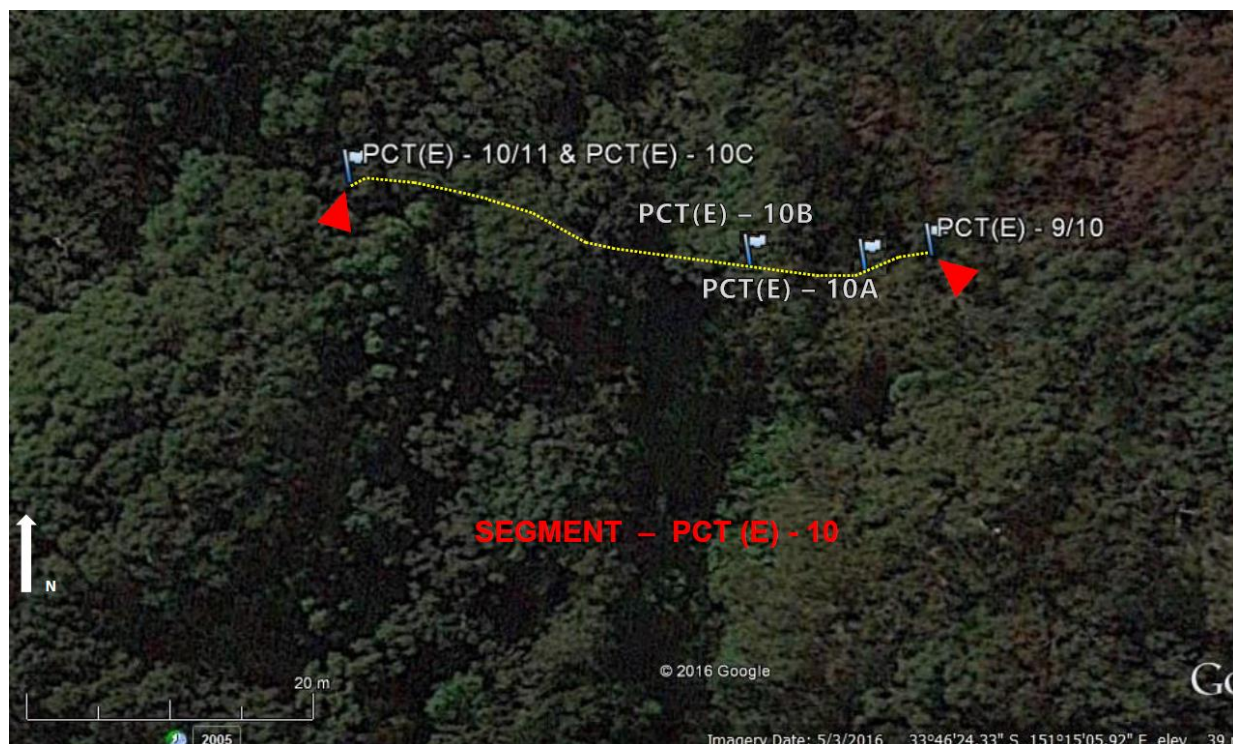
<b>SEGMENT: PCT(E) - 10</b>	
<b>Start Point: 338124 6261598</b> (junction with Segment DSB - “Dam Shoreline Boardwalk”)	<b>End Point: 338078 6261603</b>
<p><i>General Description and Condition:</i> Short section of track (42m approx.) across a wide vegetated creek with gentle timbered slopes both sides.</p> <p><i>Tread Width (mm):</i> 1,000-1,200mm wide on E slope. Bridge 1,200mm wide. 700-1,000mm wide on W slope.</p> <p><i>Track Surface:</i> Fibreglass reinforced plastic low bridge. Sandy clay and embedded rock and occasional roots on E slope. Compacted, and some loose/deposited, sand on W slope.</p> <p><i>Gradient (degrees):</i> Gentle/moderate grade on both approach slopes, 7.5°.</p> <p><i>Alignment:</i> Largely straight, gently curved on W slope.</p> <p><i>Terrain:</i> Wide vegetated creek, in board gently sloped valley. ,with g</p> <p><i>Soil:</i> Lambert (Erosional) – undulating to rolling low hills on Hawkesbury Sandstone.</p> <p><i>Vegetation:</i> Bloodwood-Scribbly Gum Woodland on E slope, creek mapped as “Artificial Wetland”, and Peppermint Angophora Forest on W slope.</p> <p><i>Track Works and Improvements:</i> Fibreglass reinforced plastic low bridge (no handrails) over wide weedy creek (braided channels), site PCT(E) - 10B, 1,200mm wide and 20m long (approx.) with drop to vegetated bed of +1m in places – good condition. Timber steps and waterbar on E approach to bridge – fair condition. Extended series of timber sleeper and log step-and-runs, with timber sleeper waterbar at top, on W approach to bridge – good/fair condition (entrenched to 400mm below NSL with flows down, but no active erosion).</p> <p><i>Signs and Wayfinding:</i> Log post with metal directional arrows at E end.</p>

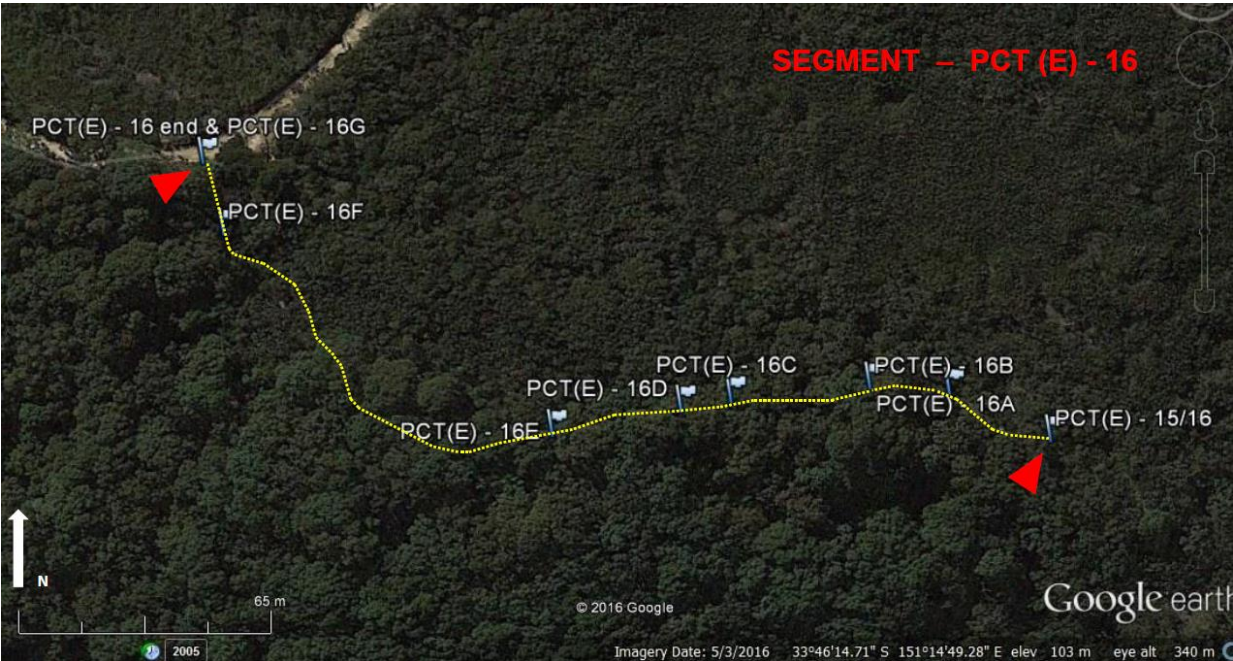
<b>SEGMENT: PCT(E) - 16</b>	
<b>Start Point: 337769 6261850</b>	<b>End Point: 337579 6261908</b> <b>(Perimeter Fire Trail and Shared Path)</b>
<p><i>General Description and Condition:</i> Mostly flat to gently undulating track (260m approx.), largely along contour across an upper hillslope with several on-ground or low boardwalks sections, though attractive Angophora forest. Junction with Perimeter Fire Trail and Shared Path at NW end.</p> <p><i>Tread Width (mm):</i> 600-1,200mm.</p> <p><i>Track Surface:</i> Mostly compacted sand and rock pavements, with occasional roots and embedded rocks. 65m (approx.) of boardwalk in 4 sections – 3 as on-ground timber boardwalk 1,200mm wide (fair to good condition), and 1 section of new fibreglass reinforced plastic boardwalk 900mm wide at NW end (good condition). Frequent seepage onto/across track with occasional ponding. Occasional concrete waste from adjacent sewer line.</p> <p><i>Gradient (degrees):</i> Flat to 3°.</p> <p><i>Alignment:</i> Very gently curving, with bend to junction with Perimeter Fire Trail and Shared Path at NW end.</p> <p><i>Terrain:</i> Upper hillslope, along break in slope or gentle/moderate cross slope, with steeper drop off track at one location (PCT(E) – 16C).</p> <p><i>Soil:</i> Hawkesbury (Colluvial) on rugged, rolling to very steep hills on Hawkesbury Sandstone.</p> <p><i>Vegetation:</i> Along boundary of Peppermint Angophora Forest downslope and Sandstone Heath upslope for E two-thirds, and Sandstone Heath at W end.</p> <p><i>Track Works and Improvements:</i> 4 sections of boardwalk (total 65m approx.) – 3 on-ground timber boardwalk, and 1 section of new fibreglass reinforced plastic boardwalk (with single steps) at NW end. Occasional log waterbar.</p>
