## **GEOTECHNICAL INVESTIGATION:**

New House and Pool at **327 McCarrs Creek Road, Terrey Hills**

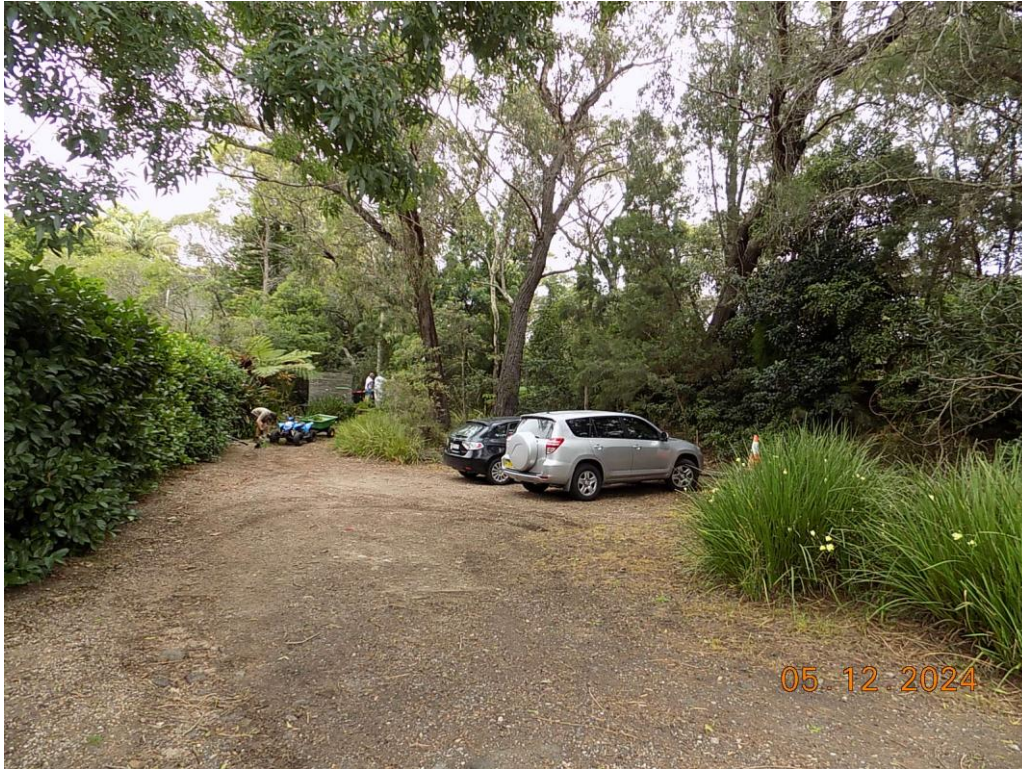
Photo 1

- 2.3** At the road frontage, a concrete driveway runs to a gravel parking area on the uphill side of the property (Photo 1). The driveway diverts to a large shed in the NW corner of the property (Photo 2). The cut for the shed is supported by a stable sandstone log retaining wall reaching ~1.9m high (Photo 3). In the SW corner of the property, the two-storey brick house is supported on brick walls. No significant signs of movement were observed in the visible supporting walls. The house will be demolished as part of the proposed works. The steeply battered but well vegetated cut for the house on the uphill sides rises ~1.5m to the S common boundary, and

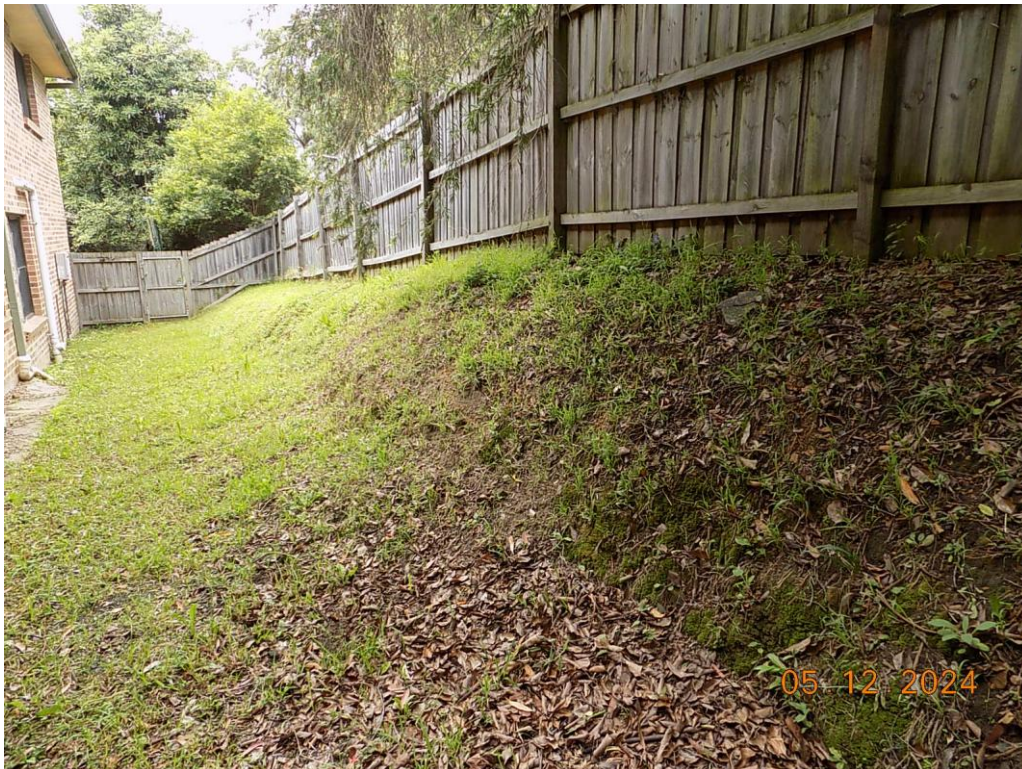
Photo 4

returns along the W side of the house. This cut is currently considered stable (Photo 4).

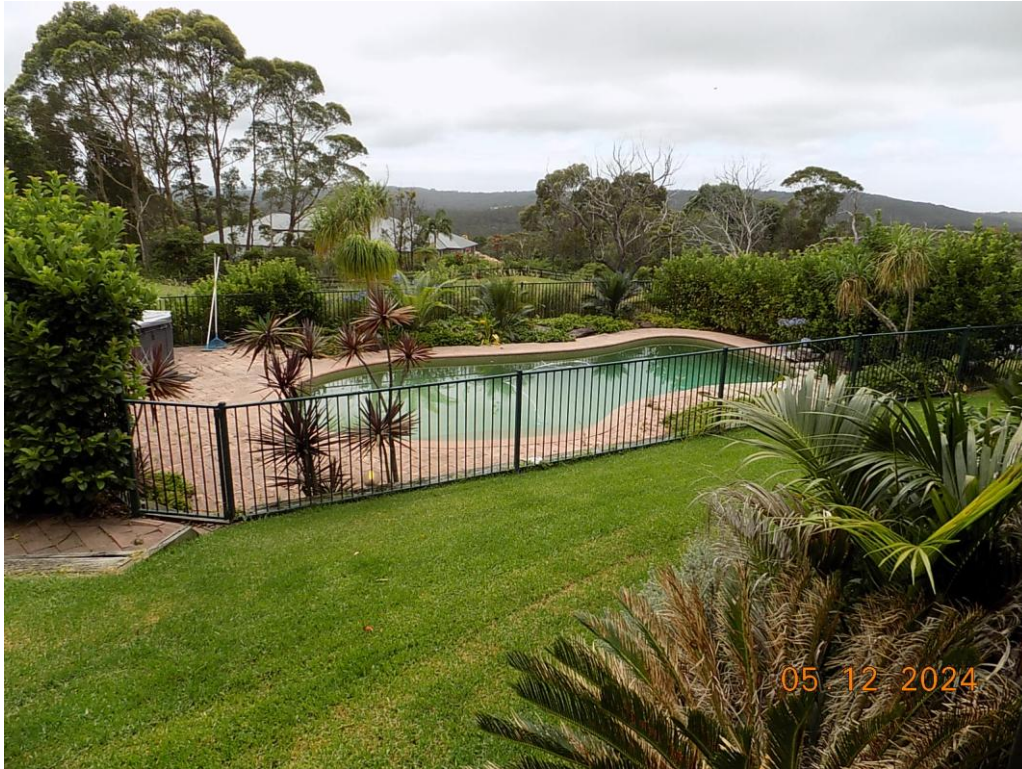
Photo 5

A gently-sloping lawn extends off the downhill side of the house to a pool which has been cut into the slope (Photo 5). The pool shows no signs of movement and will also be demolished. Competent Medium Strength Sandstone was observed to be outcropping S of the pool (Photo 6). The outcropping rock in this location was observed to be slightly undercut but is considered stable. A cut and fill has been made in the slope below the pool for a large level paddock. The cut is supported by a stable timber retaining wall ~1.4m high (Photo 7). The fill is supported by a stepped timber retaining wall reaching ~2.5m high (Photo 8). The E corner of the lower step of the wall was measured to be tilting downslope ~6° from vertical, however this wall will be demolished as part of the proposed works. The slope surrounding this paddock is lawn-covered and falls gently to the lower common boundary.

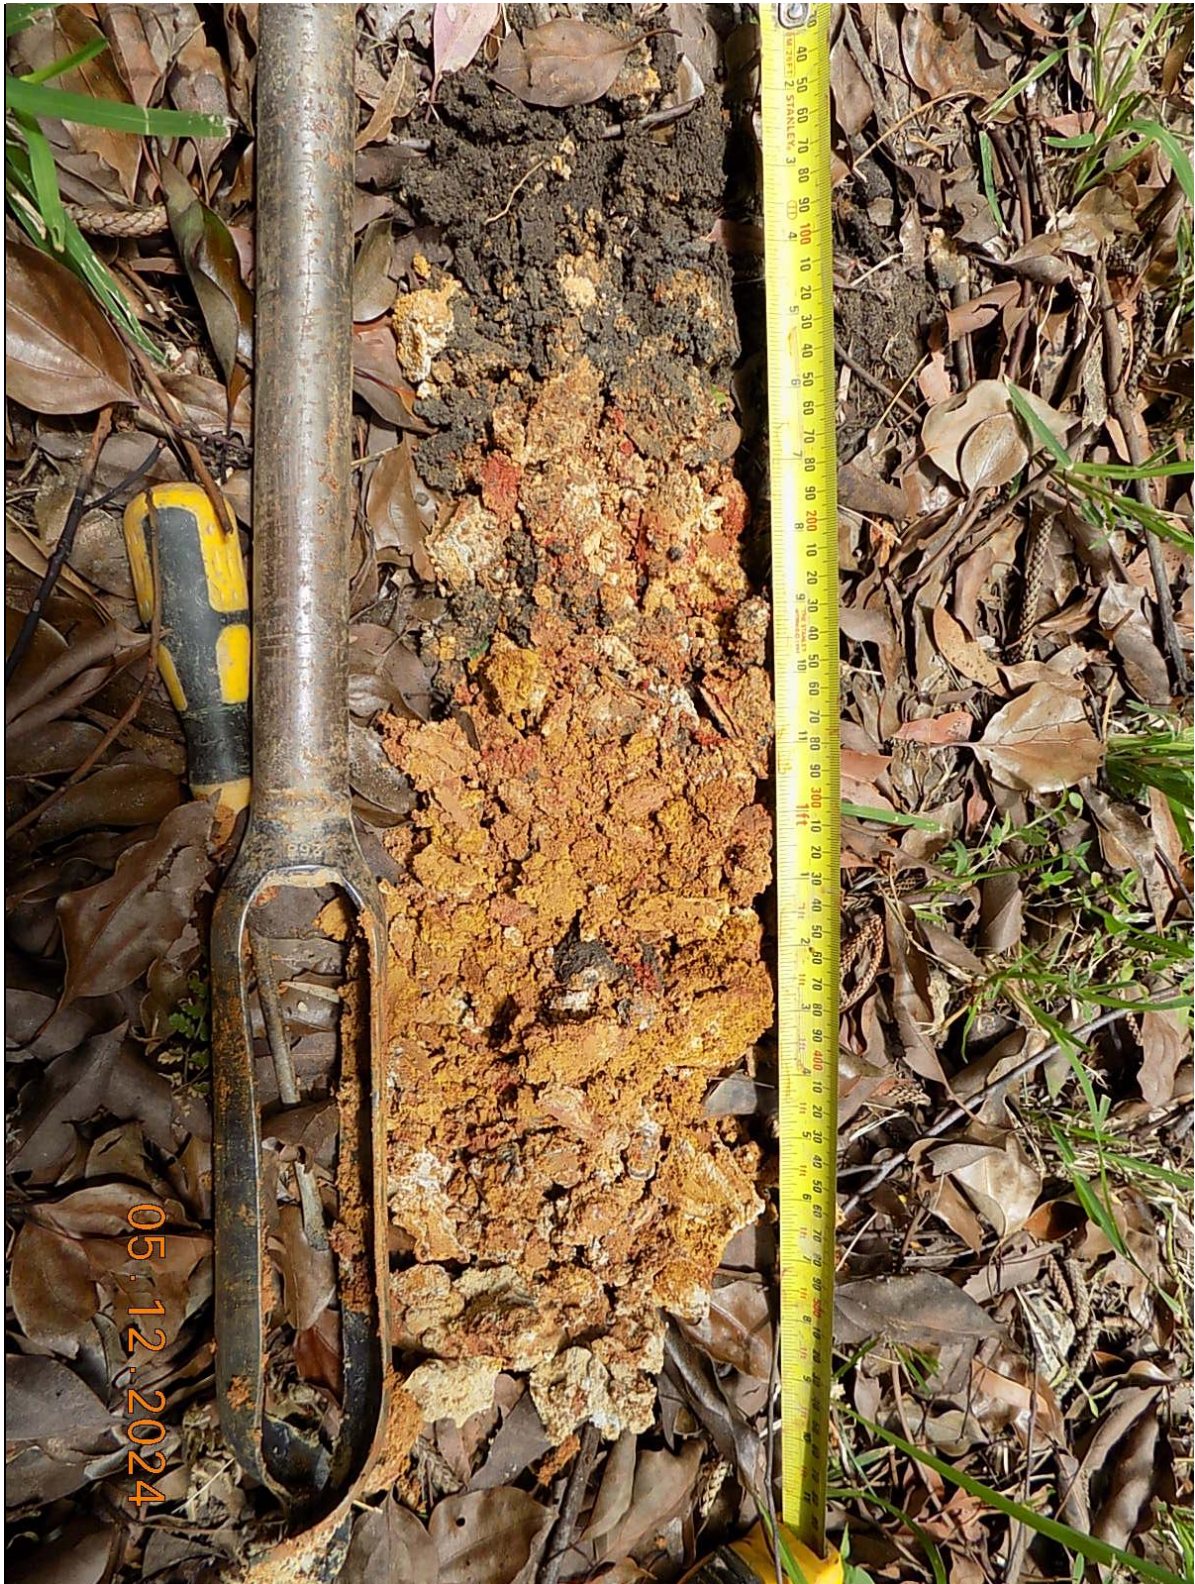
## AUGER HOLE 1 (~RL207.5) – AH1 (Photo 9)

Depth (m)	Material Encountered
0.0 to 0.2	<b>TOPSOIL</b> , clayey soil, brown, Stiff, dry, Fine to Medium grained.
0.2 to 0.5	<b>RESIDUAL CLAY</b> , sandy clay, derived from weathered sandstone, mottled orange, maroon and grey, Very Stiff, dry, Fine to Medium grained.

Refusal @ 0.5m on rock. Auger grinding. No water table encountered.

Photo 9 – downhole is top to bottom
