Report Title: Geotechnical Report 283 Hudson Parade, Clareville
Report Date: 12/5/21

GEOTECHNICAL INVESTIGATION:

Alterations and Additions at **283 Hudson Parade, Clareville**

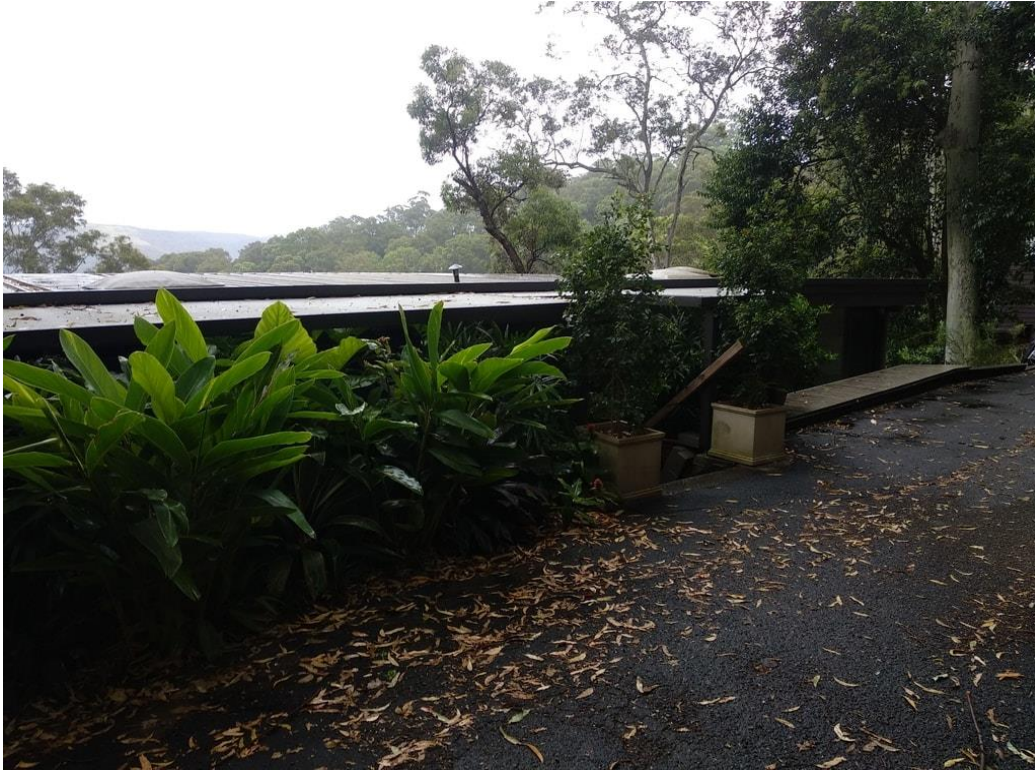
Photo 3

supported by steel posts and concrete piers (Photos 3 to 5). The supporting posts and piers show no significant signs of movement (Photos 5 & 6). Stable timber, brick and sprayed concrete retaining walls up to ~1.6m support cuts for the lower ground floor of the house.

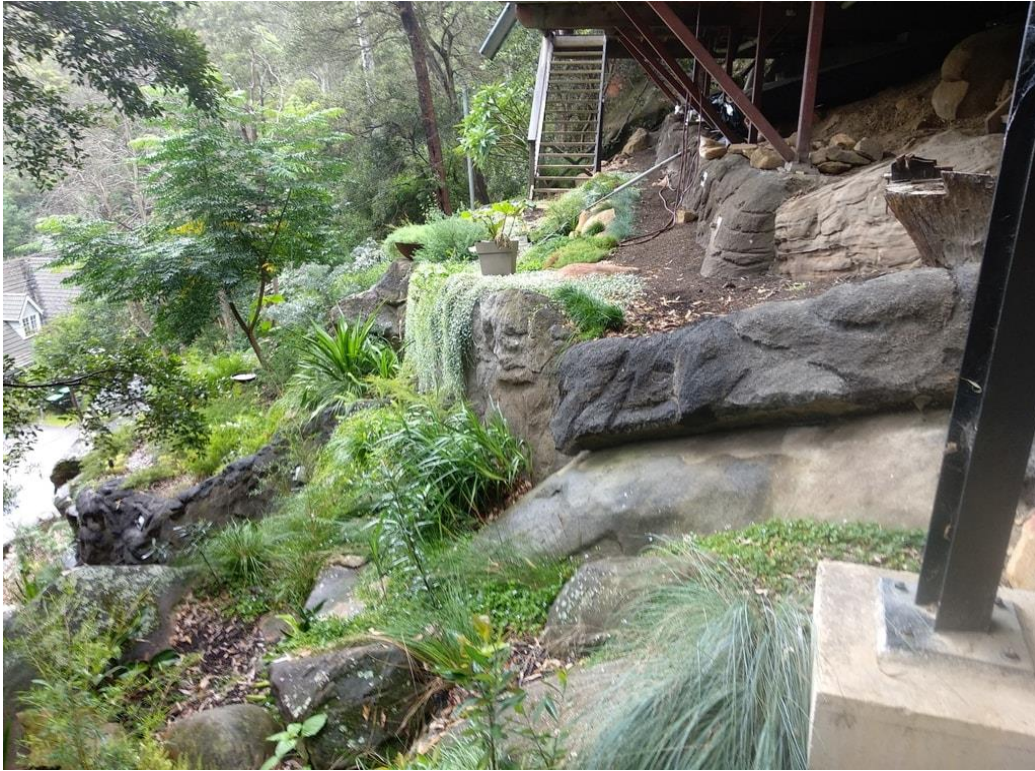
Photo 7

Fill provides level platforms for garden areas on the downhill side of the house (Photo 7). Stable sprayed concrete retaining walls up to ~1.7m high support the fill. Slope Stabilisation works appear to have recently been carried out on the site. This includes stabilisation of the downhill row of house piers with anchors and the installation of a low sprayed concrete and anchored wall immediately below the piers (Photo 8). One of the rock exposed has been anchored (Photo 9) as well a recently constructed garden bed lower on the slope. Sandstone bedrock and detached joint blocks are exposed at the surface at various locations across the property (Photos 10 to 12). The rocks are in stable positions on the slope. A watercourse runs down the slope along the W property boundary (Photos 13 & 14). During the inspection, water was observed flowing in the watercourse which diverged midway down the slope into three separate flow paths before converging near the downhill property boundary and entering a stormwater drain at the Hudson Parade road reserve (Photos 15 & 16).

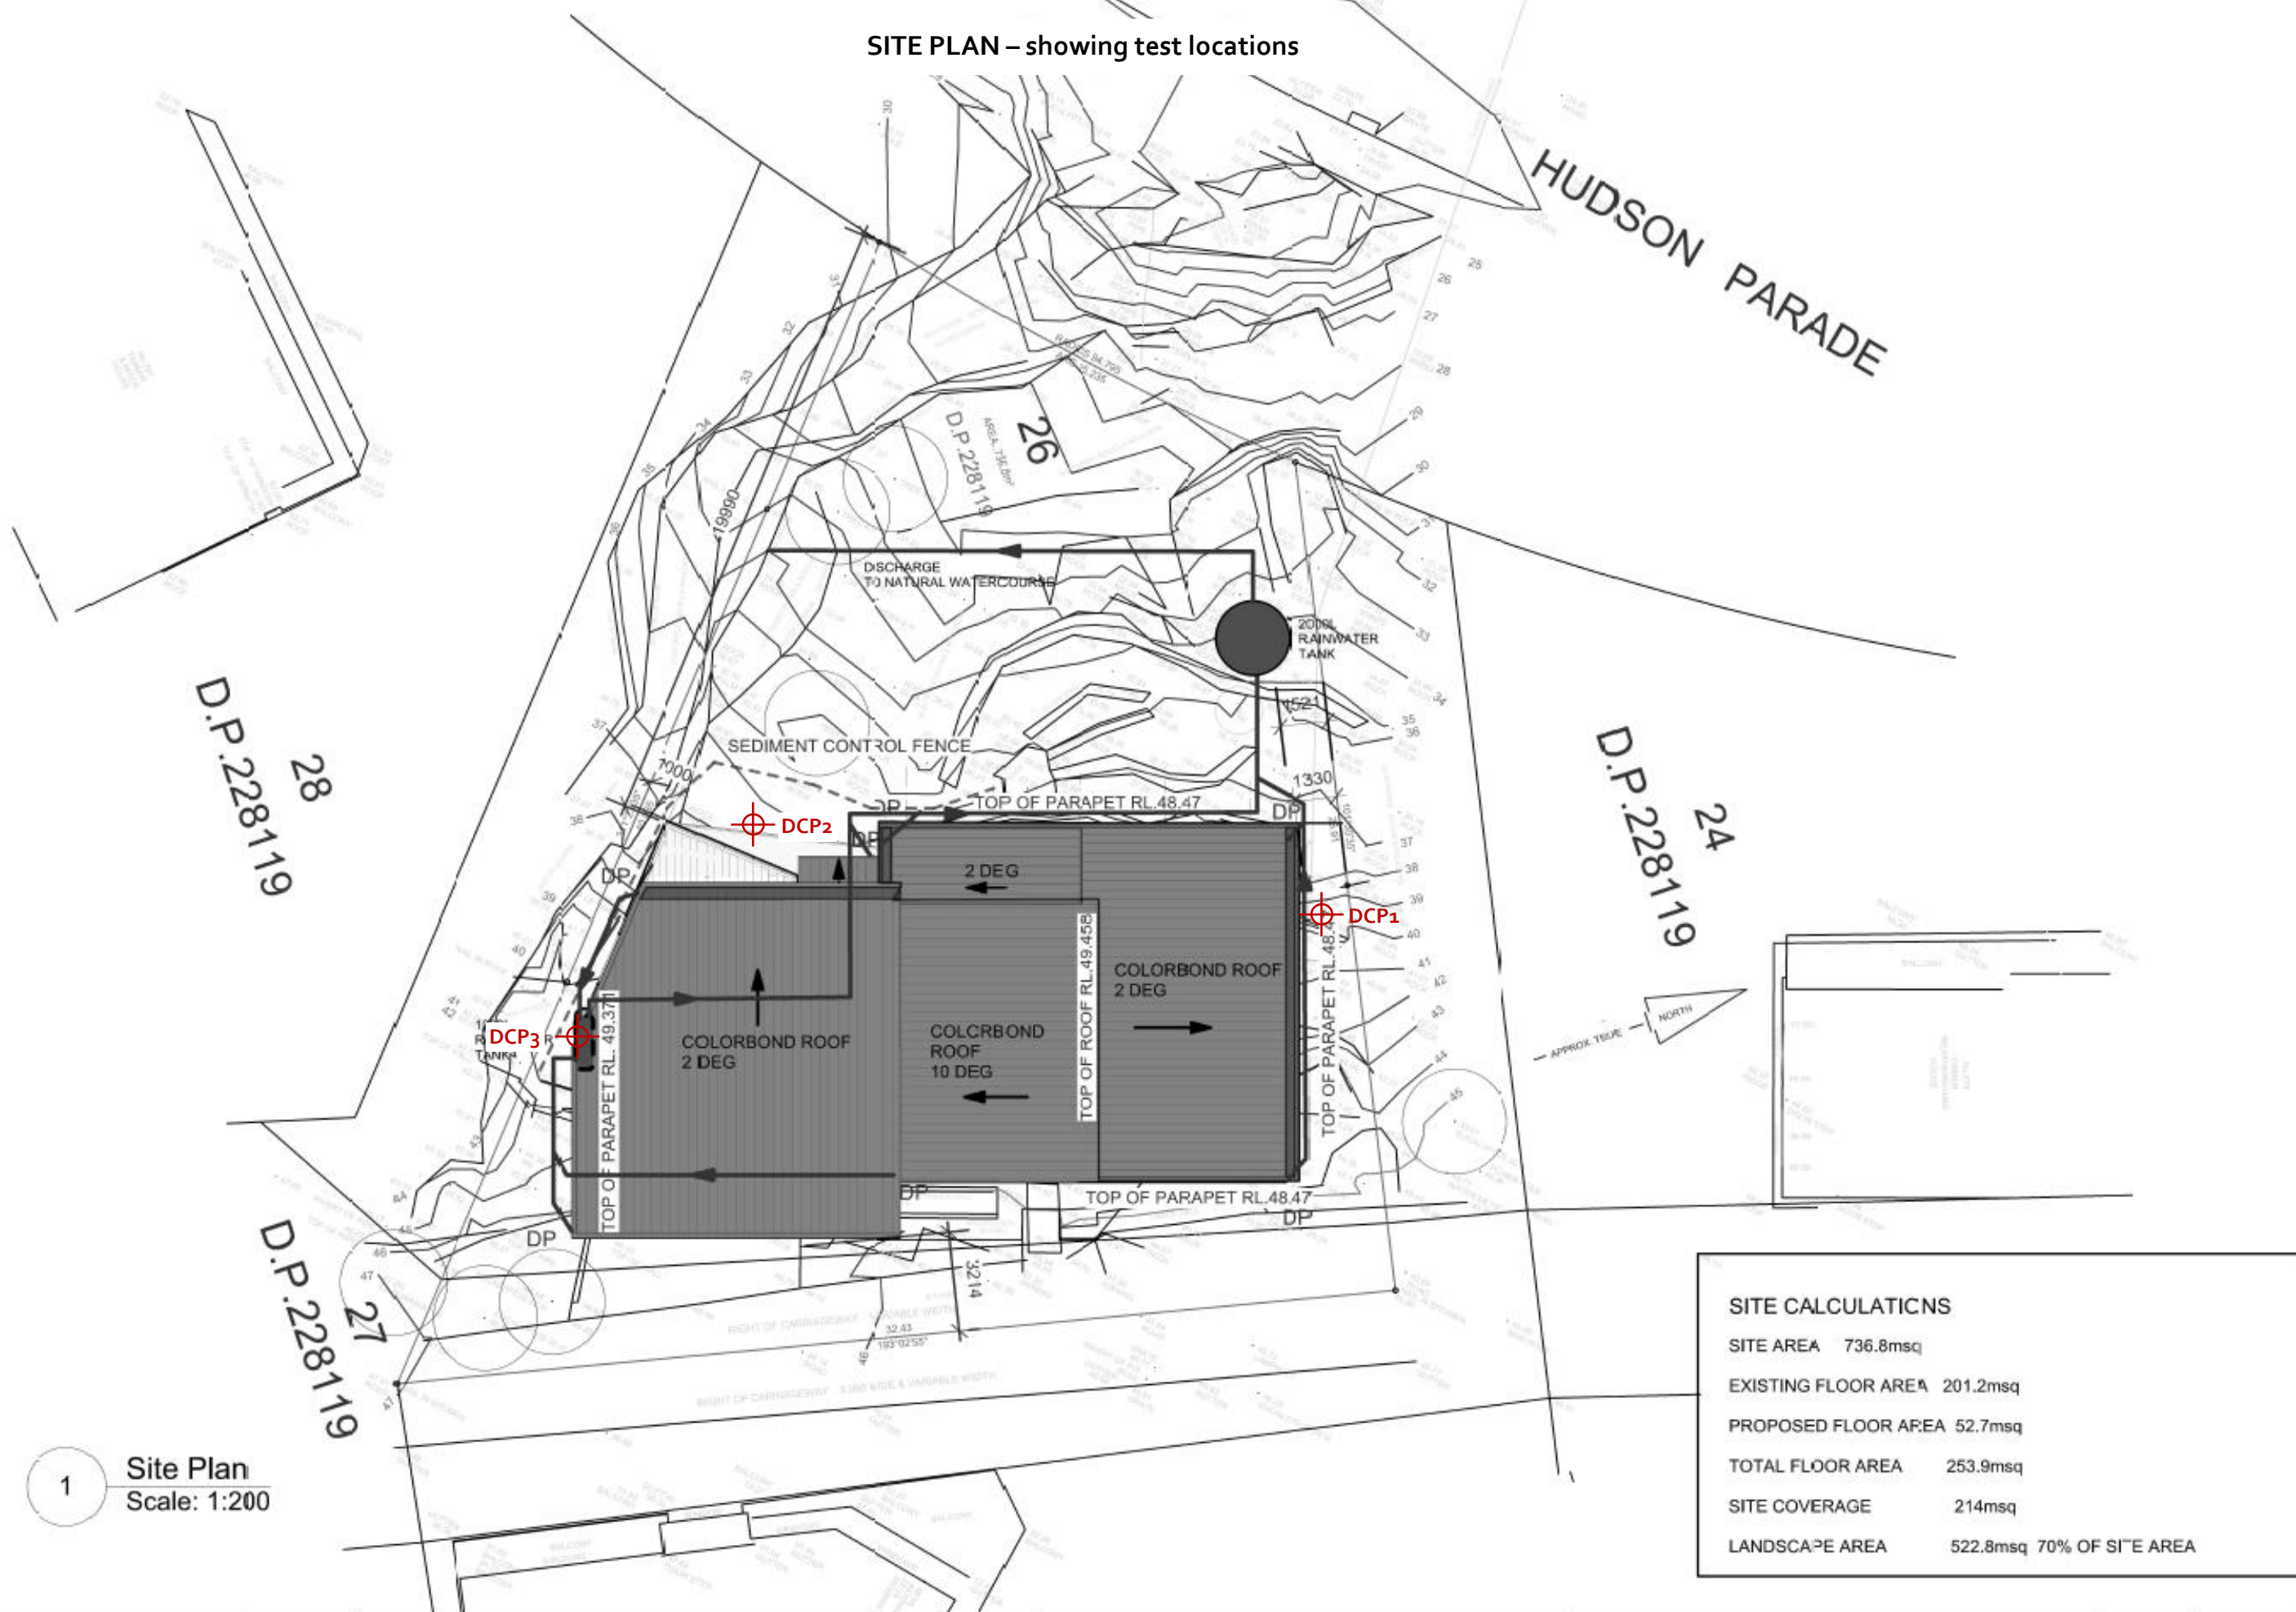
1 Site Plan
Scale: 1:200

Three Dynamic Cone Penetrometer (DCP) tests were put down to determine the relative density of the overlying soil and the depth to weathered rock. The locations of the tests are shown on the site plan. It should be noted that a level of caution should be applied when
