Report Title: Geotechnical Report 1 Belinda Place, Newport  
Report Date: 11/7/23  
Author: BEN WHITE  
Author's Company/Organisation: WHITE GEOTECHNICAL GROUP PTY LTD

## **GEOTECHNICAL INVESTIGATION:**

### **Alterations and Additions at 1 Belinda Place, Newport**

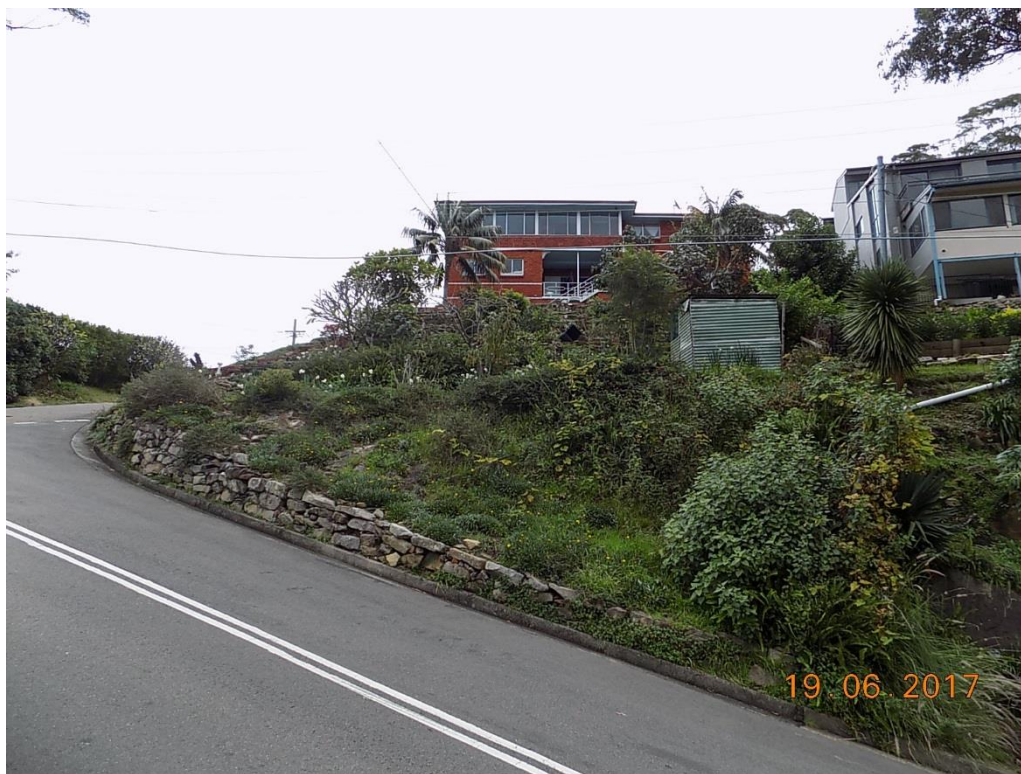
Photo 1

**2.3** At the road frontage to Belinda Place, a steep densely vegetated slope rises to the downhill side of the house (Photo 1). The slope has been terraced with a series of low stable rough stack rock retaining walls (Photo 2). A near-level lawn covered fill extends off the downhill side of the house and is supported by a low brick retaining wall (Photo 3). Competent Medium Strength Hawkesbury Sandstone outcrops at the road frontage to Cheryl Crescent (Photo 4). A steep densely vegetated slope rises from this road frontage to the S side of the house. The two-storey brick house is supported on brick walls (Photo 5). The external supporting brick walls display no significant signs of movement. A Right of Carriageway (ROW) off Cheryl Crescent provides access to the property on the W side (Photo 6). A concrete driveway runs from the ROW to a garage on the lower ground floor of the house (Photo 7). The W side of the house is terraced with two low stable timber retaining walls. Sandstone flagging up to ~2.3m high lines a cut and fill on the N side of house (Photo 8).

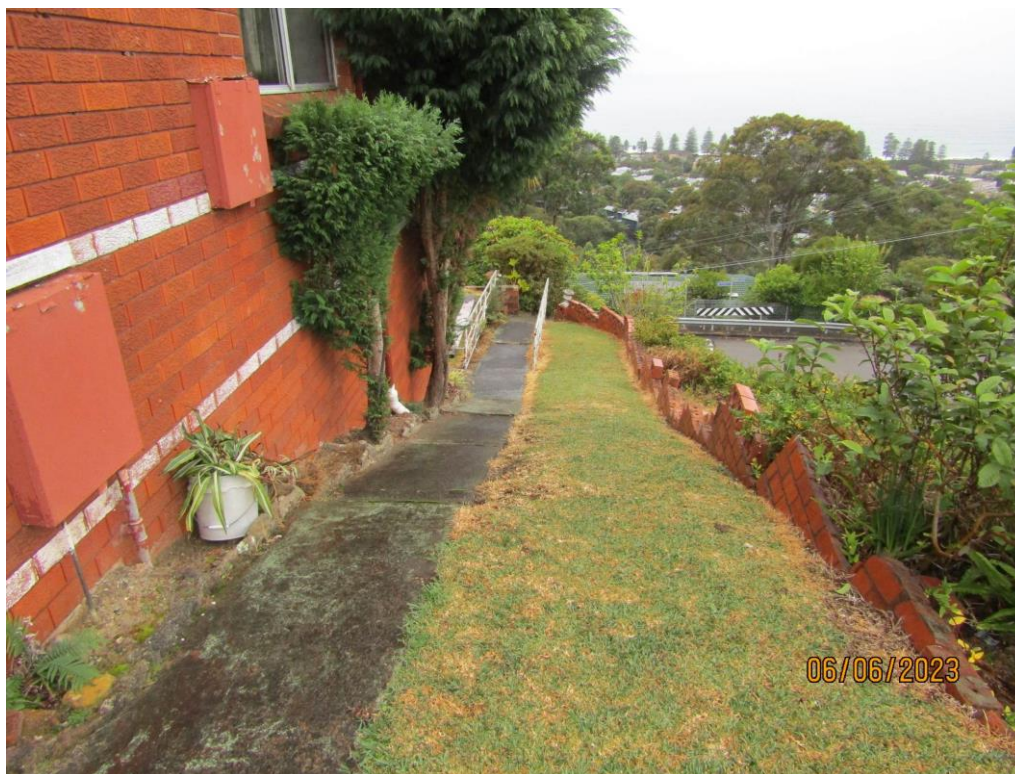
Photo 9

Allowing for backwall drainage, the excavation for the pathway/steps is set back ~1.0m from a low tilting brick fence on the subject property (Photo 9). The low brick fence will be within the zone of influence of the excavation. In this instance, the zone of influence is the area above a theoretical 30° line (from horizontal) through fill/soil and a 45° line through clay from the base of the excavation or the top of Medium Strength Rock, whichever comes first,

The low tilting brick fence (Photo 9) is to be demolished prior to the excavation commencing.

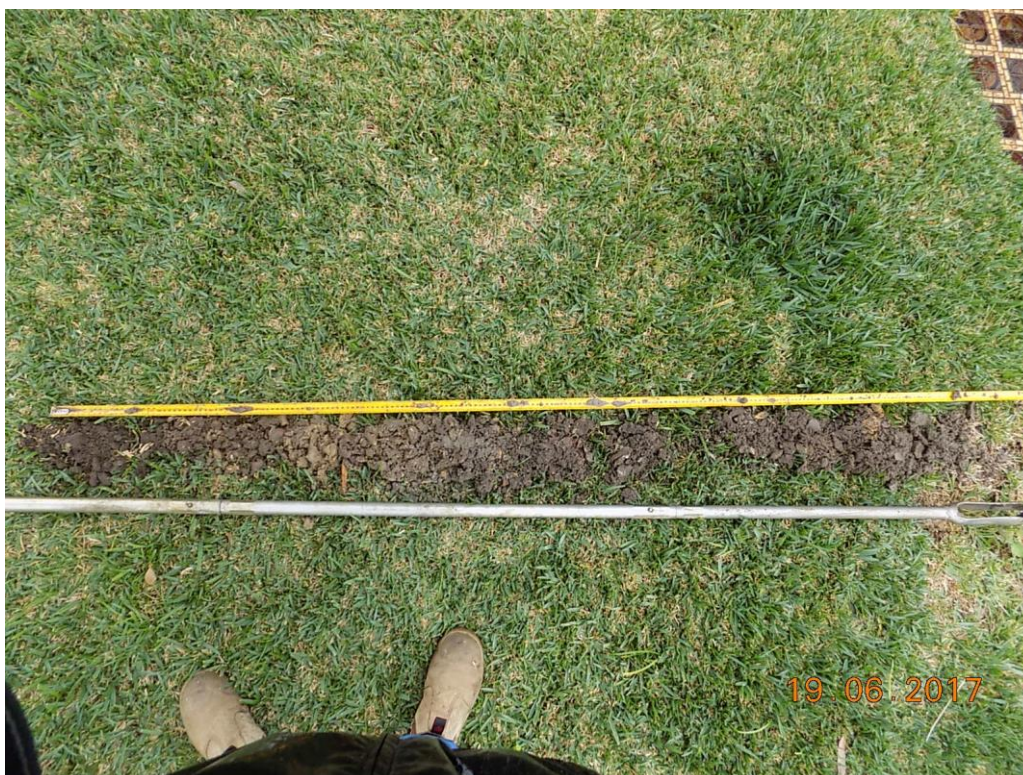
## AUGER HOLE 1 (~RL97.6) – AH1 (Photo 10)

| Depth (m) | Material Encountered |
|---|---|
| 0.0 to 0.2 | <b>TOPSOIL</b> , sandy soil, dark brown, fine to coarse grained with fine trace organic matter. |
| 0.2 to 2.2 | <b>FILL</b> , disturbed sandy soil, dark brown, fine to coarse grained with fine trace organic matter, trace clay, and rocks throughout. |

End of test @ 2.2m in sandy fill. No water table encountered.

Photo 10: AH1 – Downhole is from left to right.

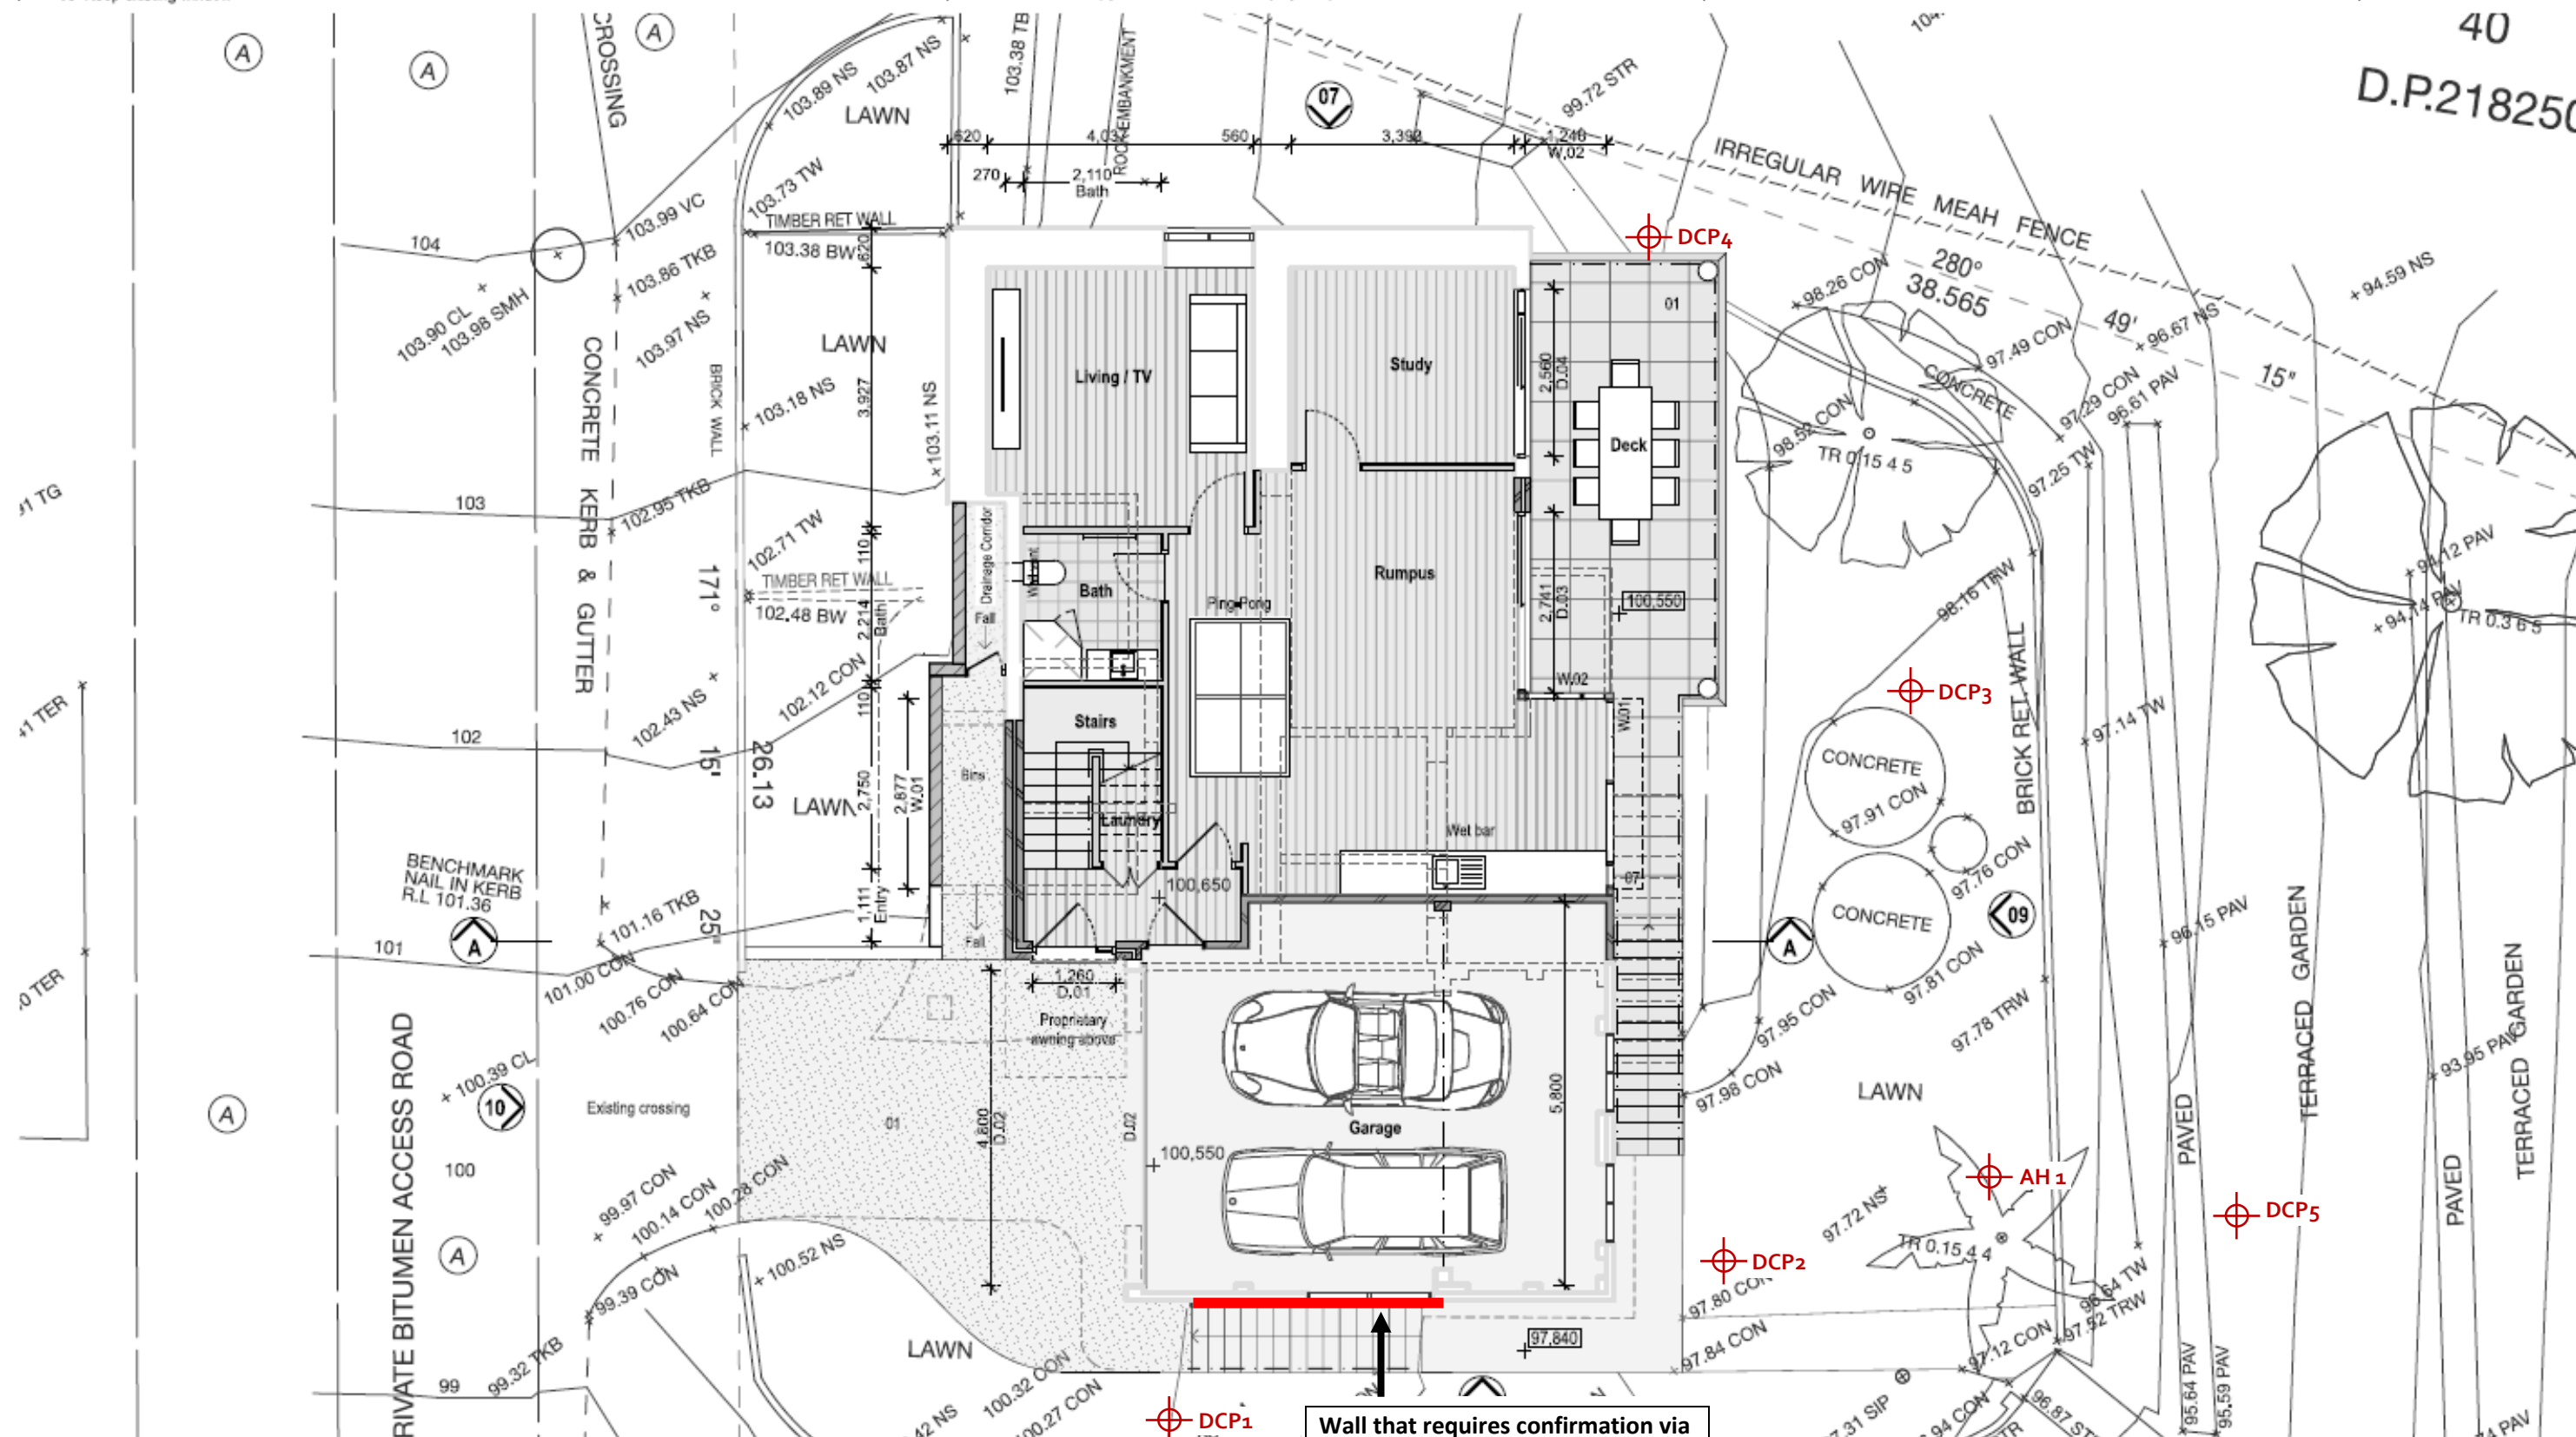
The subject brick wall (where it does not extend to the storage level below the house) may be supported on rock. However, to be sure, exploration pits along the wall will need to be put down by the builder to determine the foundation depth and material. These are to be inspected by the geotechnical consultant.

**Wall that requires confirmation via exploration pits shown in red.**

If the foundations are confirmed to be supported on Medium Strength Rock, the excavation may commence. If they are not, the walls will need to be underpinned prior to the excavation commencing. The extent of the area of the required exploration pits/underpinning are shown in red on the attached Ground Floor Plan.

Underpinning is to follow the underpinning sequence 'hit one miss two'. Under no circumstances is the bulk excavation to be taken to the edge of the wall and then underpinned. Underpins are to be constructed from drives that should not exceed 0.6m in width along strip footings and should be proportioned according to footing size for other foundation types. Allowances are to be made for drainage through the underpinning to prevent a build-up of hydrostatic pressure. Underpins that are not designed as retaining walls are to be supported by retaining walls. The void between the retaining walls and the underpinning is to be filled with free-draining material such as gravel.
