REPORT ON GEOTECHNICAL INVESTIGATION

PROPOSED ALTERATIONS AND ADDITIONS

106 PRINCE ALFRED PARADE, NEWPORT, NSW

Project No.: 2021-092.1

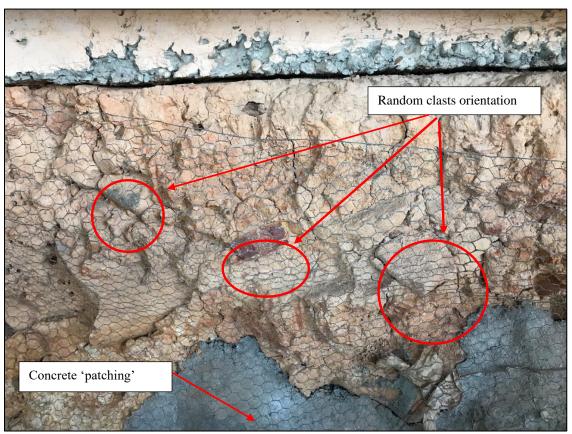
Photograph 2: View of the soil exposed under north end of house

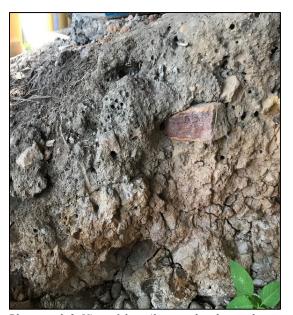
Photograph 3: View of the soil exposed under north end of the site house
