## **ARBORIST REPORT**

### **Arboricultural Hazard Assessment**

114 Lady Davidson Circuit  
Forestville  
NSW 2087

Sydney Arborist  
Paul Shearer 8<sup>th</sup> of February 2014  
Ph: 0423 568 159  
Email: [antony@sydneyarborist.com](mailto:antony@sydneyarborist.com)  
Version 01. Revision 00.

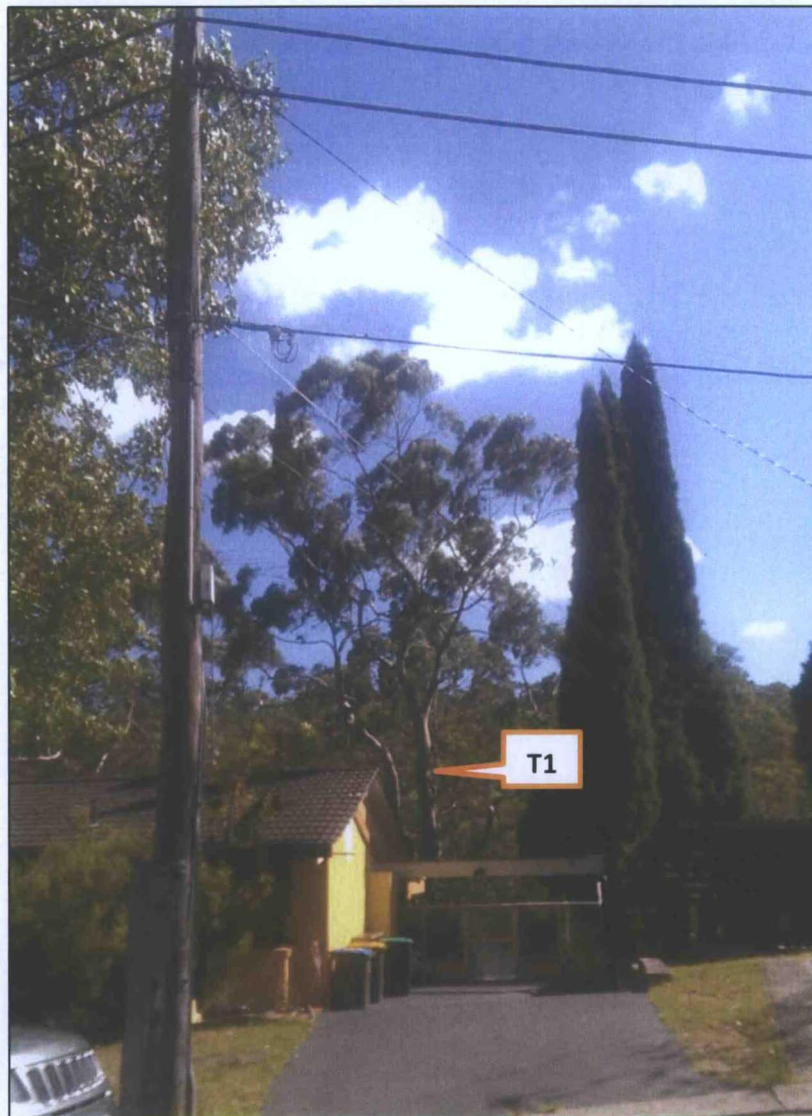
**PHOTOGRAPH 3. (South aspect.)** This photograph taken from Lady Davidson Circuit illustrates the landscape significance of the tree (T1.)

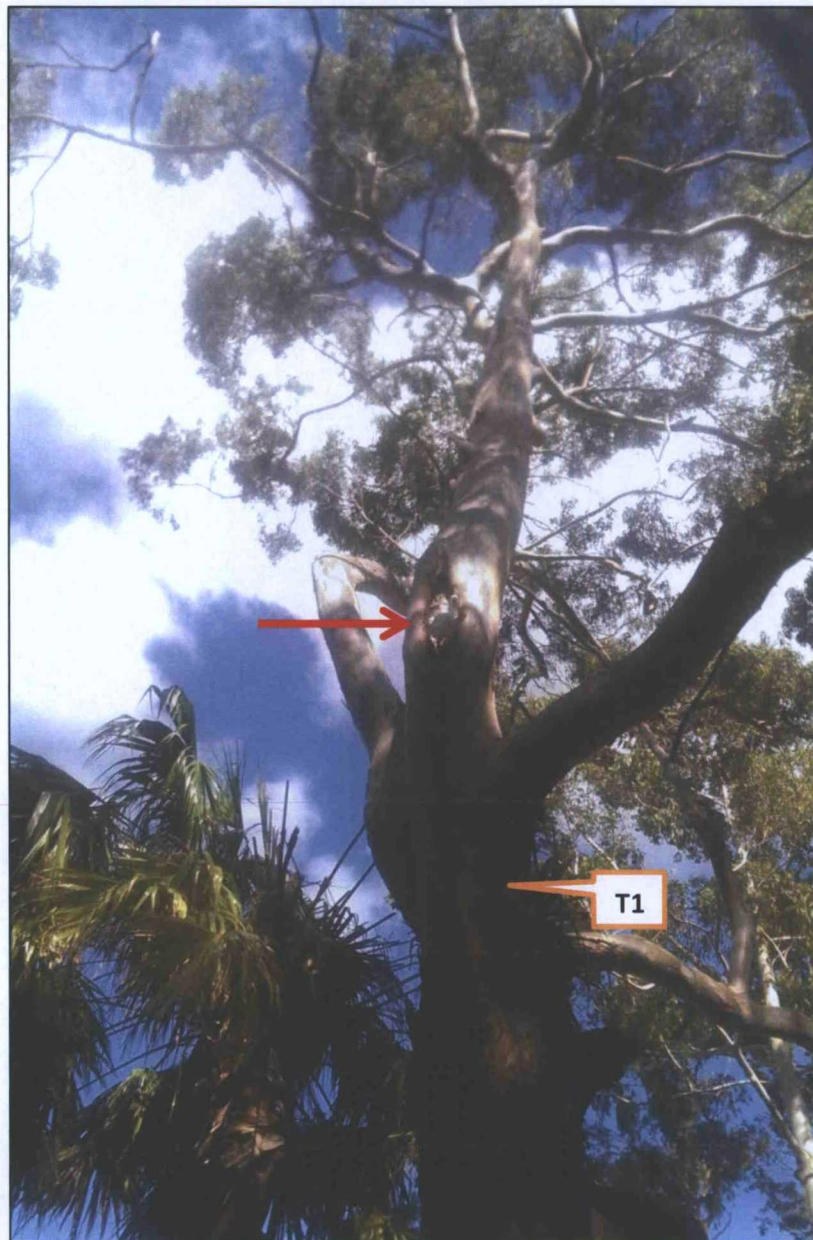
- 4.3 One (1) tree was surveyed for the purpose of producing this report. The subject tree was identified as a Sydney Blue gum (*Eucalyptus saligna*) specimen. The subject species is protected under Warringah LEP 2011. The tree was assessed as a late mature specimen. The tree is considered significant within the context of the site. (Photograph 3) The tree exhibits decay, cavities, a history of pruning, a history of failure, a loss of bark integrity and recently had been pruned to remove deadwood. The tree exhibits a cavity in a large co-dominant stem which had penetrated the stem wall on two (2) sides. Cockatoos appeared to be nesting in the cavity at the time of my on-site inspection. (Photographs 4, 5 & 6) (Further tree detail table 1 following page.)

**PHOTOGRAPH 4. (East aspect) This photograph shows a cockatoo sitting in the cavity (red arrow.)**

- 7.1 The subject tree represents a hazard and should be removed as a matter of safety. (Wires or similar should be contacted to check for cockatoo chicks in the cavity and relocate them if necessary prior to tree works commencing.)
- 7.2 Ideally the tree should be removed to approximately 1 metre above the cavity and retained for the purpose of habitat. If this approach is adopted, remaining limbs from the tree should also be removed. Alternatively; if the tree is removed to ground level, a nesting box should be installed elsewhere on-site to compensate for the loss of habitat.
- 7.3 This report must be submitted with the DA for review by Warringah Council's Tree Management. ***(The tree must not be removed until removal is approved by Council.)***

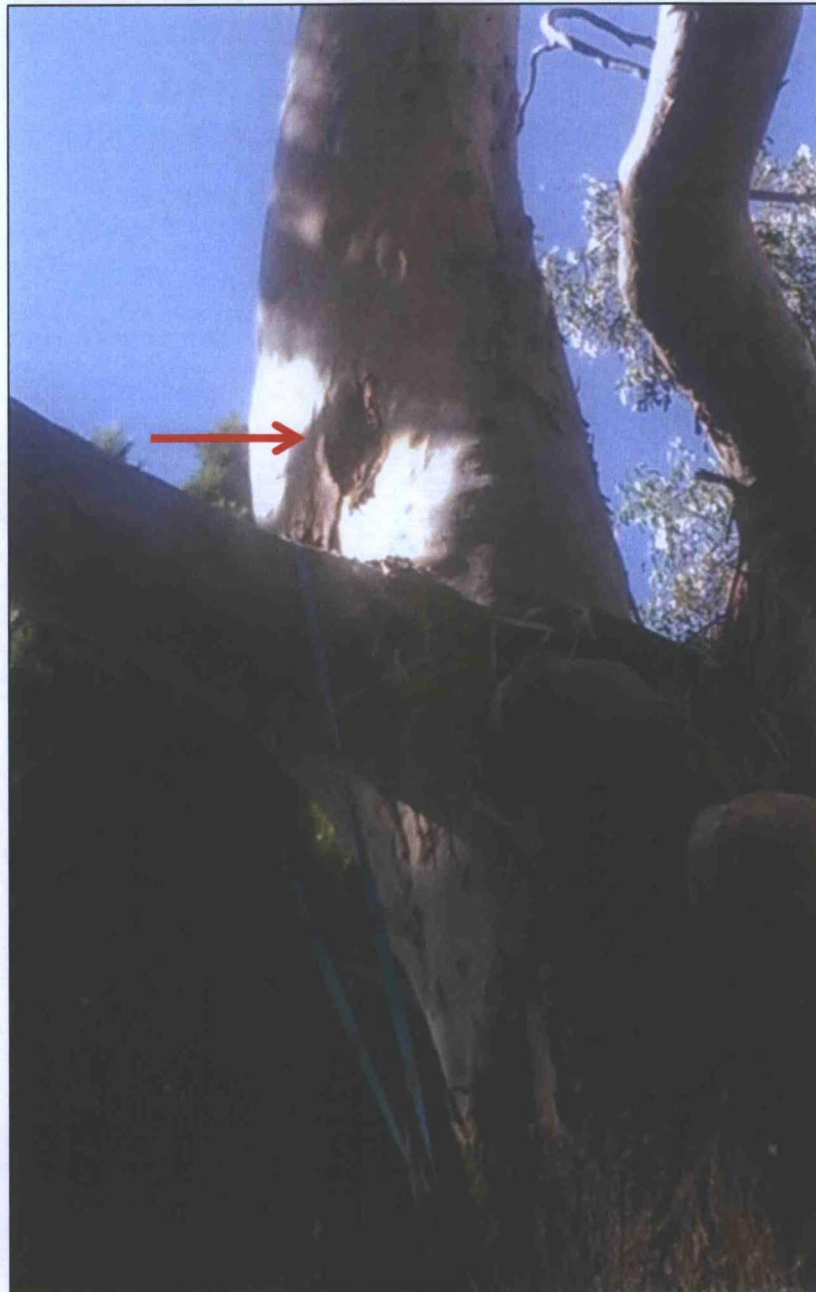
**5.3** As previously mentioned, the tree exhibits a cavity which has penetrated two (2) sections of the stem wall. A hollow section of a tree is called a shell, and whilst there are varying formulas to assess the structural integrity of a shell, most agree that a loss of >70% of sound wood is justification for tree removal based on a tree's potential to fail. (Harris, Clarke & Matheny, Lonsdale, Mattheck, Pokorney & others.)

**5.4** It is important to note that these formulae apply to trees with a closed shell. Trees with an open shell are more prone to failure and require even more sound wood. Whilst I did not conduct an aerial inspection of the tree to take measurements of the stem and extent of the cavity it is reasonable to assume that the stem has been compromised in excess of 70% due to two (2) breaches of the stem wall. (Photographs 4 & 5)

**PHOTOGRAPH 5. (North West aspect) This photograph illustrates that the cavity has penetrated the stem wall twice (red arrow.)**

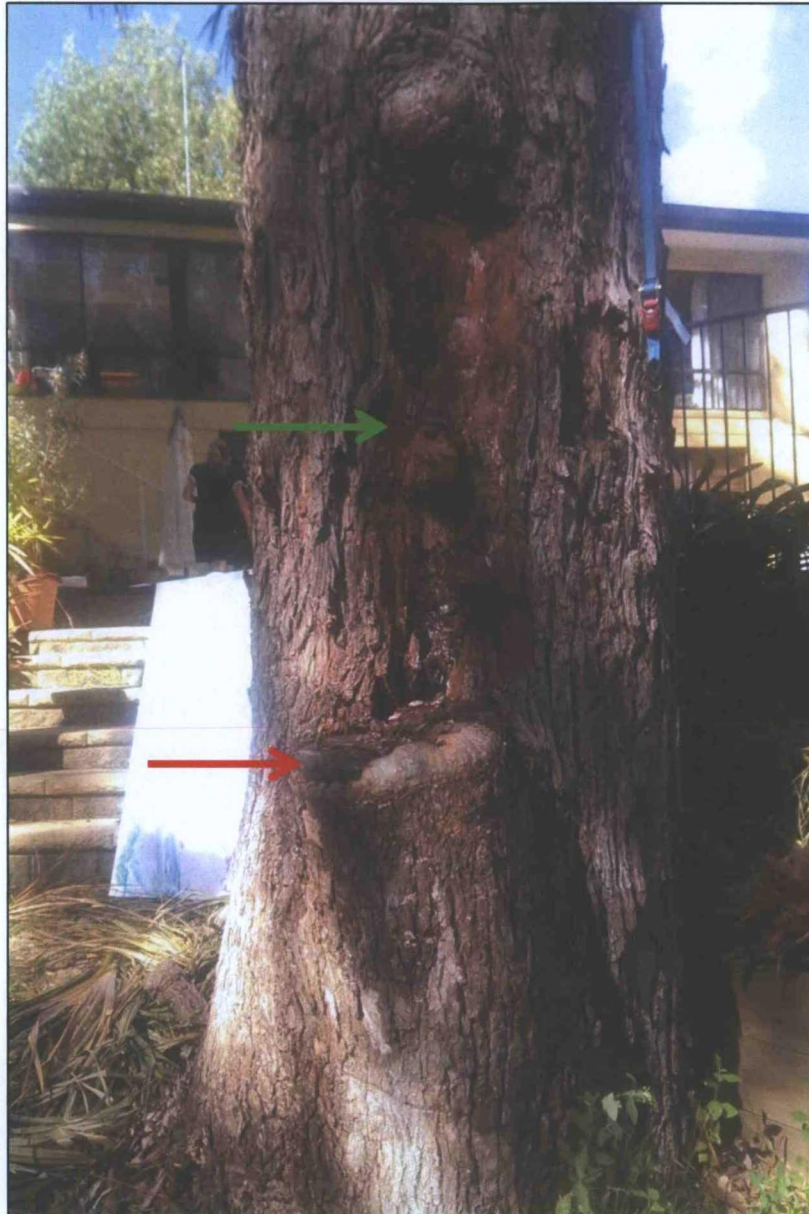
**PHOTOGRAPH 6. (North aspect) A co-dominant stem had been pruned from the tree long ago. The tree exhibited poor wound wood callusing at this pruning site (red arrow.) The tree exhibited a loss of bark integrity (green arrow.)**
