Arboricultural Impact Assessment

Tree Protection Plan

Site: 918 Barrenjoey Road Palm Beach 2108

Date of Inspection: 18 August 2021

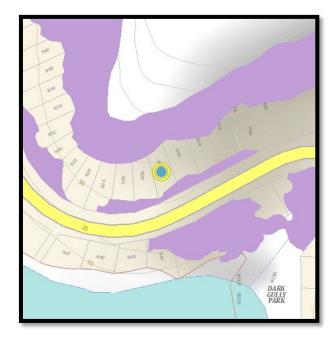
The site has been identified on the Biodiversity Values Map and Threshold Tool as a parcel containing sensitive vegetation. Threatened species or communities (Pittwater Spotted Gum Forest, Littoral Rainforest) with potential for serious and irreversible impacts (figure 2).

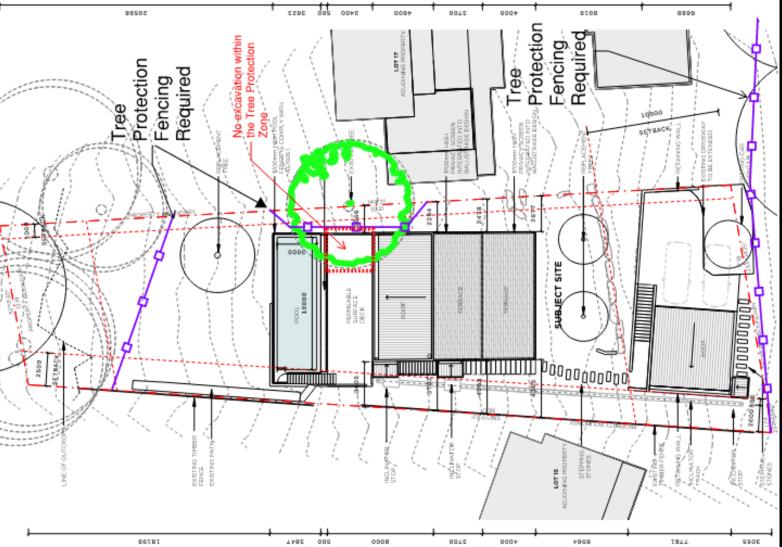
Figure 7 - Tree Protection Plan including location of Tree Protection Fencing

Figure 7 indicates the locations of tree protection fencing and signage to be erected. This plan is to be used as a guide. Site constraints, location of services and unforeseen obstacles may impede fencing. The Project Arborist (Vertical Tree Management & Consultancy) or an AQF5 Arborist can modify and certify all tree protection measures.

- Trees 1, 2, 4, 5 are a Priority for Removal.
- Tree 3 is a Priority for Retention
- Tree 2 is located within neighbouring property. The tree owners' consent is required for removal.
- Tree protection fencing & signage is required for areas indicated in purple within figures 2, 7 within Tree Protection Plan.

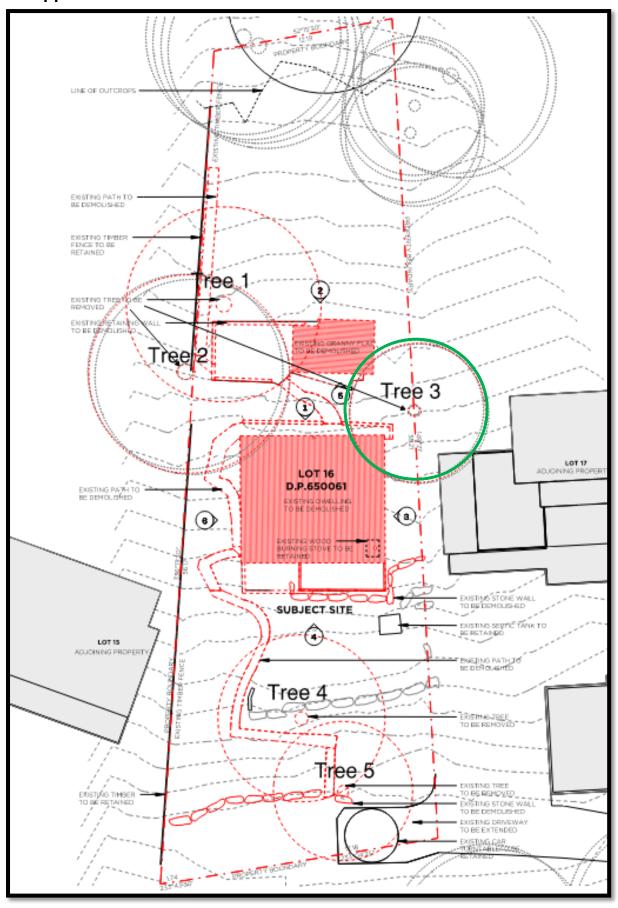
Figure 8 - Existing Site Plan - Tree 3 to be retained

The mature Red Bloodwood tree is growing on the shared property boundary with 916 Barrenjoey Road. This tree is in good health and good structure with no obvious defects. The tree is growing at 2.8 metres from the external wall of the current dwelling within the site. The canopy of the tree has been significantly crown raised to accommodate both dwellings in proximity of this tree. The canopy of the tree is in good health and good structure with no obvious defects. The tree has 30% epicormic growth, likely because of reduced sunlight availability from the surrounding canopy trees to the north. The construction of the proposed dwelling has proposed a permeable deck which will all rainwater filtration to promote root growth. The construction of the proposed structures will result in an incursion of less than 5%. This level of incursion is considered acceptable. No mechanical excavation within the highlighted area within figure 7 is permissible unless under the supervision of The Project Arborist or an AQF5 Consulting Arborist. This tree is requiring tree protection fencing and signage to be erected during the proposed construction.
