Job Number:
PX 00055
4th December, 2019
Page 1

**GEOTECHNICAL ASSESSMENT REPORT
FOR
PROPOSED ALTERATIONS AND ADDITIONS
AT
40 LINDLEY AVENUE, NARRABEEN**

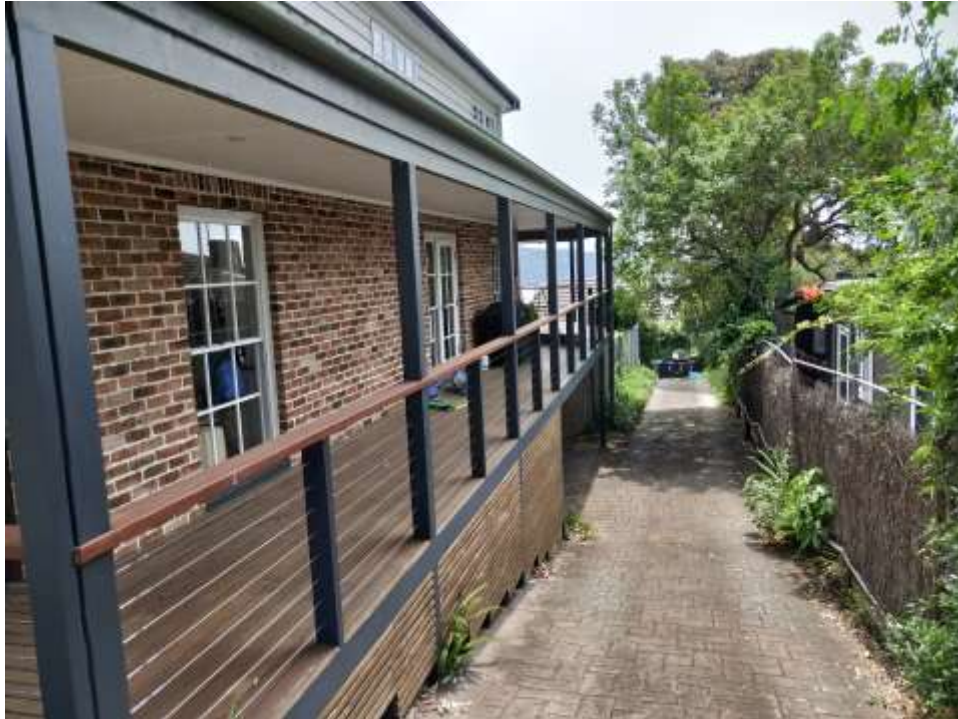
Photo 1

3.3 Vehicular access to the block is via a concrete vehicle crossing and driveway that provides access to the under house double garage on the north eastern corner of the existing residence, Photo 1. The driveway continues down the eastern boundary right of carriageway to the property located at the rear of the subject property. The road reserve is gravel and garden beds where the bitumen finishes, Photo 2. A level gravel area is at the south western corner of the property supported by timber retaining walls and also terraces the area to the east of the front yard, Photo 3. A pathway steps down from the gravel area and front gate leading to the entry of the existing residence. Access to the rear of the block is via the driveway and a gate near the existing double garage, Photo 4. A level paved and lawn area is at the rear of the existing residence, Photo 5. A swimming pool is at the north eastern corner of the property, Photo 6. A masonry retaining wall is at the northern rear boundary that supports the fill material of the level rear yard of the subject property, Photo 7. This retaining wall was observed to be stable at the time of our inspection.

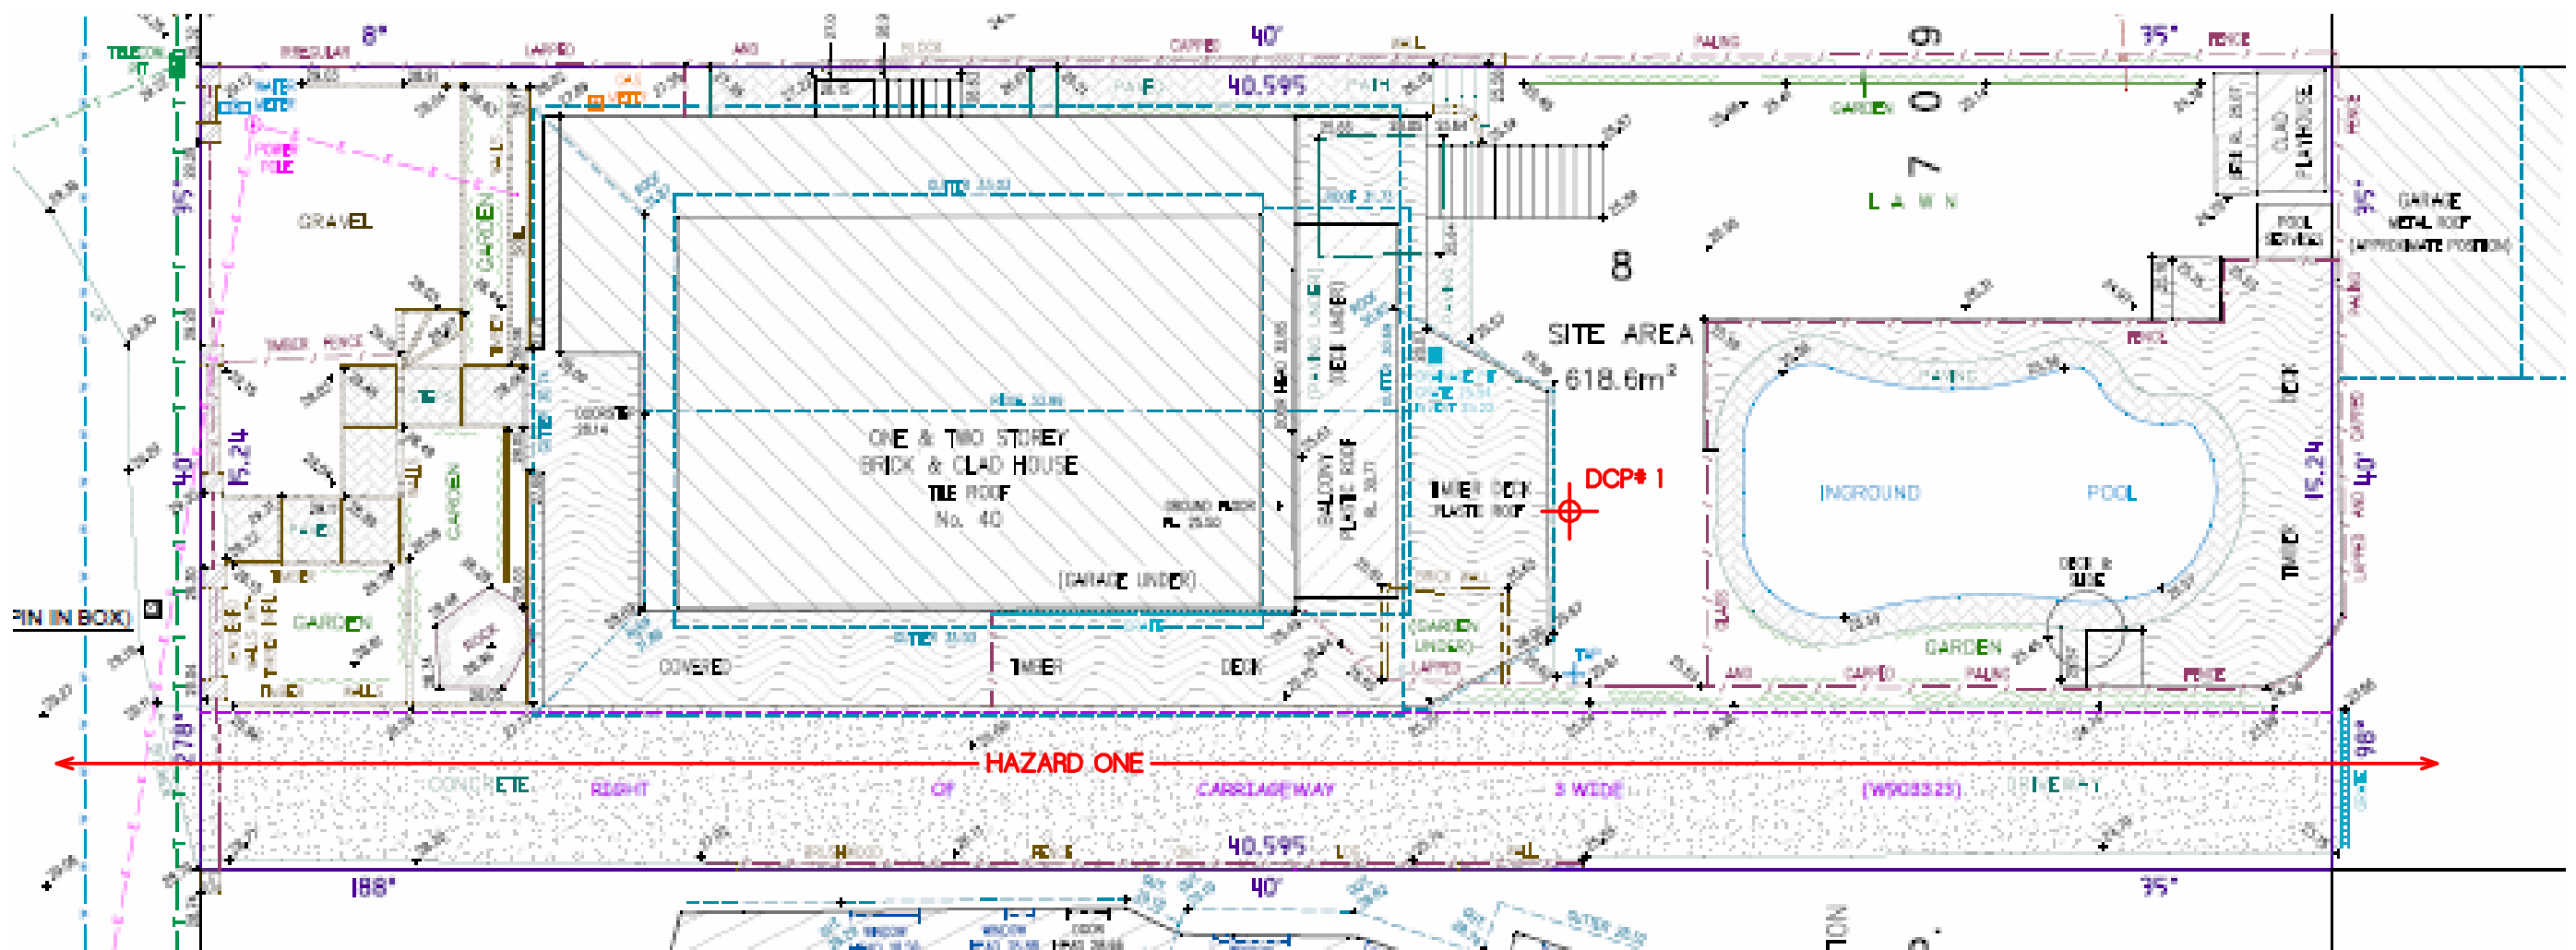
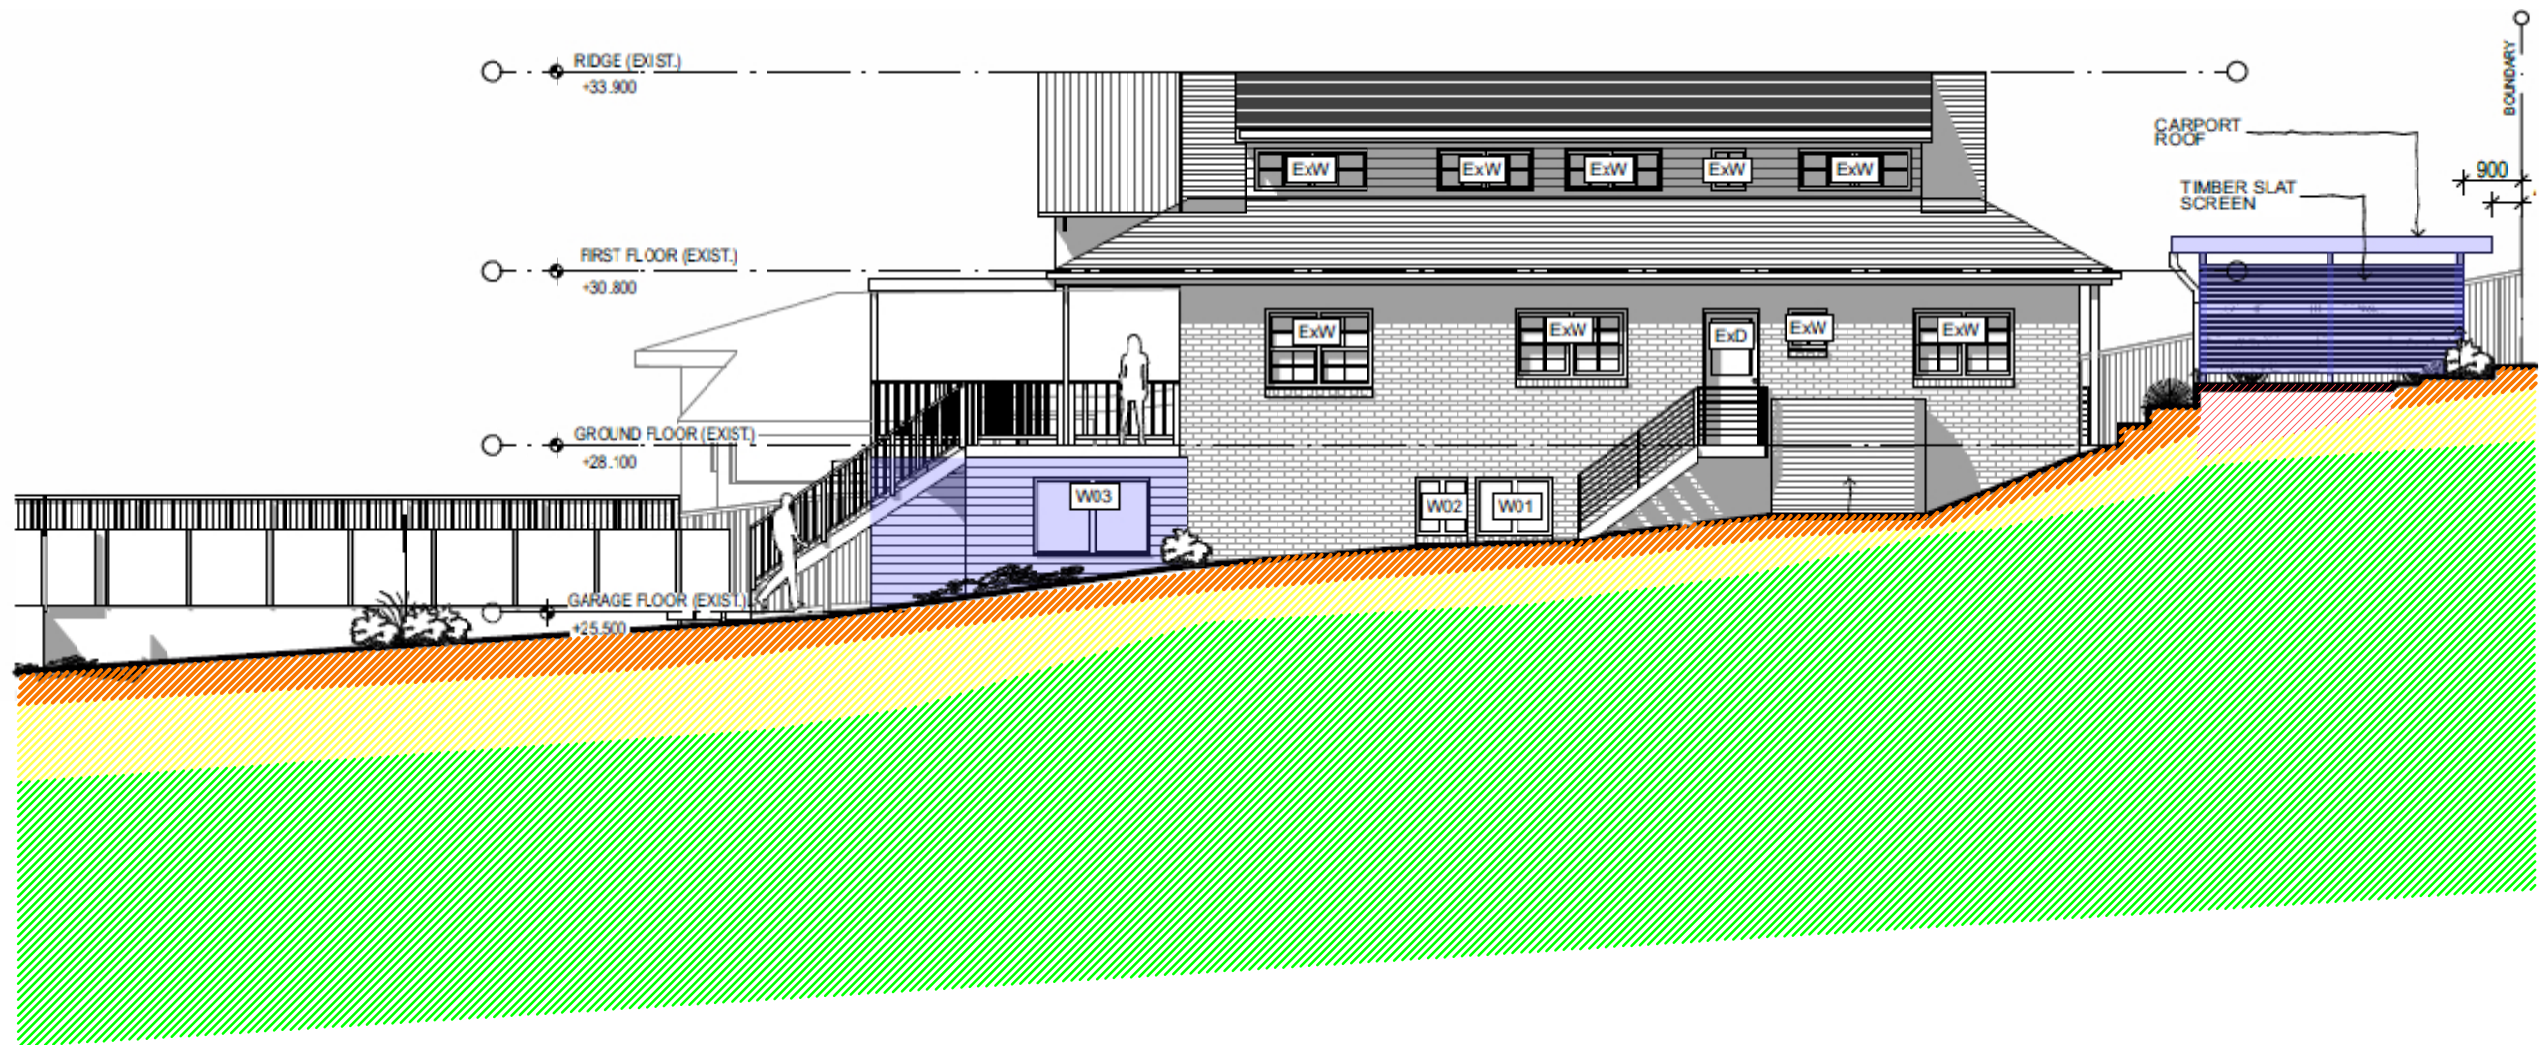
TYPE SECTION

NOTE
 INTERPRETED SUB SURFACE SECTION ONLY.
 ACTUAL GROUND CONDITIONS MAY VARY.
