Report Title: Geotechnical Report 141 Riverview Rd, Avalon

Report Date: 26/11/19

GEOTECHNICAL INVESTIGATION:

New Driveway, Carport and Store Room at **141 Riverview Road, Avalon**

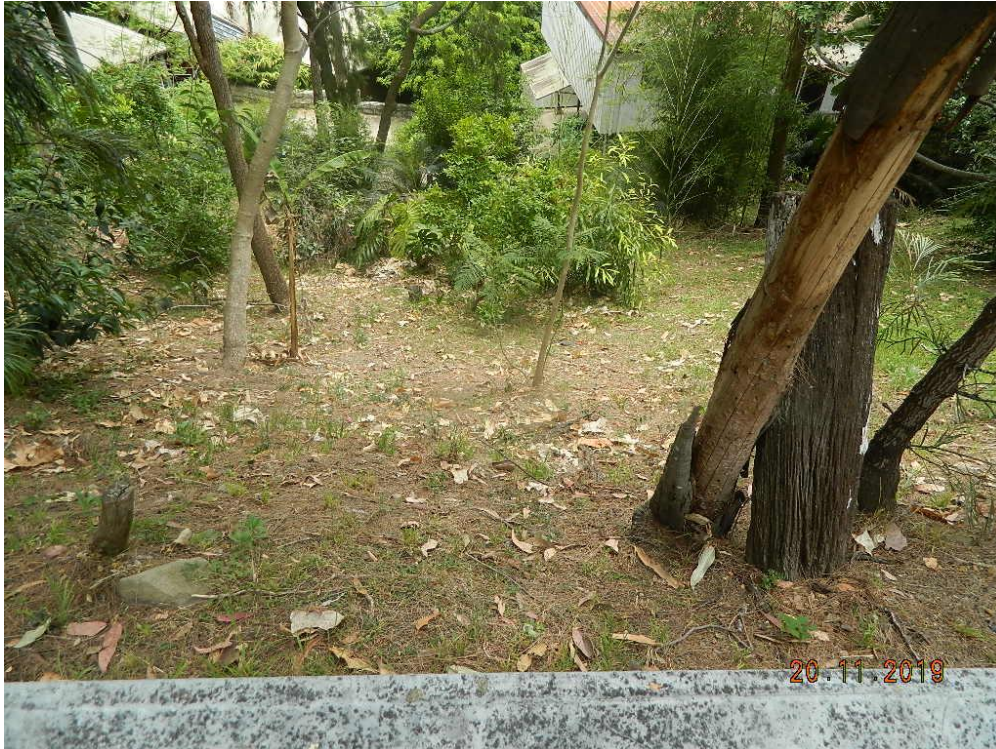
Photo 1

- 2.3** At the road frontage, the fill batter for the road drops steeply across the vacant block for a short distance before merging into the natural slope (photos 1 & 2). Along the upper and middle slope sandstone joint blocks are exposed at the surface (photo 3). It is unclear whether these are dislodged boulders from above, or are bands of outcropping sandstone bedrock. At the W boundary of the property a sandstone flagging retaining wall in good condition supports the cut batter for the neighbouring concrete driveway (photo 4). The surface of the slope is lawn covered and has a scattering of shrubs and mature gums. No significant signs of movement were observed on the block.

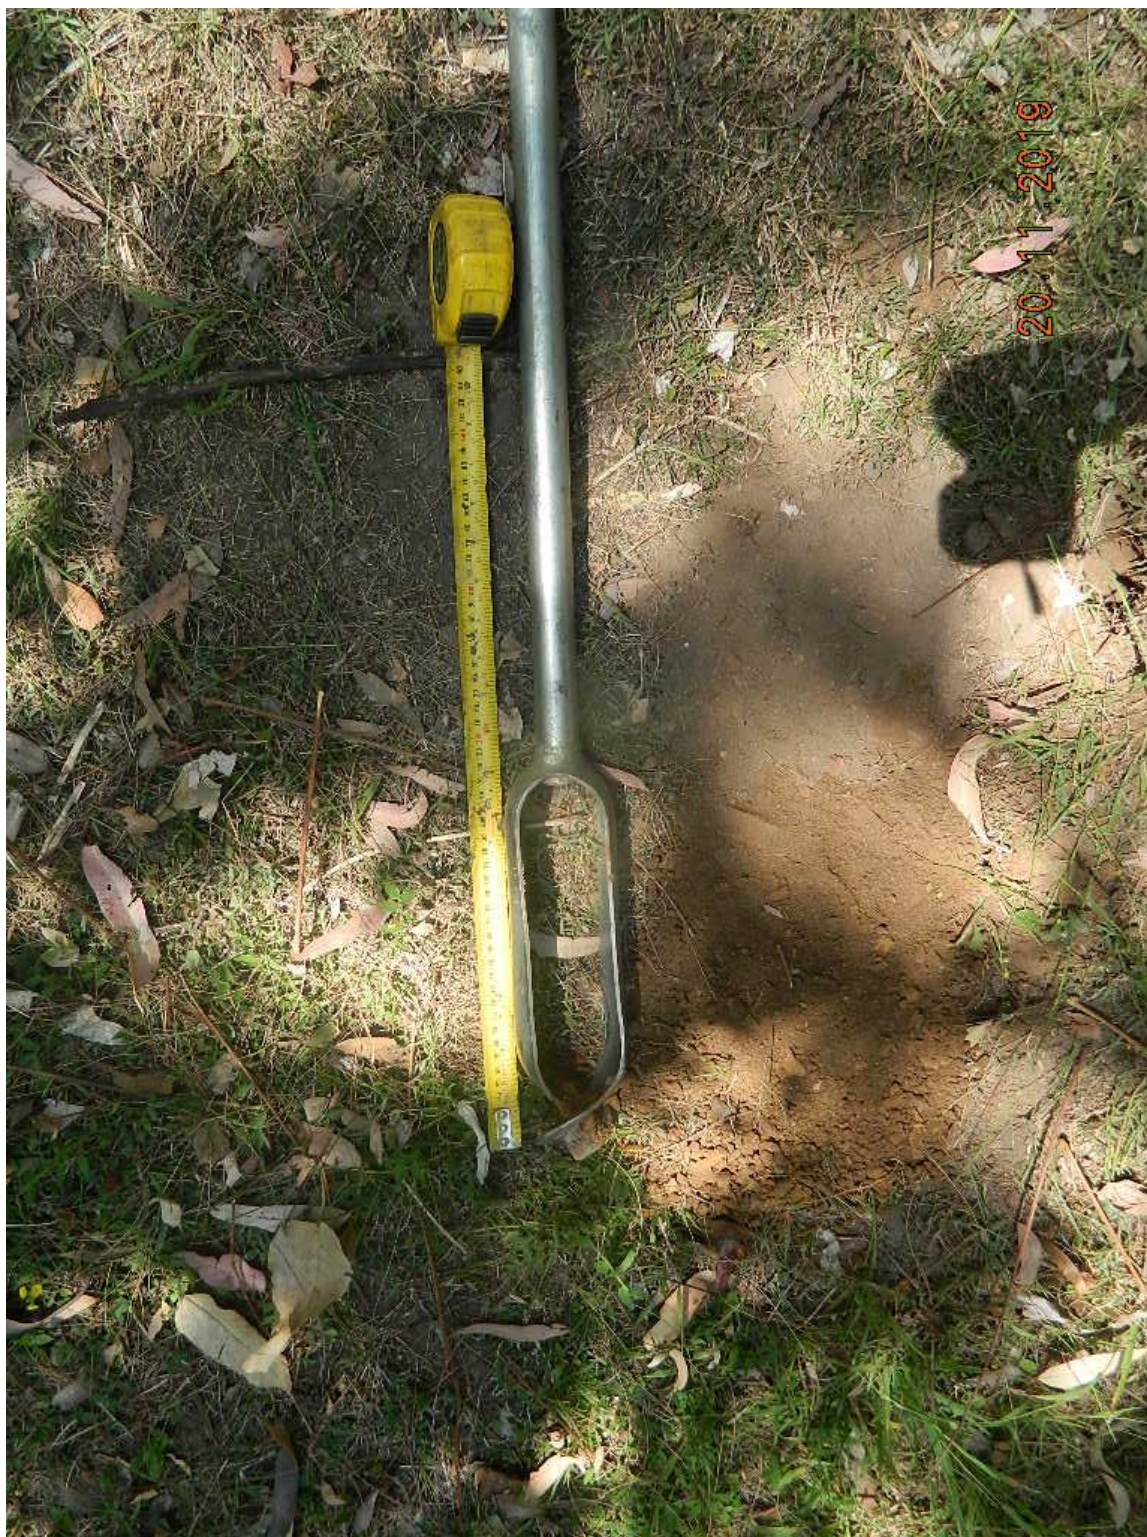
AUGER HOLE 1 (~RL35.8) – AH1 (photo 5)

Depth (m)	Material Encountered
0.0 to 0.2	SANDY SOIL , brown, fine to medium grained, dry.
0.2 to 0.5	SANDY CLAY , brown, firm, dry.

End of hole @ 0.5m in Sandy Clay. No water table encountered.

Photo 5: AH1 – Downhole is from top to bottom
