GEOTECHNICAL INVESTIGATION:

Alterations and Additions at **1 James Wheeler Place, Wheeler Heights**

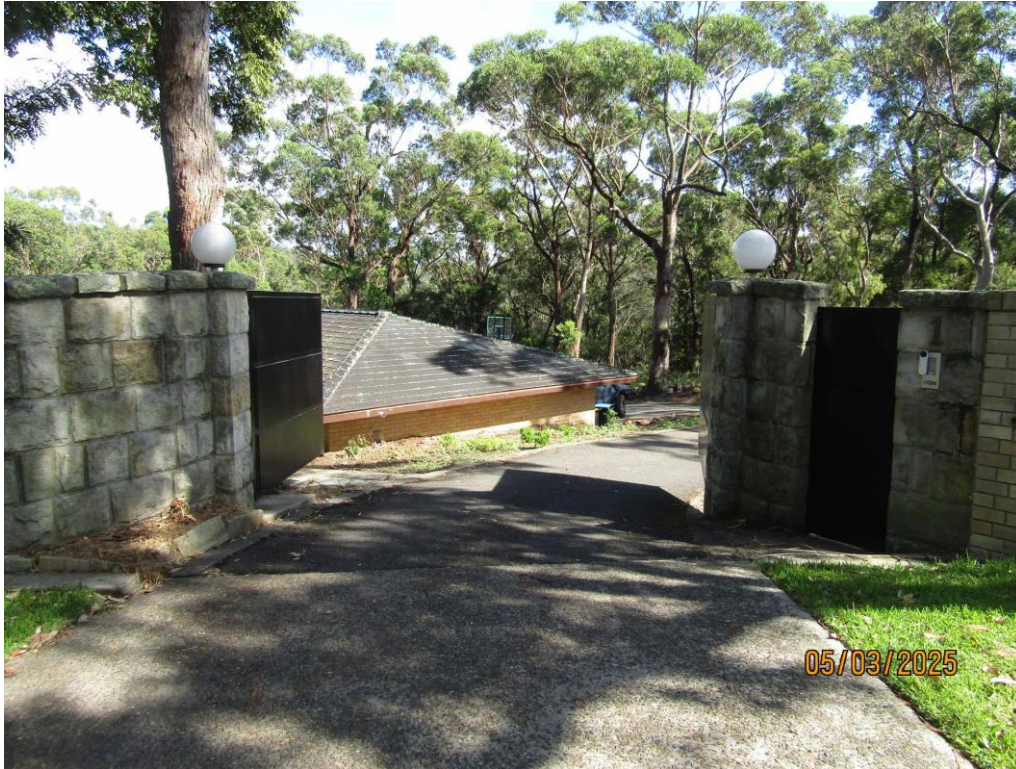
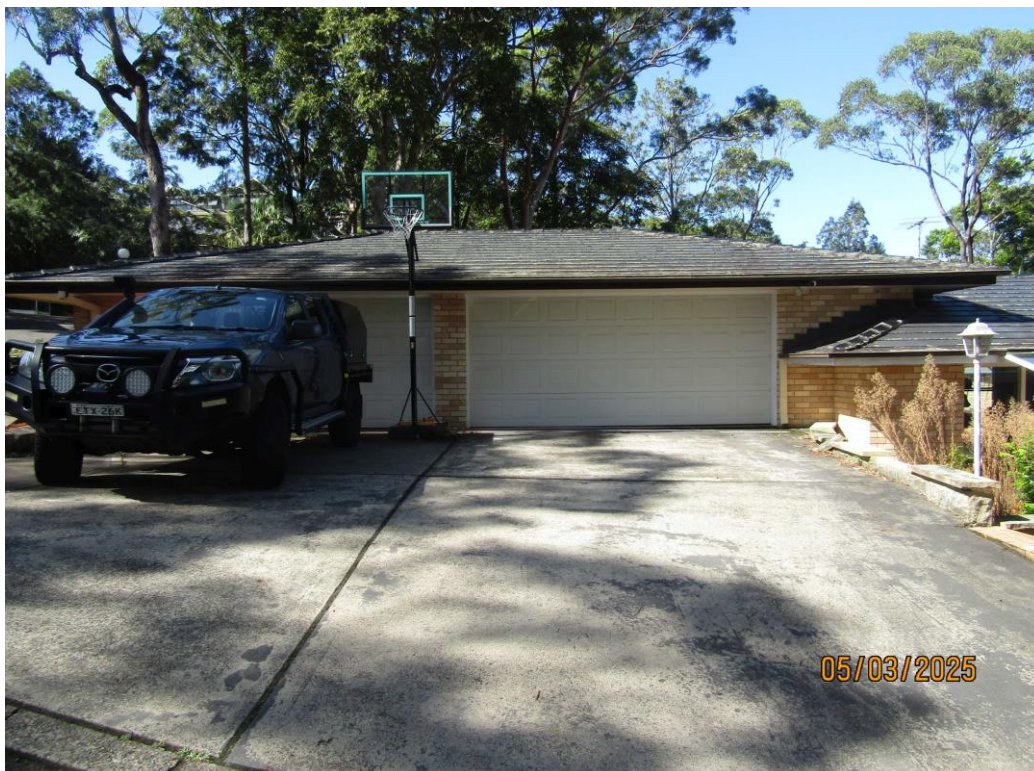
Photo 1

2.3 At the road frontage, a concrete and bitumen driveway runs down the slope to a garage at the E side of the house (Photos 1 & 2). A stable brick boundary wall up to ~2.5m high approximates the road frontage. The NE end of the wall is constructed on a stable concrete retaining wall (Photo 3) that supports a fill for the road reserve and a cut for a level area below. A stable shed and concrete parking area are located on this level area (Photo 4). The part two storey house with garage is supported on brick and sandstone block walls (Photos 2 & 5 to 7). The external supporting walls show no significant signs of movement. A balcony extends off the downhill side of the house (Photo 7). The posts that support the balcony stand vertical.

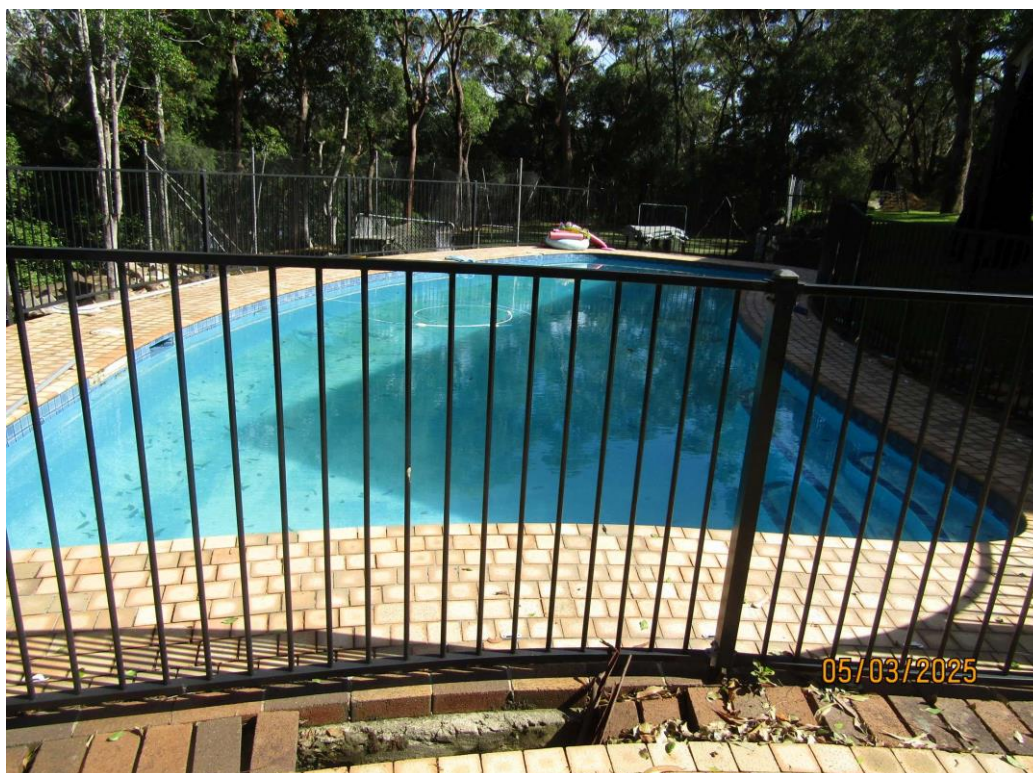
Photo 8

A pool that shows no significant signs of movement is located at the SW side of the house (Photo 8). Stable sandstone block and rendered masonry retaining walls up to ~3.5m high support fills for lawn, garden and paved areas across the property, and for a cut and fill for a tennis court in the NW corner of the property (Photos 9 to 12). The S side of the property is accessed via a gravel driveway with level parking area (Photo 12). An unsupported excavation up to ~1.5m high for the parking area has been taken through topsoil, clay and weathered rock (Photo 13). The excavation comes close to flush with a rendered masonry retaining wall supporting fill above (Photos 12 & 14). It is recommended the excavation be supported by a retaining wall as soon as possible.

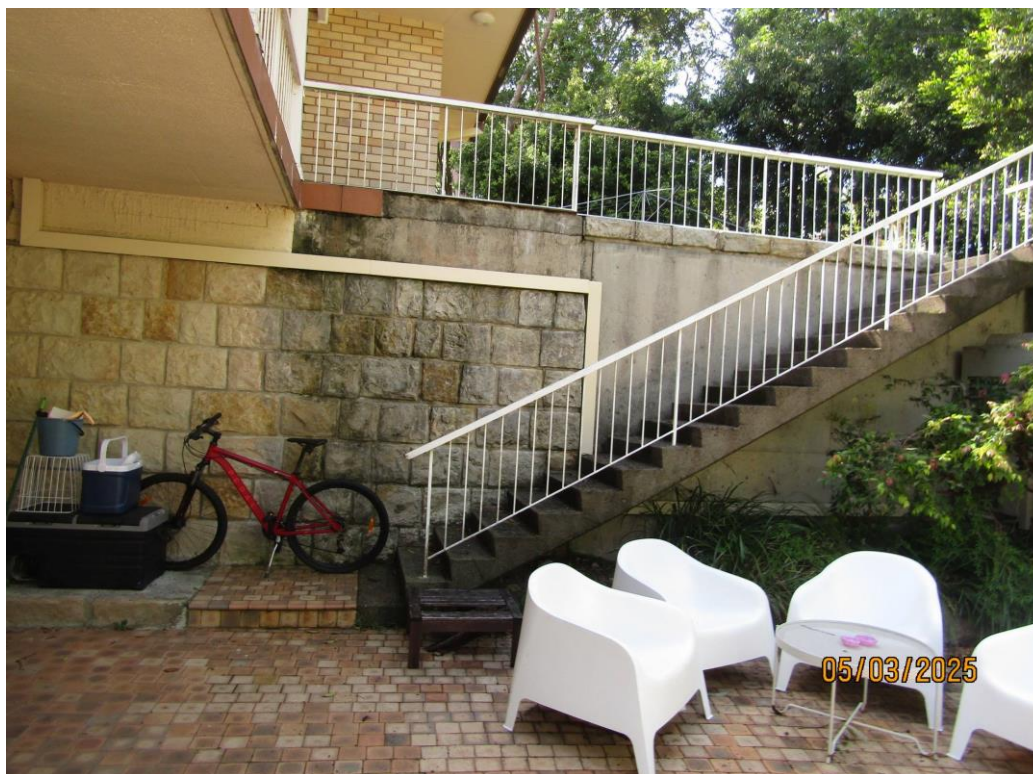
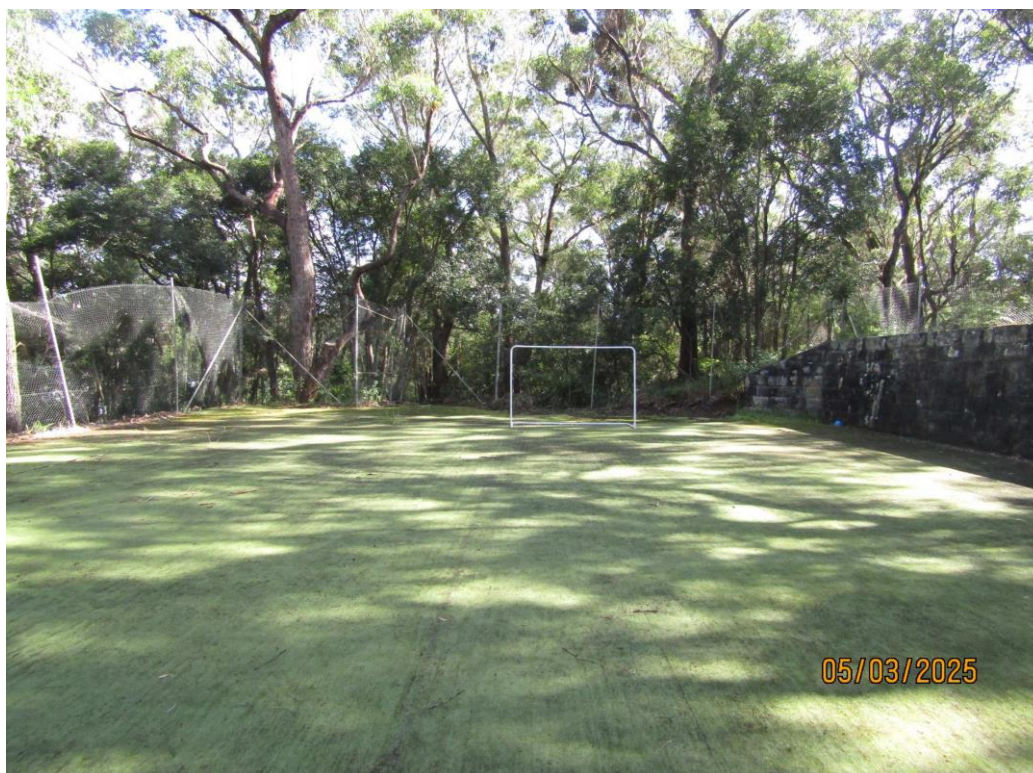
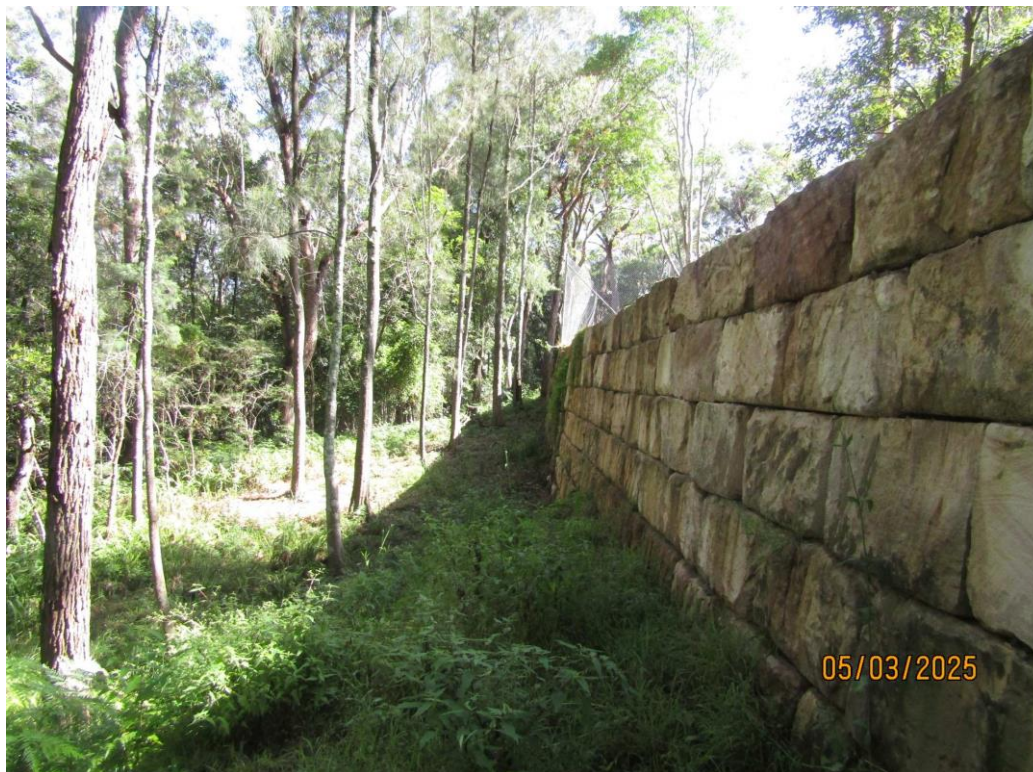
are in place (**Hazard Two**). The additional surcharge loads from the proposed house, pool, and pavilion structures are a potential hazard to the existing retaining walls (Photos 9 to 12) (**Hazard Three**).

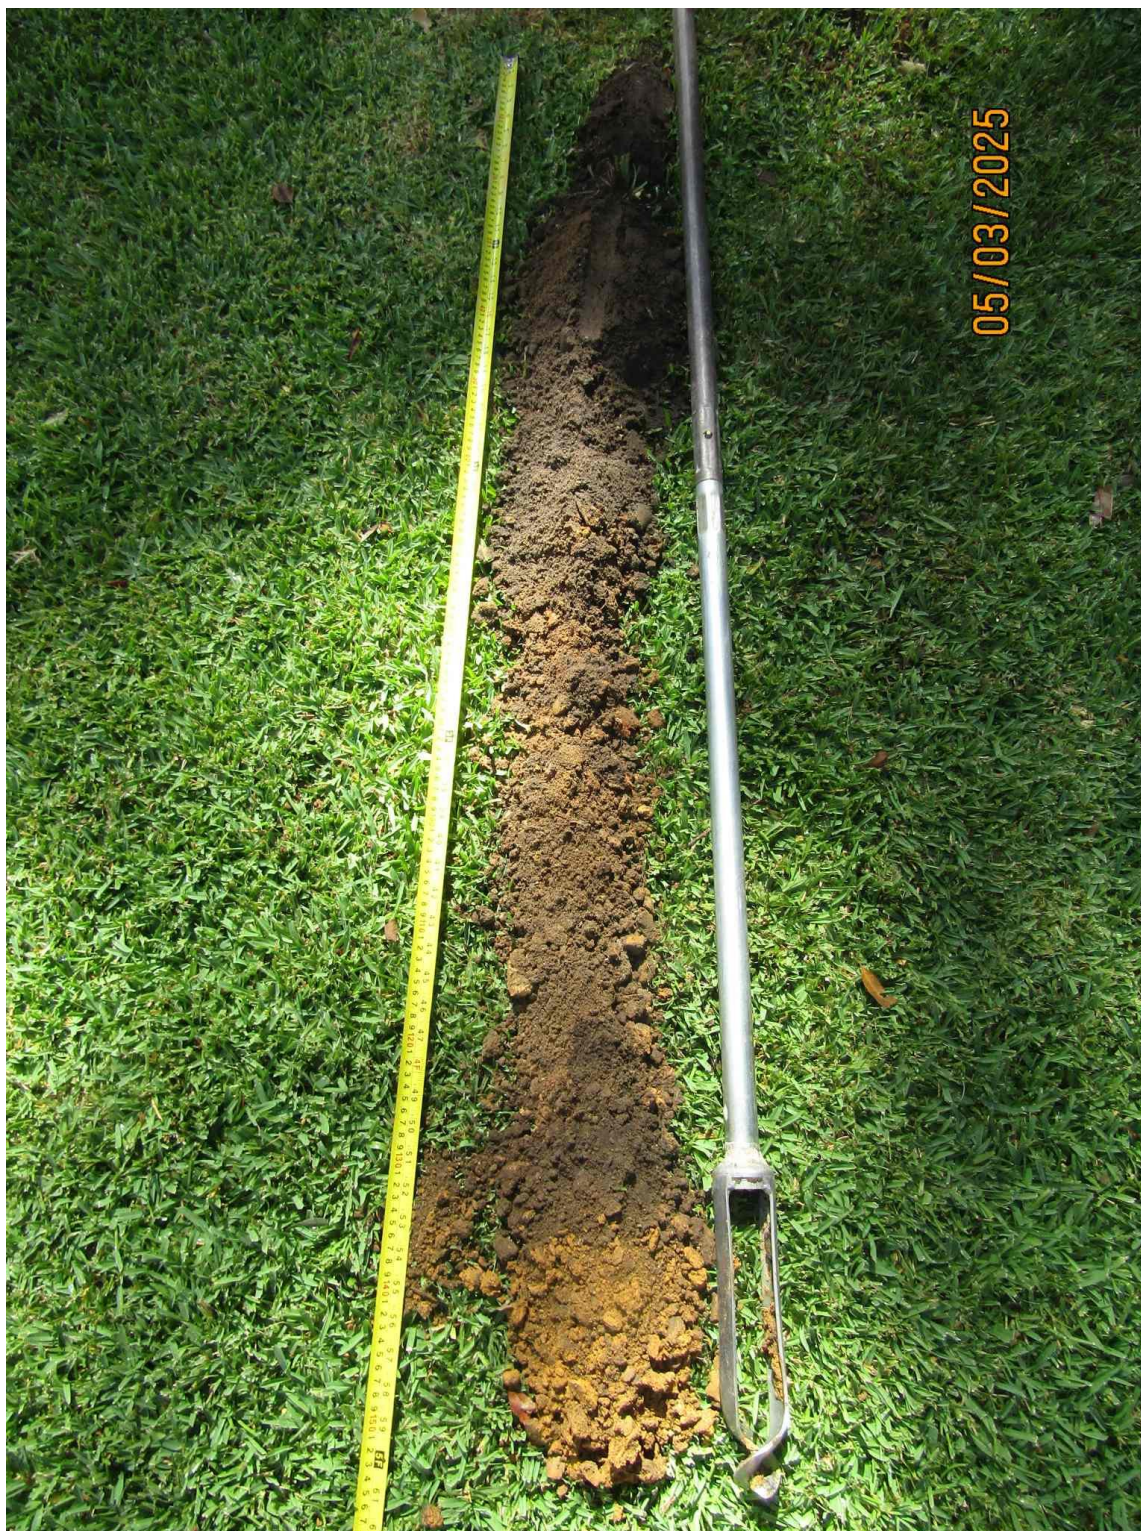
AUGER HOLE 1 (~RL13.9) – AH1 (Photo 15)

Depth (m)	Material Encountered
0.0 to 1.2	FILL , sandy soil and clay, with some rock fragments, dark brown, brown, orange, dry to moist, fine to coarse grained.
1.2 to 1.4	TOPSOIL , sandy soil, dark brown, dry, fine to medium grained.
1.4 to 1.5	CLAY , orange brown, firm to stiff, dry.

End of Test @ 1.5m in firm to stiff clay. No Water table encountered.

Photo 15: AH1 – Downhole is from top to bottom.

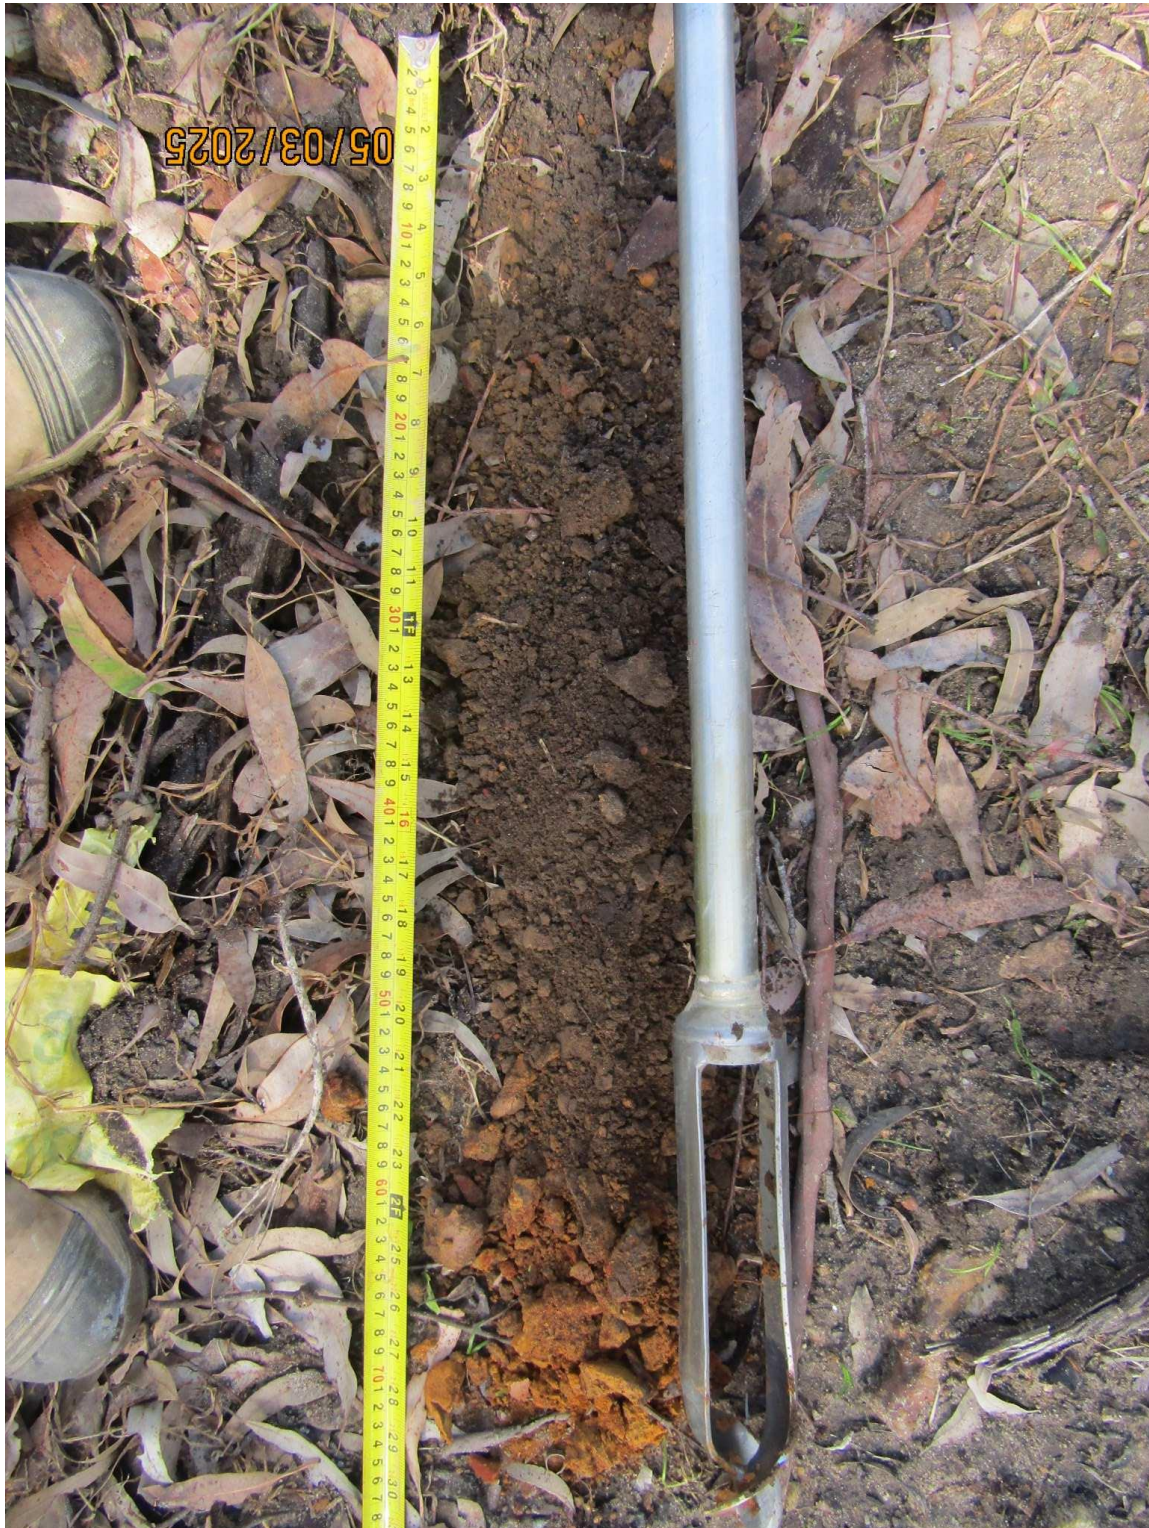
AUGER HOLE 2 (~RL15.7) – AH2 (Photo 16)

Depth (m)	Material Encountered
0.0 to 0.3	FILL , sandy soil and clay, with some rock fragments, dark brown, brown, orange, dry to moist, fine to coarse grained.
0.3 to 0.6	TOPSOIL , sandy soil, dark brown, dry to moist, fine to medium grained.
0.6 to 0.7	CLAY , orange, firm to stiff, dry.

End of Test @ 0.7m in firm to stiff clay. No Water table encountered.

Photo 16: AH2 – Downhole is from top to bottom.

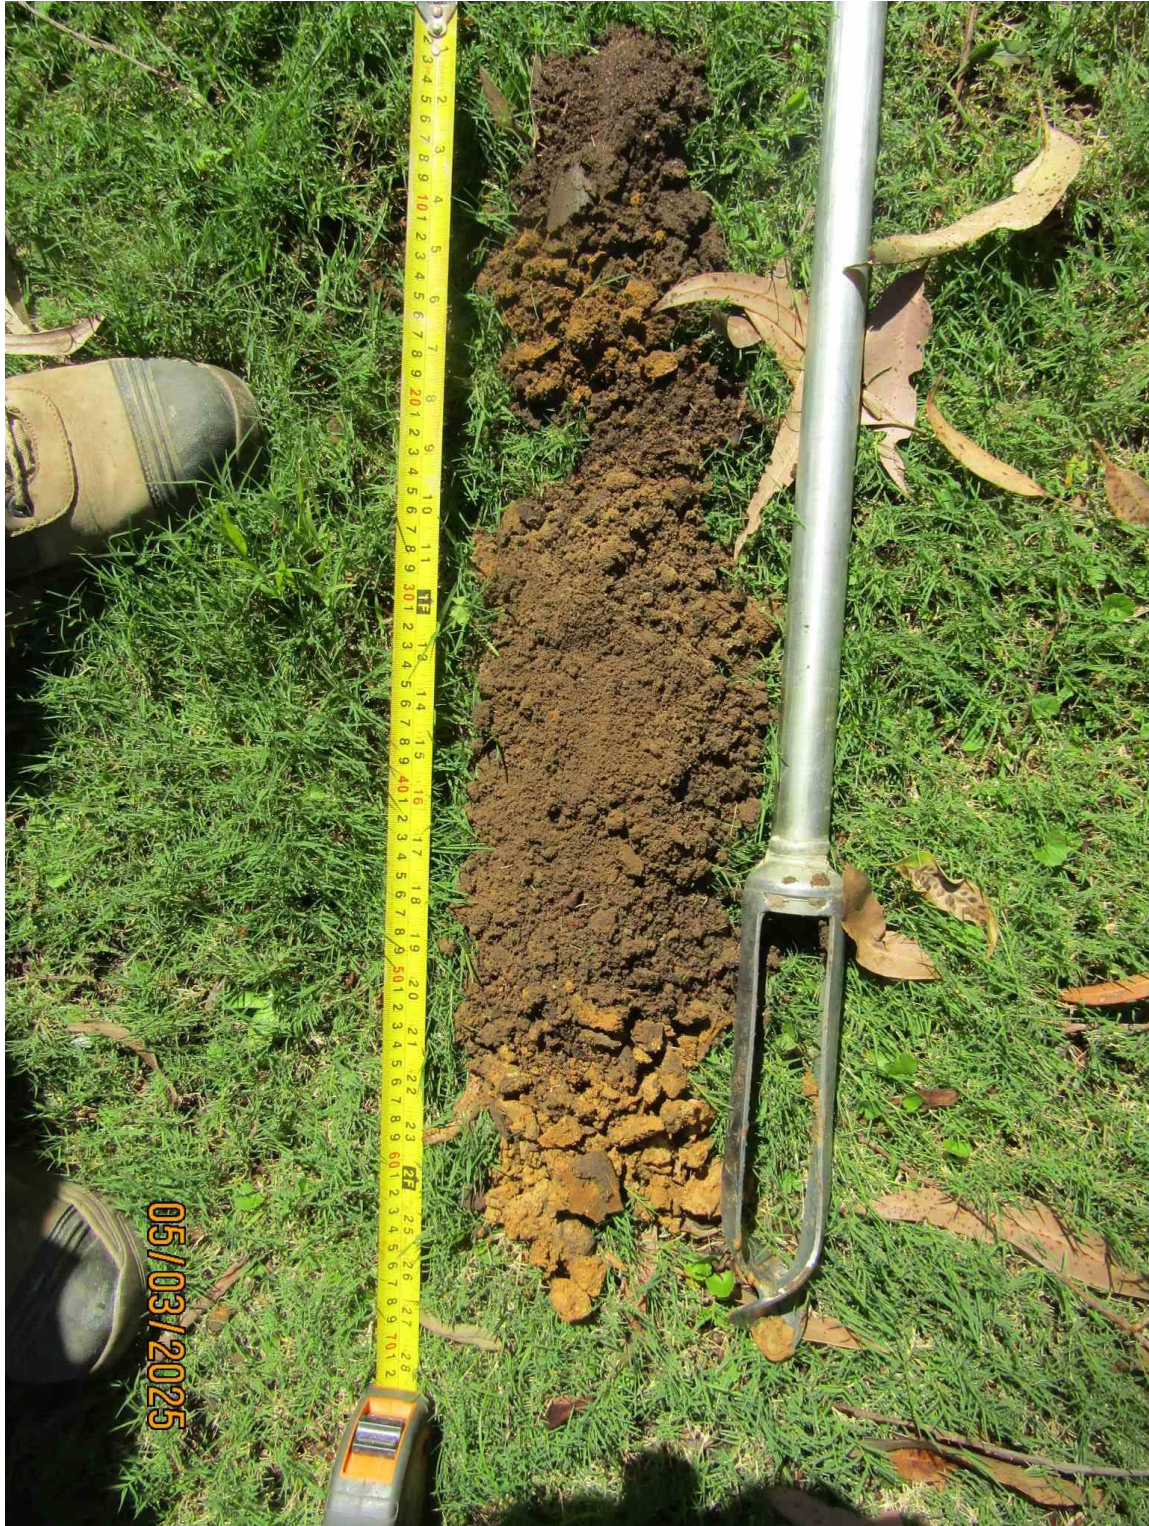
AUGER HOLE 3 (~RL11.6) – AH3 (Photo 17)

Depth (m)	Material Encountered
0.0 to 0.3	FILL , sandy soil and clay, with some rock fragments, dark brown, brown, orange, dry to moist, fine to coarse grained.
0.3 to 0.5	TOPSOIL , sandy soil, dark brown, dry to moist, fine to medium grained.
0.5 to 0.7	CLAY , orange brown, firm to stiff, dry.

End of Test @ 0.7m in firm to stiff clay. No Water table encountered.

Photo 17: AH3 – Downhole is from top to bottom.

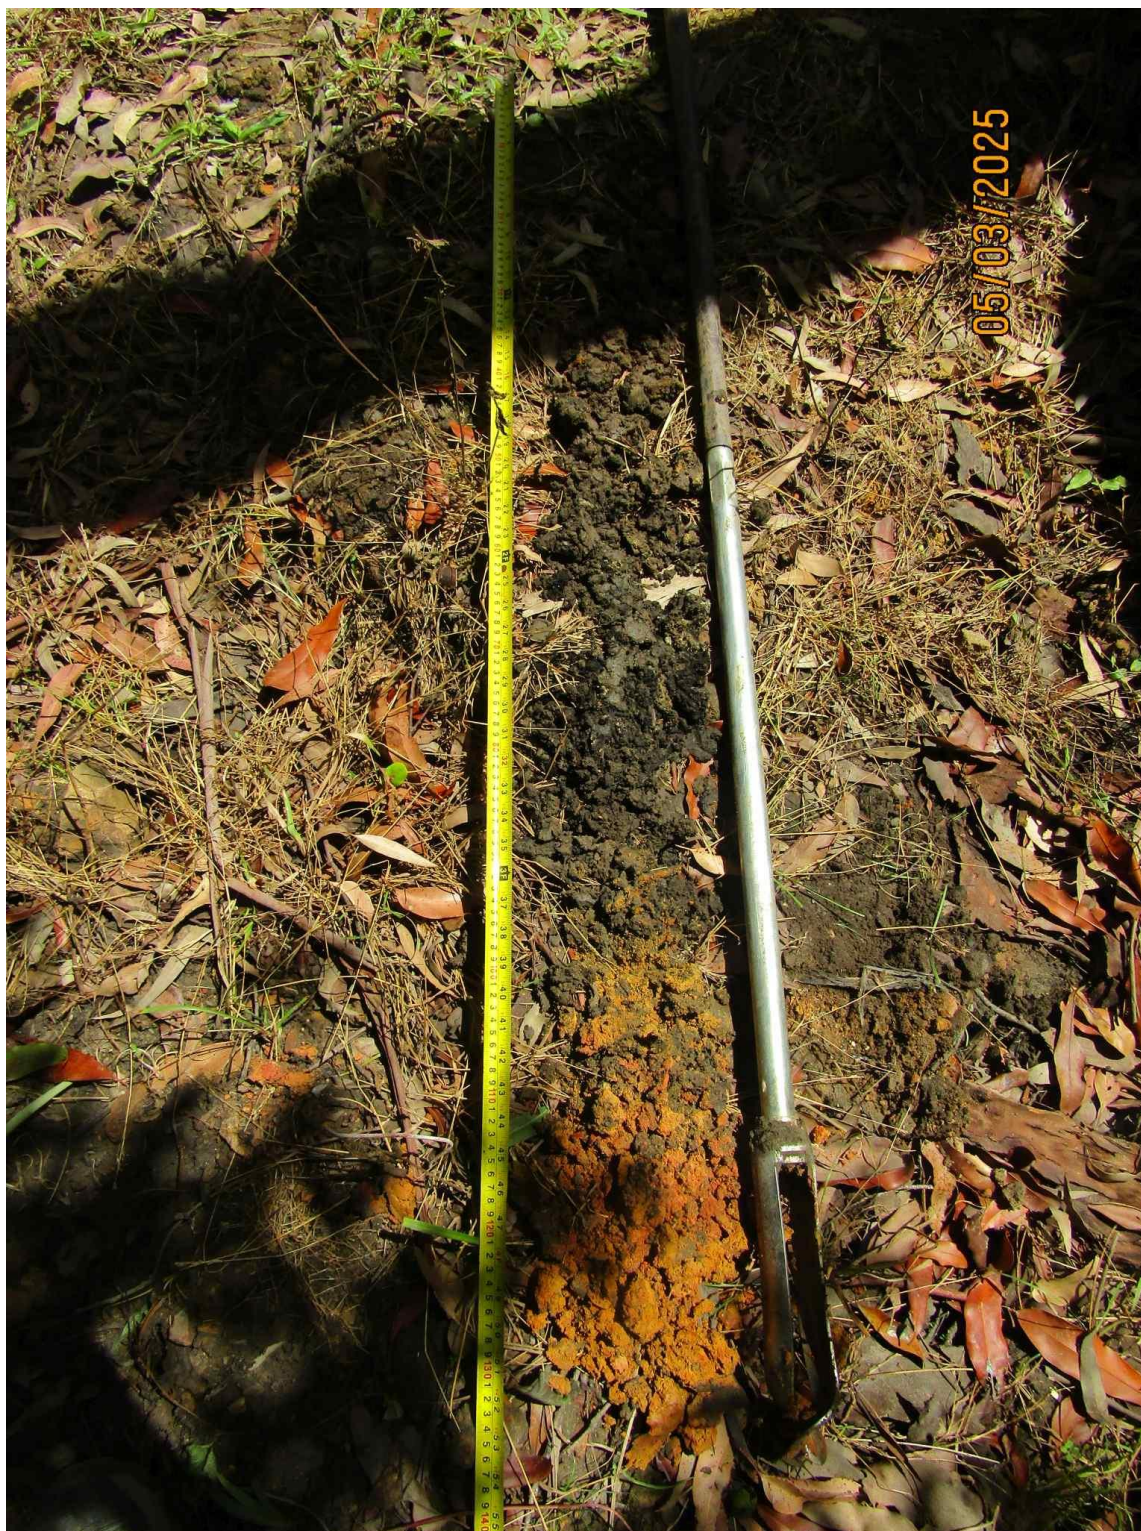
AUGER HOLE 4 (~RL7.5) – AH4 (Photo 18)

Depth (m)	Material Encountered
0.0 to 1.2	FILL , sandy soil, clayey soil and sandy clay with some rock fragments, dark grey, dark brown, orange, damp, fine to coarse grained.
1.2 to 1.4	SANDY CLAY , orange, firm to stiff, dry.

Refusal @ 1.4m, auger grinding on rock. No Water table encountered.

Photo 18: AH4 – Downhole is from top to bottom.

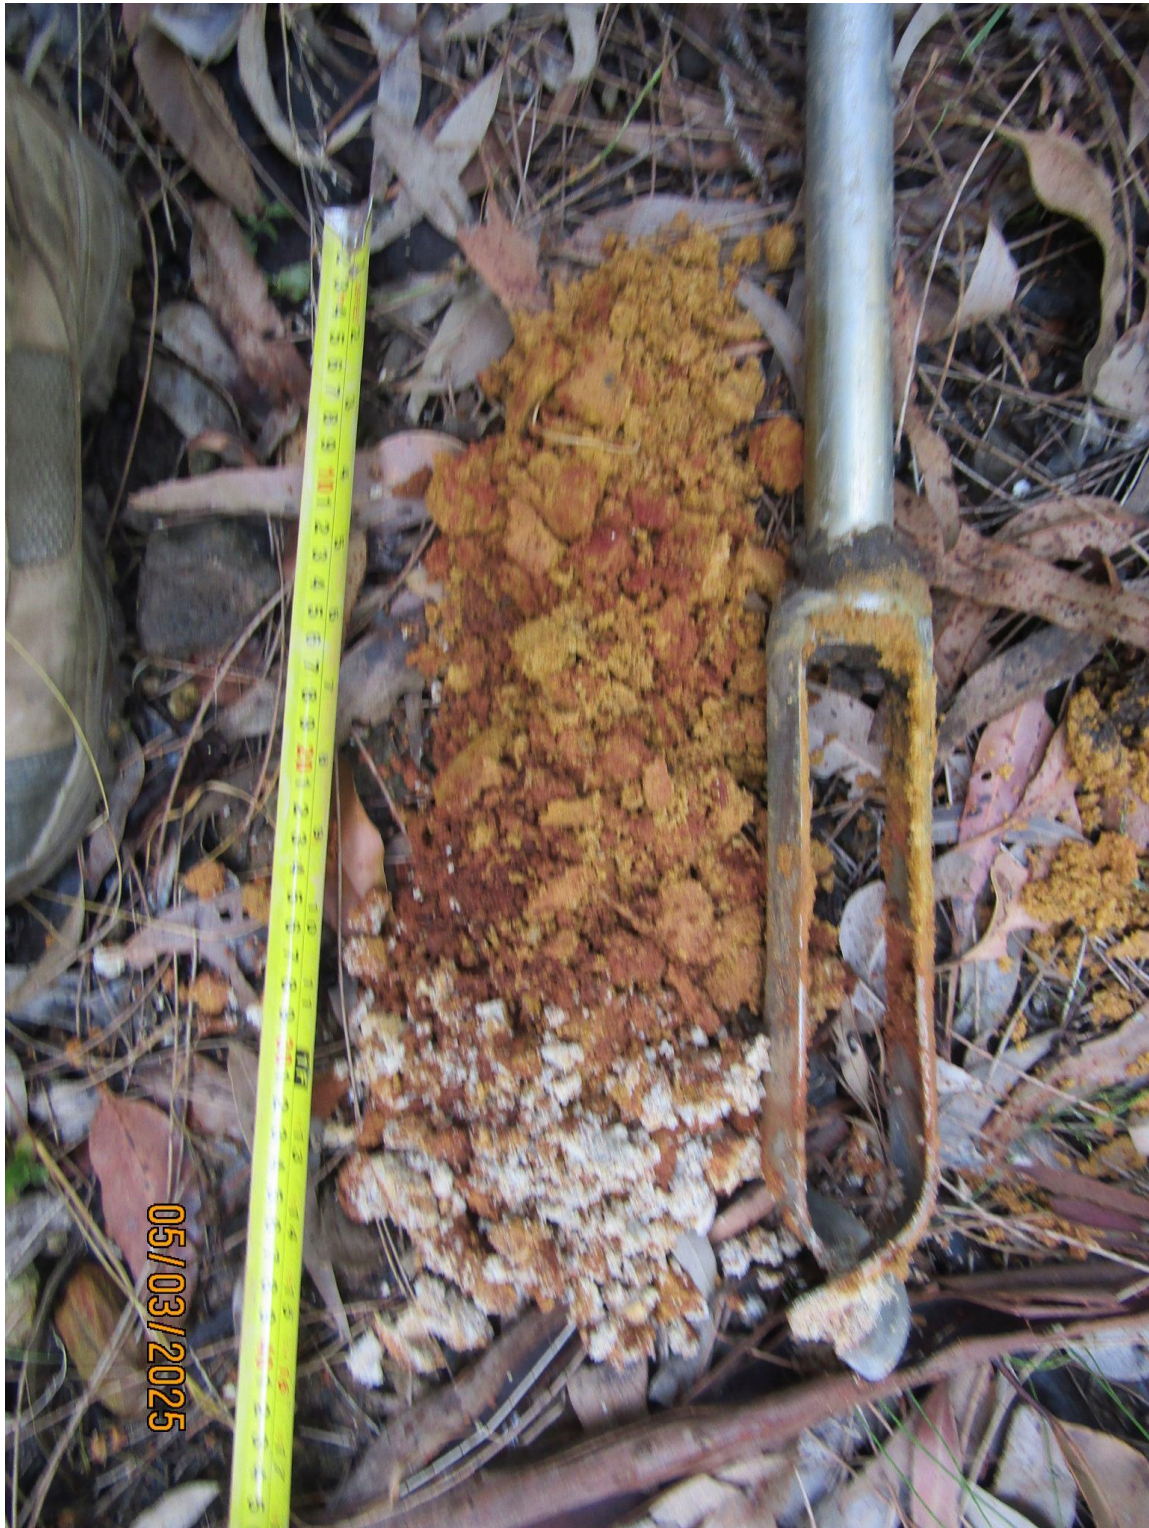
AUGER HOLE 5 (~RL4.7) – AH4 (Photo 19)

Depth (m)	Material Encountered
0.0 to 0.3	CLAYEY SAND , orange, maroon, moist, fine to coarse grained.
0.3 to 0.4	SANDY CLAY , light grey, firm to stiff, moist.

Refusal @ 0.4m, auger grinding on rock. No Water table encountered.

Photo 19: AH5 – Downhole is from top to bottom.

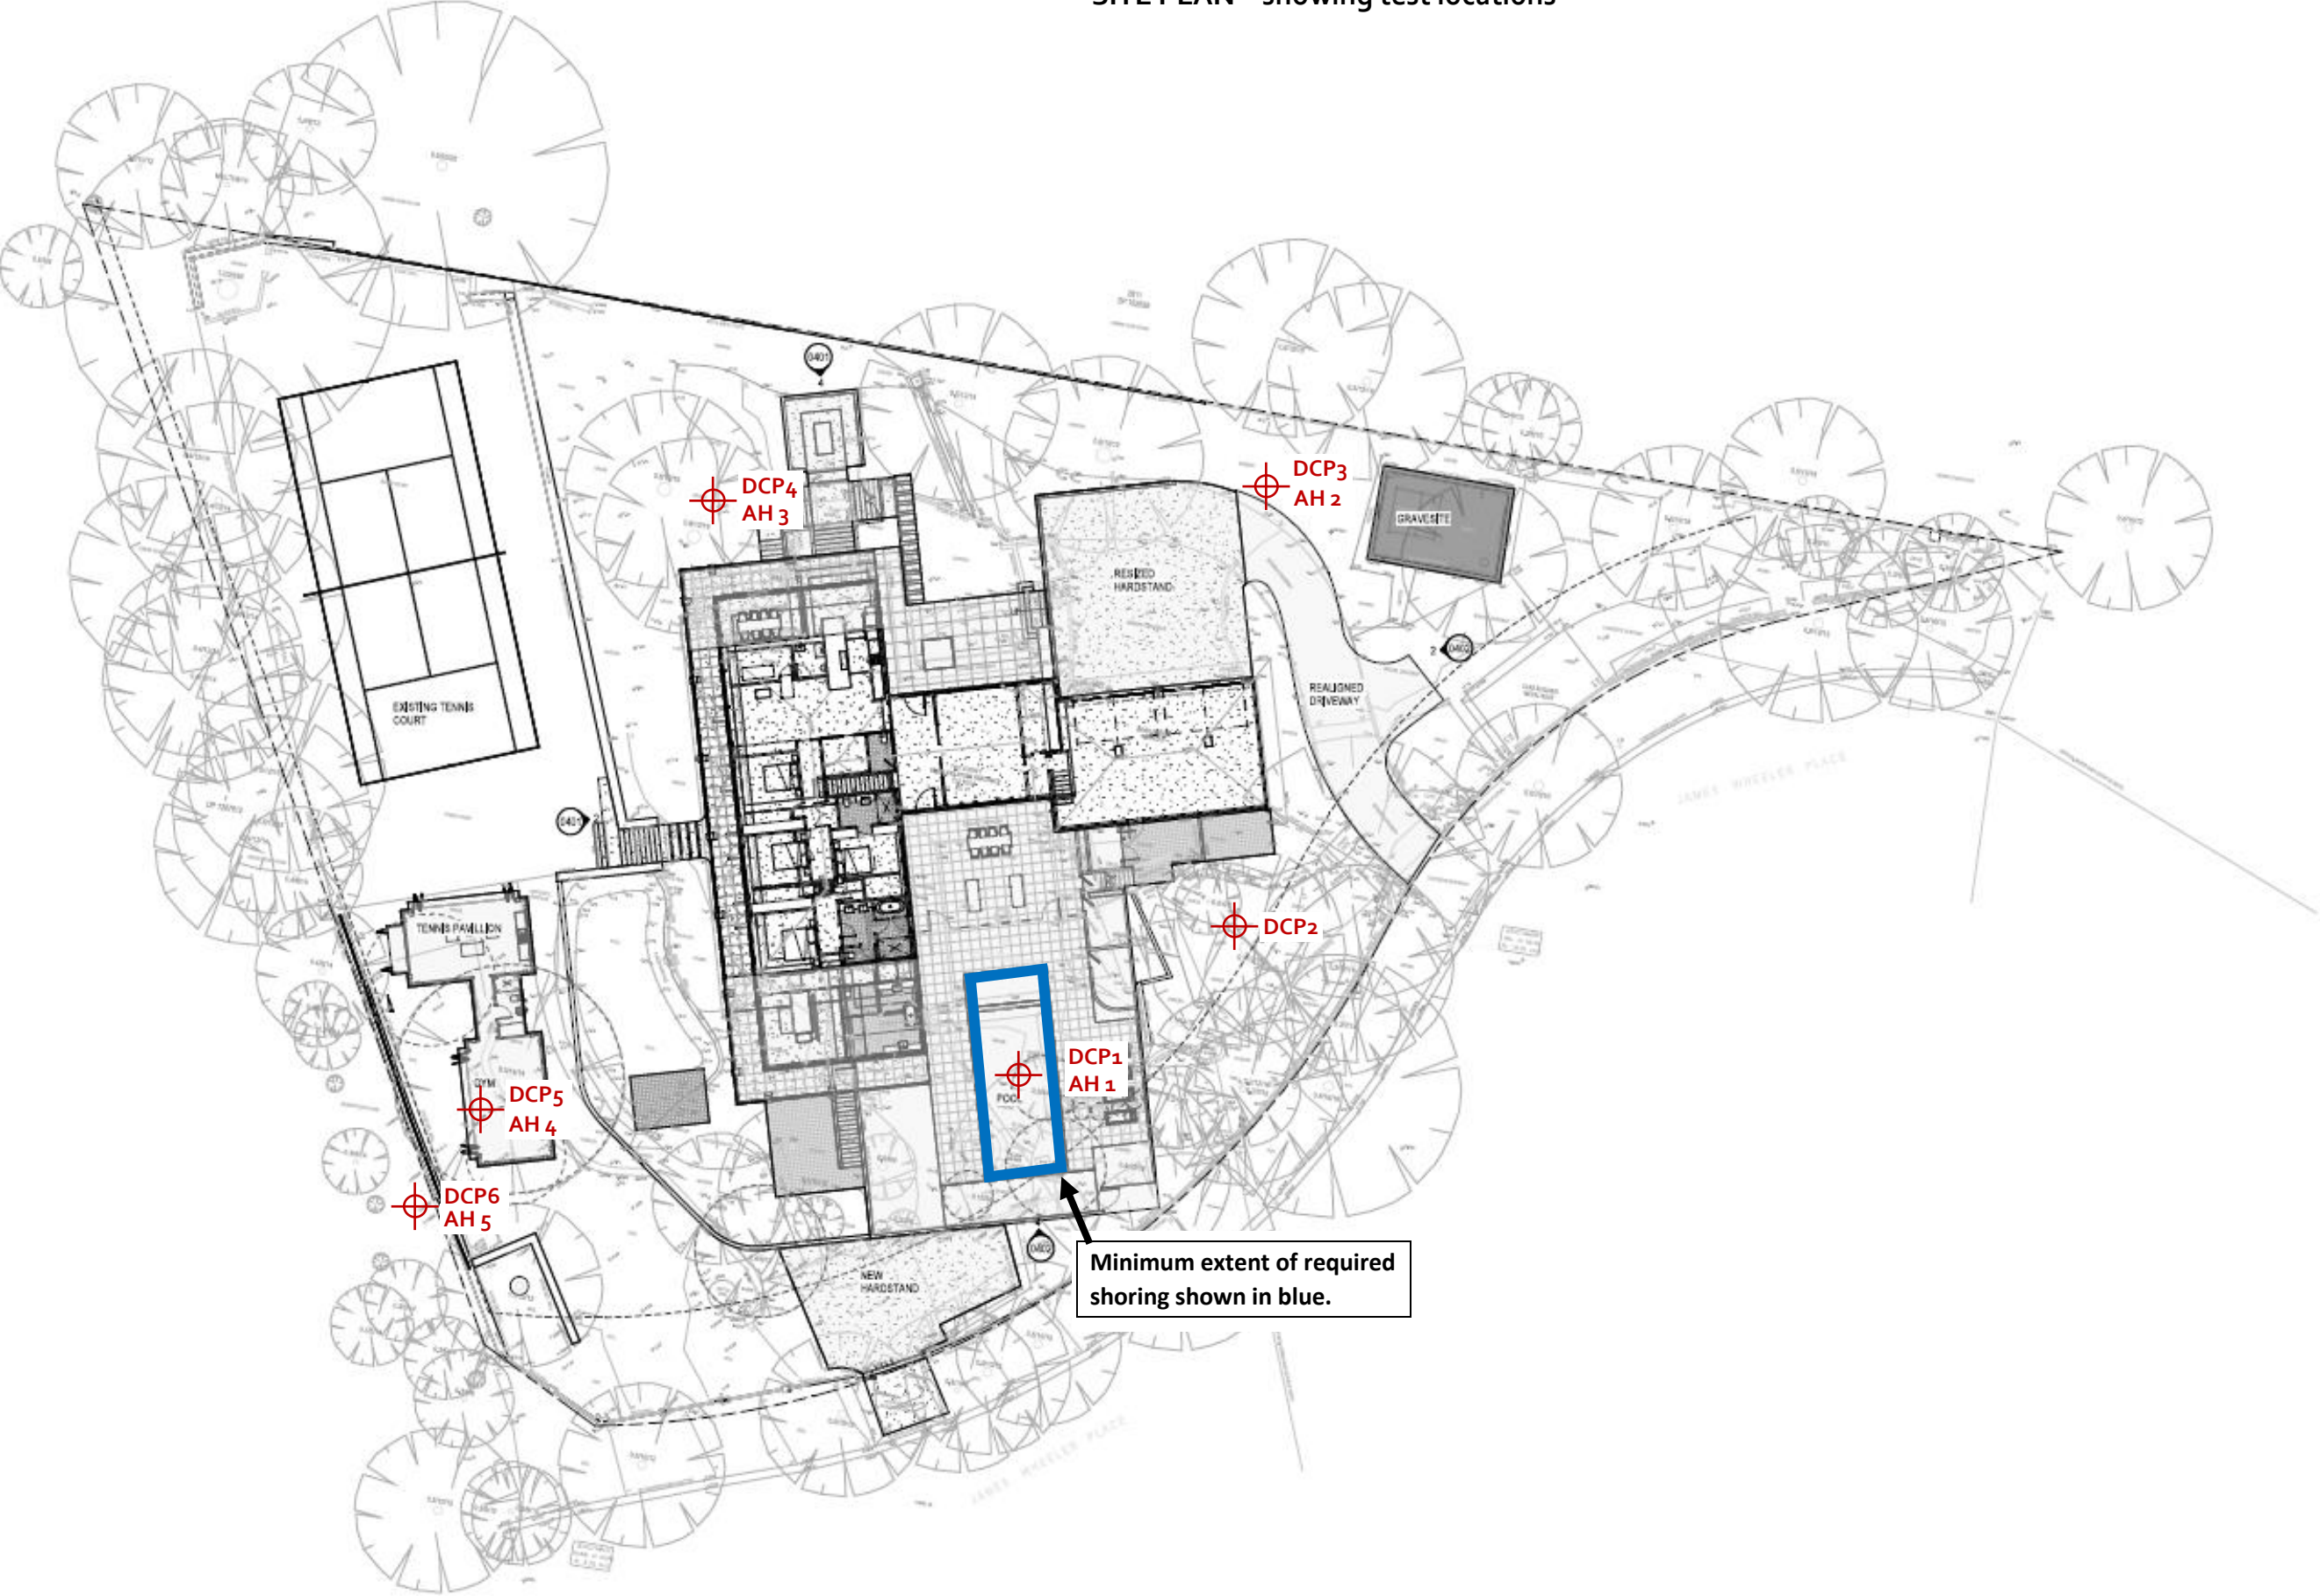
SITE PLAN – showing test locations

Minimum extent of required shoring shown in blue.

Due to the depth of the fill, all sides of the pool excavation are to be temporarily supported with typical pool shoring such as braced form ply until the pool structure is in place. See the Site Plan attached for the minimum extent of the required shoring shown in blue.

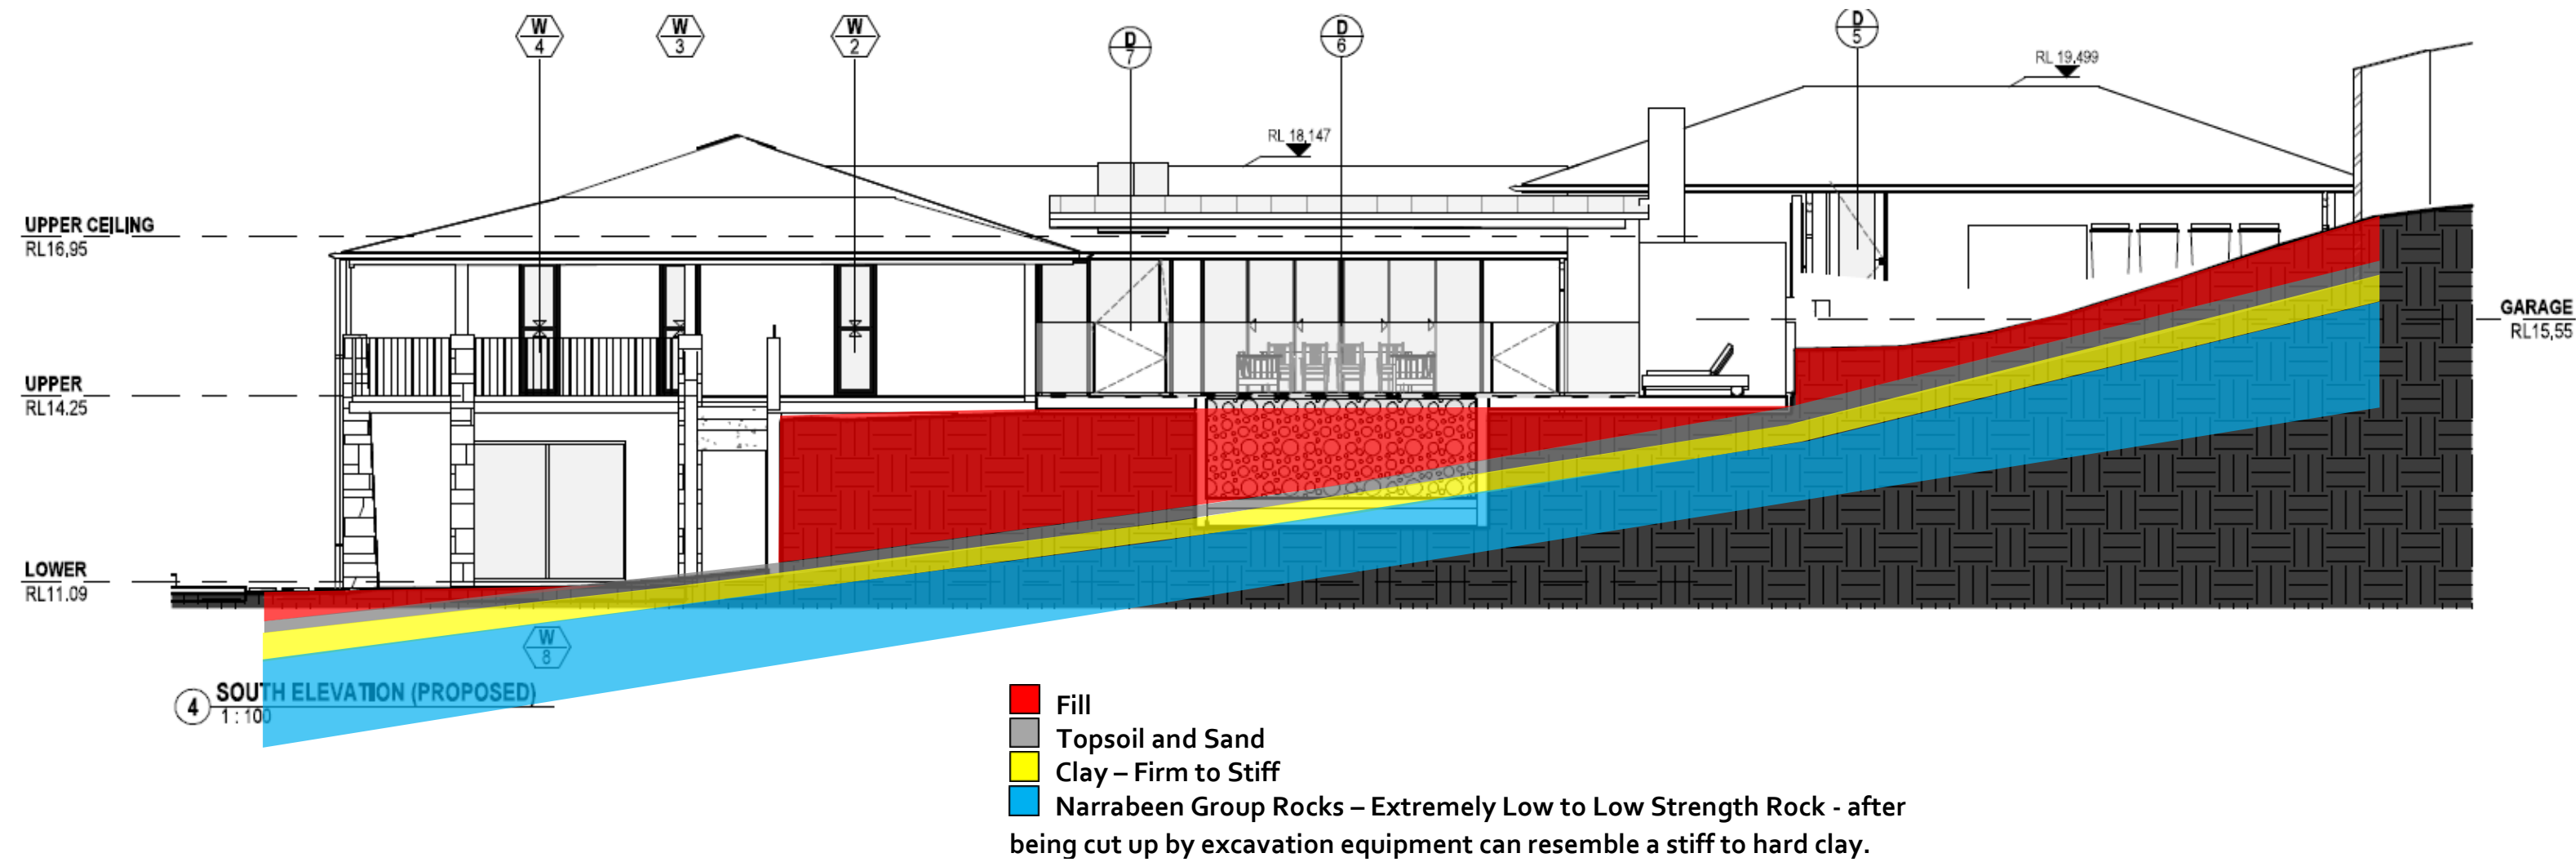
TYPE SECTION – Diagrammatical Interpretation of expected Ground Materials

The slope materials are colluvial at the near surface and residual at depth. In the test locations, the ground materials consist of fill, a thin sandy topsoil and clayey sand over Firm to Stiff Clays. Fill to an estimated maximum depth of ~3.0m provides level platforms for lawn, garden, and paved areas across the property, and a level platform for the tennis court slab. In the test locations, the clays merge into the weathered zone of the underlying rock at depths of between ~0.4m to ~1.8m below the current surface, being deeper where the fill is deeper (DCPs 1 & 5). The weathered zone of the underlying rock is interpreted as Extremely Low to Low Strength Rock. It is to be noted that this material is a soft rock and can appear as a mottled stiff clay when it is cut up by excavation equipment. See Type Section attached for a diagrammatical representation of the expected ground materials.
