## **40 Bassett Street, Mona Vale**

### Geotechnical Comments for Section 4.55.

## **GEOTECHNICAL INVESTIGATION:**

### **New House and Pool at 40 Bassett Street, Mona Vale**

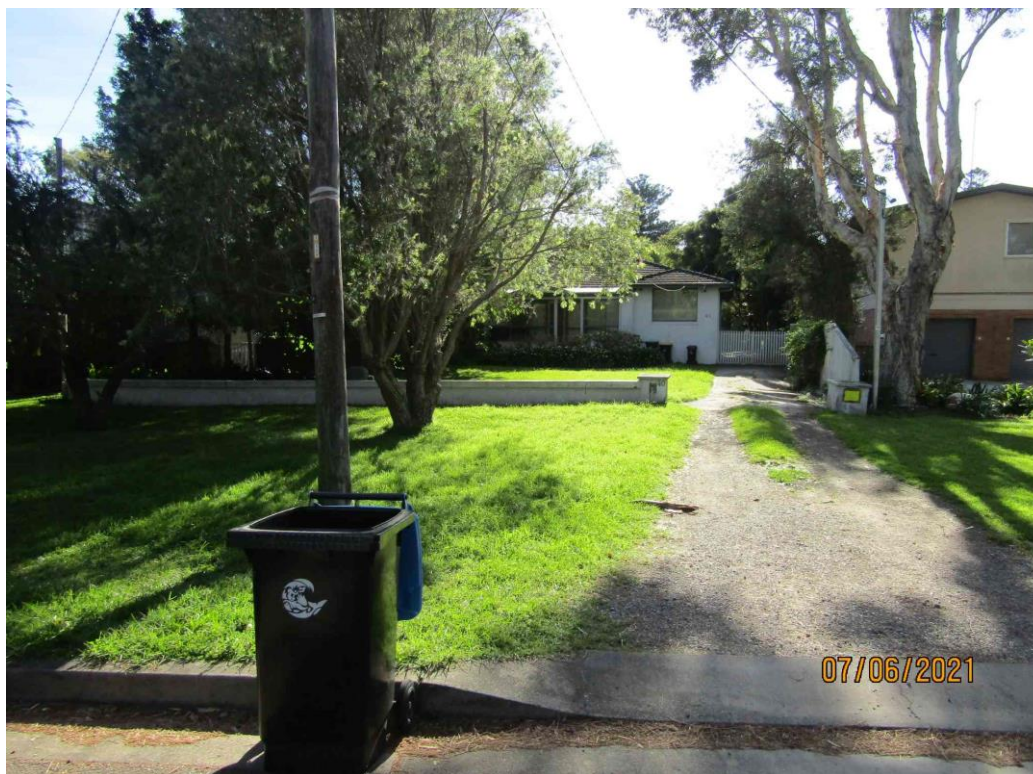
Photo 1

- 2.3** At the road frontage, a gravel and concrete driveway runs along the E side of the house to a rendered masonry garage on the uphill side of the house (Photos 1 & 2). Between the road frontage and the house is a near level lawn area (Photo 1). The single storey rendered brick house is supported by brick walls and brick piers (Photos 3 & 4). The supporting walls and piers stand vertical and show no significant signs of movement (Photo 5). A gently sloping lawn extends from the uphill side of the house and garage to the uphill property boundary (Photo 6).

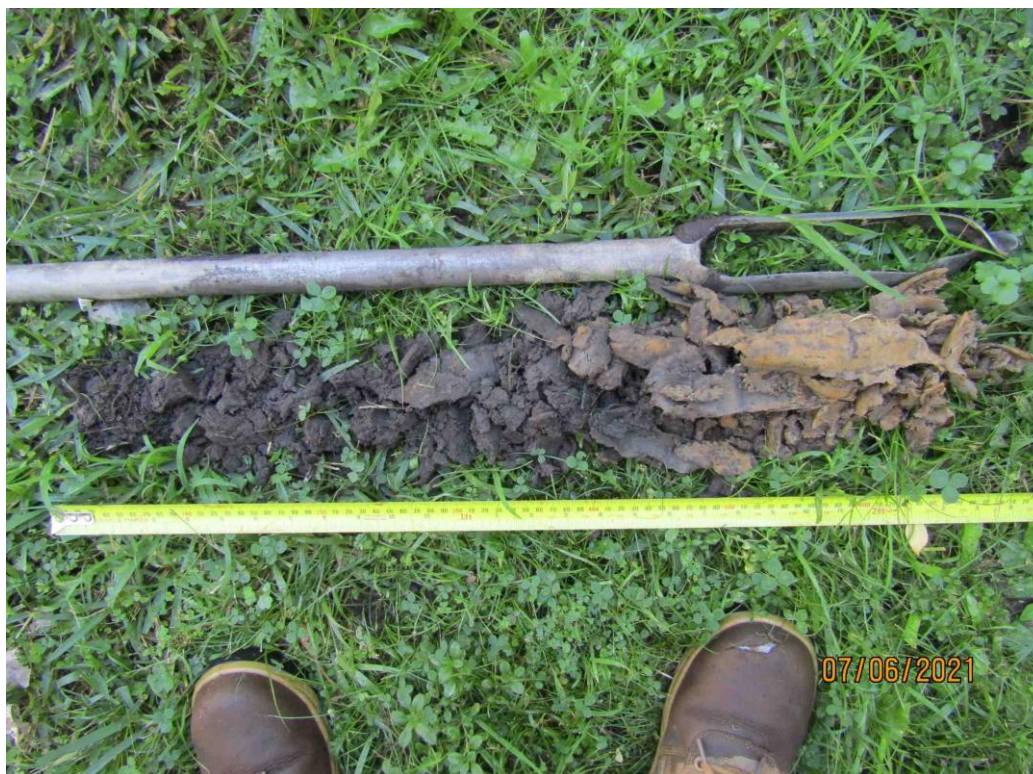
#### AUGER HOLE 1 (~RL6.7) – AH1 (Photo 7)

| Depth (m) | Material Encountered |
| 0.0 to 0.4 | <b>TOPSOIL</b> , sandy soil, dark brown, damp, fine to medium grained. |
| 0.4 to 0.7 | <b>CLAY</b> , brown orange, firm to stiff, moist. |

End of Hole @ 0.7m in firm to stiff clay. No watertable encountered.

Photo 7: AH1 – downhole is from left to right.

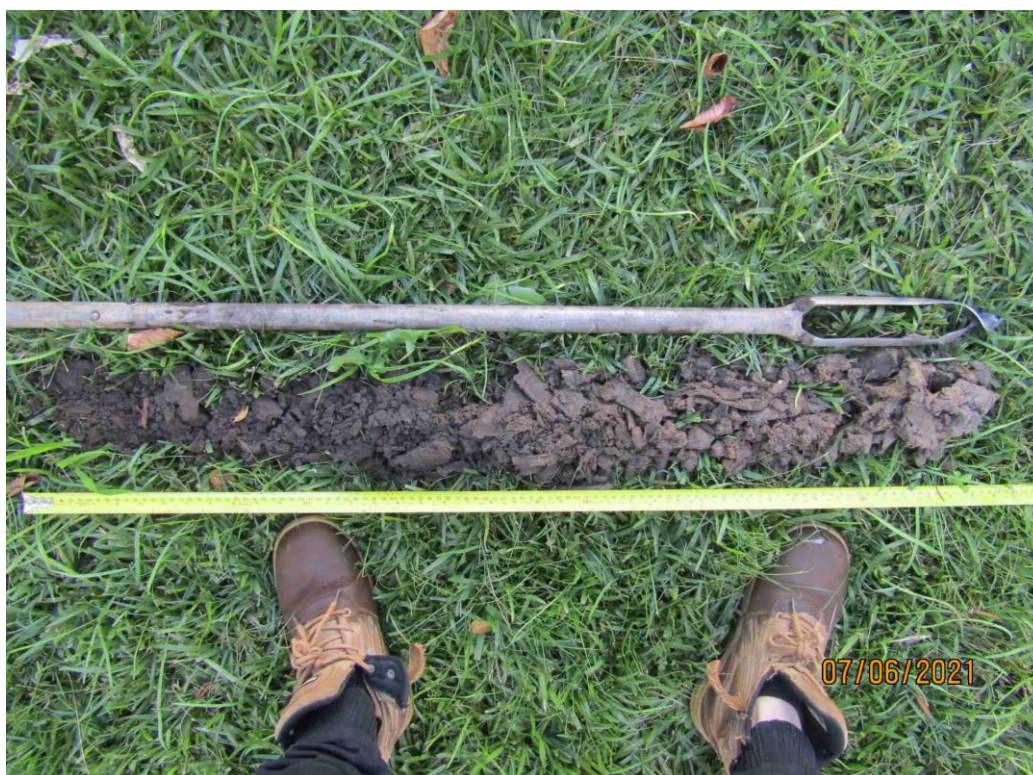
## AUGER HOLE 2 (~RL5.6) – AH1 (Photo 8)

| Depth (m) | Material Encountered |
| 0.0 to 0.6 | <b>TOPSOIL</b> , sandy soil, dark brown, damp, fine to medium grained. |
| 0.6 to 0.9 | <b>CLAYEY SOIL</b> , dark brown, damp, fine |
| 0.9 to 1.1 | <b>SANDY CLAY</b> , grey and orange brown, firm to stiff, damp. |

End of Hole @ 1.1m in firm to stiff sandy clay. No watertable encountered.

Photo 8: AH2 – downhole is from left to right.

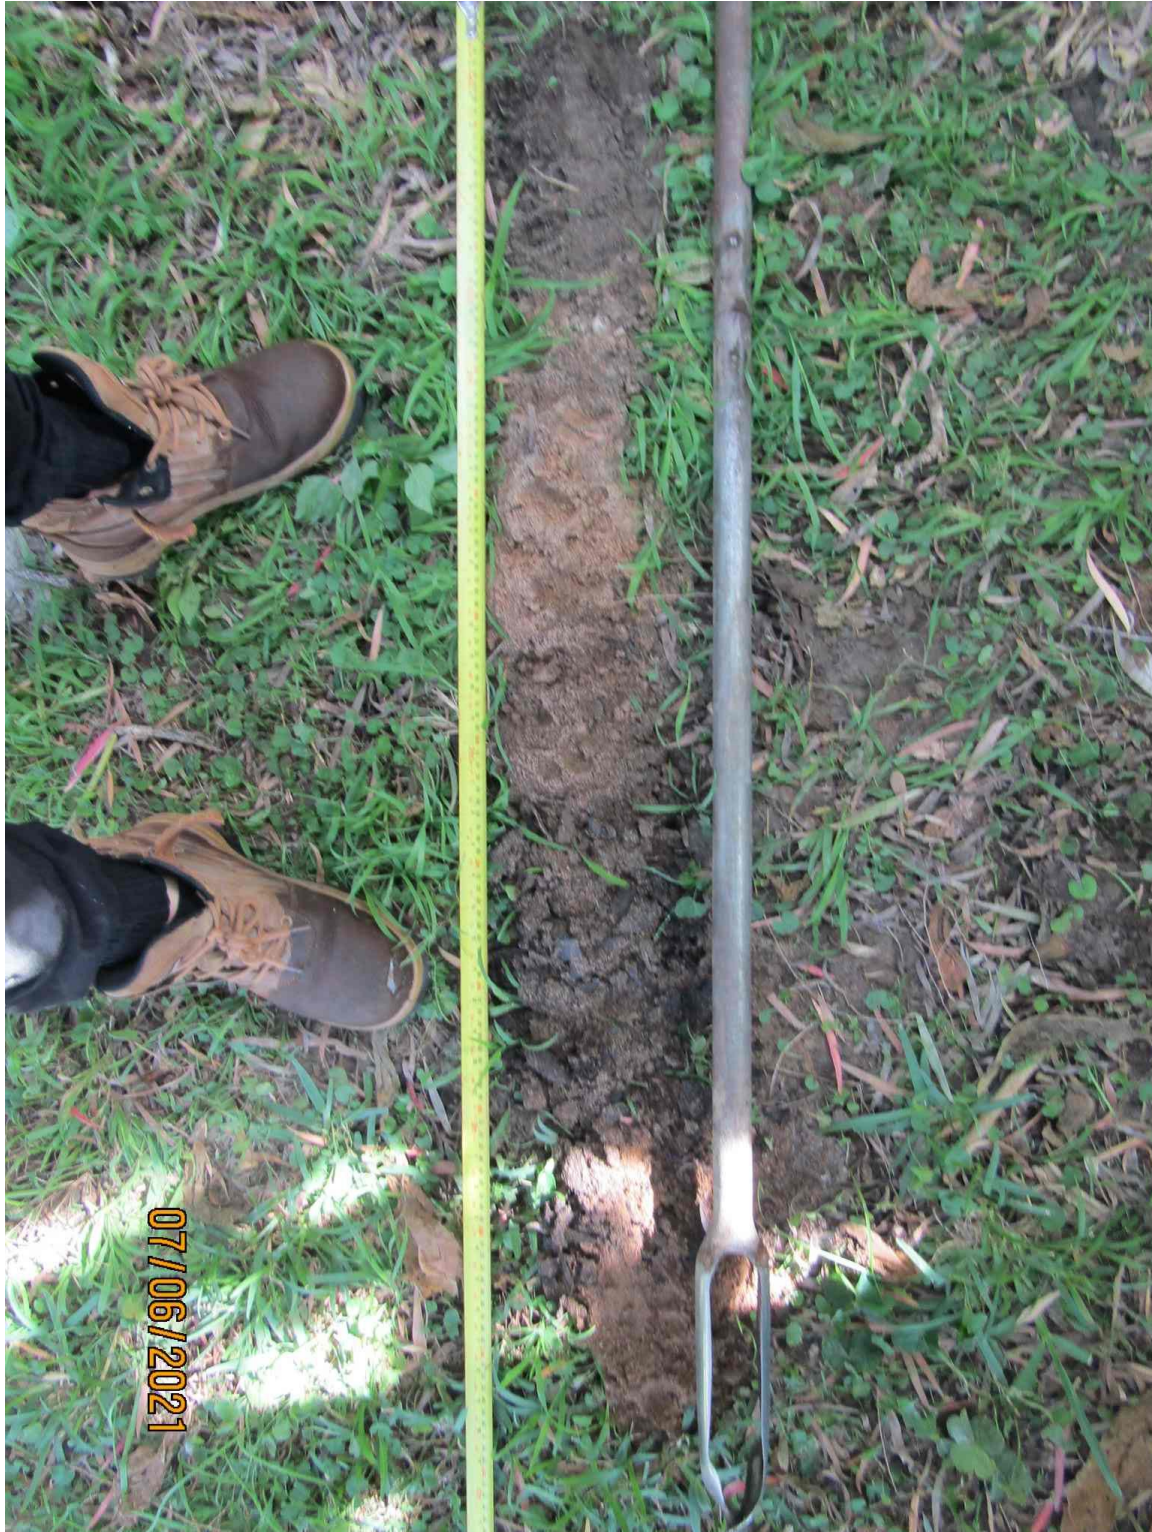
## AUGER HOLE 3 (~RL4.0) – AH1 (Photo 9)

| Depth (m) | Material Encountered |
| 0.0 to 0.1 | <b>TOPSOIL</b> , sandy soil, dark brown, moist, fine to medium grained. |
| 0.1 to 0.7 | <b>SAND</b> , dark grey, orange/brown, moist, medium grained. |
| 0.7 to 1.1 | <b>SANDY PEAT</b> , black, moist. |
| 1.1 to 1.2 | <b>SAND</b> , brown, medium dense, moist. |

Refusal @ 1.2m in medium dense sand. No watertable encountered.

Photo 9: AH3 Downhole is from top to bottom.

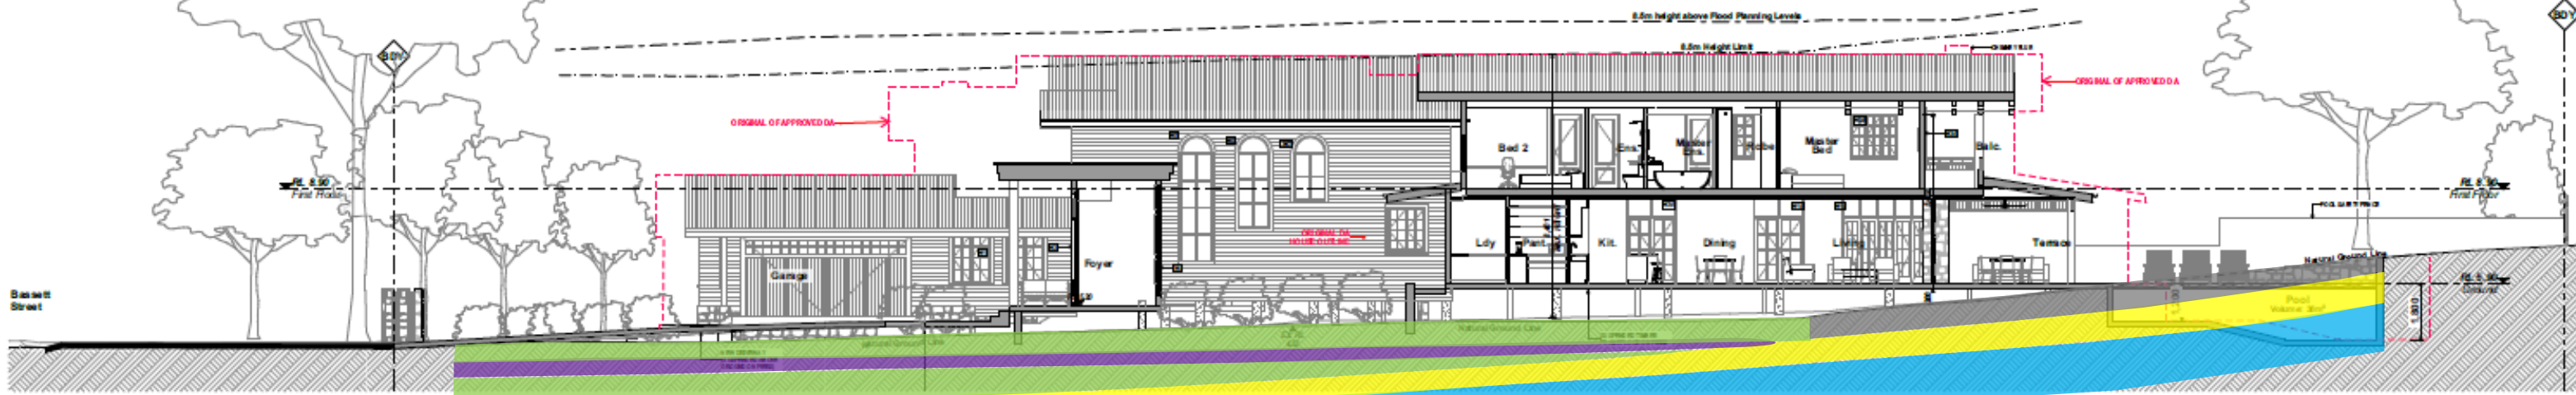
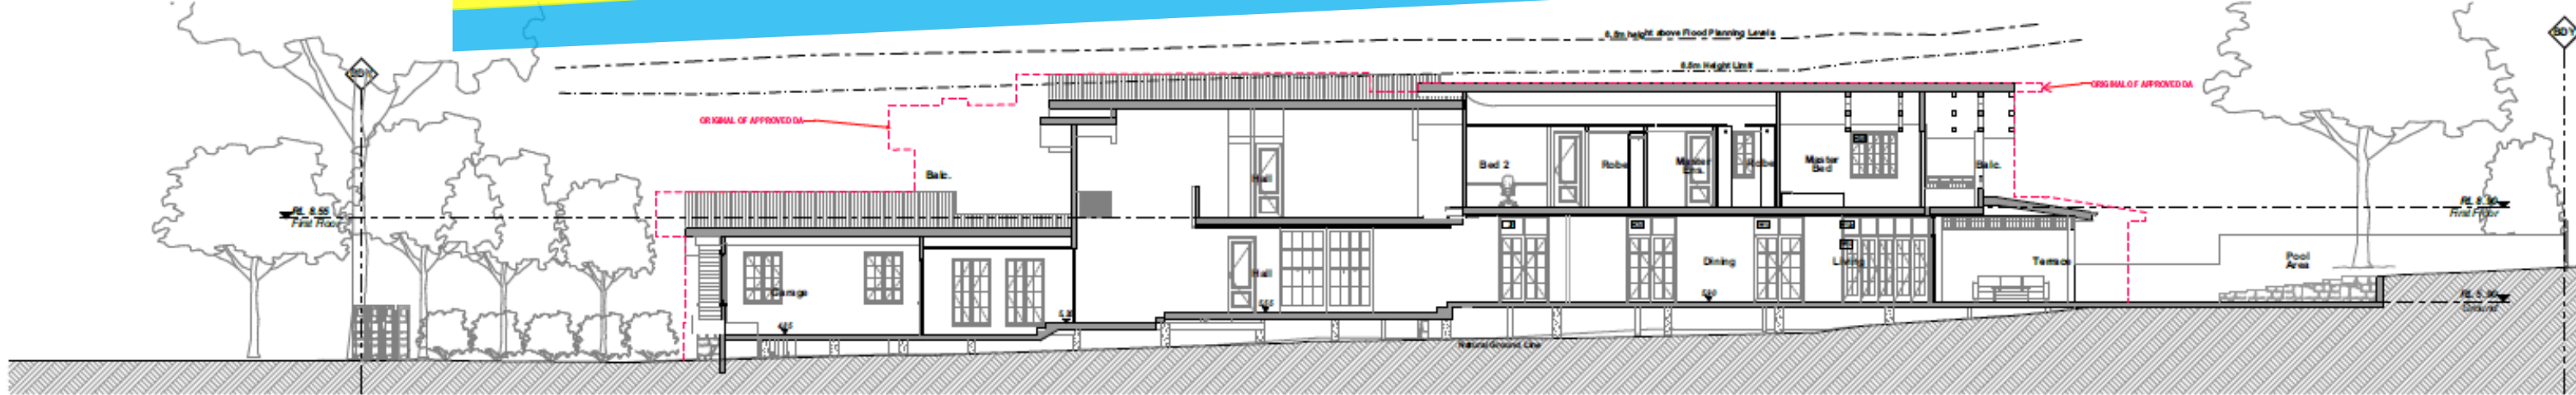
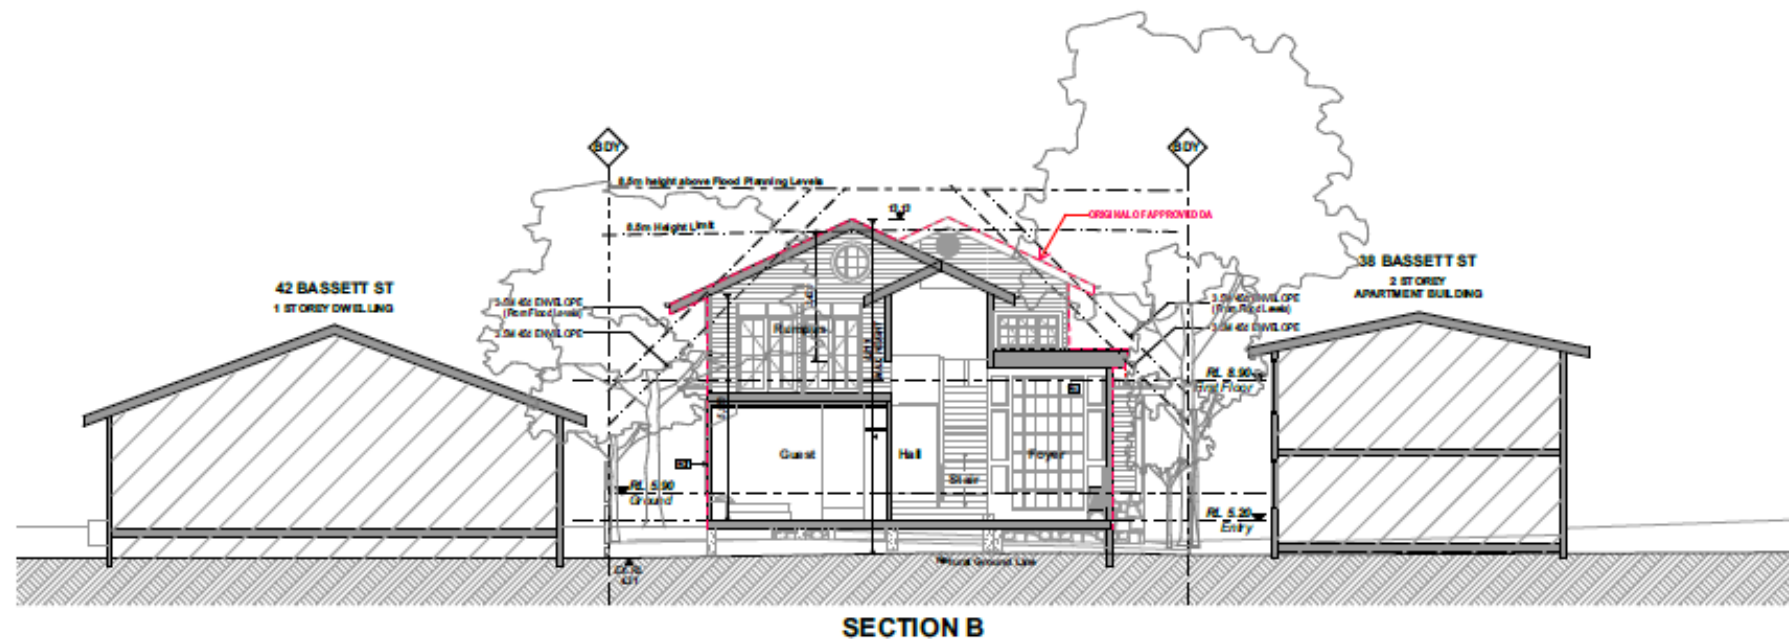
# TYPE SECTION – Diagrammatical Interpretation of expected Ground Materials

The geology across the site is variable as the site is located on the toe and lower reaches of a hillslope. In the test locations at the near level portion of the property (DCP 1 to 3 & AH3), the ground materials consist of a sandy topsoil, Medium Dense Sand and sandy peat over Medium Dense Sand and firm to stiff sandy clays, with Extremely Low Strength Rock or better encountered at depths from between ~1.8m to ~3.0m below the current surface, being

progressively shallower as the slope rises from the toe of the slope. For the ground tests at the location of the proposed pool near the uphill property boundary (DCP4 & 5, AH1 & 2), the ground materials consist of a sandy topsoil over clayey soil and clays/sandy clays, with Extremely Low Strength Rock or better encountered at depths from between ~1.5m to ~1.8m below the current surface. See the Type Section attached for a diagrammatical representation of the expected ground materials.
