# ALL ARBOR SOLUTIONS

## Arboricultural Impact Assessment

**Site Address:** 61 Loombah Street  
Bilgola Plateau  
NSW  
2107

**Date:** 2 November 2022

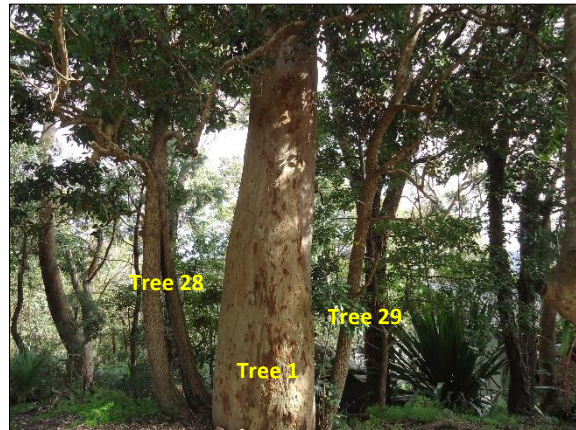
| Tree No | Botanical Name<br>Common Name | Height (m) | Canopy Spread (m) | DBH (mm) | DAB (mm) | Age Class | Vigour | Condition | ULE | Landscape Significance | Retention Value | TPZ (m) | SRZ (m) | Comments |
|---|---|---|---|---|---|---|---|---|---|---|---|---|---|---|
| 1 | <i>Angophora costata</i><br>(Smooth-barked Apple) | 20-25 | 10x10 | 840 | 940 | M | N | G | L | M | H | 10.08 | 3.22 | Significant specimen. Deadwood to 180mm dia. and epicormics observed within canopy. Slight swelling in base of trunk may indicate internal decay conditions. |

**Photograph 1:** Trees 1, 28 and 29 as seen from the front of the property.

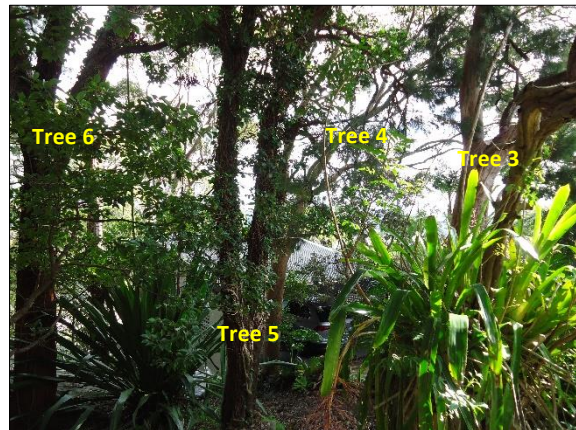
| Tree No | Botanical Name<br>Common Name | Height (m) | Canopy Spread (m) | DBH (mm) | DAB (mm) | Age Class | Vigour | Condition | ULE | Landscape Significance | Retention Value | TPZ (m) | SRZ (m) | Comments |
|---|---|---|---|---|---|---|---|---|---|---|---|---|---|---|
| 5 | <i>Allocasuarina toralosa</i><br>(Forest Sheoak) | 5-10 | 3x3 | 400 | 300 | M | N-L | P | S | L | L | 4.80 | 2.00 | Codominant stems develop at 1m. Ivy found to be growing over tree. Tree in a state of declining health and condition. |
| 6 | <i>Corymbia gummifera</i><br>(Red Bloodwood) | 20-25 | 8x8 | 450 | 500 | M | N-L | P | S | L | L | 5.40 | 2.47 | Tree in advanced state of decline, half of canopy dead. Ivy found to be growing over tree. Deadwood and epicormics within canopy. |

**Photograph 2:** Trees 3, 4, 5 and 6 as seen from the front of the property.

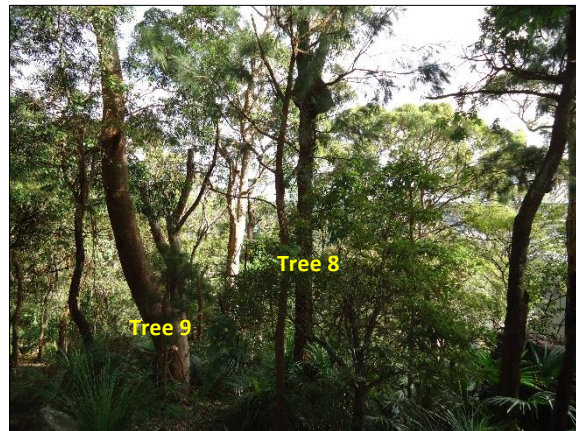
| Tree No | Botanical Name<br>Common Name | Height (m) | Canopy Spread (m) | DBH (mm) | DAB (mm) | Age Class | Vigour | Condition | ULE | Landscape Significance | Retention Value | TPZ (m) | SRZ (m) | Comments |
|---|---|---|---|---|---|---|---|---|---|---|---|---|---|---|
| 8 | <i>Corymbia gummifera</i><br>(Red Bloodwood) | 20-25 | 4x4 | 350 | 450 | M | L | P | S | M | L | 4.20 | 2.37 | Termite nest observed within branch junction. Canopy consists of epicormic shoots. Tree in an advanced state of decline. |
| 9 | <i>Eucalyptus</i> sp<br>(Eucalypt) | 15-21 | 6x7 | 600 | 700 | M | N | G | L | M | H | 7.20 | 2.85 | Termite tracking observed on trunk. Deadwood and epicormics observed within canopy. |

**Photograph 3:** Trees 8 and 9 as seen looking along the eastern boundary.

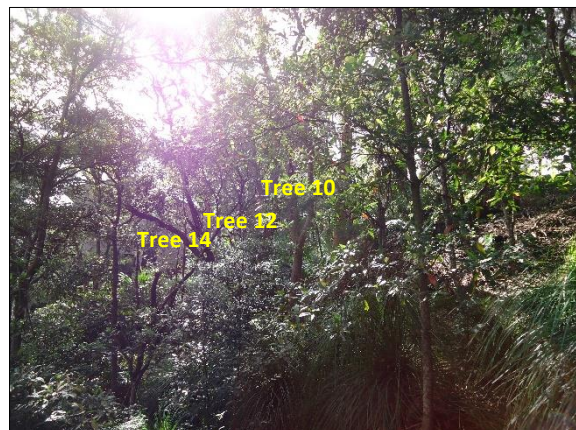
| Tree No | Botanical Name<br>Common Name | Height (m) | Canopy Spread (m) | DBH (mm) | DAB (mm) | Age Class | Vigour | Condition | ULE | Landscape Significance | Retention Value | TPZ (m) | SRZ (m) | Comments |
|---|---|---|---|---|---|---|---|---|---|---|---|---|---|---|
| 10 | <i>Angophora costata</i><br>(Smooth-barked Apple) | 20-25 | 6x6 | 400 | 500 | M | N | G | L | M | H | 4.80 | 2.47 | Deadwood and epicormics observed within canopy. |
| 14 | <i>Banksia serrata</i><br>(Old Man Banksia) | 10-15 | 3x3 | 300 | 300 | M | N | G | M | M | M | 3.60 | 2.00 | Dieback observed within top of canopy. |

**Photograph 4:** Looking west from eastern boundary at trees 10, 12 and 14.

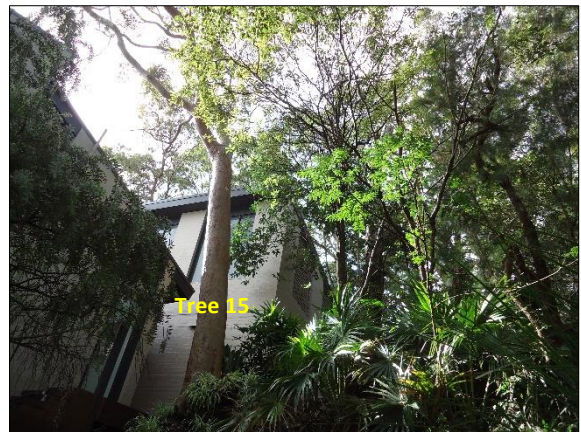
**Photograph 5:** Tree 15 located on the western boundary.

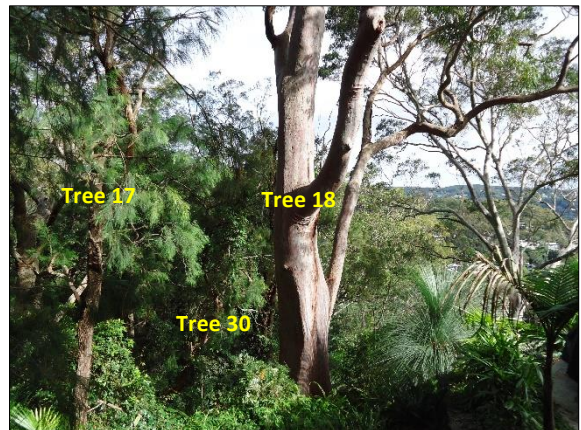
| Tree No | Botanical Name<br>Common Name | Height (m) | Canopy Spread (m) | DBH (mm) | DAB (mm) | Age Class | Vigour | Condition | ULE | Landscape Significance | Retention Value | TPZ (m) | SRZ (m) | Comments |
|---|---|---|---|---|---|---|---|---|---|---|---|---|---|---|
| 17 | <i>Allocasuarina toralosa</i><br>(Forest Sheoak) | 10-15 | 5x5 | 350 | 450 | M | N | G-F | S | M | L | 4.20 | 2.37 | Tree has poor form and has multiple failed and broken branches. Trunk exhibits a slight lean to the north. |
| 18 | <i>Angophora costata</i><br>(Smooth-barked Apple) | 20-25 | 10x10 | 900 | 1000 | M | N | G | L | M | H | 10.80 | 3.31 | Significant tree located adjacent edge of rocky outcrop. Deadwood and epicormics observed within canopy. |

| Tree No | Tree name | Development Impacts | Controls | Retain or Remove Tree |
|---|---|---|---|---|
| 30 | <i>Allocasuarina toralosa</i><br>(Forest Sheoak) | Tree is located within the alignment of the Lower-Level decking area and cannot be retained under the current design. | Nil | Remove |

**Photograph 6:** Looking south from western boundary at trees 17, 18 and 30.

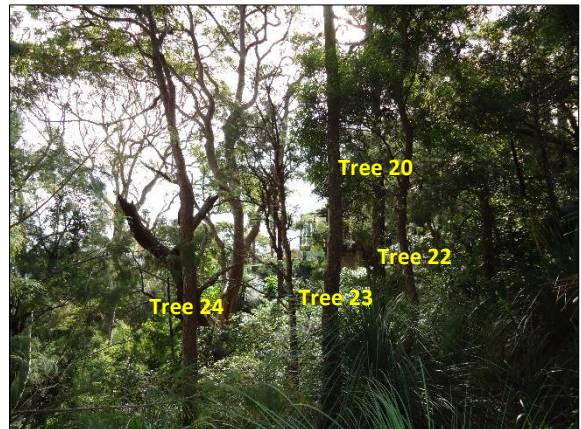
| Tree No | Botanical Name<br>Common Name | Height (m) | Canopy Spread (m) | DBH (mm) | DAB (mm) | Age Class | Vigour | Condition | ULE | Landscape Significance | Retention Value | TPZ (m) | SRZ (m) | Comments |
|---|---|---|---|---|---|---|---|---|---|---|---|---|---|---|
| 23 | <i>Allocasuarina toralosa</i><br>(Forest Sheoak) | 10-15 | 1x1 | 200 | 300 | M | L | P | S | M | L | 2.40 | 2.00 | Tree is near dead. Top of tree has failed. Canopy consists of epicormic growth. |

**Photograph 7:** Looking west from the eastern boundary at trees 20, 22, 23 and 24.

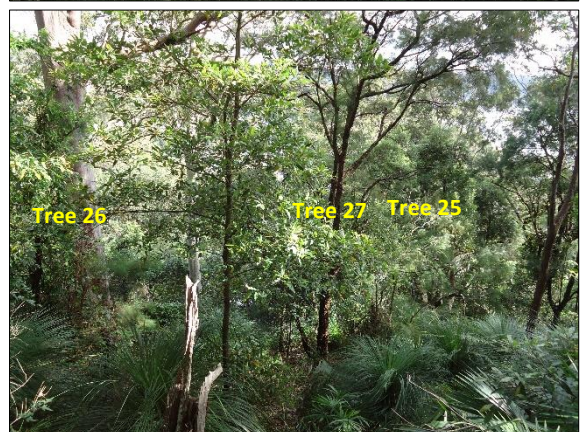
| Tree No | Botanical Name<br>Common Name | Height (m) | Canopy Spread (m) | DBH (mm) | DAB (mm) | Age Class | Vigour | Condition | ULE | Landscape Significance | Retention Value | TPZ (m) | SRZ (m) | Comments |
|---|---|---|---|---|---|---|---|---|---|---|---|---|---|---|
| 27 | <i>Allocasuarina toralosa</i><br>(Forest Sheoak) | 5-10 | 4x4 | 250 | 350 | M | N | G | S | L | L | 3.00 | 2.13 | Twin stems at base of trunk. Canopy density is sparse. Broken branches observed. |

**Photograph 8:** Looking south from the eastern boundary at trees 25, 26 and 27.
