ARBORICULTURAL IMPACT REPORT

8 LIDO AVENUE
NORTH NARRABEEN NSW

12 JULY 2019

PREPARED FOR JENNY SHARPLES

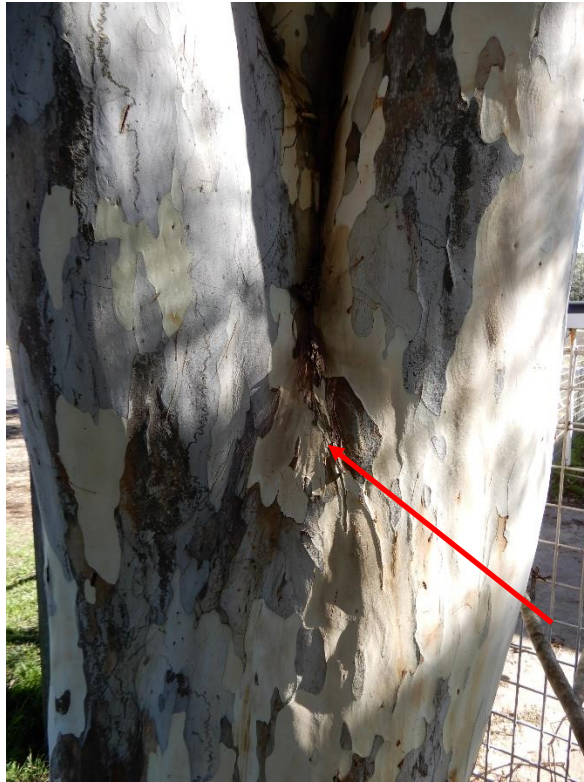
Photograph 1: Tree # 1 – Illustrating multiple leaders with some evidence of poor attachment.

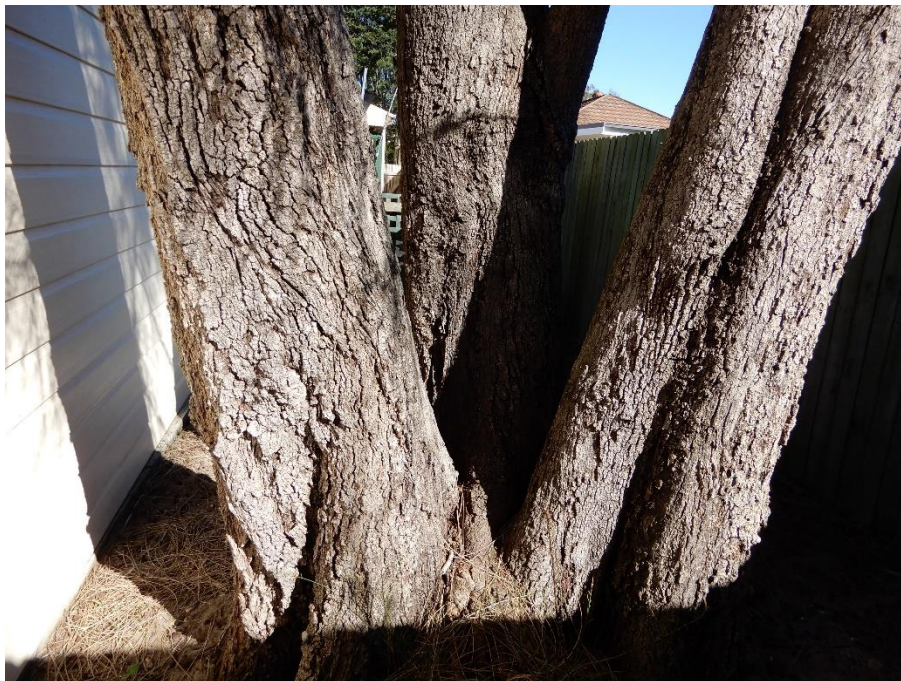
Photograph 2: Tree # 5 – Illustrating multiple leaders from ground level with some evidence of poor attachment.

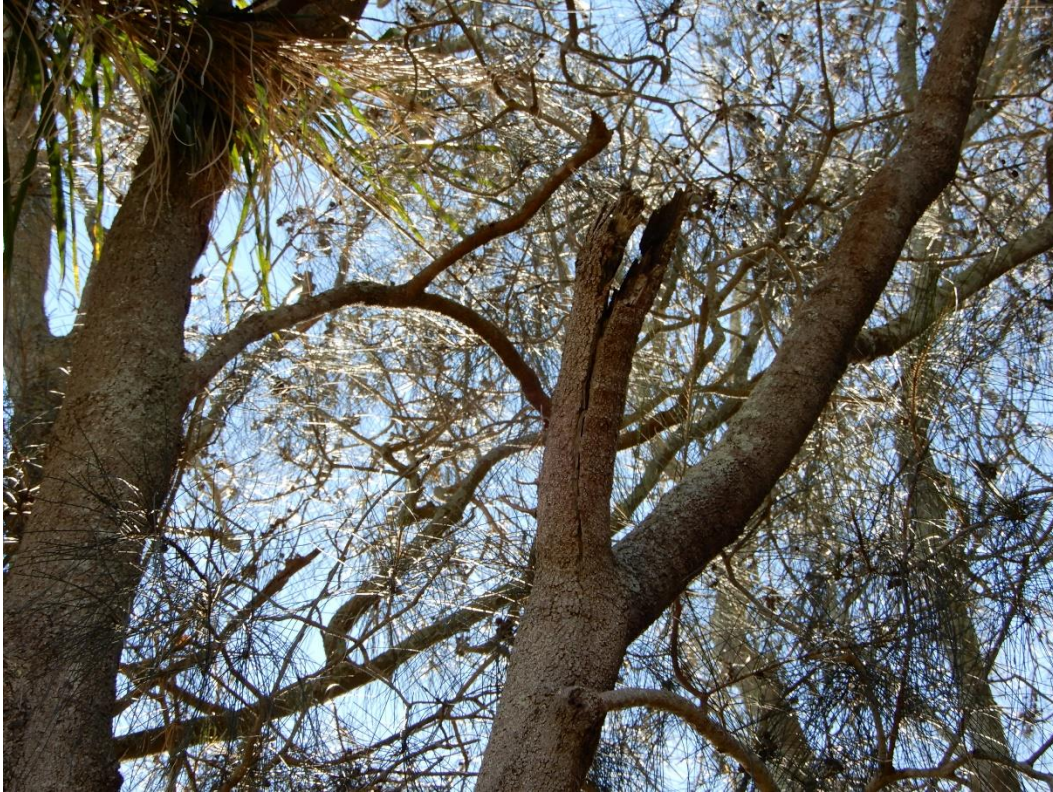
Photograph 3: Tree # 5 – Illustrating the reduced foliage density and dieback.

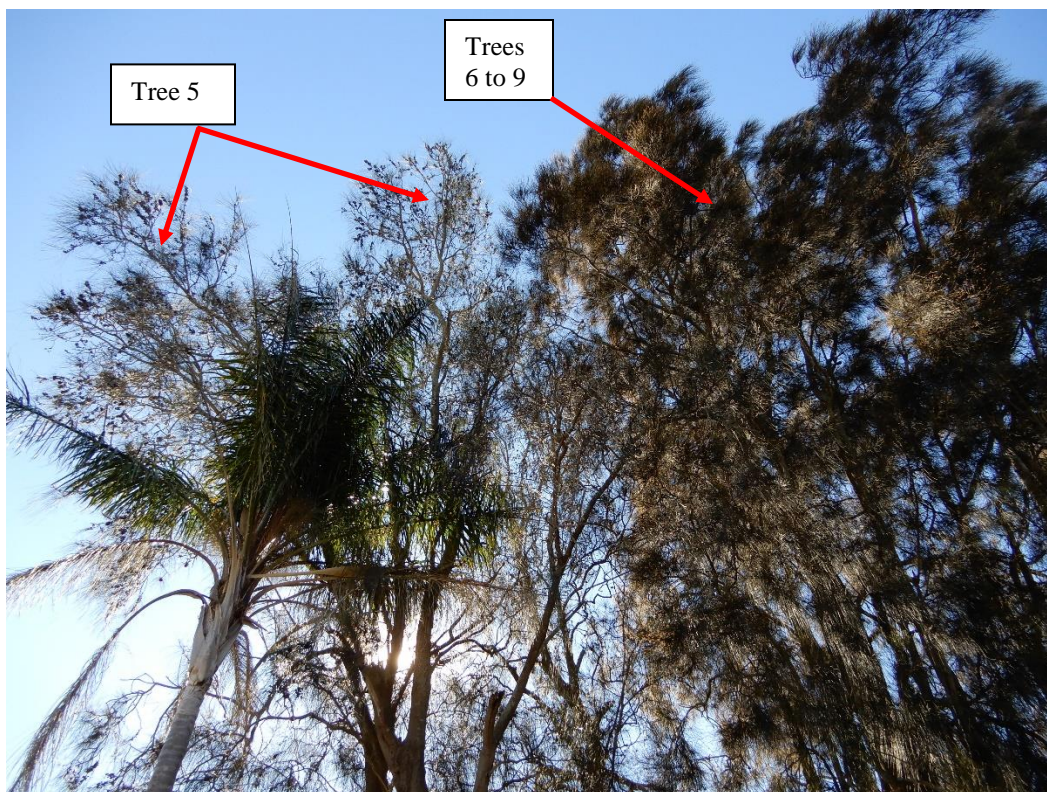
Photograph 4: : Tree # 5 – Illustrating the reduced foliage density and dieback compared with healthy Swamp Oaks 6 to 9.

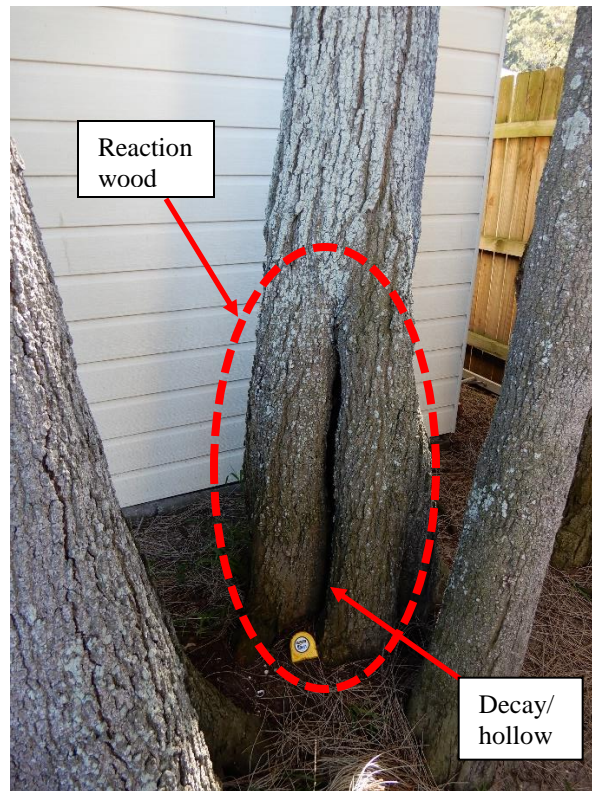
The tree's past canopy development has been significantly suppressed. Th tree displays fair to poor branch attachment with evidence of a past failure at 1 metre to ground level on the south side with subsequent decay entry and associated reaction wood - not considered at risk of failure at the moment due to good vigour (ongoing production of reaction wood) and shelter provided by adjacent trees.
8	<i>Casuarina glauca</i> (Swamp Oak)	A mature, twin trunked specimen approximately 15 metres in height with a canopy spread of 9 metres and DBH of 370 and 400mm. In good health and of moderate to high landscape significance. The tree's past canopy development has been significantly suppressed. Th tree displays fair branch attachment with codominant leaders from ground level with some evidence of poor attachment (small bark inclusion) - not considered at risk of failure in the short term - monitoring of junction recommended.

Photograph 5: : Tree # 7 – Illustrating the decay in basal trunk following past branch failure.

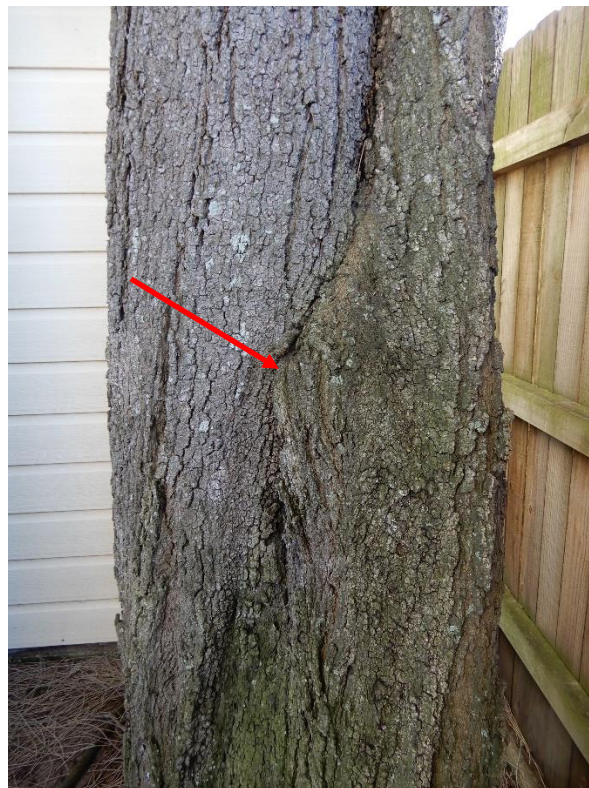
Photograph 6: Tree # 8 - Illustrating codominant leaders from 1 metre.

8	<i>Casuarina glauca</i> (Swamp Oak)	15	9	370, 400	540	630	Good foliage condition	Mature	Twin trunked	Upright trunk	All canopy to the north	Lower limbs pruned in past to 3 metres	Appears stable	Fair branch attachment	Good health	Good vigour	5%	No visual evidence of significant pest or disease	2 Medium (15 to 40 years)	Moderate to high landscape significance	2	The tree's past canopy development has been significantly suppressed. Th tree displays fair branch attachment with codominant leaders from ground level with some evidence of poor attachment (small bark inclusion) - not considered at risk of failure in the short term - monitoring of junction recommended.

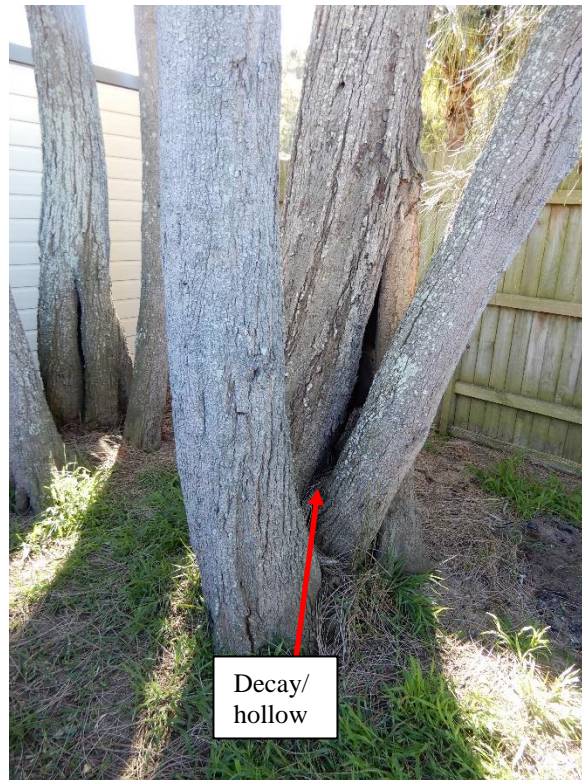
9	<i>Casuarina glauca</i> (Swamp Oak)	A mature, multi trunked specimen approximately 14 metres in height with a canopy spread of 8 x 10 metres and DBH of 260, 290 and 480mm. In good health and of moderate to high landscape significance. The tree displays fair to poor branch attachment with multiple leaders from ground level with some evidence of poor attachment - this poor attachment is compounded by past wounding in the main leader with evidence of significant decay extending from 1.2 metres into the basal trunk at the junction of trunks - this is a weak point in the tree with increased risk of failure. There is also evidence of past wounding (following a branch failure) on the eastern leader at 1.6 metres with extensive decay. Risk of failure will increase if any adjacent trees are removed resulting in increased wind loading. Short ULE.

Photograph 7: Tree # 9 - Illustrating multiple leaders from ground level with evidence of extensive decay at the junction.

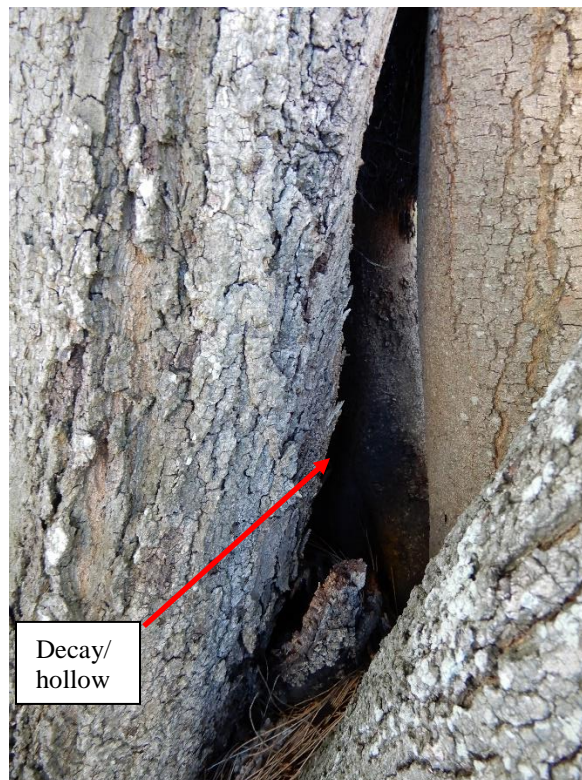
Photograph 8: Tree # 9 – Illustrating a closer view of the decay/hollow at the junction.
