# Arboricultural Impact Assessment

Site Address: 6 Killawarra Rd Duffys Forest, NSW

Date: February 2025

Prepared by Ian Hills - Associate Diploma Horticulture  
Certificate III Arboriculture  
Diploma Arboriculture (AQF5)

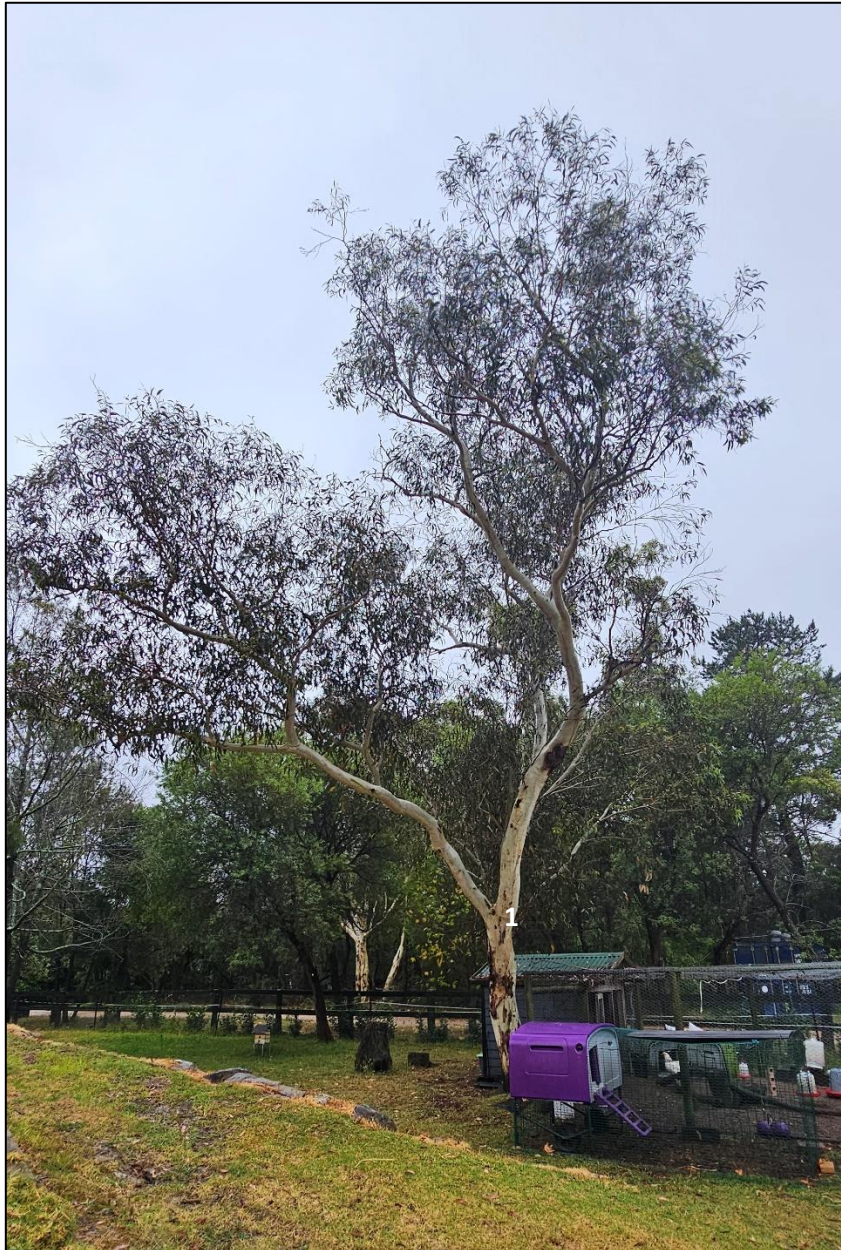
**Figure 1 Tree 1 *Eucalyptus racemosa*.**

| No. | Common Name | Species | DBH (M) | TPZ (M) | SRZ (M) | HEIGHT (M) | SPREAD (M) | Vigour | Age Class | SULE | Comments |
|---|---|---|---|---|---|---|---|---|---|---|---|
| 1 | Snappy Gum | <i>Eucalyptus racemosa</i> | 0.35 | 4.2 | 2.37 | 8 | 6 | G | m | 2a | Appears structurally sound, small deadwood noted, wounds on trunk |

| No. | Species | Health and Vigour | Condition | Suitability | Sustainability | Landscape rating | Retention Value | Encroachment level | Proposal |
|---|---|---|---|---|---|---|---|---|---|
| 1 | <i>Eucalyptus racemosa</i> | Good | Good | High | 15-40 years | 2 | High | Nil | Retention |

Tree 1 *Eucalyptus racemosa* is a mature example of the locally endemic vegetation that appears in good health and condition and is assessed with high retention value.

That Trees 1 *Eucalyptus racemosa*, 2 *Hakea salicifolia*, 4 *Banksia integrifolia* and 6 *Banksia serrata* will be retained and protected by the implementation of protective measures in accordance with the provisions of AS4970-2009, "Protection of Trees on Development Sites" as detailed at section 9.0 and appendices 12.2-12.3.A of this report.

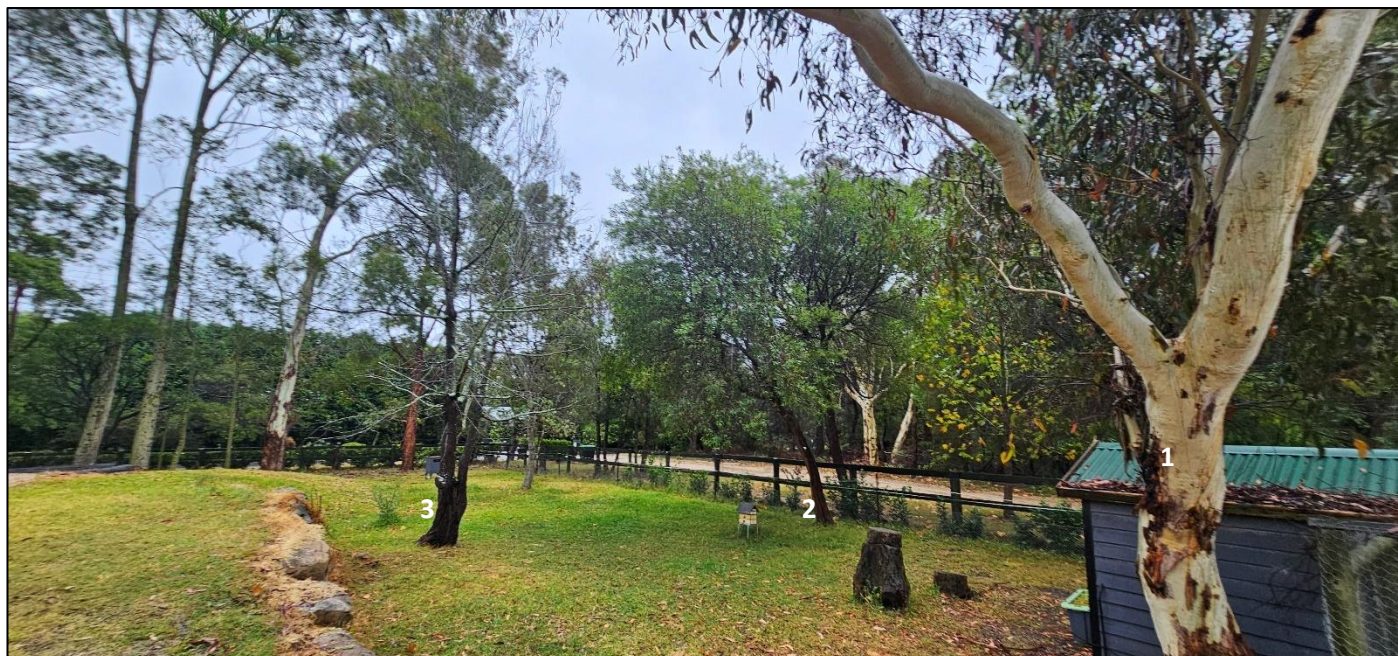
**Figure Trees 2 *Hakea saligna* and 3 *Allocasuarina torulosa*.**

| No. | Common Name | Species | DBH (M) | TPZ (M) | SRZ (M) | HEIGHT (M) | SPREAD (M) | Vigour | Age Class | SULE | Comments |
|---|---|---|---|---|---|---|---|---|---|---|---|
| 2 | Willow Hakea | <i>Hakea salicifolia</i> | 0.2 | 2.4 | 2.0 | 5 | 4 | G | m | 2a | Appears structurally sound |
| 3 | Forest Oak | <i>Allocasuarina torulosa</i> | 0.1, 0.2 | 2.64 | 2.05 | 5 | 3 | F | m | 3b | Appears in declining condition excessive branch dieback noted |

Tree 2 *Hakea salicifolia* is a mature native tree that appears in good health and condition. The tree has been planted and is assessed with moderate retention value.

Tree 3 *Allocasuarina torulosa* is a mature example of the locally endemic vegetation that appears in fair health and condition indicated by extensive branch die-back of branches, the tree is assessed with low retention value.

The tree is located within the plan area of the proposed arena shelter and consent is sought for its removal in conjunction with the proposed development. The removal of the tree can be supported based on its lack of vigour and subject to the provision of replacement planting in a suitable position on the property.

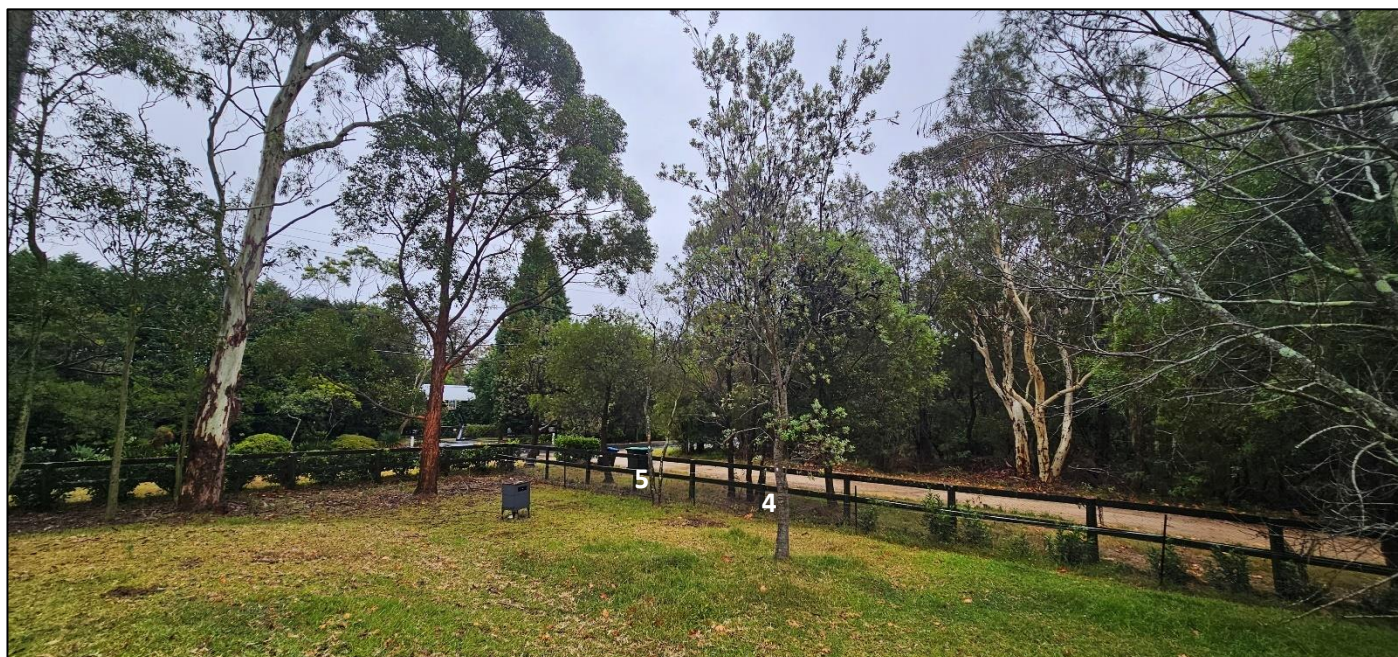
**Figure 3 Trees 4 and 5 *Banksia integrifolia*.**

| No. | Common Name | Species | DBH (M) | TPZ (M) | SRZ (M) | HEIGHT (M) | SPREAD (M) | Vigour | Age Class | SULE | Comments |
|---|---|---|---|---|---|---|---|---|---|---|---|
| 4 | Coast Banksia | <i>Banksia integrifolia</i> | 0.15 | 2.0 | 0.15 | 7 | 3 | G | sm | 2a | Appears structurally sound |
| 5 | Coast Banksia | <i>Banksia integrifolia</i> | 0.1, 0.12 | 2.0 | 1.8 | 5 | 2 | P | dead | 4a | Co-dominant trunks, dead tree, no hollows noted, storm damaged. |

Tree 4 *Banksia integrifolia* is a semi-mature native tree that appears in good health and condition. The tree has been planted and is assessed with moderate retention value.

Tree 5 *Banksia integrifolia* is an over-mature native tree that appears dead and has fallen during recent storms, the tree is assessed with very low retention value.

Tree 5 *Banksia integrifolia* is not affected by the proposal but can be removed if required under Council's exempt removal provisions due to being dead and damaged by recent storms.

That Tree 5 *Banksia integrifolia* is removed due to its poor condition.

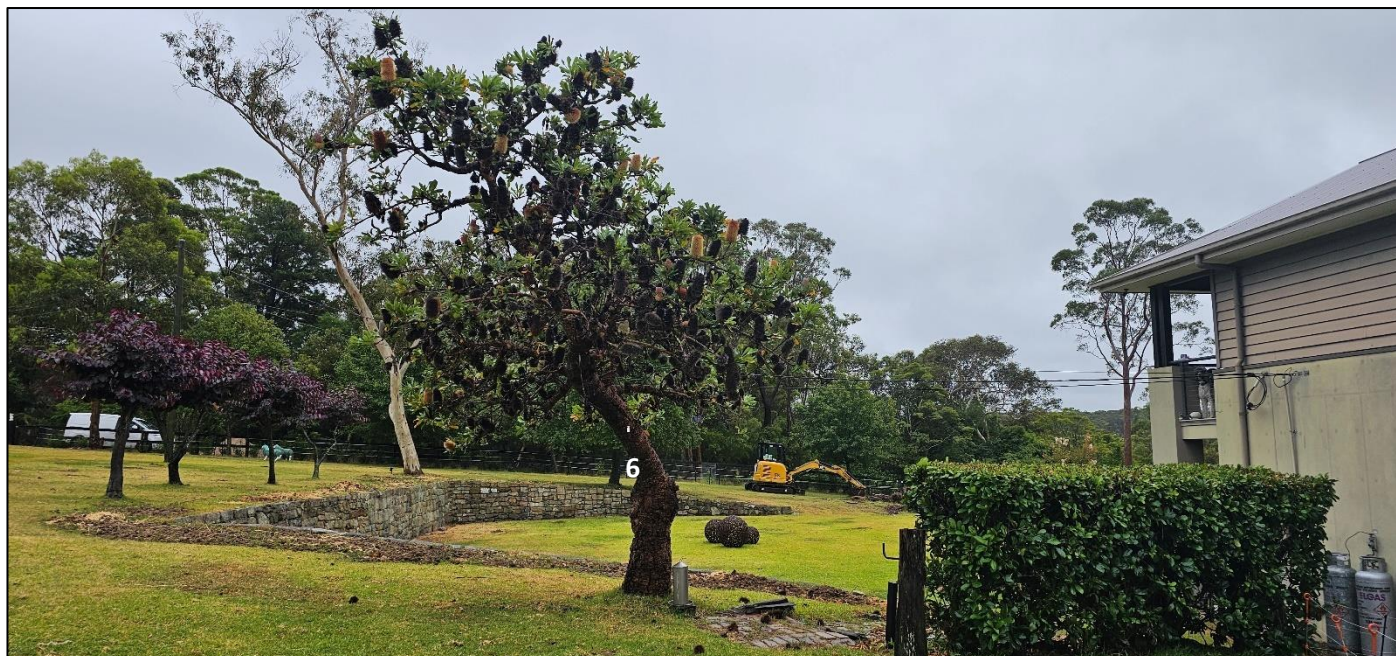
Figure 4 Tree 6 *Banksia serrata*.

| No. | Common Name | Species | DBH (M) | TPZ (M) | SRZ (M) | HEIGHT (M) | SPREAD (M) | Vigour | Age Class | SULE | Comments |
|---|---|---|---|---|---|---|---|---|---|---|---|
| 6 | Old-man Banksia | <i>Banksia serrata</i> | 0.3 | 3.6 | 2.25 | 4 | 4 | G | m | 2a | Appears structurally sound |

Tree 6 *Banksia serrata* is a mature native tree that appears in good health and condition, the tree is assessed with moderate retention value.

The tree is located approximately 6 metres from the existing retaining wall and will not be subject to encroachment from construction of the proposed gazebo. Accordingly, the tree will be retained in conjunction with the development.

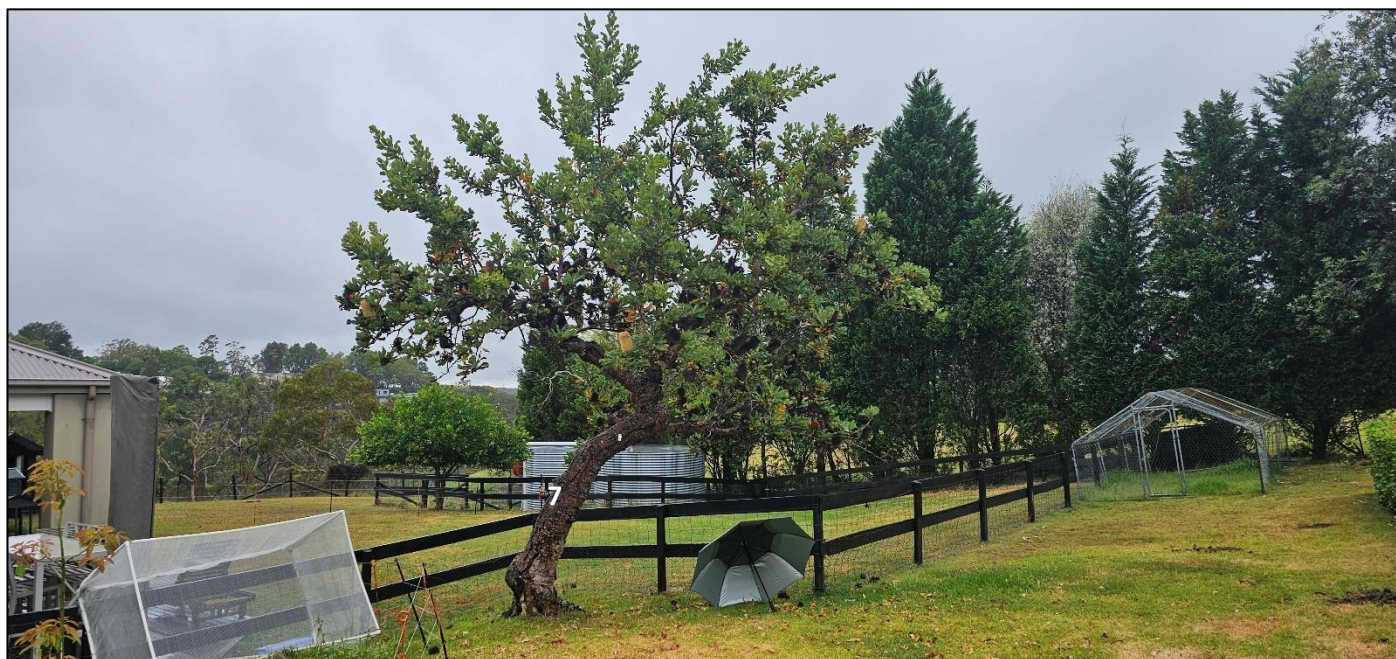
Figure 5 Tree 7 *Banksia serrata*.

| No. | Common Name | Species | DBH (M) | TPZ (M) | SRZ (M) | HEIGHT (M) | SPREAD (M) | Vigour | Age Class | SULE | Comments |
|---|---|---|---|---|---|---|---|---|---|---|---|
| 7 | Old-man Banksia | <i>Banksia serrata</i> | 0.3 | 3.6 | 2.25 | 4 | 5 | G | m | 2a | Appears structurally sound |

Tree 7 *Banksia serrata* is a mature native tree that appears in good health and condition, the tree is assessed with moderate retention value.

The tree is located approximately 3 metres from the existing dwelling and will be subject to major and unsustainable encroachment affecting 25% of the TPZ and SRZ caused by construction of the proposed tennis court and aluminium Vergola®.

Tree 7 *Banksia serrata* will be subject to major and unsustainable encroachment caused by construction of the proposed tennis court and aluminium Vergola®.

That Tree 7 *Banksia serrata* is approved for removal to accommodate the construction of the proposed tennis court and aluminium Vergola®, subject to Council's requirements for the provision of replacement planting within the property boundary.

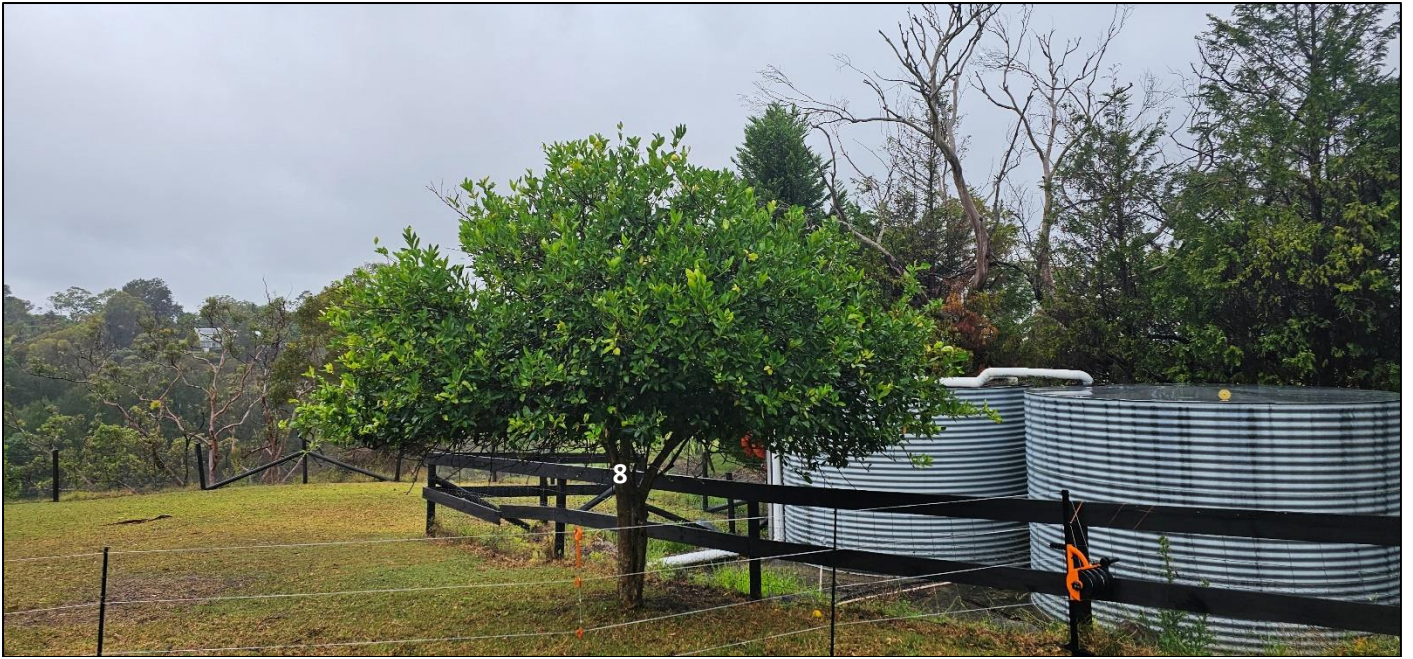
Figure 6 Tree 8 Citrus x limon.

| No. | Common Name | Species | DBH (M) | TPZ (M) | SRZ (M) | HEIGHT (M) | SPREAD (M) | Vigour | Age Class | SULE | Comments |
|---|---|---|---|---|---|---|---|---|---|---|---|
| 8 | Lemon | <i>Citrus x limon</i> | 0.1 x 2 | 2.0 | 1.75 | 3 | 3 | G | m | 3b | Appears structurally sound, exempt species |

Trees 8 *Citrus x limon* and 9a-9k *Cupressocyparis x lleylandii* are planted exotic trees that appear in average to good health and condition. The trees will be subject to major and unsustainable encroachment affecting 100% of the TPZ/SRZ of Tree 8, and 17-27% of the TPZ and 17-19% of the SRZ of Trees 9a-9k caused by construction of the proposed tennis court.

Trees 8 and 9a-9k are listed in Northern Beaches Council's exempt species list and can therefore be removed as required without the requirement for gaining consent.

That Trees 8 *Citrus x limon* and 9a-9k *Cupressocyparis x lleylandii* will be removed as required to accommodate the proposed development.

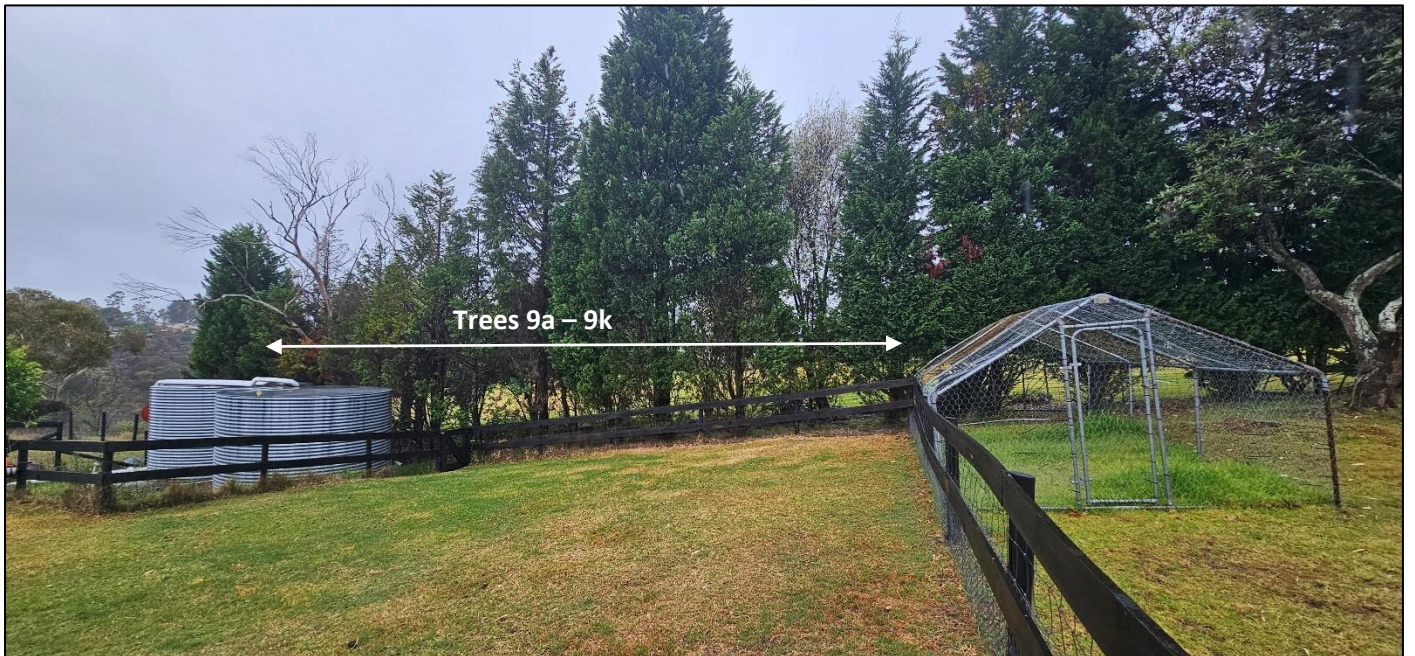
Figure 7 Trees 9a – 9k Cupressocyparis X leylandii.

| No. | Common Name | Species | DBH (M) | TPZ (M) | SRZ (M) | HEIGHT (M) | SPREAD (M) | Vigour | Age Class | SULE | Comments |
|---|---|---|---|---|---|---|---|---|---|---|---|
| 9 | Lleylands Cypress x 11 | <i>Cupressocyparis x lleylandii</i> | 0.15-0.25 | 2.0-3.0 | 2.0-2.13 | 6-8 | 2-3 | Av | m | 3b | Appears structurally sound, hedge planting, exempt species |
