J0830. 6th June, 2016. Page 1.

GEOTECHNICAL INVESTIGATION:

Alterations & Additions at 2 Herbert Avenue, Newport

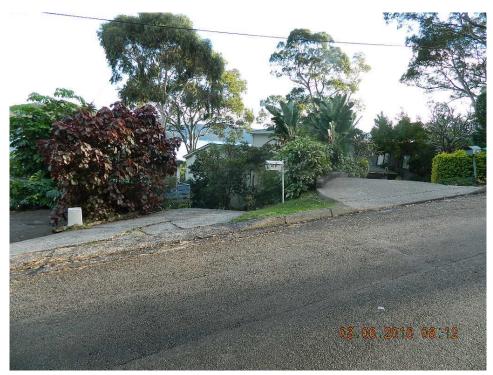
Photo 1

- 2.3 At the road frontage a concrete driveway runs to a concrete paved car parking area under the house (Photo 1 & 2). The fill batter for the driveway is supported by an old stack rock retaining wall that is inclined upslope and shows no significant signs of movement (Photo 3). The area beside the driveway has been terraced with an old formed concrete retaining wall that has failed on its N side (Photo 4). The plans indicate the N side of the wall will be demolished as part of the proposed works. The S side of the wall that will remain currently appears stable (Photo 5). The single storey steel, brick and timber framed house is in good condition for its age. Its supporting steel posts stand vertical. The concrete slab for the parking area under the house displays cracking and minor settlement in areas however it poses no risk to life or property (Photo 6 & 7). A low elevation, mortared rock retaining wall supports a fill for the downhill side of the car parking area (Photo 8). It displays minor cracking but is currently considered stable. The land surface surrounding the house, driveway and parking area is mostly lawn covered.

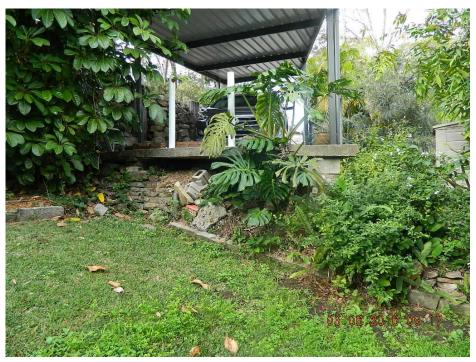
Photo 9

HAZARDS	Hazard One	Hazard Two	
ТҮРЕ	The moderately graded slope that falls across the property failing and impacting on the existing house or the proposed works.	The proposed excavation impacting on the suspended concrete slab for the carport on the neighbouring property to the S (Photo 9).	
LIKELIHOOD	'Unlikely' (10 ⁻⁴)	'Likely' (10 ⁻²)	
CONSEQUENCES TO PROPERTY	'Minor' (9%)	'Medium' (20%)	
RISK TO PROPERTY	'Low' (5 x 10 ⁻⁶)	'High' (2 x 10 ⁻³)	
RISK TO LIFE	8.3 x 10 ⁻⁷ /annum	3.2 X 10 ⁻⁴ /annum	
COMMENTS	This level of risk is 'ACCEPTABLE'.	This level of risk is 'UNACCEPTABLE'. To move risk to acceptable levels the recommendations in Section 13 are to be followed.

The S side of the proposed excavation to level the area above the existing house will be as close as ~0.5m

to a partly suspended concrete slab for a carport on the adjoining neighbouring property. The portion of

the suspended carport slab that lines the common boundary is supported on two, poorly constructed, stack

brick and paver piers that do not meet current engineering standards (Photo 9). The lower pier (Photo 10)

Where the cut is adjacent to the neighbouring carport, for a distance of at least 2.5m we recommend

contiguous piers be installed before the cut commences so no ground movement is possible. For ease of

construction it may be easier to extend the piers along the length of the S cut which extends a distance of

~4.0m

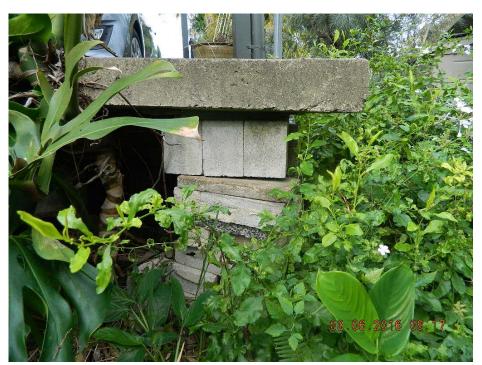
Photo 10

and the land surface along the neighbouring property will be inside the excavations zone of influence. In

this instance the zone of influence is the area above a theoretical 45° line from the base of the excavation

towards the surrounding structures and boundaries.
