J3342 16<sup>th</sup> April, 2021 Page 1.

#### **GEOTECHNICAL INVESTIGATION:**

New House at 9 Wandeen Road, Clareville

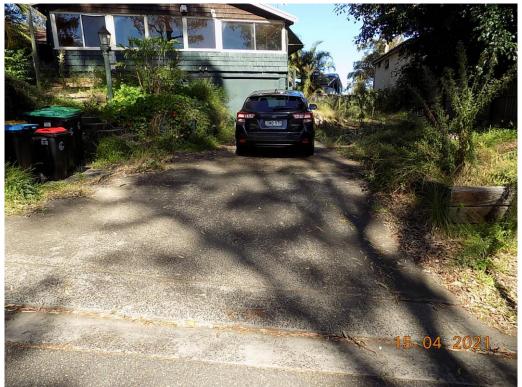
Photo 1

- 2.3 At the road frontage, a concrete driveway runs to a garage under the downhill side of the house (Photo 1). Between the road frontage and the house is a gently sloping lawn-covered fill (Photo 2). The fill is supported by a sleeper retaining wall reaching ~1.5m high (Photo 3). The wall was observed to be tilting downslope to a maximum angle of ~5° from the vertical. The plans show the wall is to remain as part of the proposed works. See Section 16 for recommendations regarding this wall. Large sandstone floaters appear to be sitting in stable positions within the lawn area between the road frontage and the house (Photo 4). The single-storey timber framed and clad house will be demolished as part of the proposed works (Photo 5). Overgrown lawns and gardens surround the house in its current state. Another large sandstone

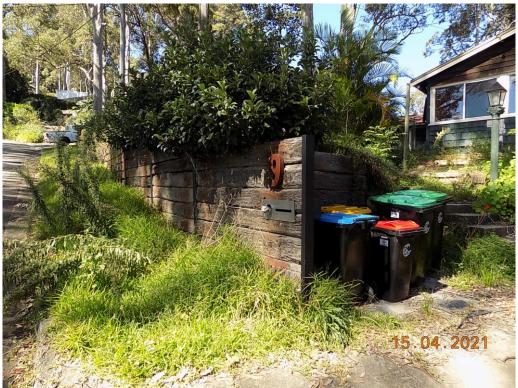
Photo 3

HAZARDS	Hazard One	Hazard Two	Hazard Three	
ТҮРЕ	The gentle slope that rises across the site and continues above at increasing angles failing and impacting on the proposed works.	Further movement of the sleeper tilting retaining wall at the road frontage of the property that causes failure (Photo 3).	The excavations (up to a depth of ~1.8m) collapsing onto the work site before retaining walls are in place.	
LIKELIHOOD	'Unlikely' (10 <sup>-4</sup> )	'Possible' (10 <sup>-3</sup> )	'Possible' (10 <sup>-3</sup> )	
CONSEQUENCES TO PROPERTY	'Medium' (12%)	'Medium' (15%)	'Medium' (15%)	
RISK TO PROPERTY	'Low' (2 x 10 <sup>-5</sup> )	'Moderate' (2 x 10 <sup>-4</sup> )	'Moderate' (2 x 10 <sup>-4</sup> )	
RISK TO LIFE	5.5 x 10 <sup>-7</sup> /annum	8.3 x 10 <sup>-7</sup> /annum	9.2 x 10 <sup>-6</sup> /annum	
COMMENTS	This level of risk is 'ACCEPTABLE'.	This level of risk to life and property is 'TOLERABLE'. To move the risk to 'ACCEPTABLE' levels, the recommendations in <b>Section 16</b> are to be followed.	This level of risk to life and property is 'UNACCEPTABLE'. To move the risk to 'ACCEPTABLE' levels, the recommendations in <b>Section 13</b> are to be followed.

The treated timber retaining wall along the road frontage of the property was observed to be

tilting to a maximum of ~5° (Photo 3). To be prudent, we recommend the retaining wall be

inspected by the owners on an annual basis or after heavy prolonged rainfall, whichever

occurs first, keeping a photographic record of the inspections. We can carry out these

inspections upon request. Should any new movement be observed, the retaining wall is to be

remediated or rebuilt to current engineering standards.

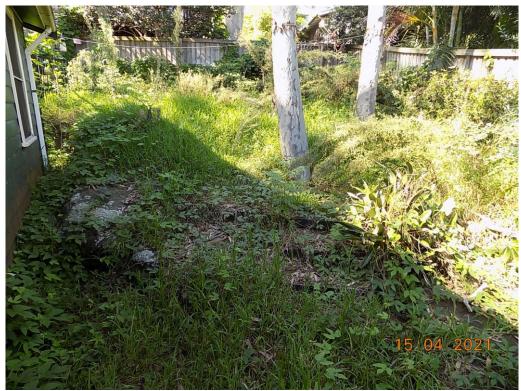
Photo 6

floater was observed to be sitting in a stable position between the S side of the house

and the S common boundary (Photo 6).

No structures or boundaries will be within the zone of influence of either excavation. Any

large sandstone floaters within the footprint and zone of influence of either excavation are to

be cut/broken down without the use of pneumatic hammers and removed prior to the

commencement of the excavations (Photos 4 & 6).
