ARBORICULTURAL IMPACT ASSESSMENT REPORT

relating to a new garage and timber decking at

129 RIVERVIEW ROAD AVALON NSW 2107

19 February 2021 Revision A

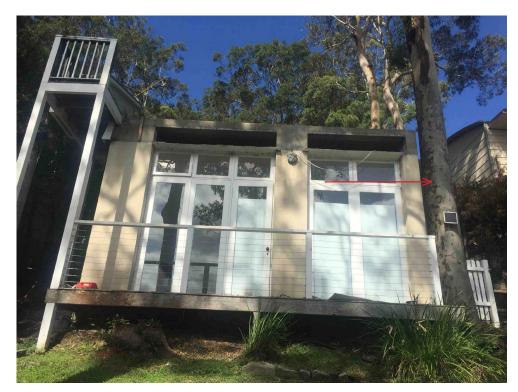
Figure 3: Photograph viewing east at the studio with the garage concrete slab above. The trunk of Tree No. 1 (Spotted Gum) is visible to the right hand side. (Photo: J Willis)

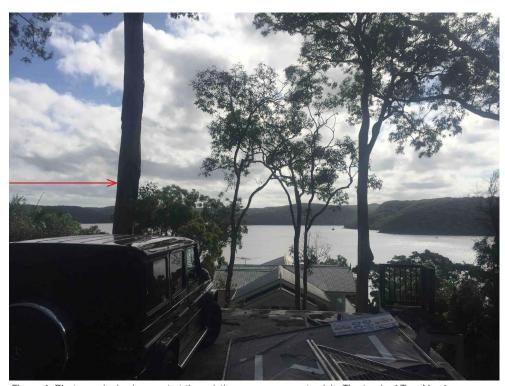
Figure 4: Photograph viewing west at the existing garage concrete slab. The trunk of Tree No. 1 (Spotted Gum) is visible to the left hand side - see red arrow. (Photo: J Willis)

The construction of the new garage is located within the TPZ and SRZ of Tree No. 1 (Spotted Gum). However, given the garage will be constructed within the line of the existing concrete slab the works should not result in any impact upon the tree. Additionally, the new roof will not necessitate any canopy pruning to the tree.

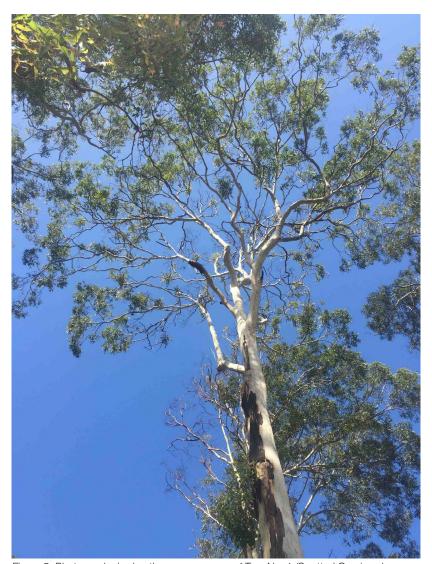
Figure 5: Photograph viewing the upper canopy of Tree No. 1 (Spotted Gum) and evident fire damage to the tree (Photo: J Willis)

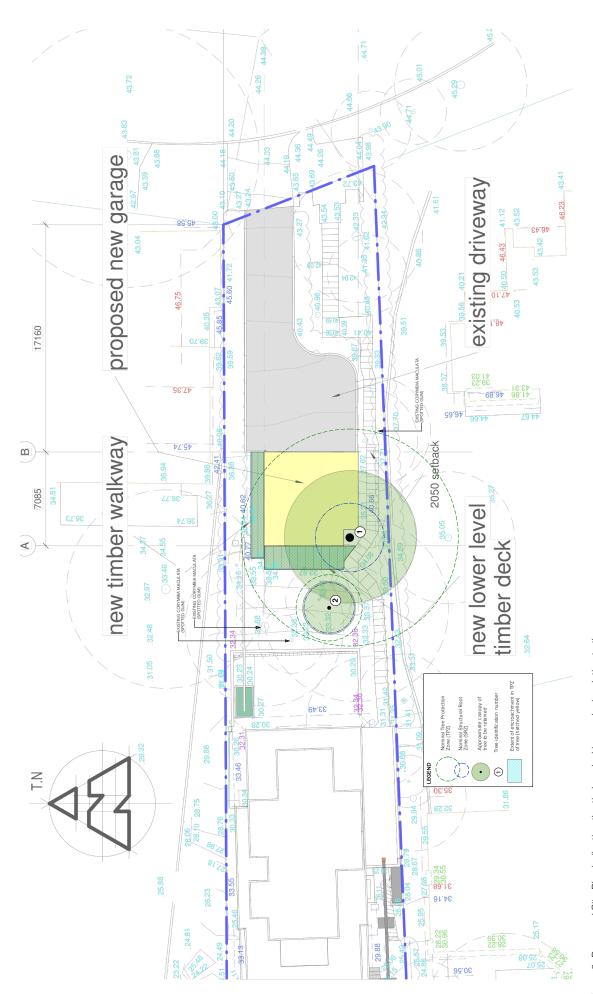
Figure 6: Proposed Site Plan indicating the timber decking works in relation to the existing trees located immediately adjacent to the works. The indicative Tree Protection Zone (TPZ) and Structural Root Zone (SRZ) are also indicated

It is proposed to replace the existing decrepit timber deck which extends out from the garage level and studio level. The line of the new deck at studio level will extend out 1.8 metres to the west. The deck is located in the SRZ of Tree No. 1 (Spotted Gum) and immediately adjacent to the trunk of the tree. It is imperative any excavation for post footings is undertaken by hand digging, and no woody roots greater than 40mm diameter are severed to ensure the stability of the tree is not compromised in any way. Existing ground levels should be retained within the TPZ of the tree. Providing the appropriate tree protection measures are undertaken, it is the author's opinion the works should not result in any adverse impact upon the tree.

4.4 Tree No. 2 (Spotted Gum) is positioned approximately 2.8 metres away from the edge of the new timber deck. Based on the calculated TPZ for the tree, the works are located just outside the tree's TPZ and as such there should be no adverse impact upon the tree. Tree protection measures should be implemented to ensure the tree is not inadvertently damaged during the course of the works.

- (i) Existing post footings are utilised as part of the building of the new deck.
 - (ii) All excavation for new footings must be hand dug carefully, ensuring no damage or severance to woody roots. The final positioning of footings must ensure there is no cutting of any woody roots greater than 40mm diameter. Where woody roots greater than 40mm diameter are encountered and the footing cannot be relocated, further advice must be sought from a qualified Arborist prior to root severance. Any roots less than 40mm in diameter shall be cut cleanly with sharp pruning implement. (iii) It is recommended trunk protection is installed around all trees located within five metres of the proposed works and positioned within the site boundaries (some of which are not included in this assessment). As a minimum, the trunk protection shall consist of 1.8 metre lengths of pine board timbers (90 x 45mm) spaced at 100-150mm centres secured together with perforated metal straps. These shall be strapped around the trunk (not fixed in any way) to avoid mechanical injury or damage. Trunk protection should be installed prior to any site works and maintained in good condition for the duration of the construction period. Trunk protection will help to protect the trees from any inadvertent damage that may result from the building works. Note: The trunk of Tree No. 1 should be protected at studio level and also at the garage slab level.
