Report Title: Geotechnical Report 5 Northview Road, Palm Beach  
Report Date: 23/12/20

## **GEOTECHNICAL INVESTIGATION:**

### **Alterations and Additions at 5 Northview Road, Palm Beach**

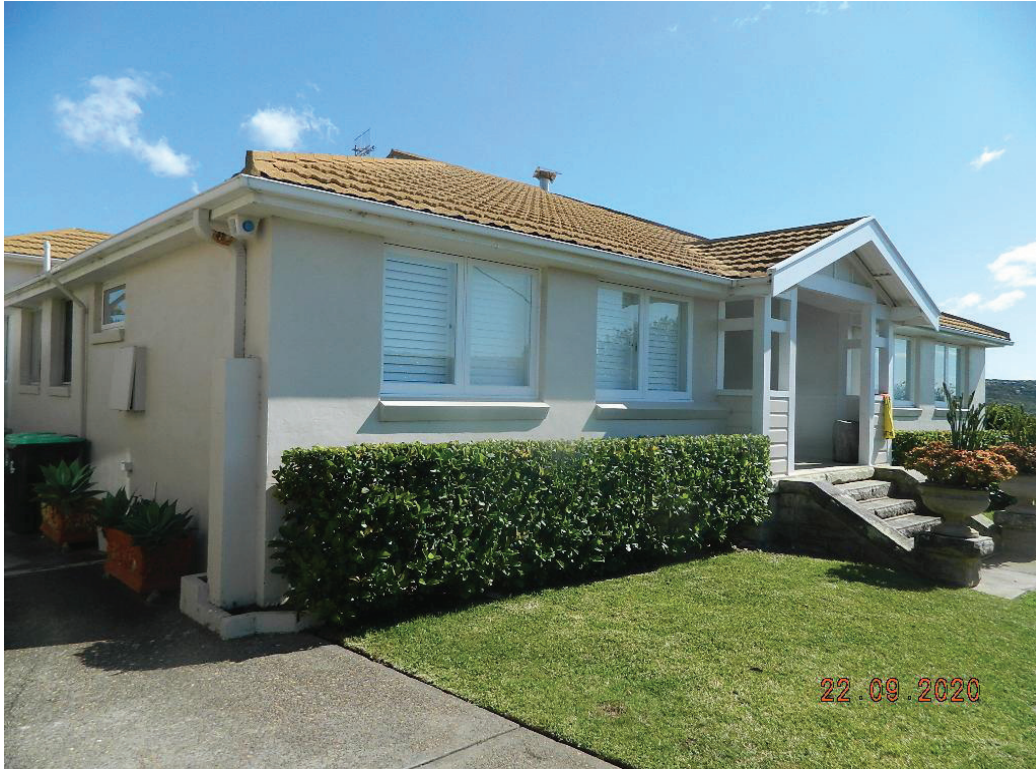
Photo 3

house is supported by rendered masonry walls, sandstone block walls and brick walls (Photos 3 & 4). One of the supporting sandstone block walls displays cracking through the mortar but is considered to be stable (Photo 5). Sandstone bedrock outcrops on the N and downhill sides of the house (Photos 6 & 7). A sandstone block retaining wall ~1.5m supports fill near the SW corner of the house (Photo 7). The wall displays two thick stepped and vertical cracks through the mortar. See 'Section 14 Ongoing Maintenance'. Fill provides a near level lawn area on the downhill side of the house. The fill is supported by timber crib and stack rock retaining walls up to ~2.5m high (Photos 8 & 9). The timber crib retaining wall is in a dilapidated state. See 'Section 14 Ongoing Maintenance'. Sandstone bedrock is outcropping on the steep slope below the lawn area (Photo 10). No signs of slope instability were observed on the property that could have occurred since the property was developed. The adjoining neighbouring properties were observed to be in good order as seen from the street and subject property.

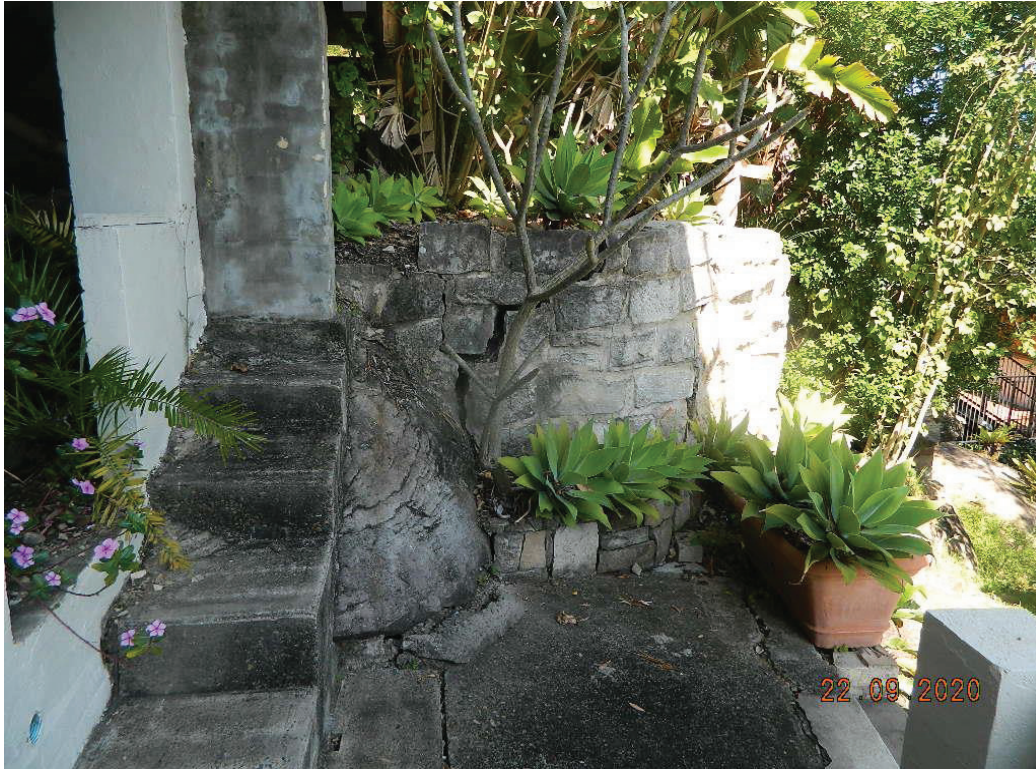
Photo 7

If the sandstone block, timber crib and stack rock retaining walls (Photos 7 to 9) are to remain, they are to be monitored by the owners on an annual basis. A photographic record of these

inspections is to be kept. Should further movement occur the wall is to be remediated so it meets current engineering standards. We can carry out these inspections upon request.

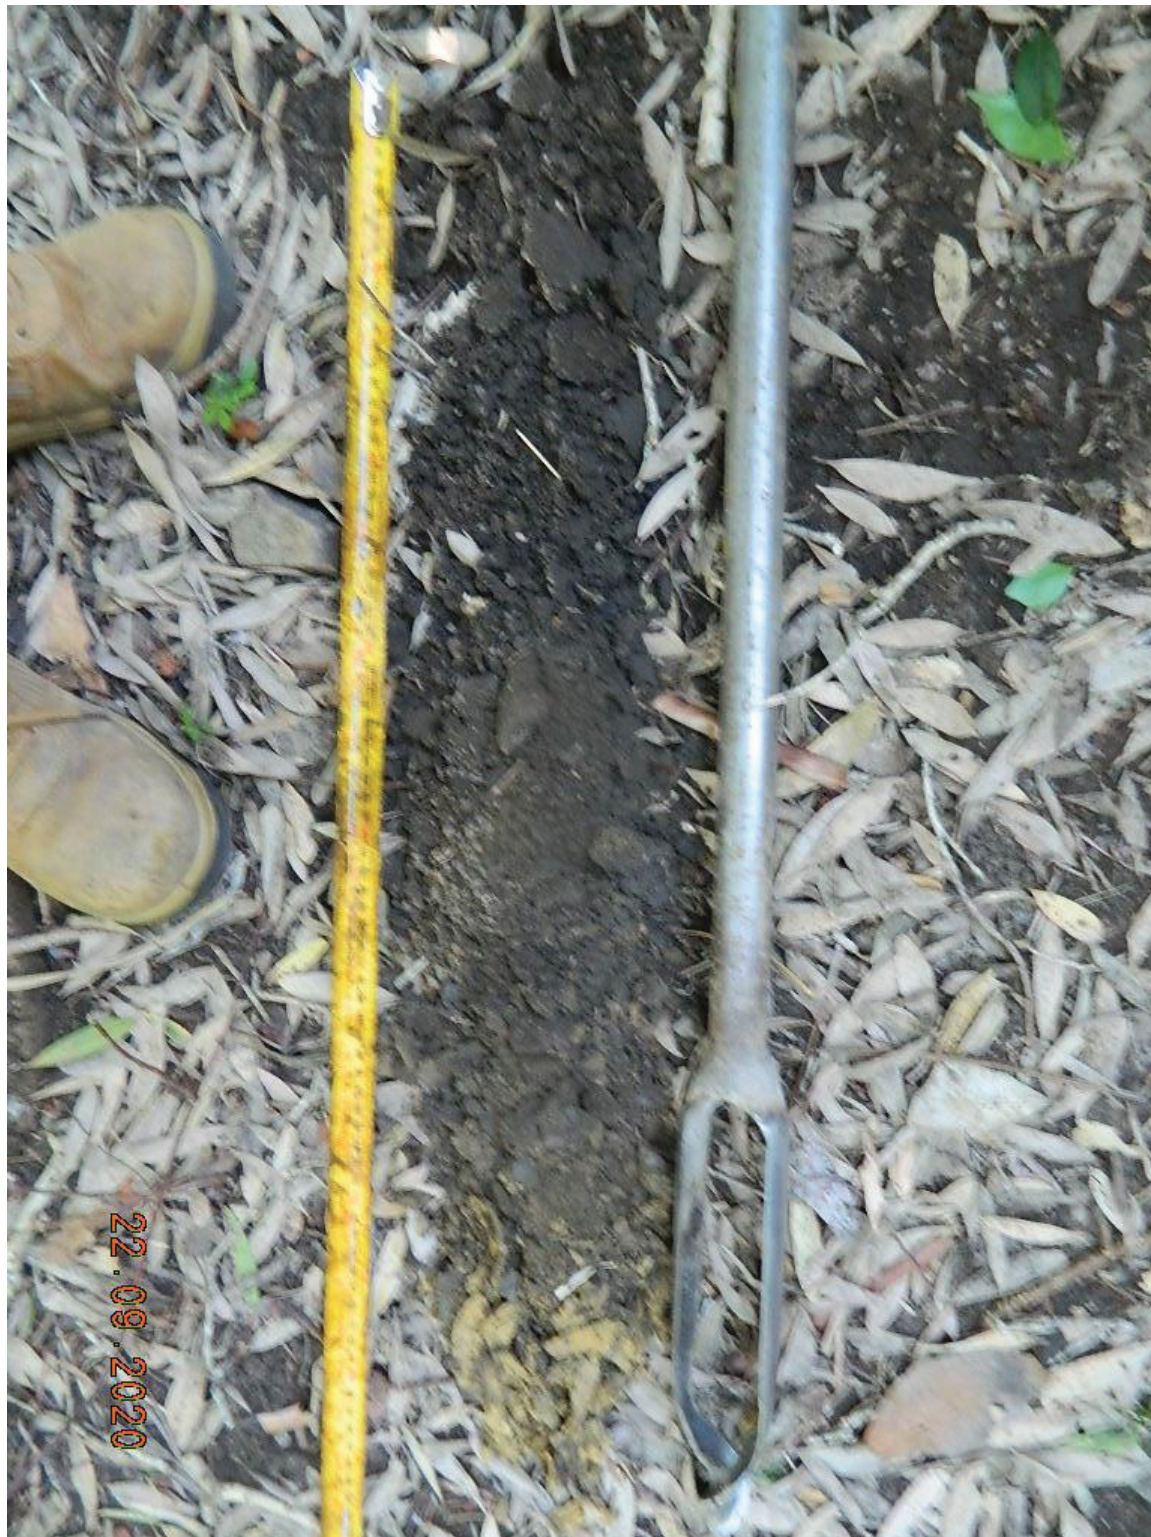
**AUGER HOLE 1 (~RL37.0) – AH1 (photo 11)**

| Depth (m) | Material Encountered |
|---|---|
| 0.0 to 0.6 | <b>TOPSOIL</b> , sandy soil, dark brown, moist, fine to medium grained with fine trace organic matter. |
| 0.6 to 0.7 | <b>CLAY</b> , brown yellow, stiff, moist. |

End of Test @ 0.7m in stiff clay. No watertable encountered.

Photo 11: AH1 – Downhole is from top to bottom.
