## **2A Beatty Street, Balgowlah Heights**

## **GEOTECHNICAL INVESTIGATION:**

### **New Inclined Lift at 2A Beatty Street, Balgowlah Heights**

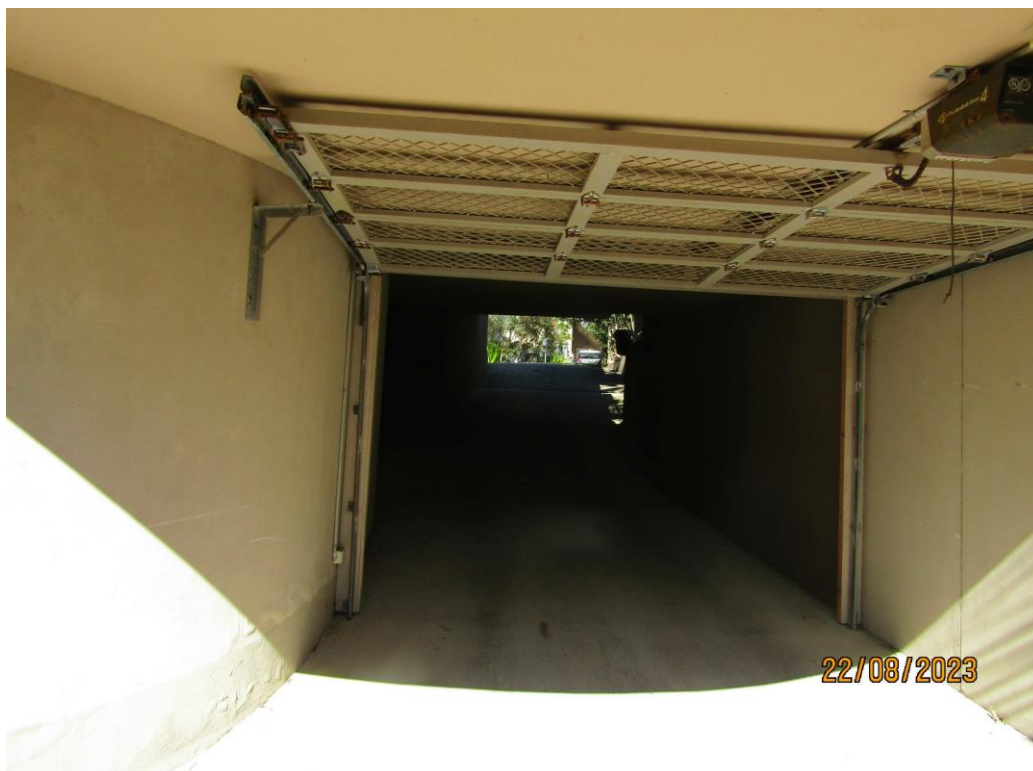
Photo 1

- 2.3** At the road frontage, a concrete Right of Carriageway (ROW) runs down the slope to a suspended carport (Photos 1 & 2). The concrete piers that support the carport stand vertical. An inclined lift runs through a narrow strip of land to the SE of 2 Beatty St from beside the carport to beside the subject house (Photo 3). Medium Strength Sandstone bedrock outcrops and steps down the slope between the carport and the house (Photos 4 & 5). Sprayed concrete has been installed onto part of the rock face upslope of the subject house and below the uphill neighbouring house (Photo 6). This is expected to have remediated a defect in the rock face. The visible portion of the rock face appears to be stable. The two-storey tile and sandstone dressed house and single-storey secondary dwelling show no significant signs of

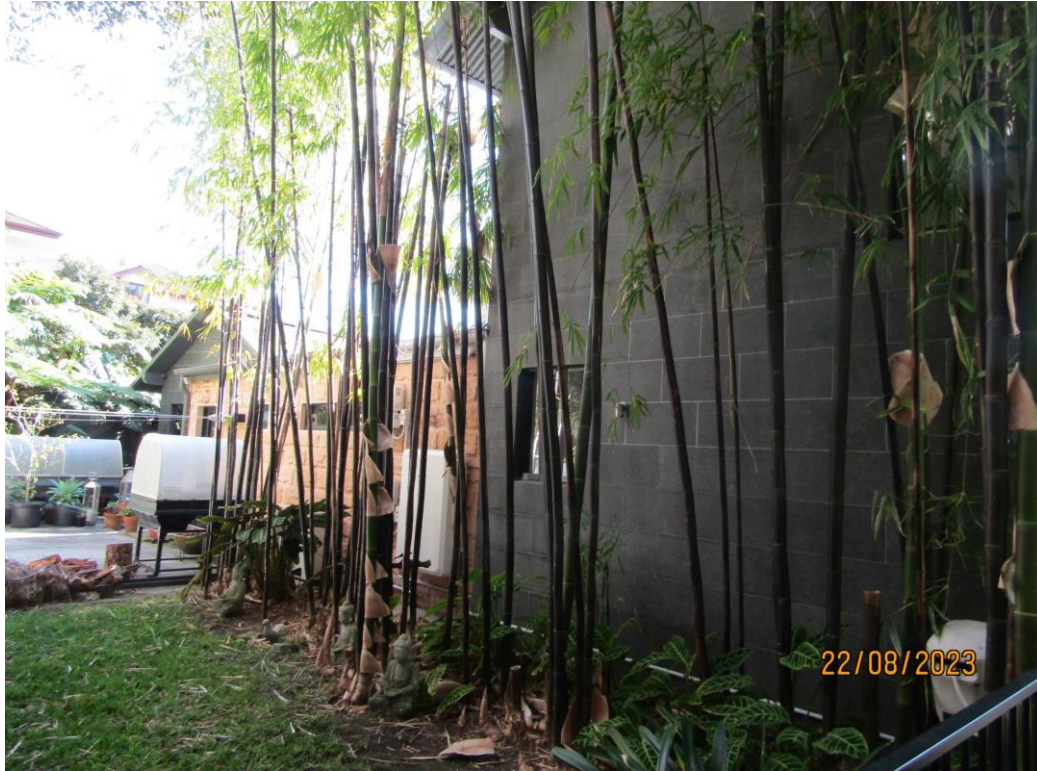
Photo 7

movement (Photos 7 & 8). Paved areas and a pool are located on the downhill side of the house (Photo 9). The pool shows no significant signs of movement.

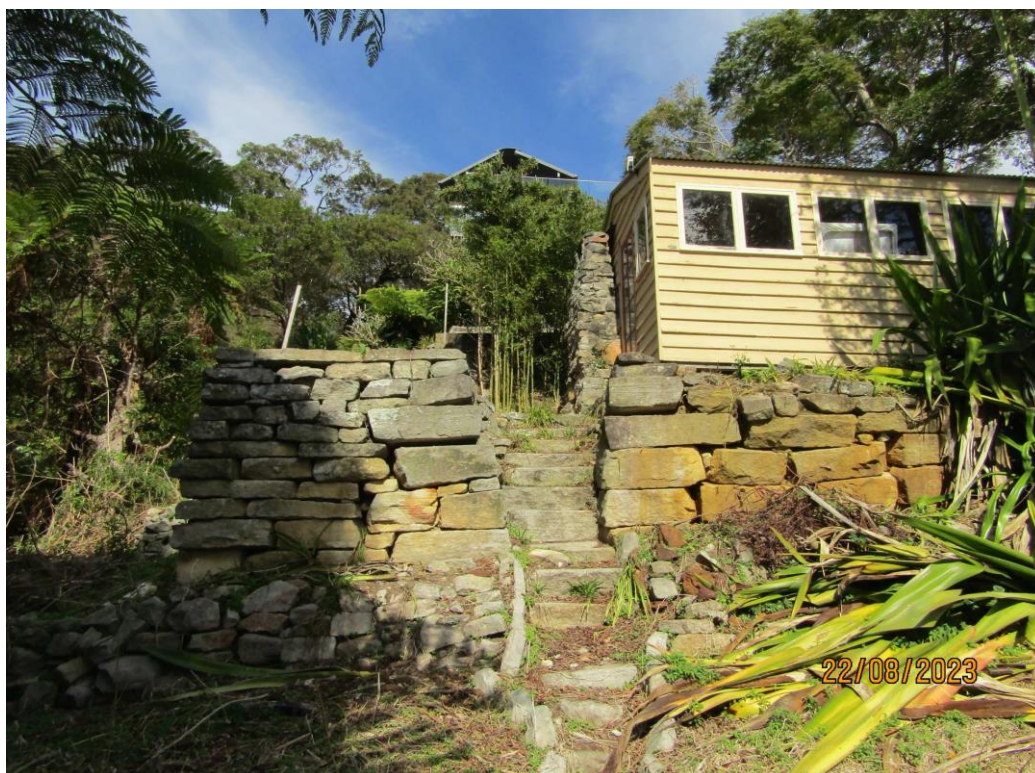
Photo 12

The upper excavation requires the partial demolition of an existing stack rock retaining wall (Photo 12). The wall is to be demolished from the top down as the excavation is progressed. The fill behind the wall is to be battered at 1.0 Vertical to 1.7 Horizontal (30°) as the wall is demolished.

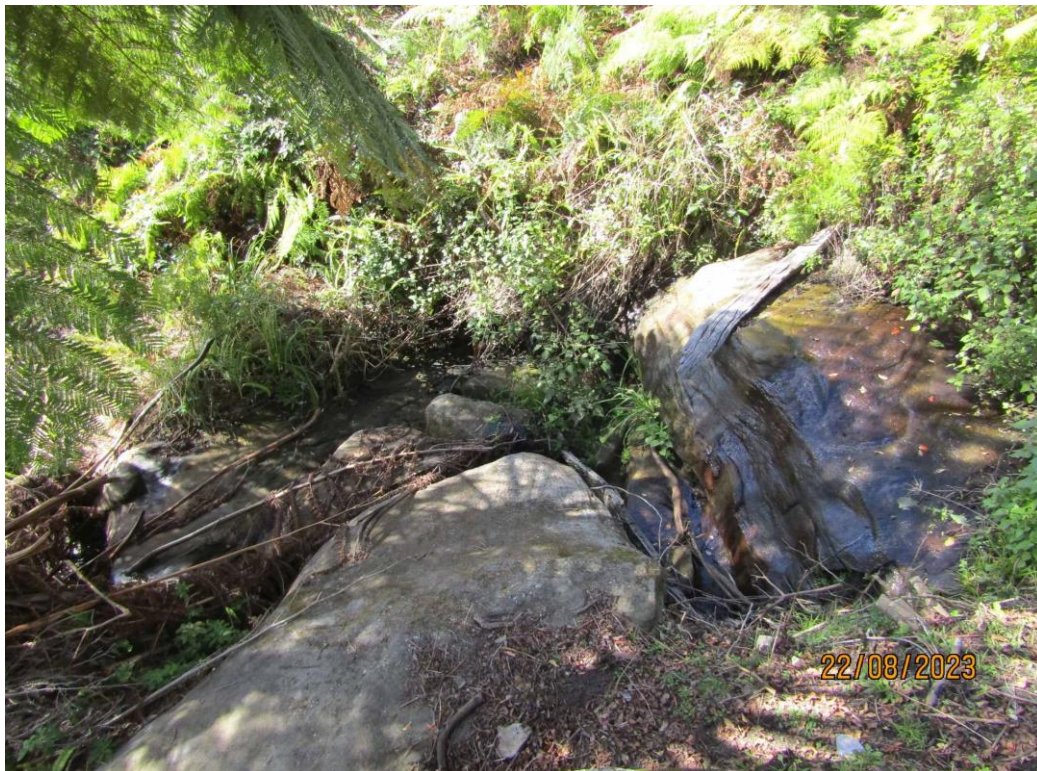
Photo 14

Apart from the natural watercourse that runs down the council reserve to the SE of the property (Photo 14), no evidence of surface flows were observed during the inspection. It is expected that normal sheet wash will move onto the site from above the property during heavy down pours. If the owners know, or become aware in the future, that overland flows enter the property during heavy prolonged rainfall events our office is to be informed so appropriate drainage measures can be recommended and installed. It is a condition of the slope stability assessment in Section 8 (**Hazard One**) that this be done.
