# **Arboricultural Impact Assessment**

**8 Alan Avenue Seaforth**

**December 2020**

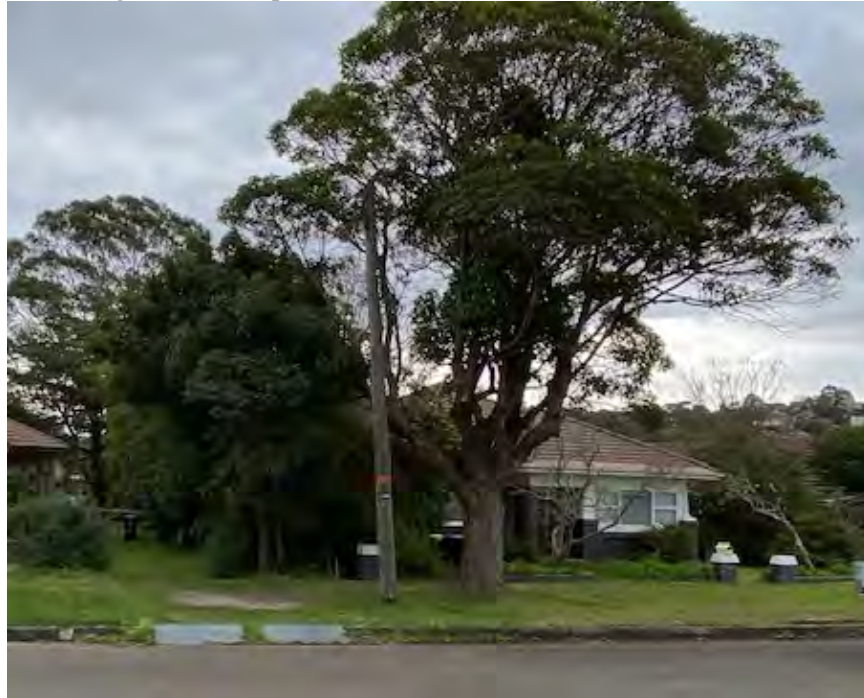
Tree 1 is located on the council verge at the front of the neighbouring property. The tree has a high landscape significance and long life expectancy. Tree 1 is in proximity to the works and must be protected from damage. The existing driveway is to have ground protection mats and tree protection fencing installed to protect the TPZ from damage.

**Figure 8:** Tree 1 in the landscape. (Source: Austin 16/072020)

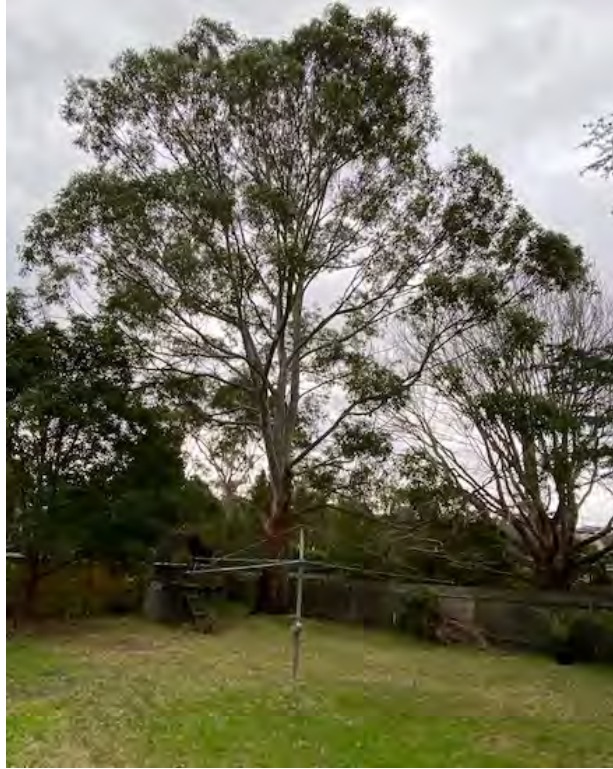
Tree 18 is a large tree in good condition situated in the rear corner of the site. It has high landscape significance and a long useful life expectancy.

**Figure 9:** Tree 18 in the landscape. (Source: Austin 16/072020)

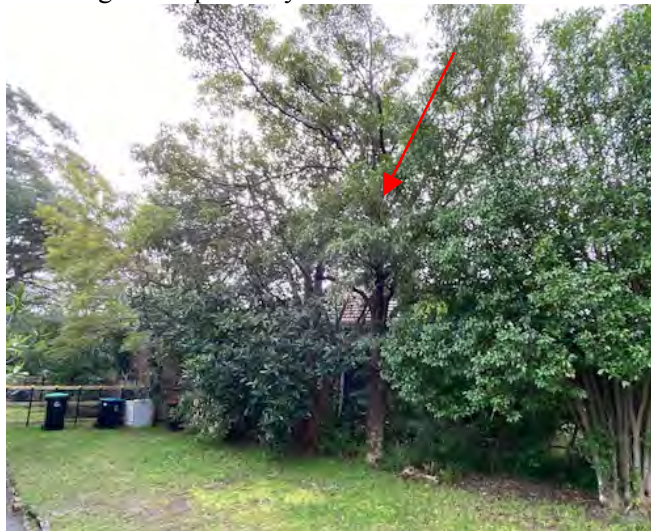
Tree 8 is located on the northern boundary. The tree has good attributes and is a desirable native species and the tree has a long life expectancy.

**Figure 10:** Tree 18 in the landscape. (Source: Austin 16/072020)

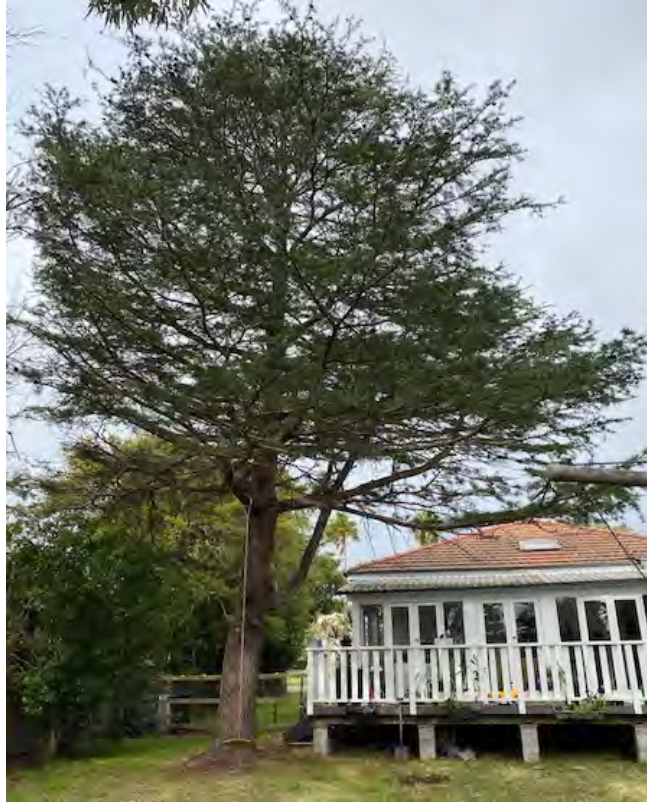
Tree 16 is located a good example of a *Cedrus atlantica* (Atlas cedar). Tree 16 is located in the middle of the block, the existing deck is located in the TPZ and SRZ. Tree 16 is of medium landscape significance as it is dominated by tree 18 located behind. The tree has good health and structure as well as good prospects as a long term landscape component however, its position has ultimately conflicted with the design options presented.

**Figure 11:** Tree 16 in the landscape. (Source: Austin 16/072020)

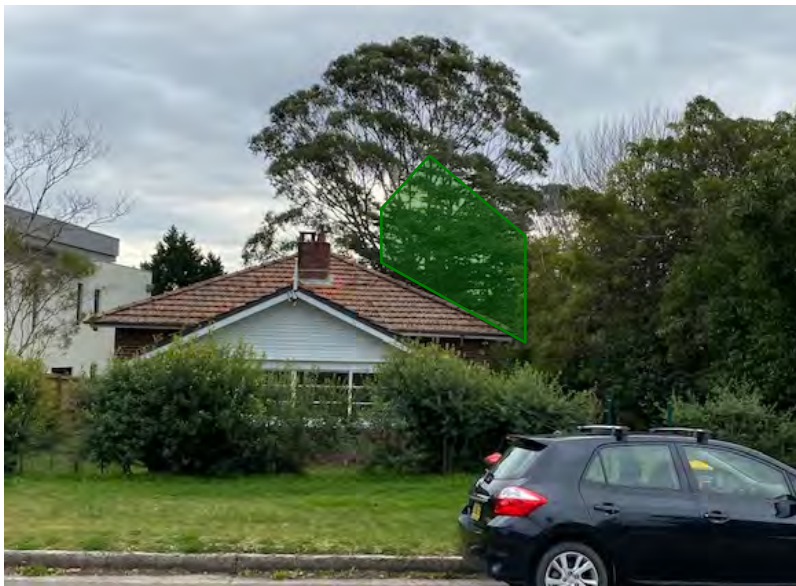
**Figure 12.** The canopy of Tree 16 when viewed from the street is indicated by the green shaded polygon. (Source: Austin 16/7/20)

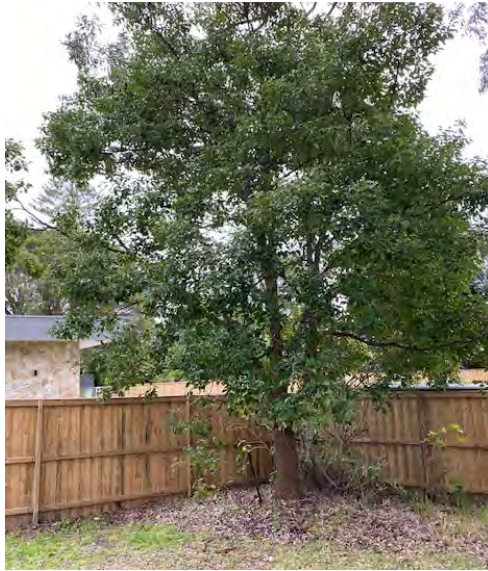
Tree 20 is a small self sown *Cinnamomum camphora* (Camphorlaurel) which is considered an undesirable species due to its weed seed production potential.

**Figure 13:** Tree 20 is located in the rear corner of the site. (Source: Austin 16/072020)

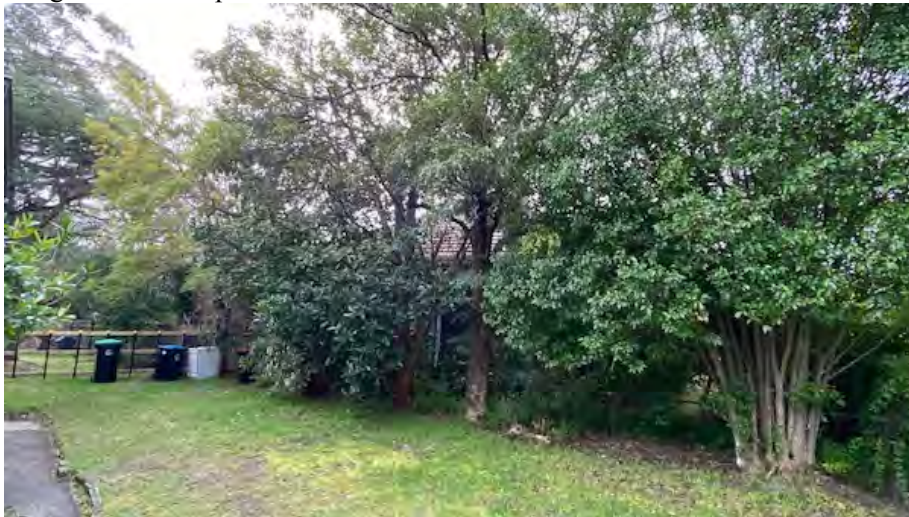
A group of trees both planted and self sown are located between the residences of 6 & 8 Allan Ave. Screening benefits are provided.

**Figure 14:** Tree 5, 6, 7, 8 & 9 can be observed in the landscape. (Source: Austin 16/072020)

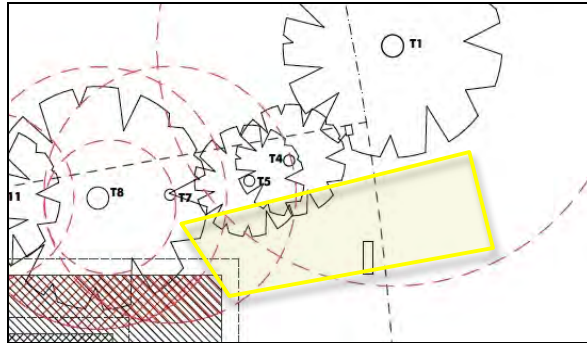
Demolition works/access is likely to occur in the root zone as the existing access is located within the TPZ. The tree must be fenced off to protect it construction activities.

**Figure 15:** The proposed foot print is not within the TPZ of Tree 1 however, current site access is through the TPZ of Tree 1 indicated by the yellow polygon. (Source Tree Protection Plan by JR Residential Design, 11/12/2020)

Ground protection mats or rumble boards will be required on the council verge through the TPZ during the demolition and construction phases of the project.

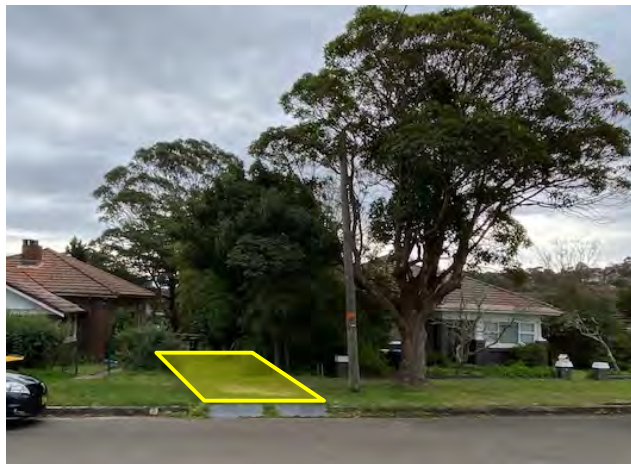
**Figure 16:** Tree 1 can be observed in the landscape. Current site access is through the TPZ of Tree 1 indicated by the yellow polygon (Source: Austin 16/072020)

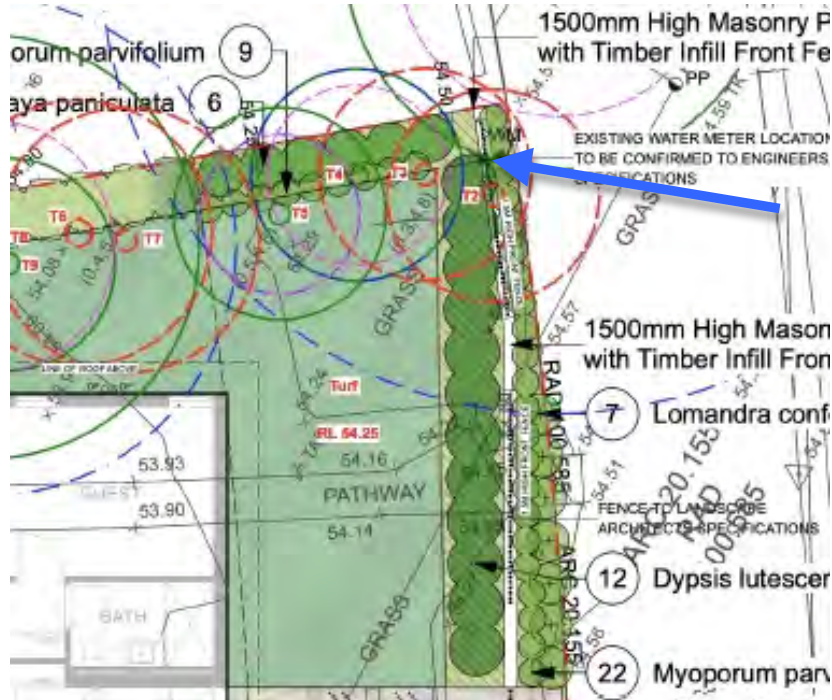
The proposed masonry and timber front fence is located within the TPZ of Tree 1. The excavation for the masonry pier must be completed by hand and not damage roots larger than 40mm diameter. It is unlikely that major roots will be identified during the excavation due to the competition in the growing environment in that area by Trees 2 & 3.

**Figure 17:** The masonry pier for the front fence is indicated by the blue arrow. (Source: Landscape Plan, by Site Design + Studios Dated 3/12/20)

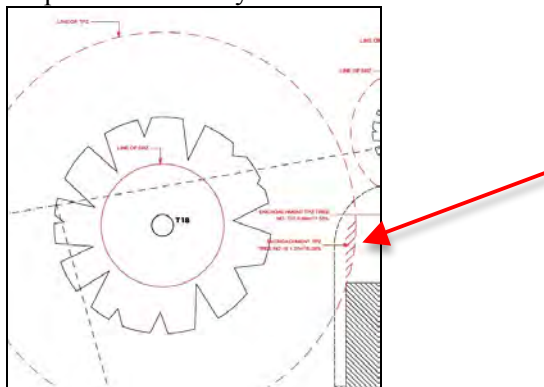
Tree 18 *Eucalyptus saligna* (Sydney BlueGum) has a 0.4% root zone encroachment. This is a minor encroachment and will not impact tree viability.

**Figure 18:** The proposed foot print has a 0.4% encroachment into the TPZ of Tree 18. (Source Tree Protection Plan by JR Residential Design, dated 11/12/2020)

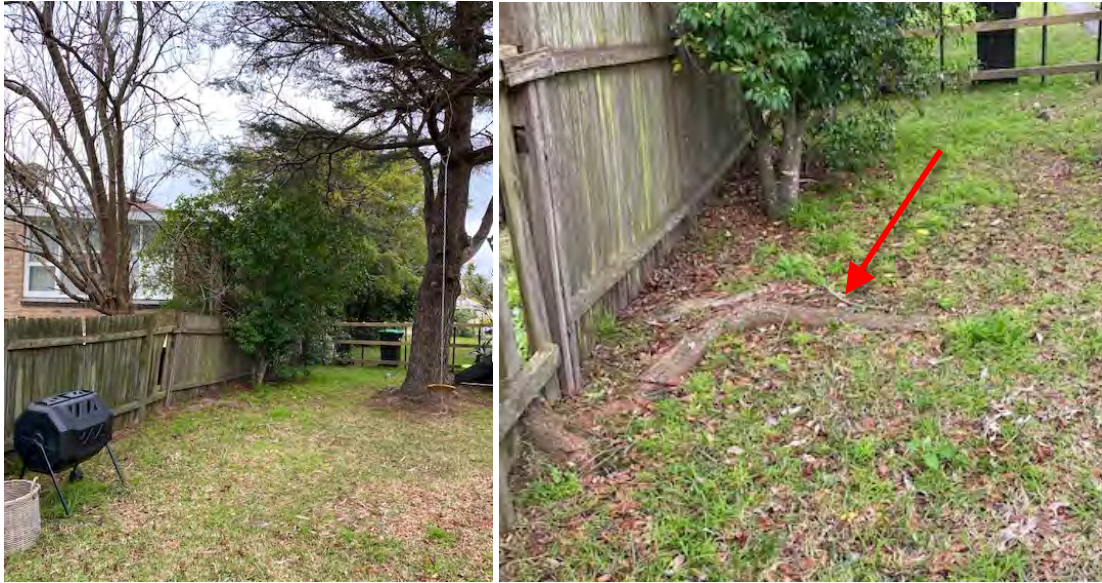
Tree 17 is a *Morus ngra* (Mulberry) located along the boundary on 6 Allan Ave. The tree is a fruit tree that often self sows. There is a large surface root growing onto 8 Allan Ave which must be protected to preserve the viability of Tree 17. Tree 17 has a 1.5% root zone encroachment.

**Figure 19 (Left):** The proximity of neighbours Tree 17 to the boundary can be observed (Source: Austin 16/072020)

**Figure 20 (Right):** The surface root can be observed. (Source: Austin 16/072020)

This is considered a minor encroachment under Australian Standard 4970–2009: *Protection of trees on development sites*. The required excavation works in the TPZ are to be completed. The large surface root must be protected with mulch through the life of the project.

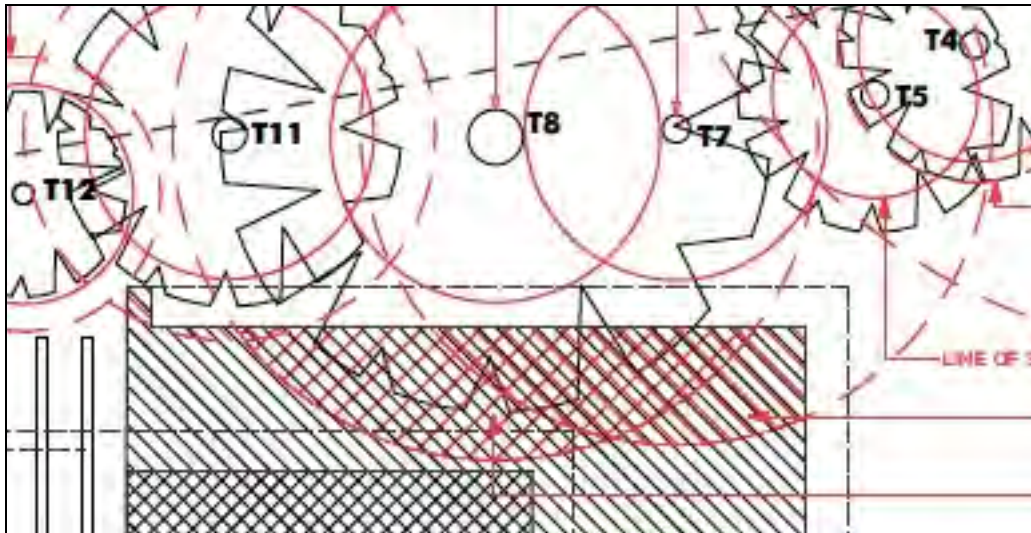
Tree 8 is a semi mature *Glochidion ferdinandi* (Cheese tree) with good opportunity to become a long term landscape component. A total of a 15% encroachment is considered to be necessary if the proposal is to proceed in its current form. . The existing ground levels are to stay the same. All required excavation works are to be completed by hand.. This is considered a major encroachment under Australian Standard 4970–2009: *Protection of trees on development sites*. The tree is semi mature and of good health., It is anticipated that if the adjacent lower quality trees are removed as planned and the proposed works within the TPZ are completed by hand , the tree will tolerate the major encroachment and will remain viable post construction.

**Figure 22:** The proposed foot print has a 0.4% encroachment into the TPZ of Tree 18. (Source Tree Protection Plan by JR Residential Design, dated 11/12/2020)

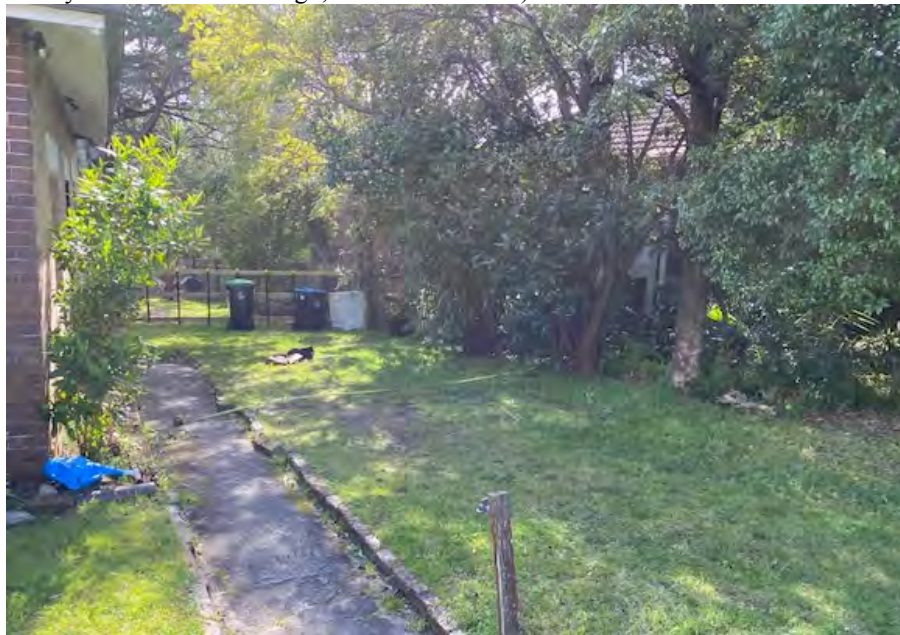
**Figure 23:** The TPZ of Tree 8 is indicated by the measuring tape in the image (Source: Austin 16/072020)

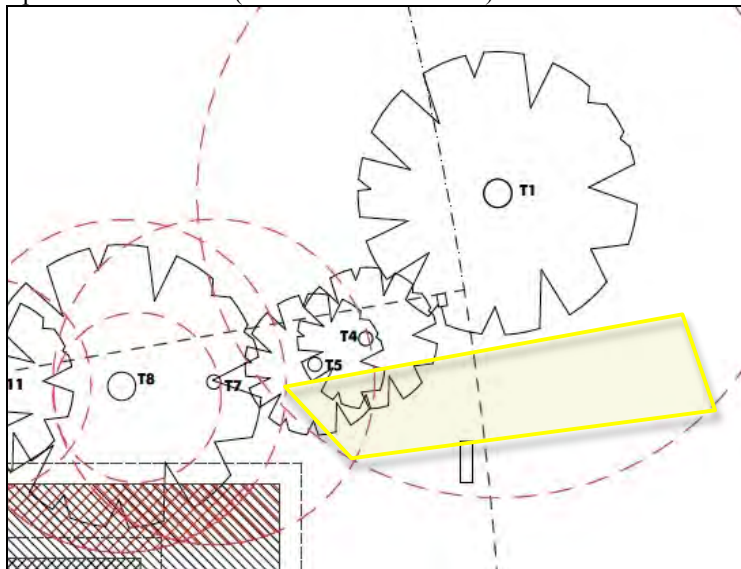
**Figure 26:** Install ground protection in the current site access is through the TPZ of Tree 1 indicated by the yellow polygon. (Source Tree Protection Plan by JR Residential Design, dated 11/12/2020)

Ground protection matts or rumble boards of suitable thickness to prevent ground compaction and root damage are to be installed in the access route through the TPZ of Tree 1.

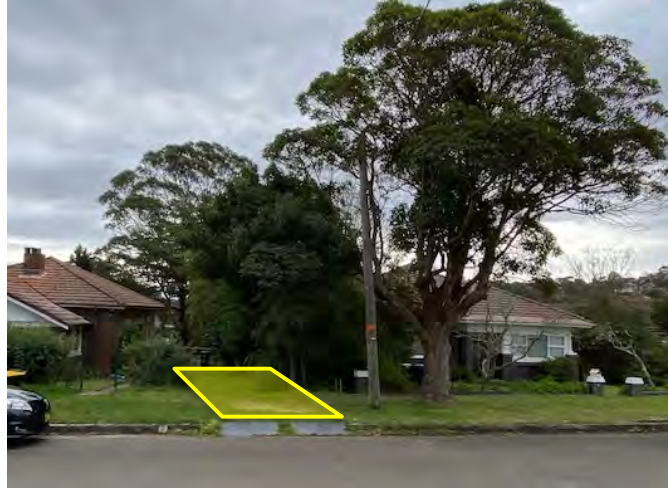
**Figure 27:** Current site access is through the TPZ of Tree 1 indicated by the yellow polygon requires ground protection. (Source: Austin 16/072020)
