**GEOTECHNICAL RISK MANAGEMENT POLICY FOR PITTWATER**  
**FORM NO. 1 – To be submitted with Development Application**

Report Title: Geotechnical Report 2A William Street, Avalon

## **GEOTECHNICAL INVESTIGATION:**

New Garage and Pool and Lift at **2A William Street, Avalon**

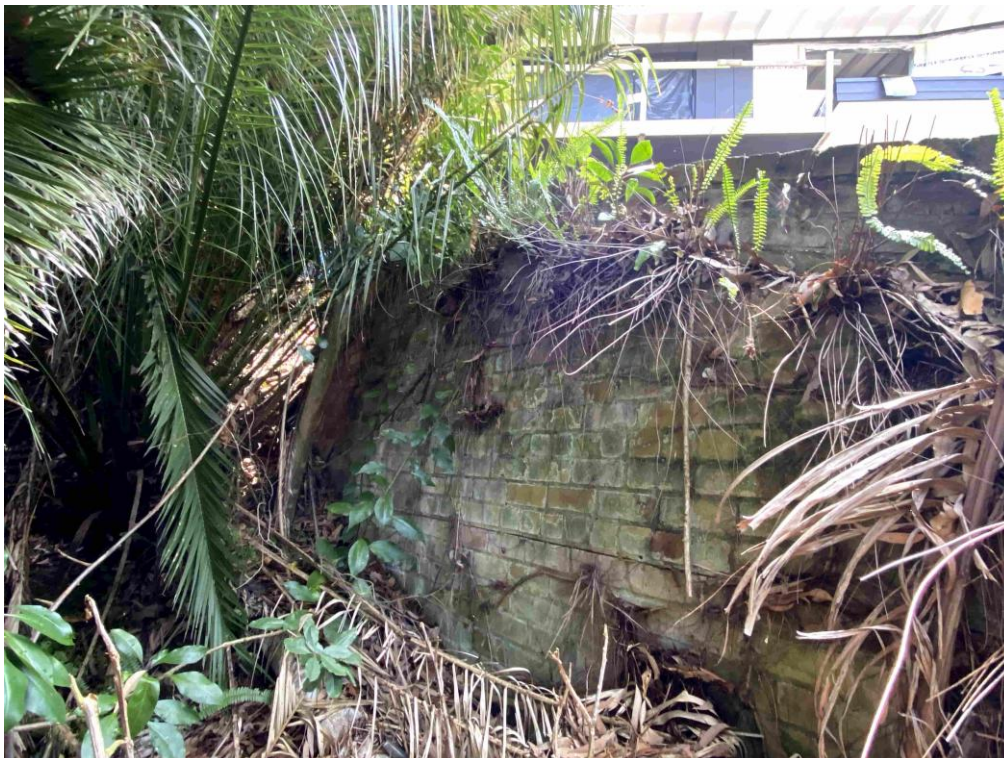
Photo 2

- 2.1** The site was inspected on the 13<sup>th</sup> November, 2024, and previously in August 2022, and March 2024.
- 2.2** The property is accessed by a Right of Carriageway (ROW) off the uphill side of William Street and has an E aspect. The block runs lengthways to the NW so the slope is a cross-fall. It is located on the steeply graded upper reaches of a hillslope. The natural slope rises across the property at an average angle of ~23°. The slope above the property eases in grade. The slope below the property continues at similar steep angles.
- 2.3** At the road frontage, a concrete ROW and driveway run to a garage on the ground floor of the house (Photo 1). Fill for the driveway on the downhill side is supported by a brick retaining wall reaching ~1.8m high which has been constructed with a tilt back into the slope (Photo 2). Stepped settlement cracking up to ~ 8mm

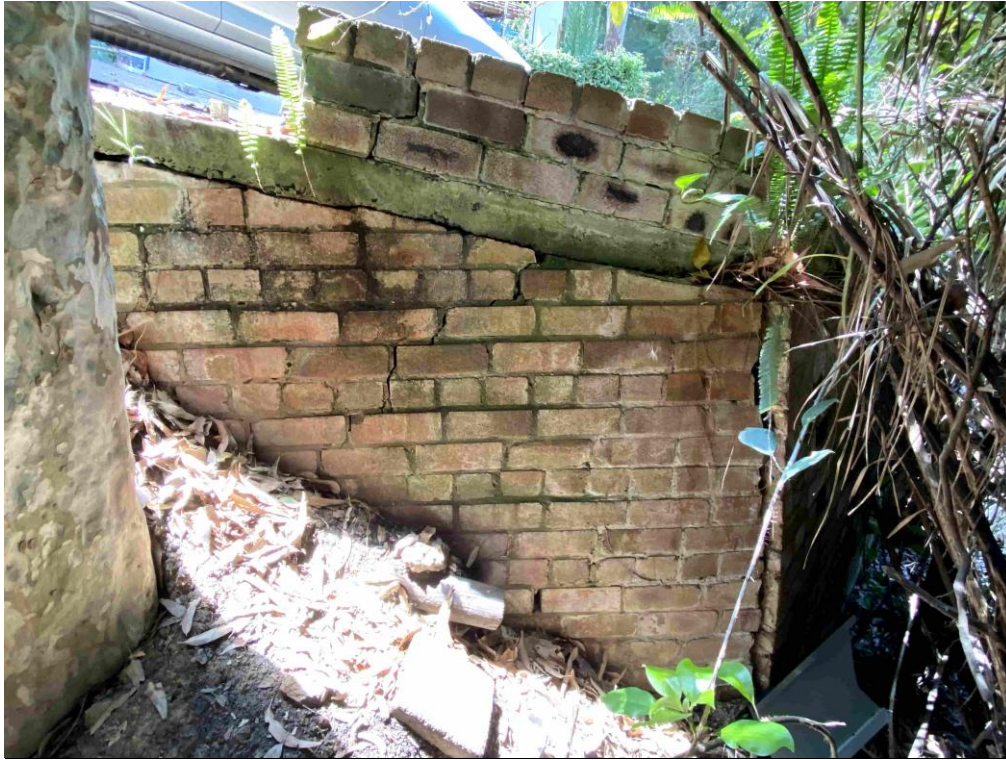
Photo 3

wide was present on the wall face (Photo 3). No deflection was observed and the wall is considered stable. A cut for the driveway and ROW and fill for landscaping below the house is supported by a stone block retaining wall reaching ~1.8m high (Photo 4). This wall will be demolished as part of the proposed works.

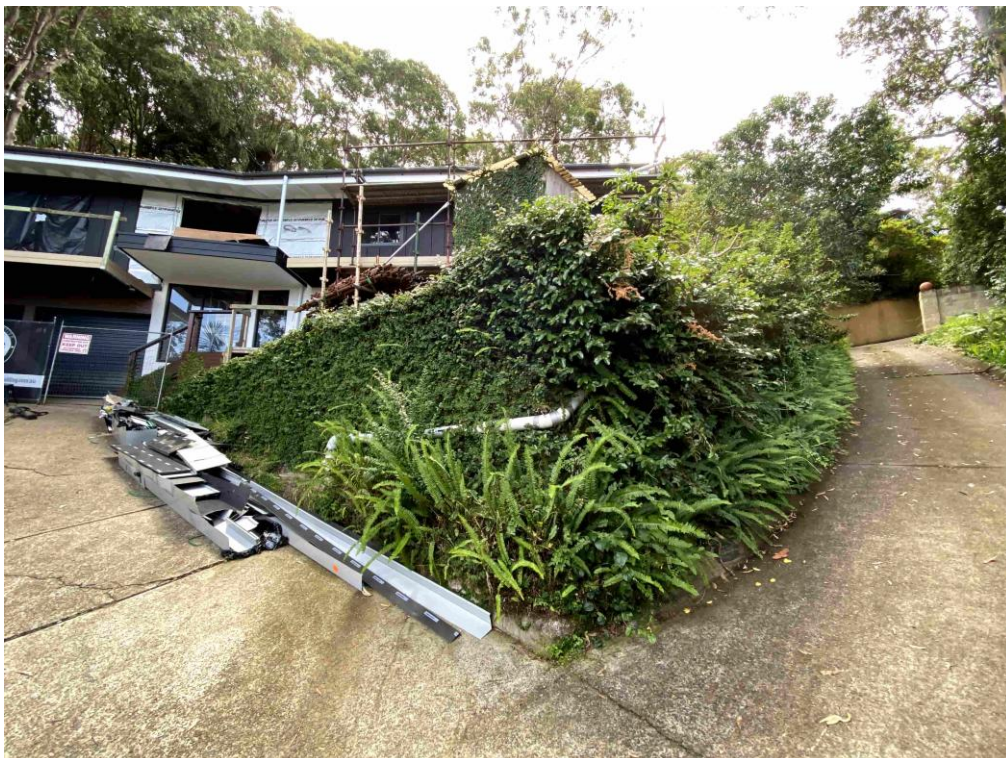
Photo 4

- ~Flush with a retaining wall on the uphill side of the driveway which will be demolished as part of the works (Photo 4).
- ~Flush with a retaining wall on the downhill side of the driveway (Photo 2).
- ~0.5m from the SE common boundary.
- Close to flush with the supporting house walls at the corner of the garage excavation but angling away at 45° (Photo 13).

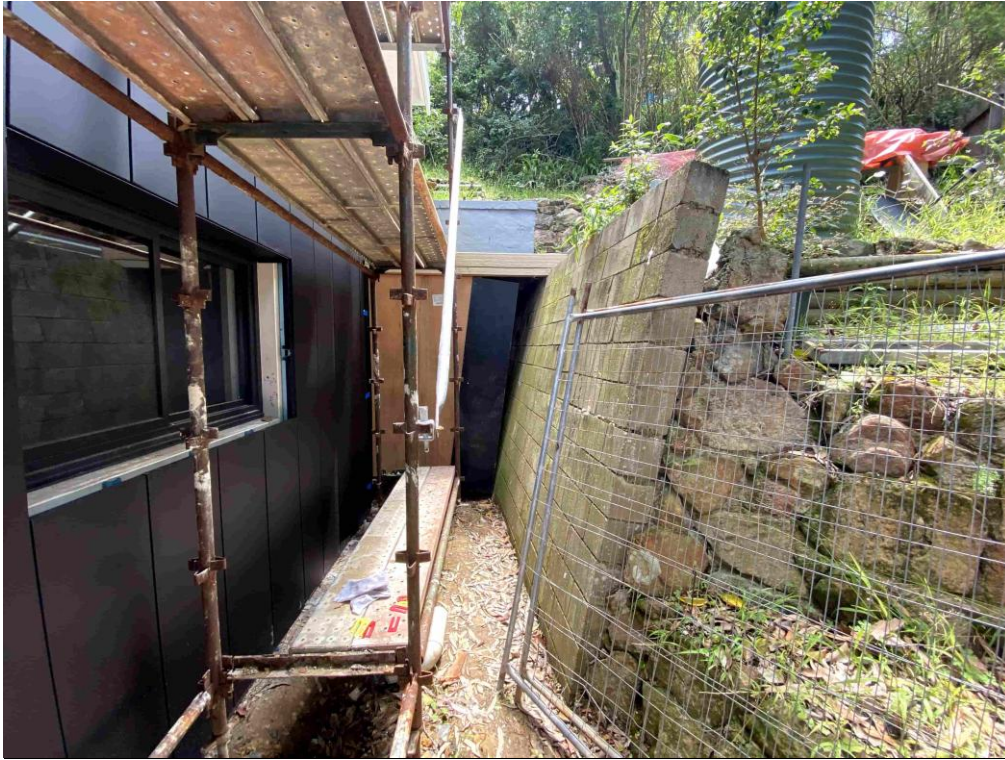
Photo 5

The two-story rendered brick house is supported on brick walls. No significant signs of movement were observed in the visible supporting walls. A cut for the house is supported by a concrete block retaining wall reaching ~3.0m high (Photo 5). Behind the house the wall is tilting at the southern end. This has recently been reinforced with 3 ground anchors taken at least 5.0m into the slope. Various cuts and fills above the house for landscaping are supported by retaining walls of dry stack stone, brick, and timber composition and reaching ~2.9m high (Photos 6 & 7). The brick wall which has been constructed with a tilt back into the slope exhibits stepped cracking. However, no deflection was observed. These walls are considered stable.

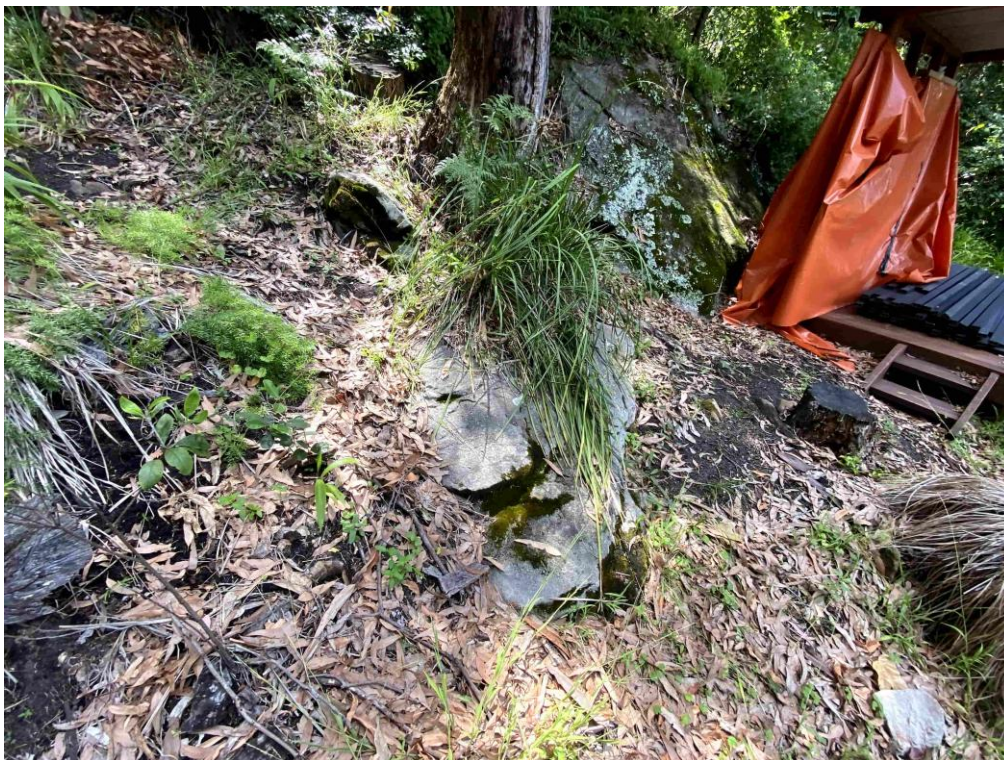
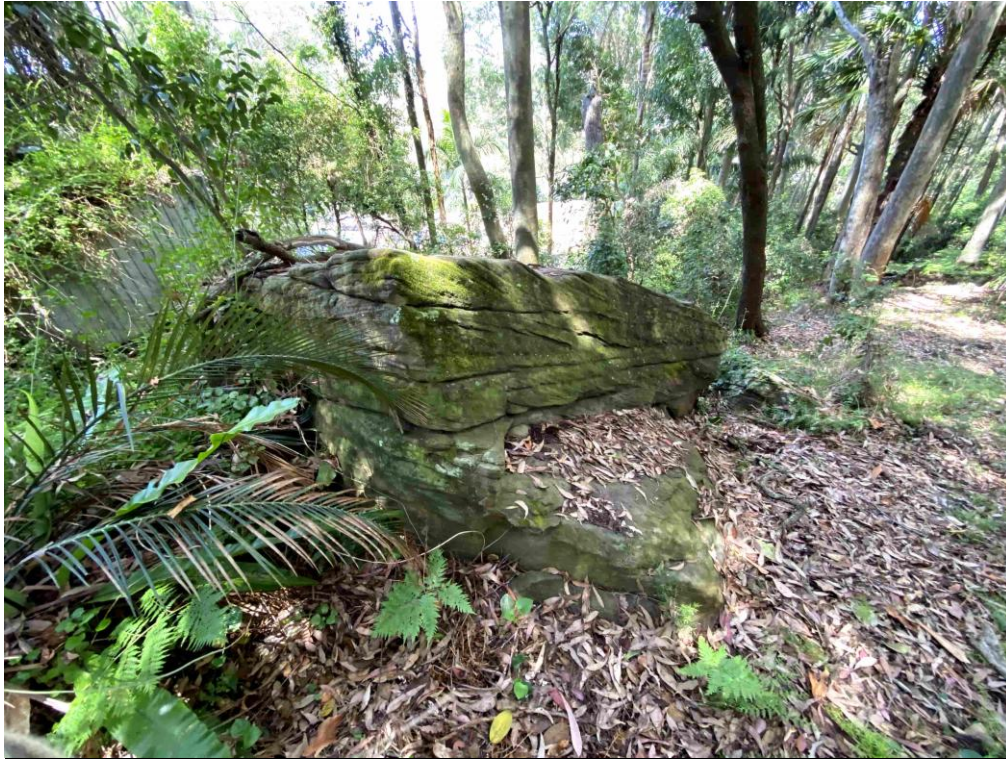
Where the steep slope above the house is not supported by retaining walls, it is well vegetated. Sandstone boulders are scattered in this location as well as across the easing slope above the subject property (Photos 8 and 9). Most of the boulders were observed to be resting/sufficiently embedded in stable positions. One boulder was observed to be perched on, and overhanging another boulder upslope from the subject property (Photo 10). It has likely remained in this position for hundreds if not thousands of years. The boulder is ~1.8m wide and ~3.0m long, and is overhanging by ~0.9m. The majority of the rock mass is on the uphill side. As such, the balance point of the upper boulder does not appear to be compromised and the boulder is considered to be in a stable position.

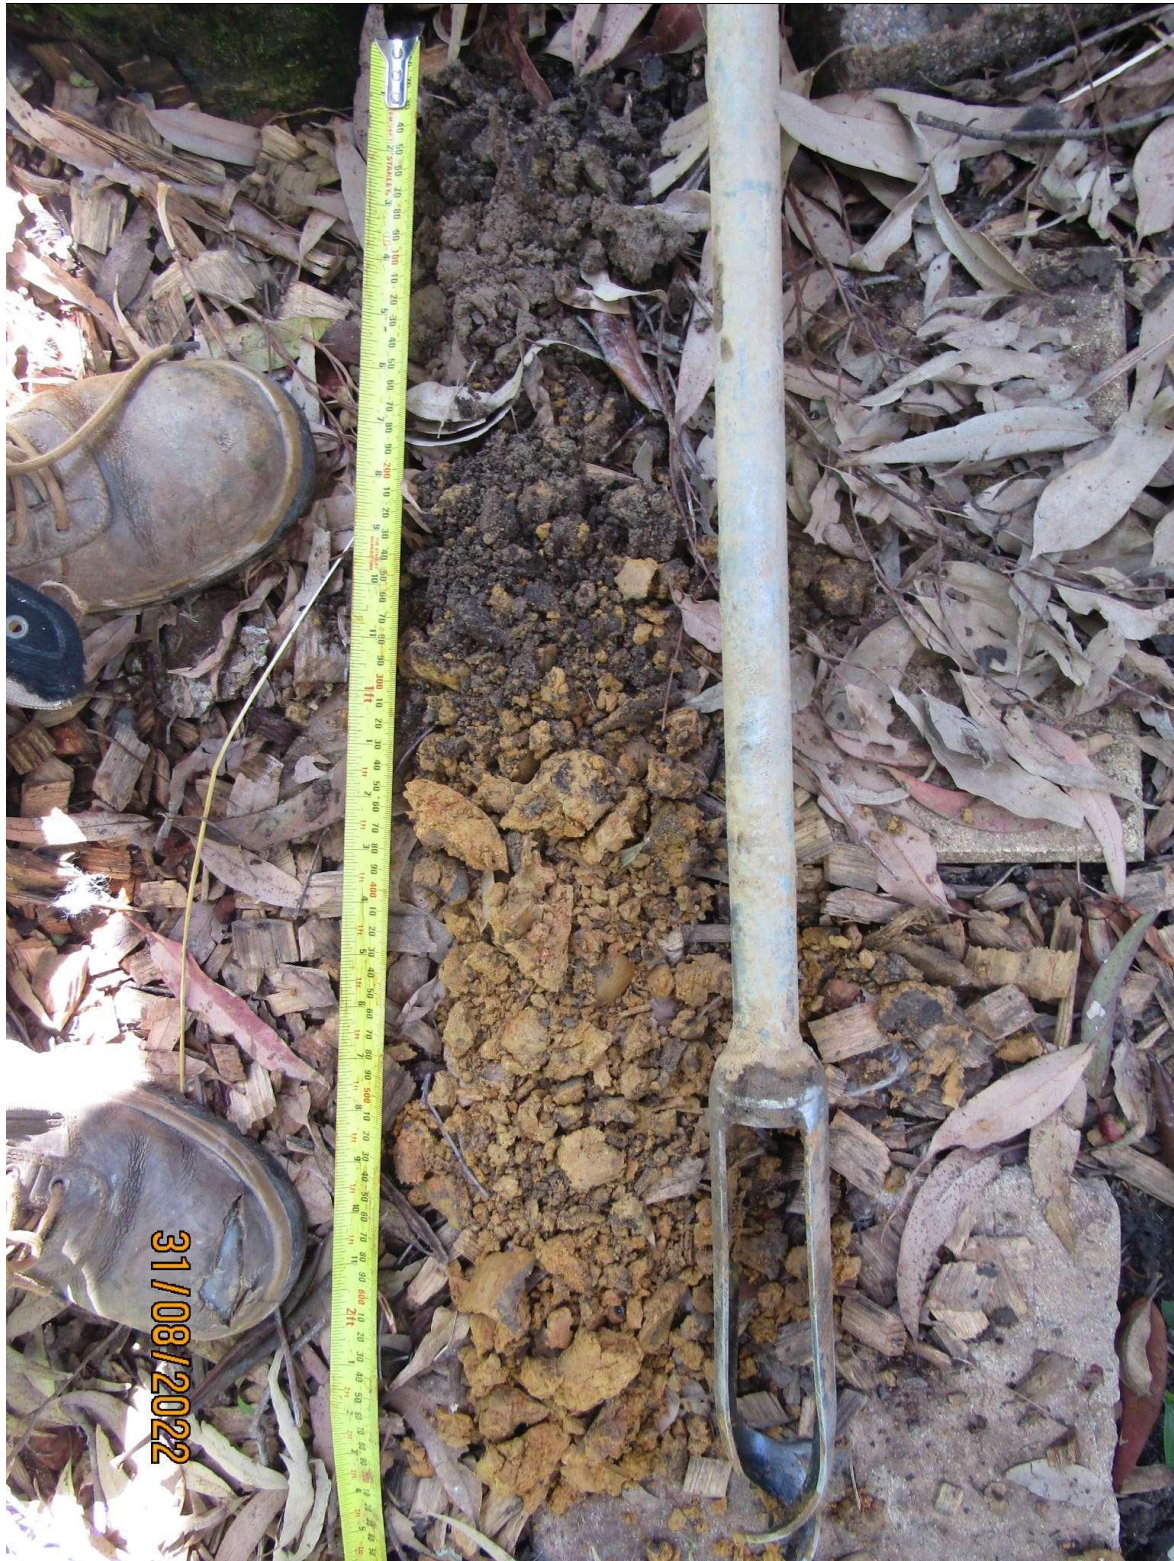
Photo 11 – downhole is top to bottom

##### AUGER HOLE 1 (~RL67.0) – AH1 (Photo 11)

Depth (m)	Material Encountered
0.0 to 0.3	<b>TOPSOIL</b> , sandy soil, grey and dark brown, loose, moist, fine to medium grained.
0.3 to 0.7	<b>RESIDUAL CLAY</b> , light brown orange, firm to stiff, dry to moist.

End of test @ 0.7m in residual clay. No water table encountered.

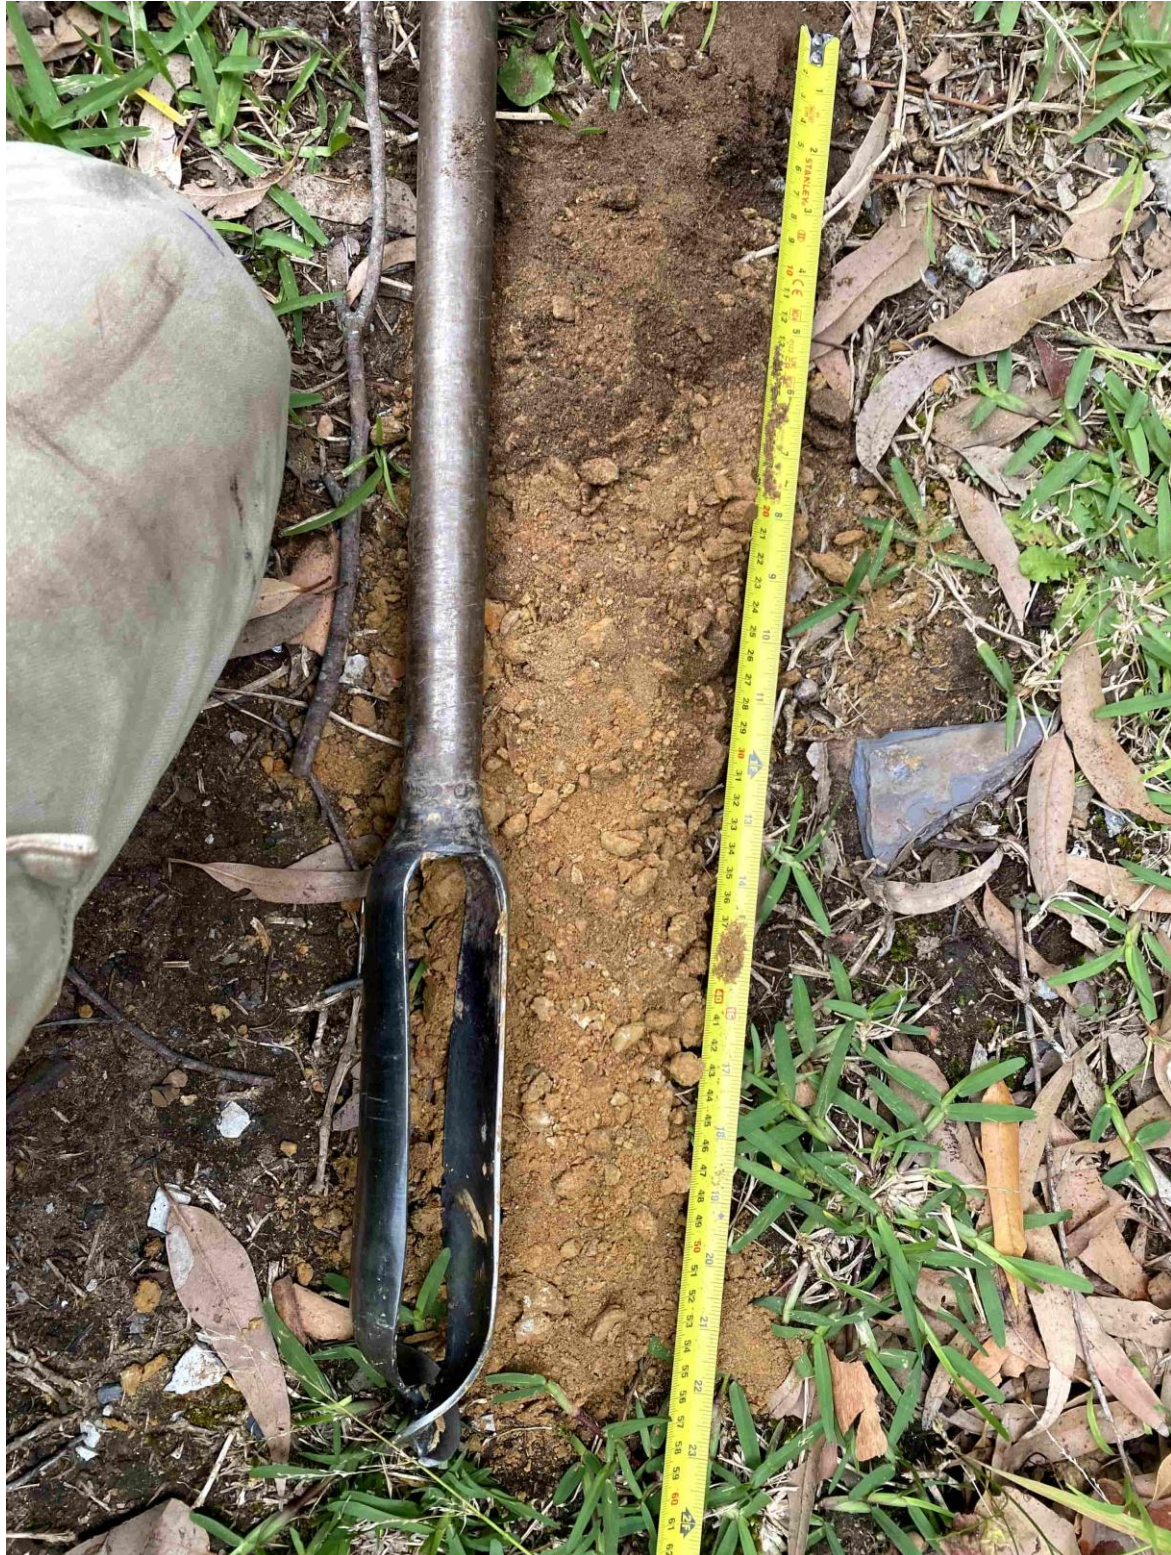
Photo 12 – downhole is top to bottom

## AUGER HOLE 2 (~RL63.7) – AH2 (Photo 12)

Depth (m)	Material Encountered
0.0 to 0.2	<b>TOPSOIL</b> , silty sandy, brown, fine to medium grained, Dense, dry.
0.2 to 0.6	<b>RESIDUAL CLAY</b> , orange, Very Stiff, dry, fine to medium grained.

End of test @ 0.6m auger not progressing through residual clay. No water table encountered.

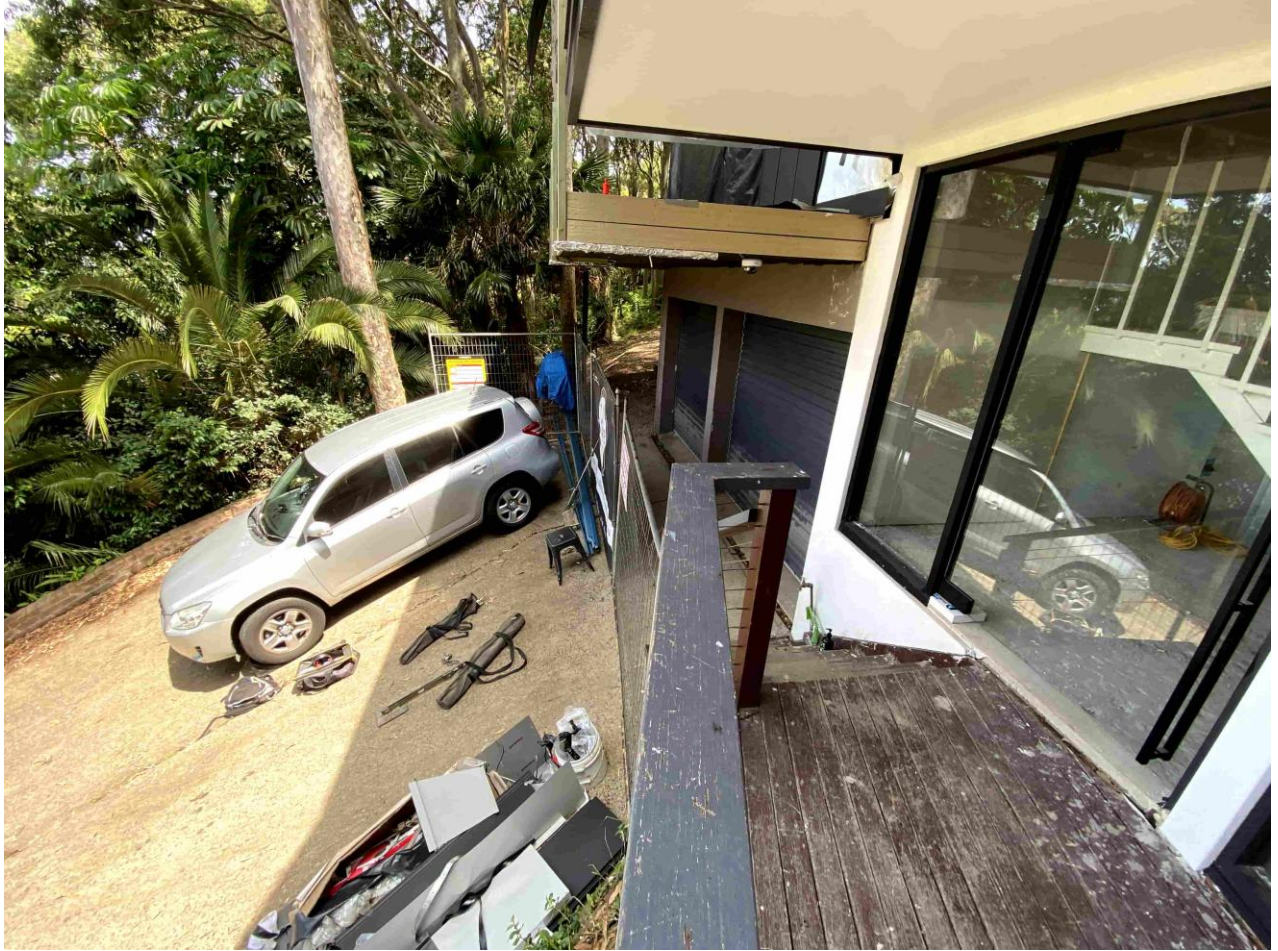
Photo 13

HAZARDS	Hazard Three	Hazard Four
TYPE	The excavations collapsing onto the work site before retaining structures are in place.	The proposed excavation for the garage and lift undercutting the footings of the house (Photo 13) and brick retaining wall (Photo 2), causing damage or failure.
LIKELIHOOD	'Possible' ( $10^{-3}$ )	'Possible' ( $10^{-3}$ )
CONSEQUENCES TO PROPERTY	'Medium' (25%)	'Medium' (35%)
RISK TO PROPERTY	'Moderate' ( $2 \times 10^{-4}$ )	'Moderate' ( $2 \times 10^{-4}$ )
RISK TO LIFE	$5.9 \times 10^{-5}$ /annum	$5.3 \times 10^{-5}$ /annum
COMMENTS	This level of risk to life and property is 'UNACCEPTABLE'. To move risk to 'ACCEPTABLE' levels, the recommendations in <b>Section 13 and 15</b> are to be followed.	This level of risk to life and property is 'UNACCEPTABLE'. To move risk to 'ACCEPTABLE' levels, the recommendations in <b>Section 13</b> are to be followed.

Due to the depth of the excavation grade of the slope, and its proximity to the subject house, common boundaries, and brick retaining wall which is to remain, it is recommended ground support be installed along all sides of the excavation prior to the excavation commencing. See the site plan attached for the minimum required extent of the shoring shown in blue.

A spaced piled retaining wall is one suitable method of support. Pier spacing for the wall is typically ~2.0m but can vary between 1.6 to 2.4m depending on the design. To drill the pier holes for the wall, a mini piling rig or similar that can excavate through Medium to High Strength Rock is recommended as the ground testing did not extend to the likely required depth of the piles. If a machine of this type is not available, we recommend carrying out core
