Project 24750.02  
19 July 2013  
RKL:pc

**Unit 16, 20 Narabang Way, Belrose**  
**Development Application DA2013/0714**  
**Preliminary Geotechnical Assessment and Report**

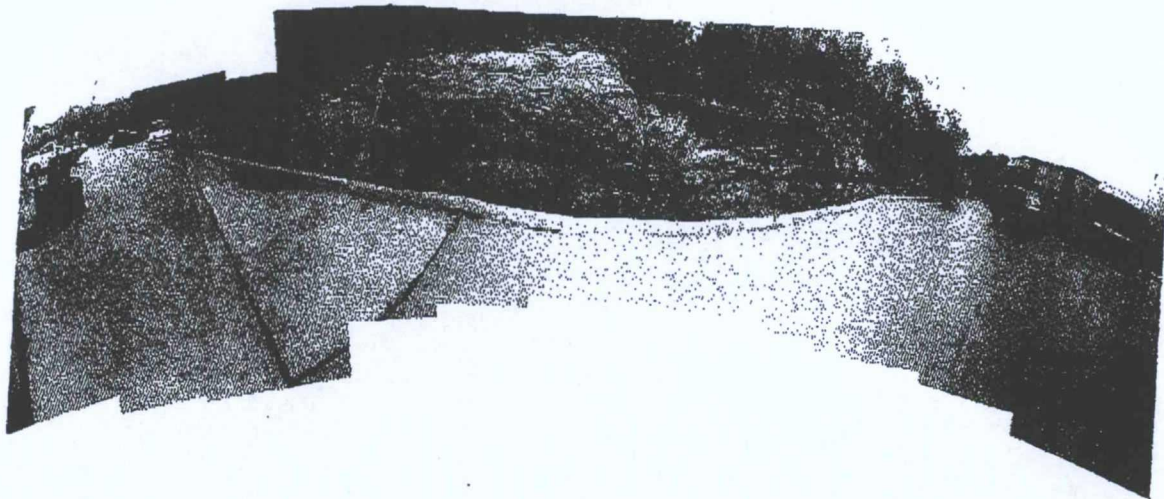
The construction comprises an on-grade concrete pavement (refer to Figure 1 below) which is supported at the western side by a concrete block retaining wall of up to about 1.4 m height (refer to Figure 2).

Figure 1. 270° panorama of the hardstand area (distortion due to photo merging).

- it is noted that the eastern side of the hardstand area comprises a natural cliff (refer to Figure 1), however the height is less than 3 m and, although some weathering of the lower part is likely, the exposed rock is considered to be of adequate stability.

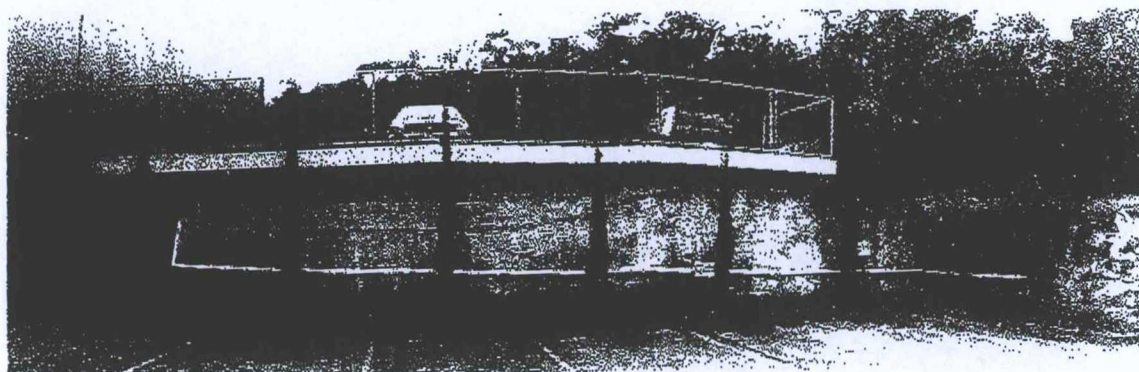
Figure 2. Panorama of the low, western side of the hardstand area.

- the site is currently developed and there appears to be filling of up to about 1.8 m depth present at the northern end of the western retaining wall (refer to Figure 2). It is noted that the filling is retained by a well-constructed concrete block retaining wall, with no evidence of distress or cracking of the wall. The wall is founded on sandstone of at least medium to high strength which is more than adequate to support the wall.

- the western retaining wall is founded at the top of an excavation in sandstone bedrock which ranges from about 1.2 m to 2.6 m in height. The excavated rock face comprises medium and high strength sandstone with no adversely oriented defects observed. The excavation is considered to be stable and adequate to support the overlying wall.
